SITE AUDIT REPORT AND SITE AUDIT STATEMENT

Caddens Release Area C, Kingswood, NSW, 2747

Report Number. 097623019_014_R_Rev0

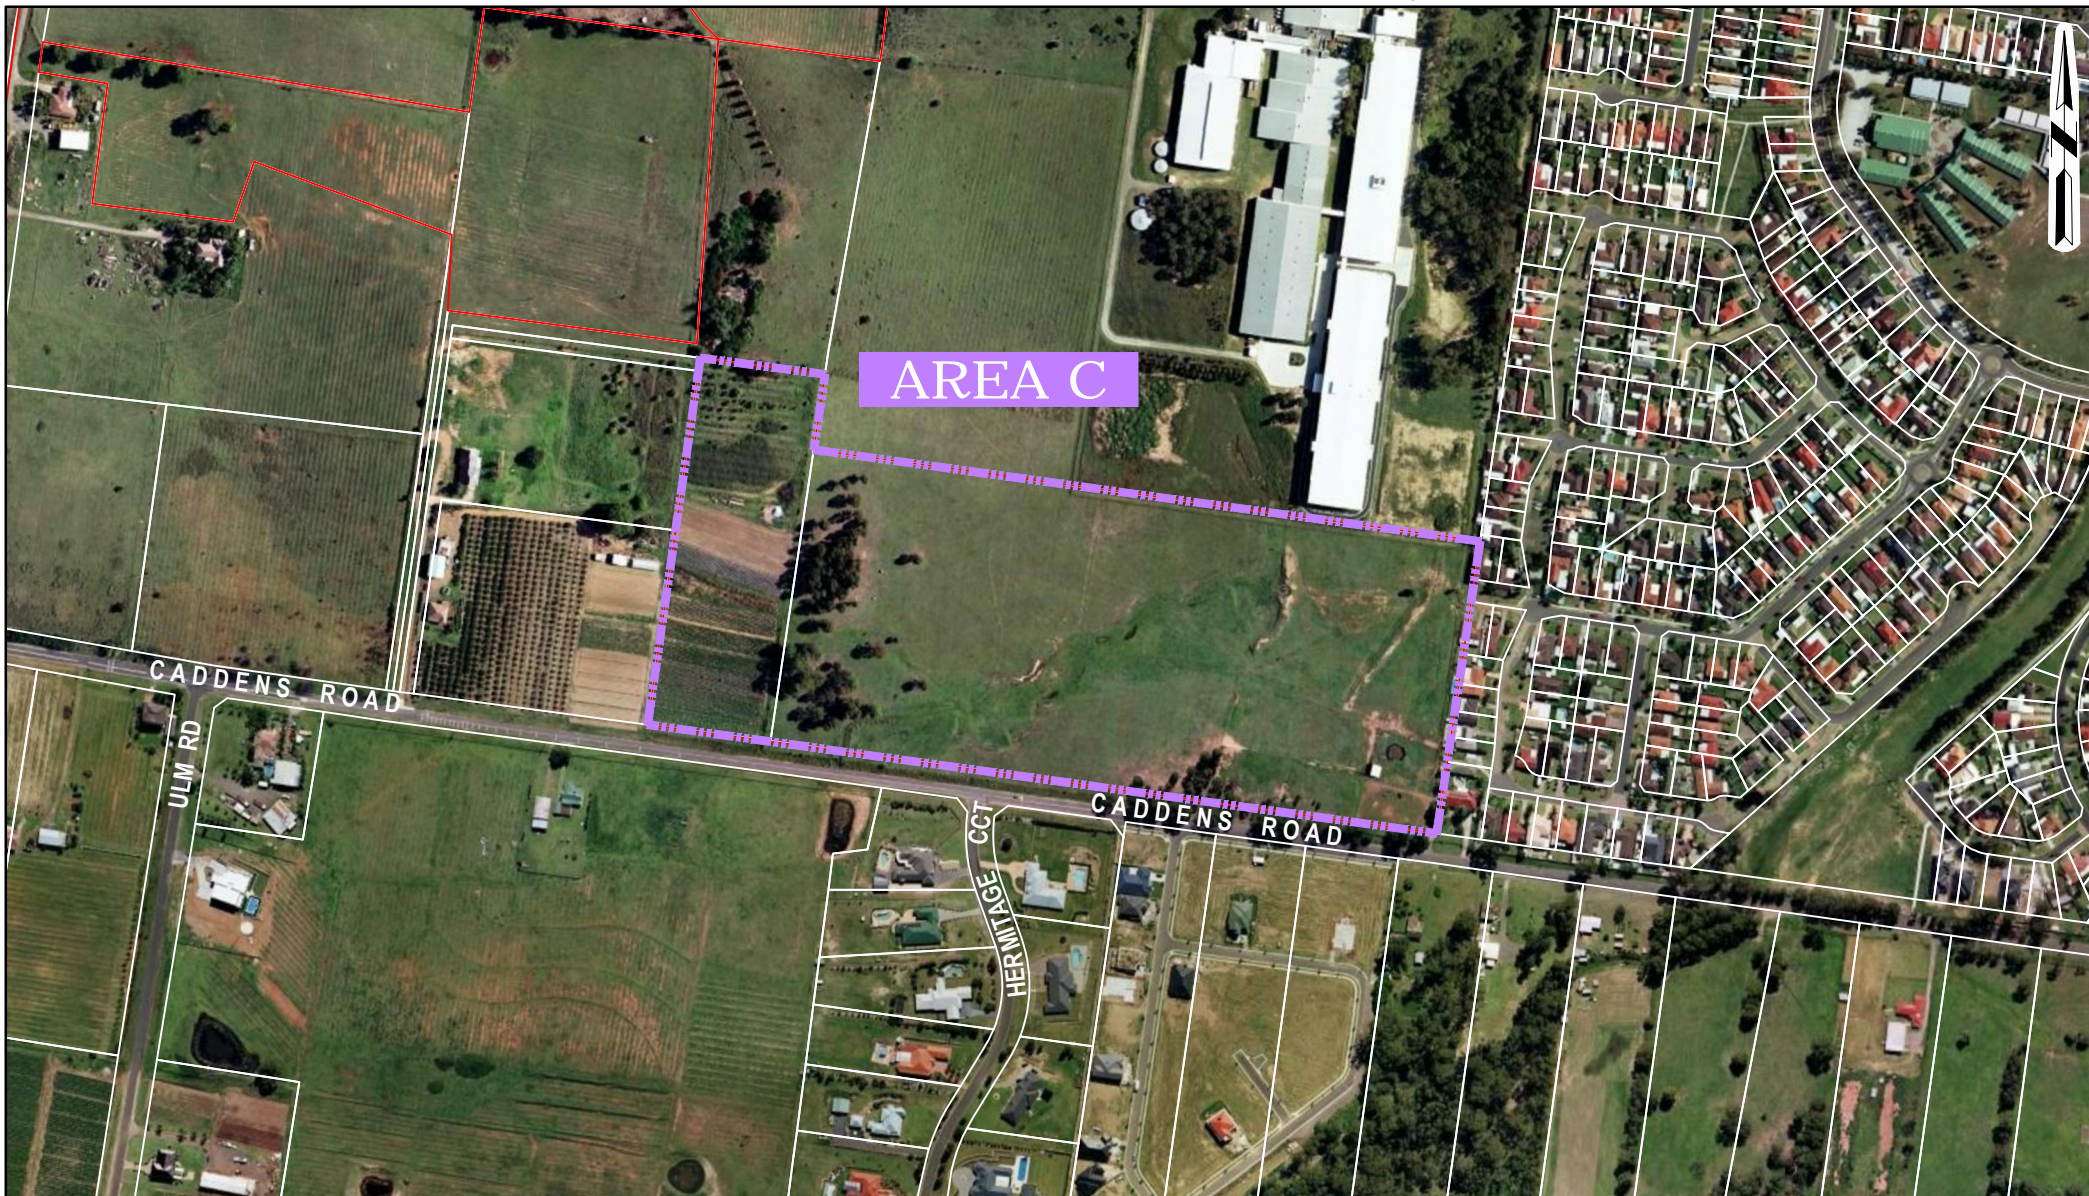
LEGEND BOUNDARY OF AREA C	©2008 Source: Google Earth Pro 2008 IMAGE DATED: 20.01.2007 SUPPLIED BY AND SOURCED UNDER LICENCE FROM GOOGLE EARTH PRO ON 14.08.2009 IMAGE GEOREFERENCED BY GOLDBER AND INTENDED FOR INDICATIVE PURPOSES ONLY				CLIENT LANDCOM	PROJECT SITE AUDIT REPORT : CADDENS RELEASE AREA, KINGSWOOD, NSW				
	ADAPTED FROM DIGITAL CADASTRE DATABASE, NSW DEPARTMENT OF LANDS, 2004, ZONE 56 MGA COORDINATES	www.golder.com GOLDBER ASSOCIATES PTY LTD		DRAWN HC	DATE 23.05.2011	TITLE AREA C				
1:5,000 			SCALE 1:5000	PROJECT No A4 097623019	DOC No 014	DOC TYPE R	FIGURE No F0002	REV No 0	FIGURE 2

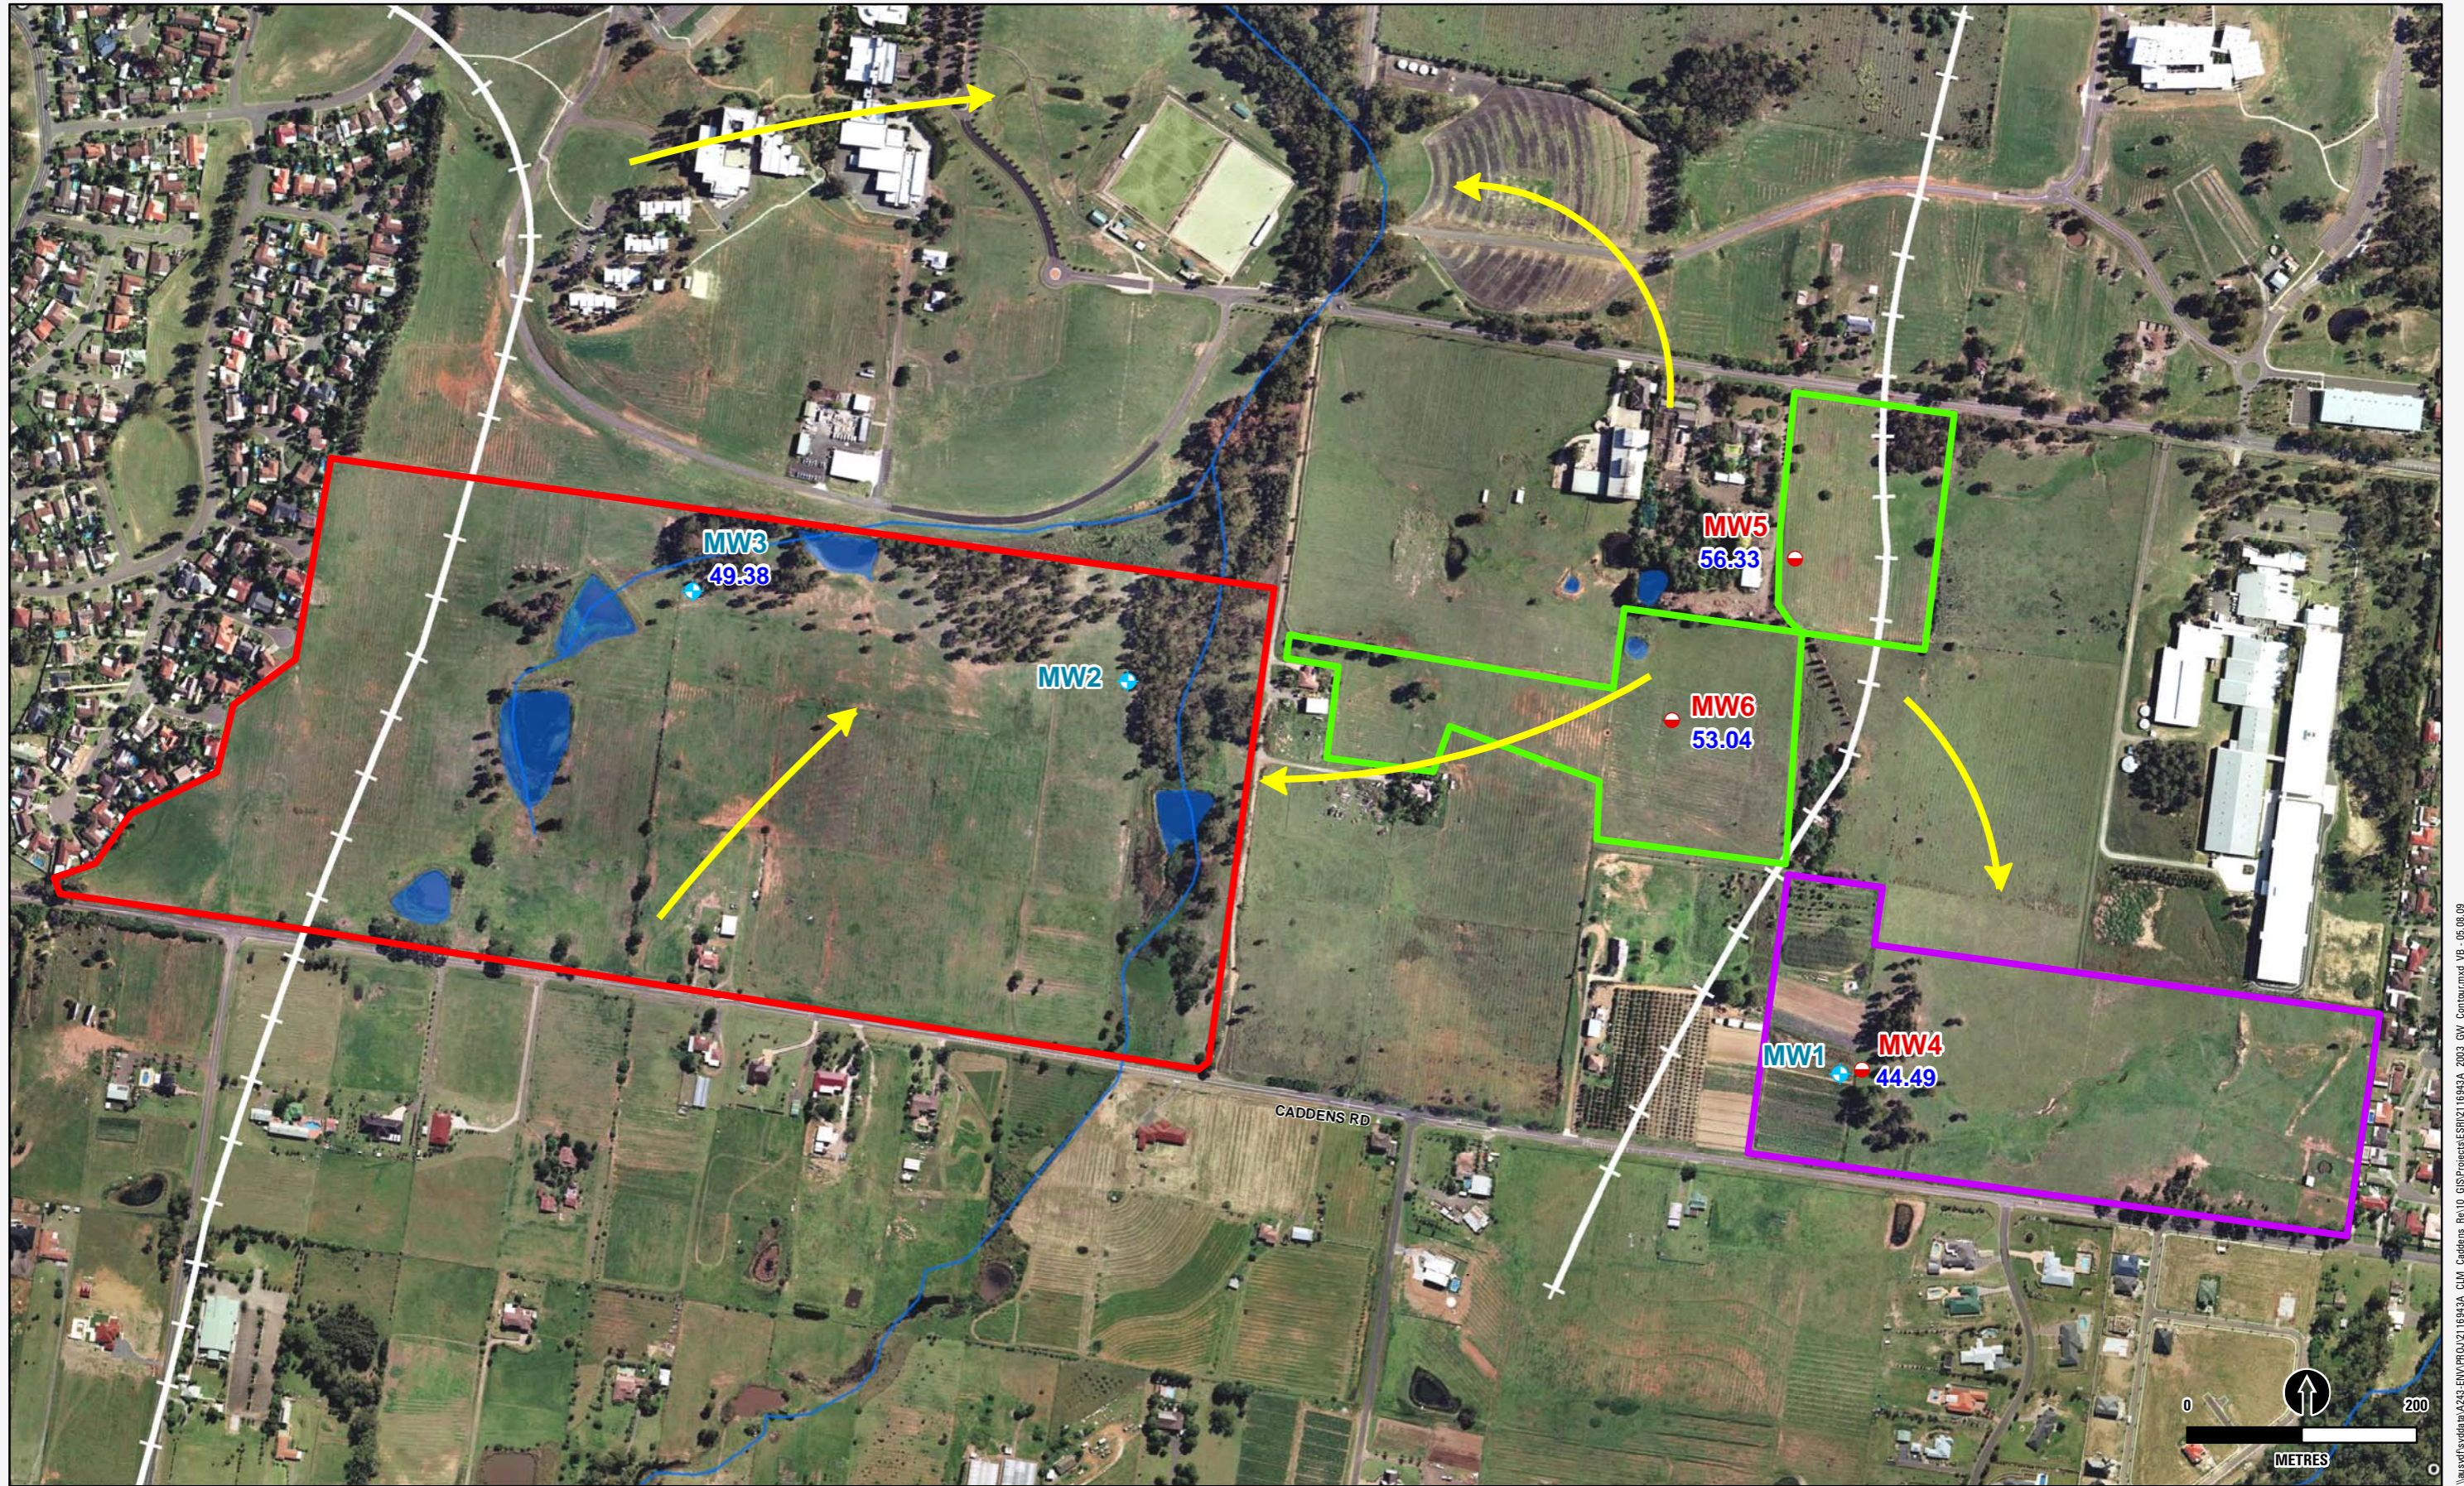
Figure 12 Groundwater Flow

- Catchment divide
- Inferred groundwater flow direction
- 49.3 Groundwater elevation (mAHD)
