GTE1735 – Geotechnical and Environmental Report
7 August 2018

**RE: Geotechnical Investigation, Salinity Assessment and Stage 1 Contamination Assessment
at No.20 Robert Street, Penrith**

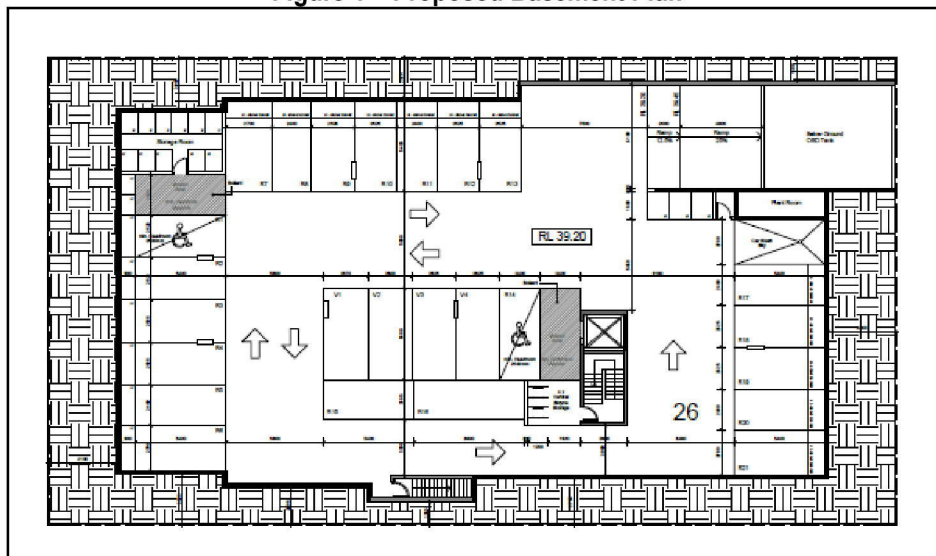
Figure 1 – Proposed Basement Plan

It is understood that the proposed development will entail the demolition of the existing structure allowing the construction of a four storey apartment building with a basement level car park. Excavations of up to 4.4m will be required across the entire building envelope in order to accommodate the basement level car park.

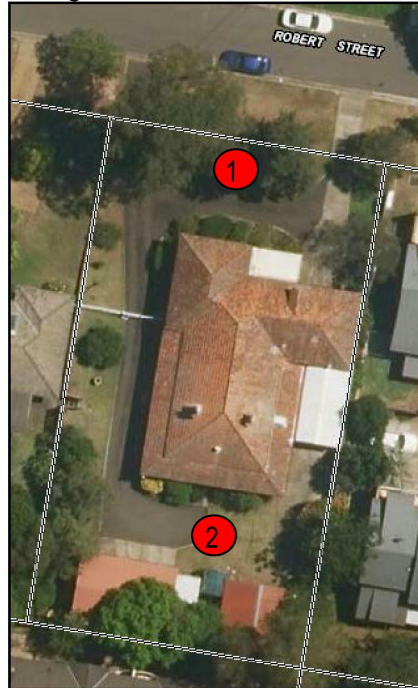
Figure 4 – Borehole Locations

Fieldwork was undertaken on 13th of June 2018 and included drilling two boreholes using a 4WD Toyota Landcruiser Ute mounted drill rig with 100 mm solid flight spiral augers at locations shown on Figure 4. Two (2) samples were recovered for environmental testing and four (4) samples were recovered for salinity testing. Laboratory test certificates are presented in Appendix B.

Six (6) distinct geological units were encountered during the field investigation. These units are detailed in table 2 along with the approximate depth of each unit. Full borehole logs are presented in Appendix A.

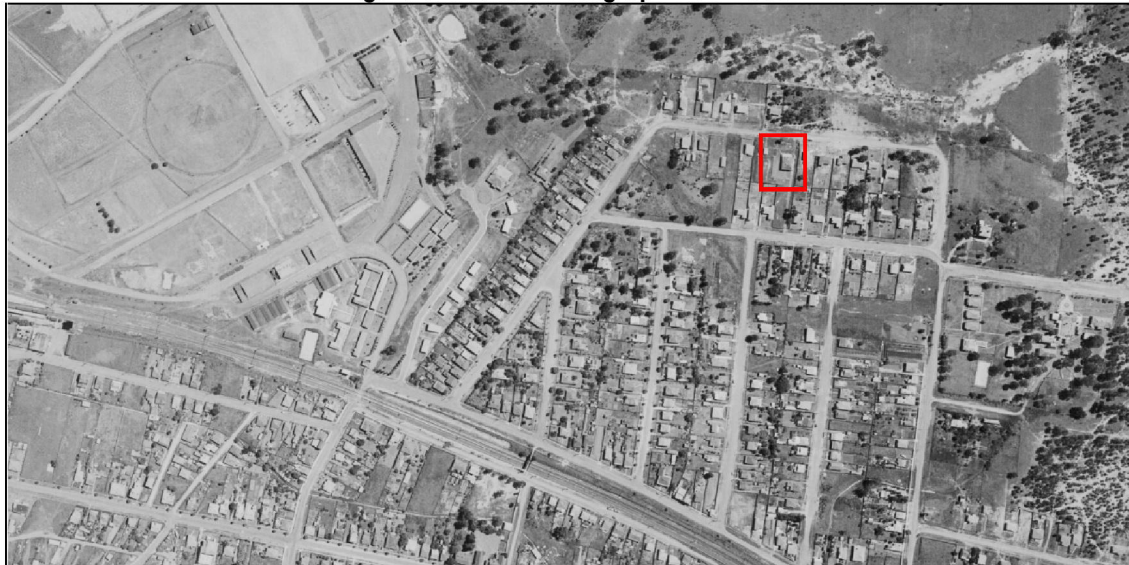
Figure 6 – Aerial Photograph from 1956

1956 – In 1956, the subject site and surrounding sites were in use for residential purposes. No industrial facilities can be observed within the area. The approximate location of the subject site is highlighted in figure 6.

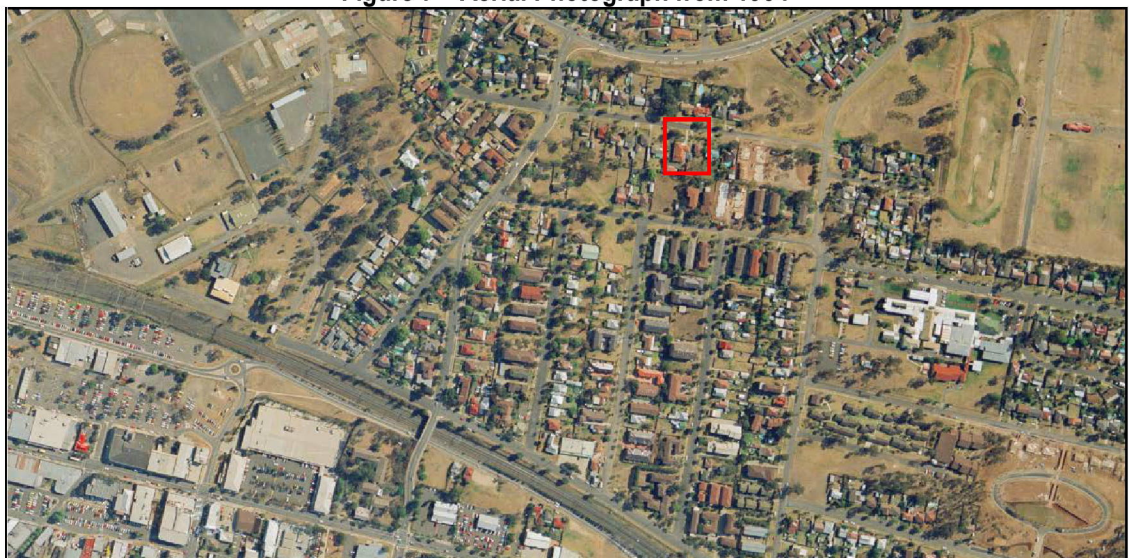
Figure 7 – Aerial Photograph from 1994

1994 – In 1994, the site and surrounds are still in use for residential purposes. The site and surrounds are in a similar condition to 2018. No industrial facilities can be observed within the area. The approximate location of the subject site is highlighted in figure 7.
