DETAILED SITE CONTAMINATION INVESTIGATION

**25-29 Chameleon Drive
ERSKINE PARK NSW 2759**

CLIENT: Penrith City Council

REPORT NUMBER: 11538.04.TSCA

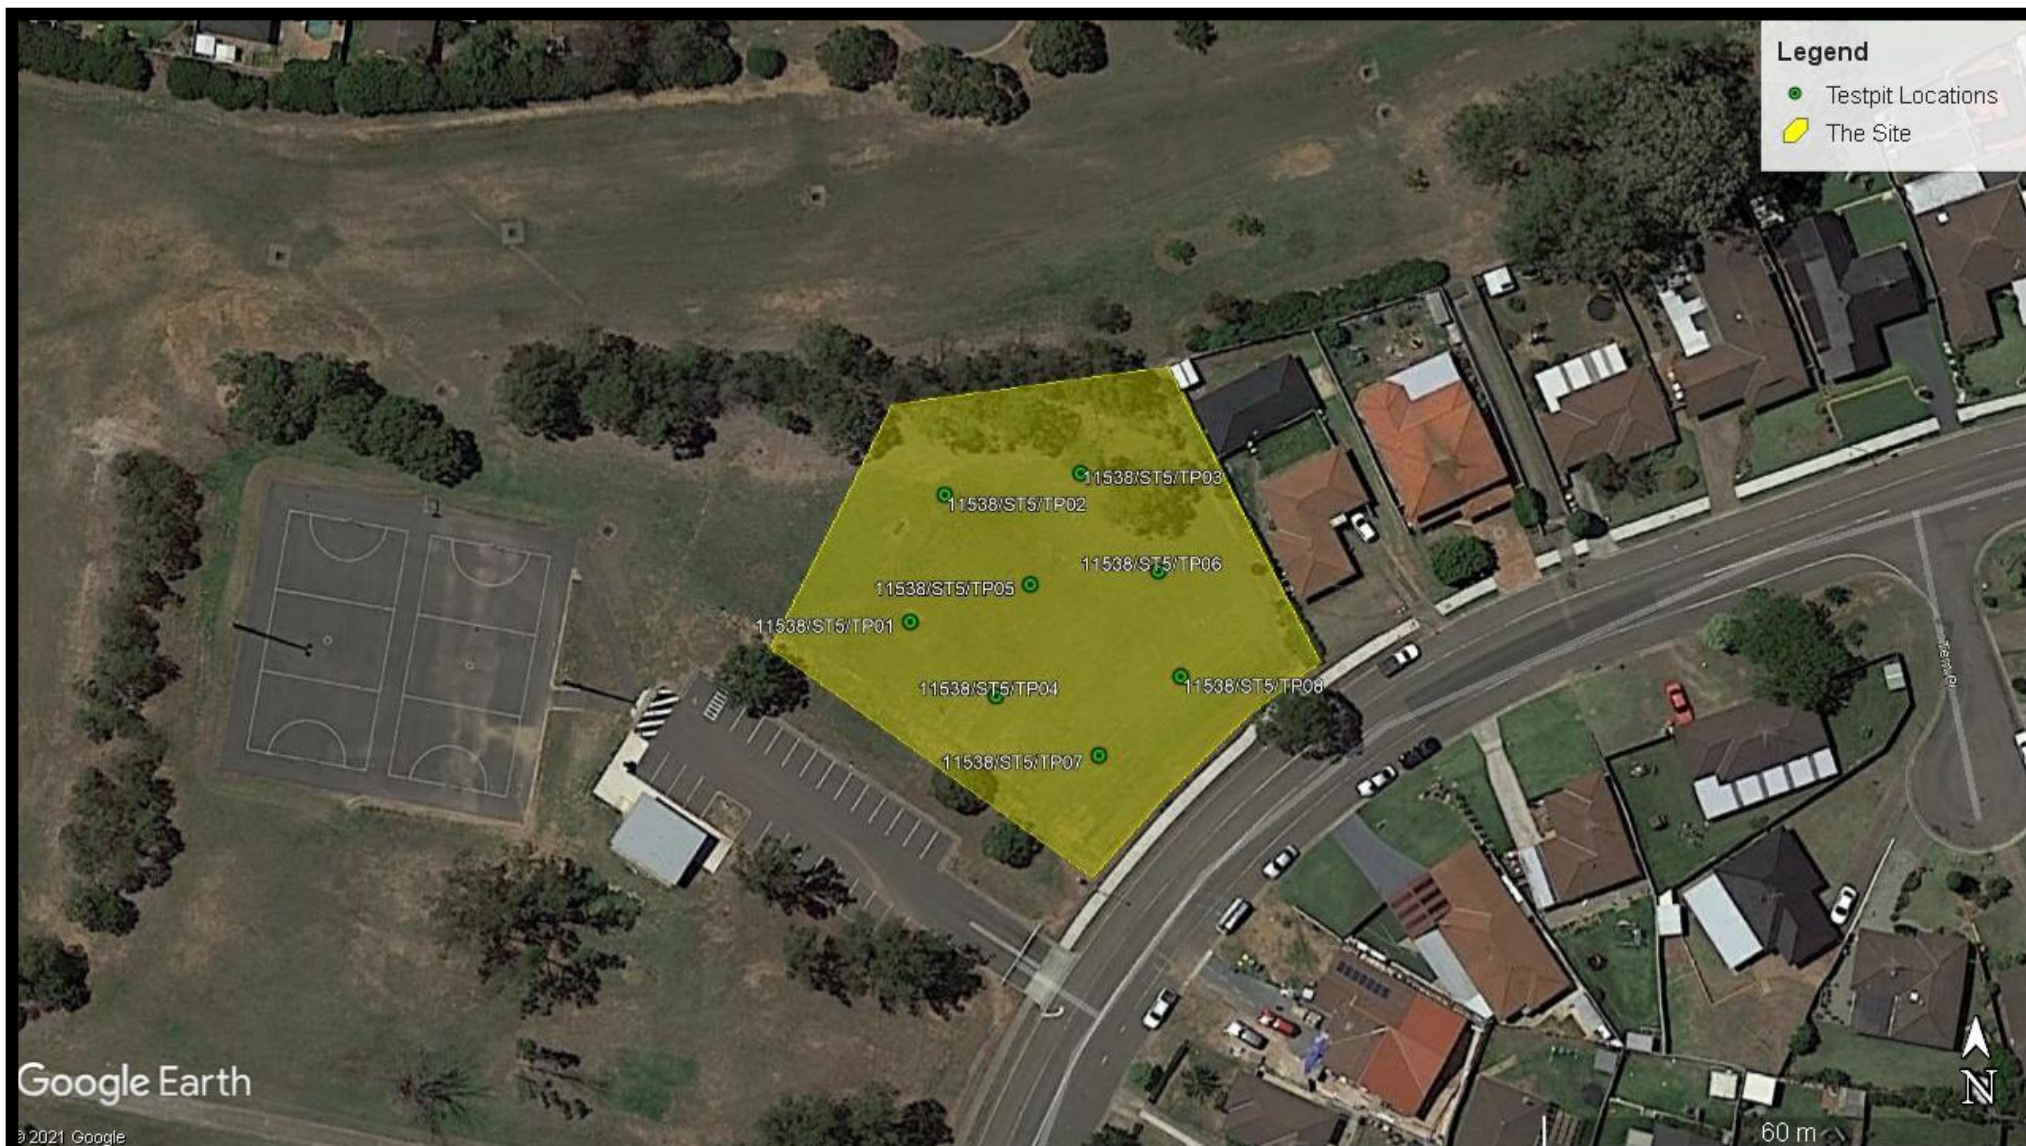
Figure 2: Site Map
25-29 Chameleon Drive, ERSKINE PARK NSW 2759

The following table lists potential contaminants based on site activities and conditions identified during the site historical review and walkover inspection (refer to Sections 5 to 7). Refer to **Appendix I** for Site Map of the sources.

During excavation of the test pits, it was noted that the test pits were excavated up to depths ranging from 0.55-1.0m due to natural clay observed at depths ranging from 0.2-1.0m

Upon inspection of each test pit, Getex identified minor foreign material at a depth of 0.35m from test pit TP05. The foreign materials observed include black asphalt.
