CCL Development Pty Ltd Site Remediation and Validation Report Highland Views: Stage 4, Glenmore Park NSW

To undertake a validation assessment following the remediation of asbestos impacted fill soils at the site.

S-00573.SRVR.001 / C0009

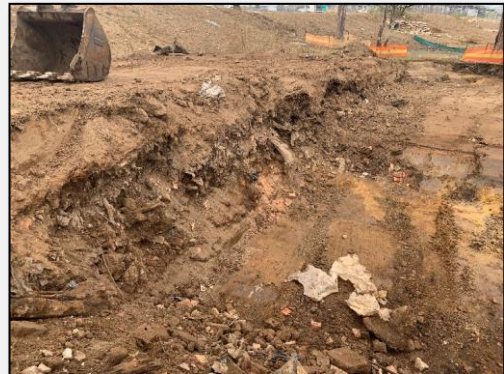
Photo 2: 08 January 2020: Commencement of excavation in remediation zone. Foreign materials including ACM observed.

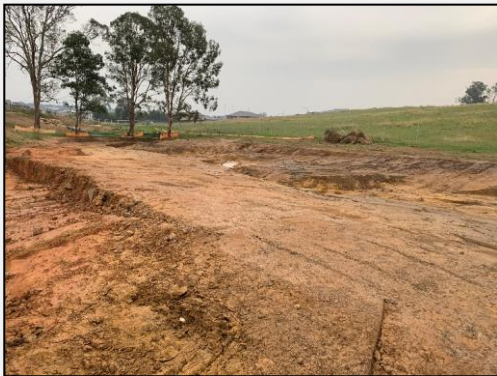
Photo 3: 24 January 2020: Completion of excavation in remediation zone.

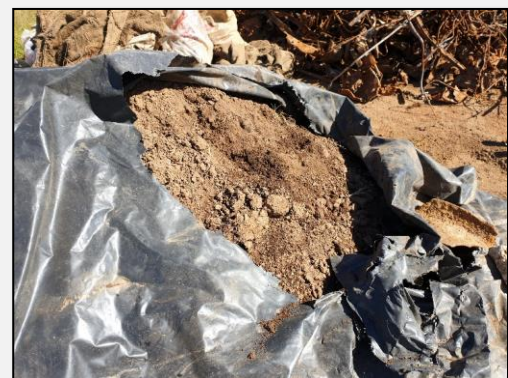
Photo 18: 19 March 2020: General soil material encountered within stockpile of residual asbestos impacted soils.

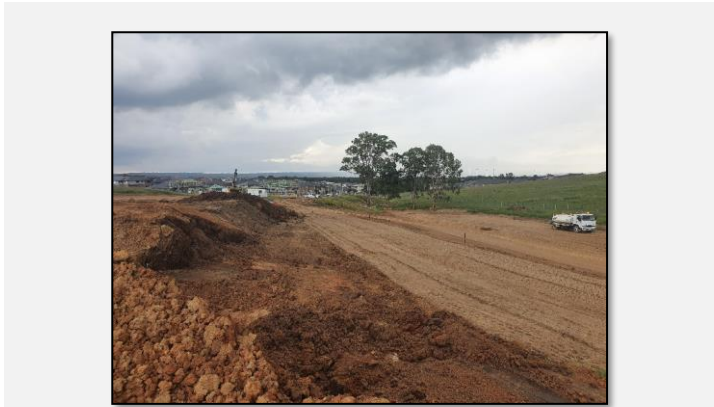
Photo 25: 25 March 2020: Capping completed over cell.

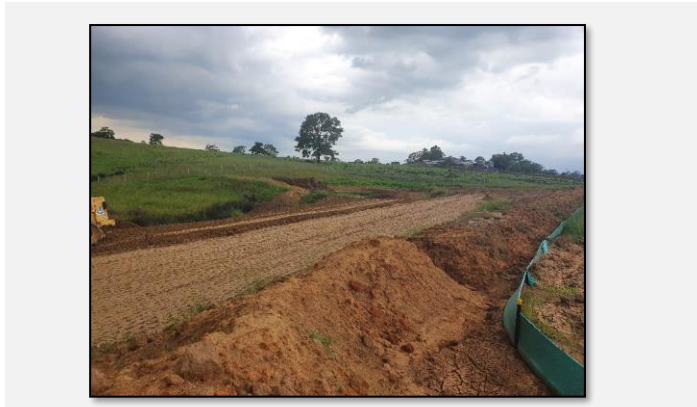
Photo 26: 25 March 2020: Capping completed over cell.

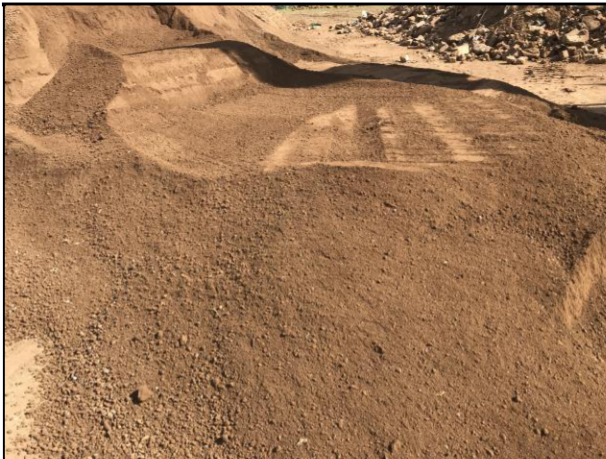
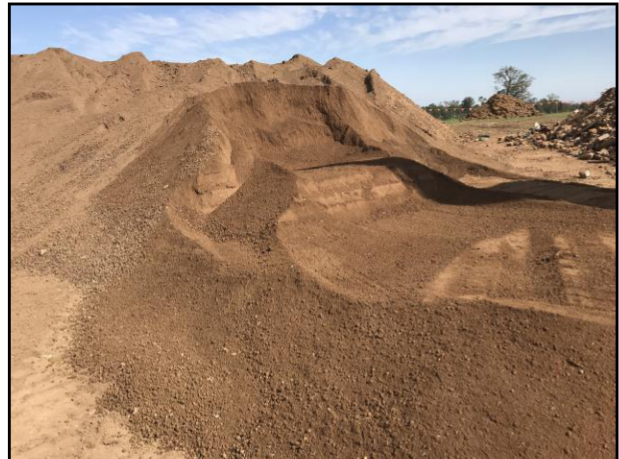
Photos of the Screened Type 2 Material Stockpile 3/02/2020

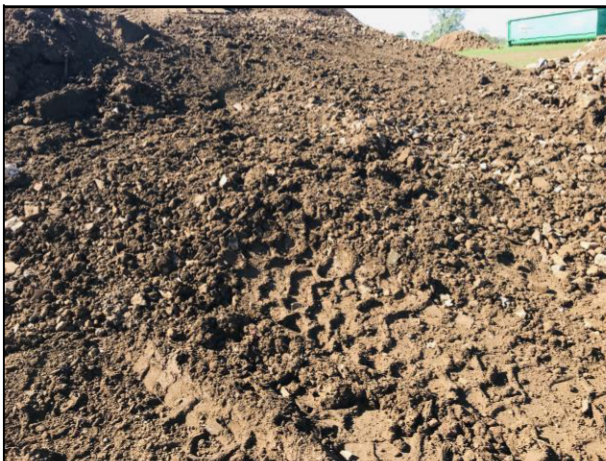
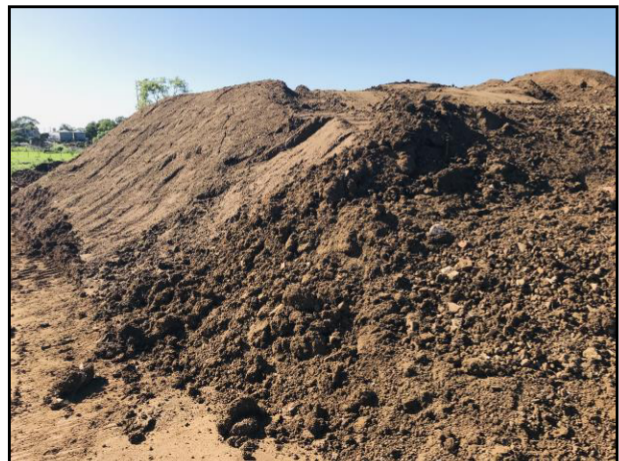
Photos of the Screened & Processed Type 2 Material Stockpile 19/02/2020

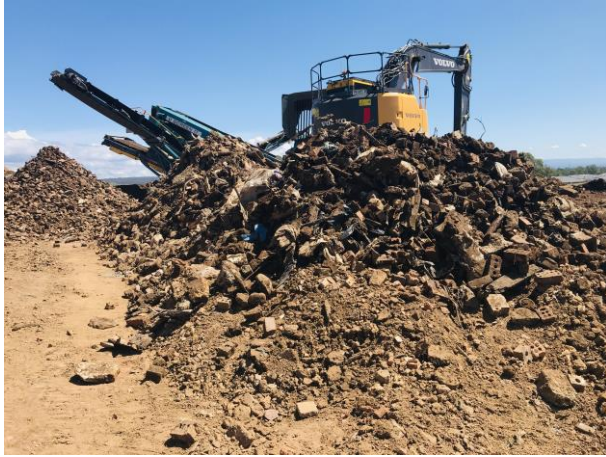
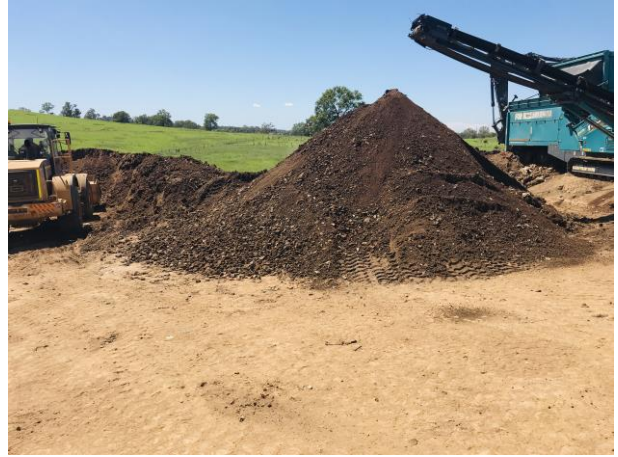
Photos of the Unscreened & Screened ACM Material Stockpiles - 25/02/2020

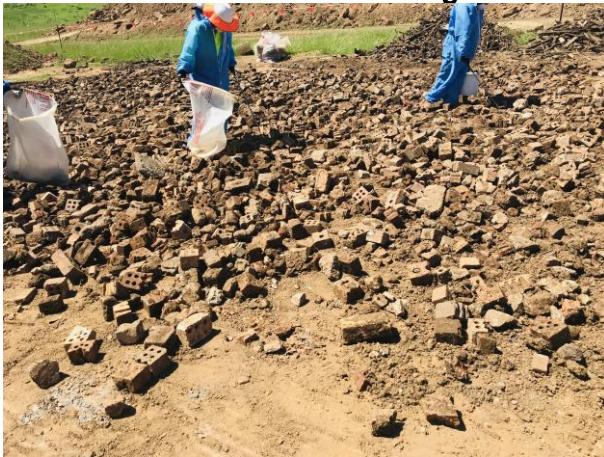
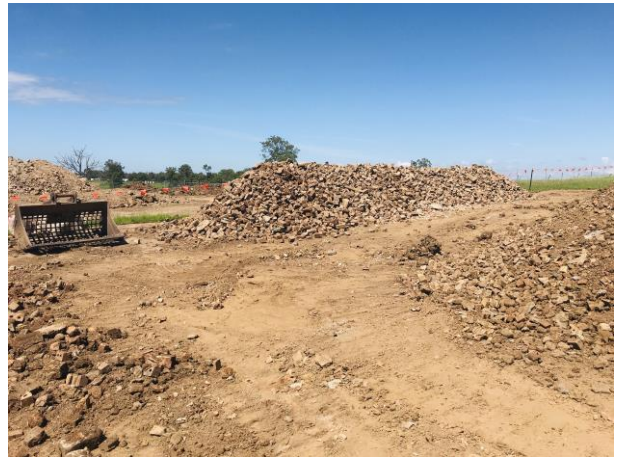
Processing of Oversize Materials - 25/02/2020

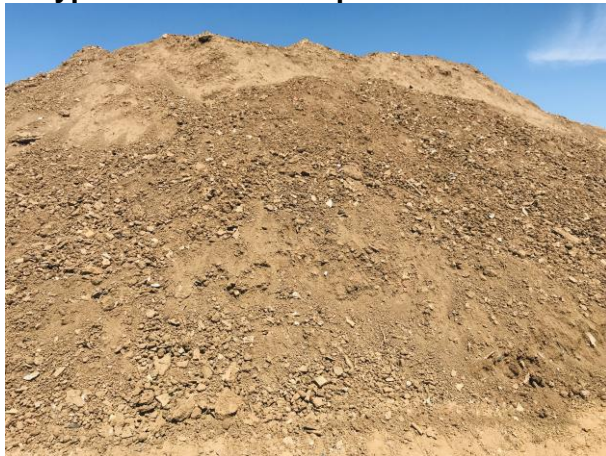
Screened & Processed Type 2 Material Stockpile - 25/02/2020

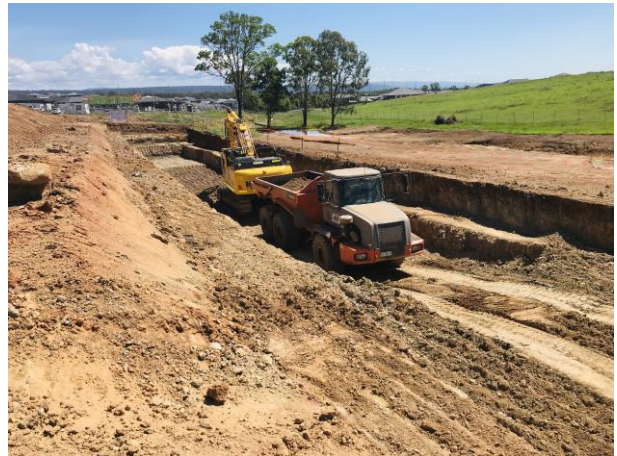
Containment Cell - Road 104 - 25/02/2020

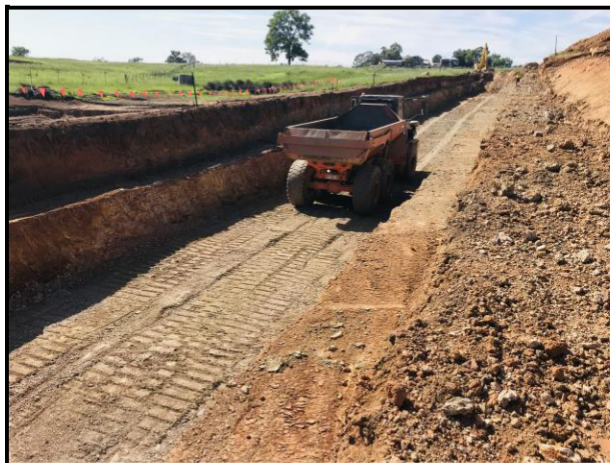
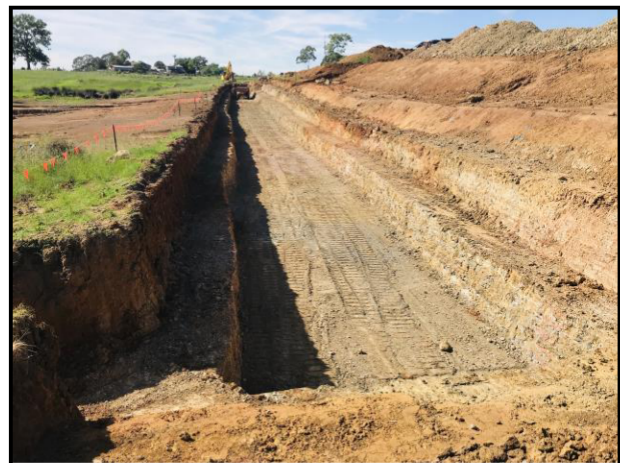
Photos of Road 104 ACM containment Cell – Proofroll of Initial Subgrade
