Geotechnical Investigation Report

Project
Proposed Residential Development
10-14 Lethbridge Street, Penrith NSW 2750

Date
25 June 2021

Report No
12970-GR-1-1 Rev A

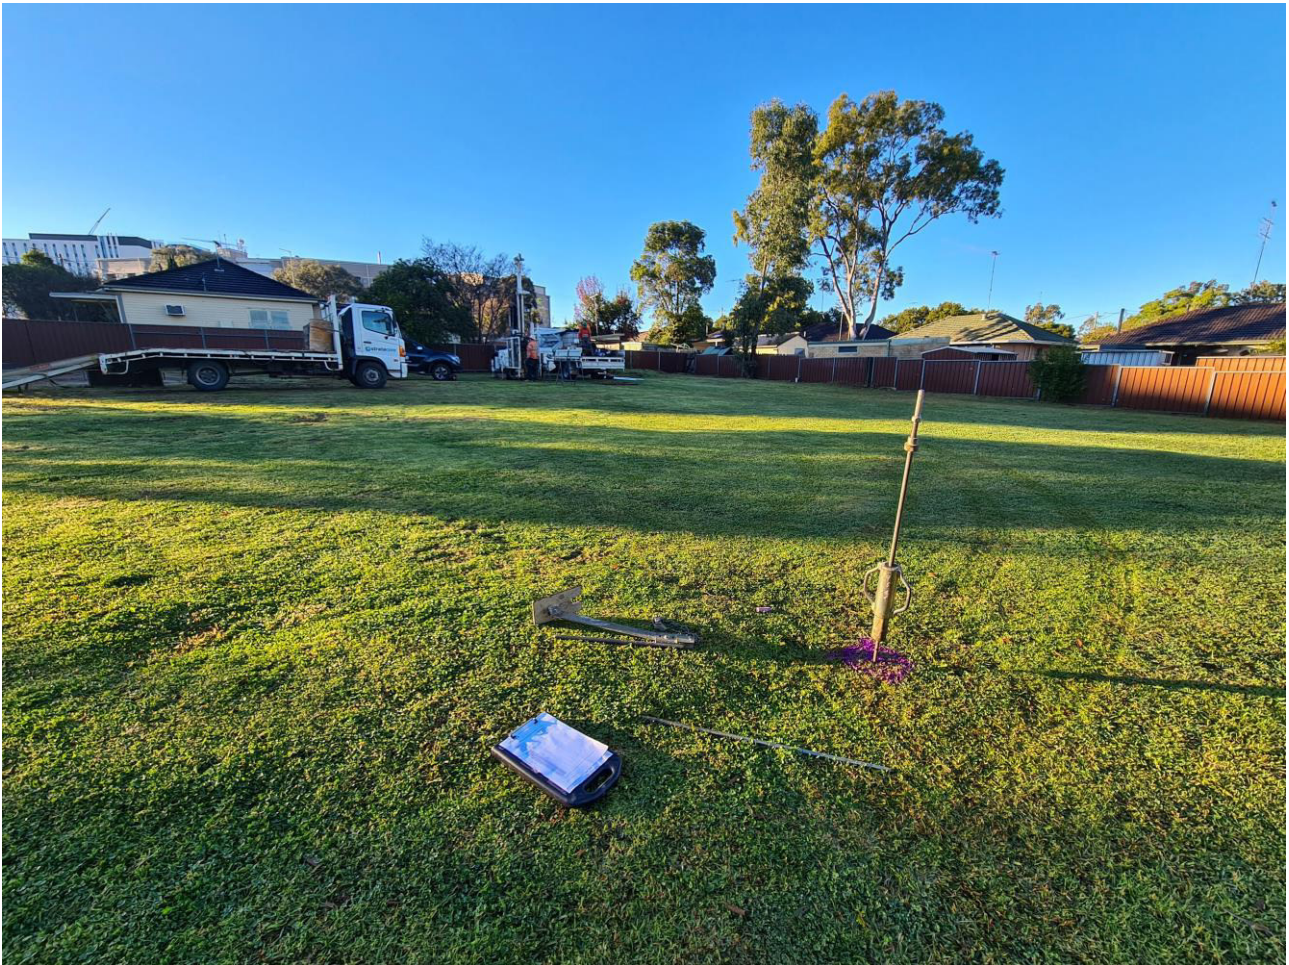
Photo 1 – DCP Test at BH02 Location Looking Southeast at BH01 Location

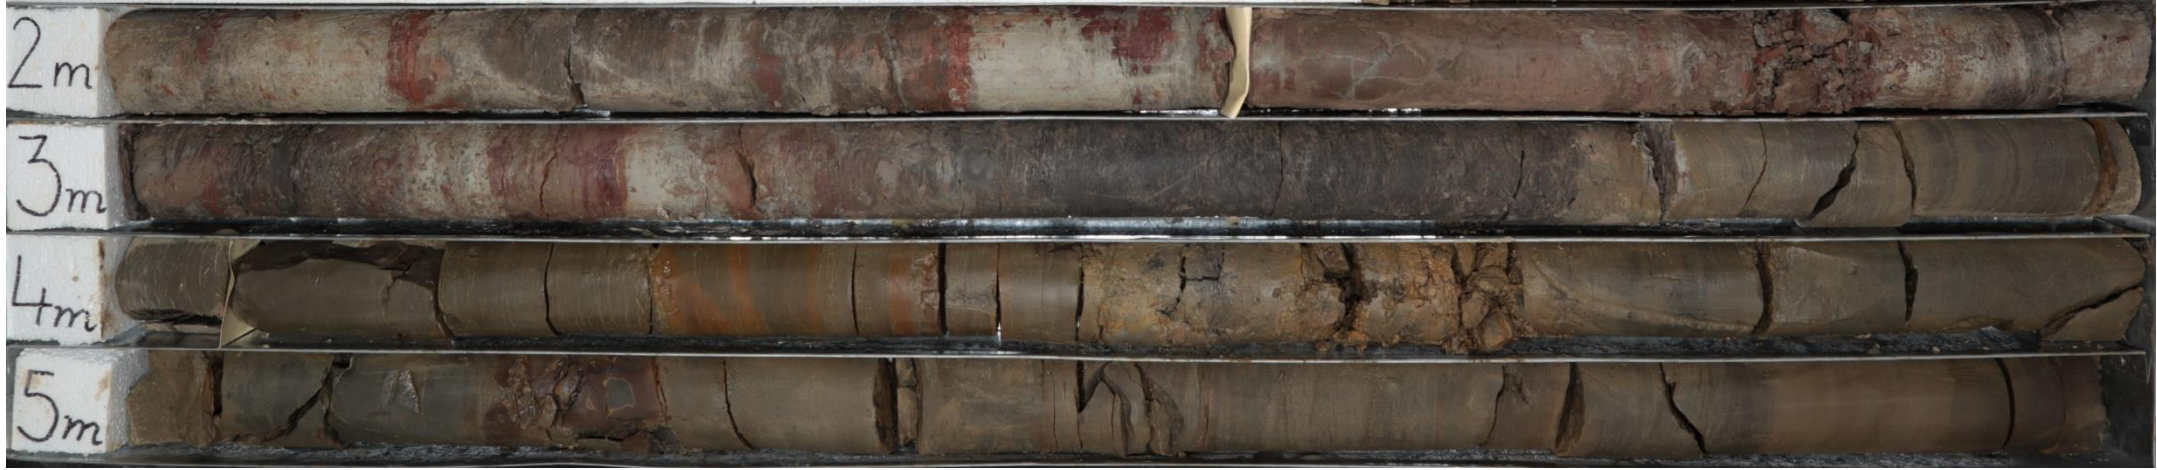
Core Box 1 - BH01

PROJECT # 12970 BH01 CORING STARTS 1.64m

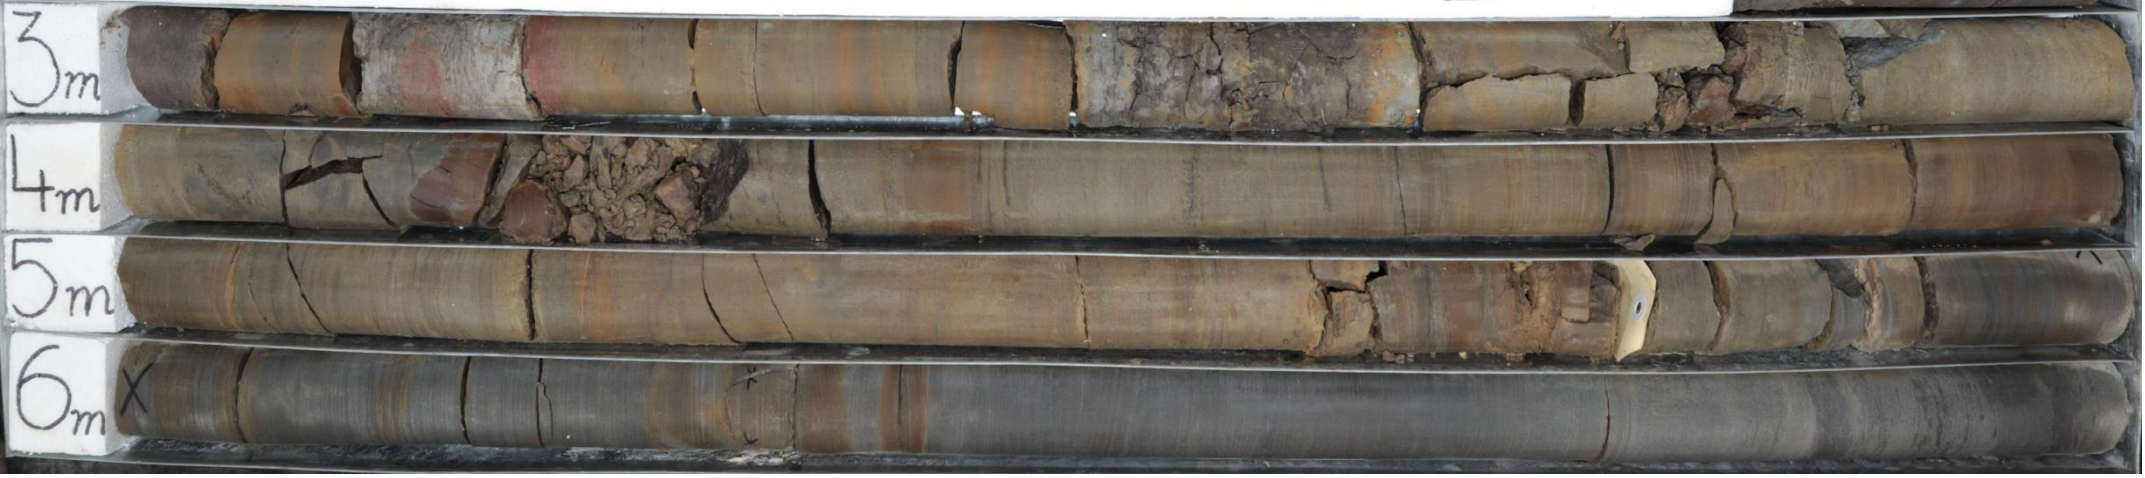
Core Box 3 - BH02

PROJECT # 12970 BH02 CORING STARTS AT 2.76m
