**RE: WESTERN NORTH SOUTH LINK ROAD
(OAKDALE WEST ESTATE – PART B)
GEOTECHNICAL INVESTIGATION**

WESTERN NORTH-SOUTH LINK ROAD- OAKDALE WEST ESTATE (PART B) GEOTECHNICAL INVESTIGATION

PSM1541-140R

JUNE 2016

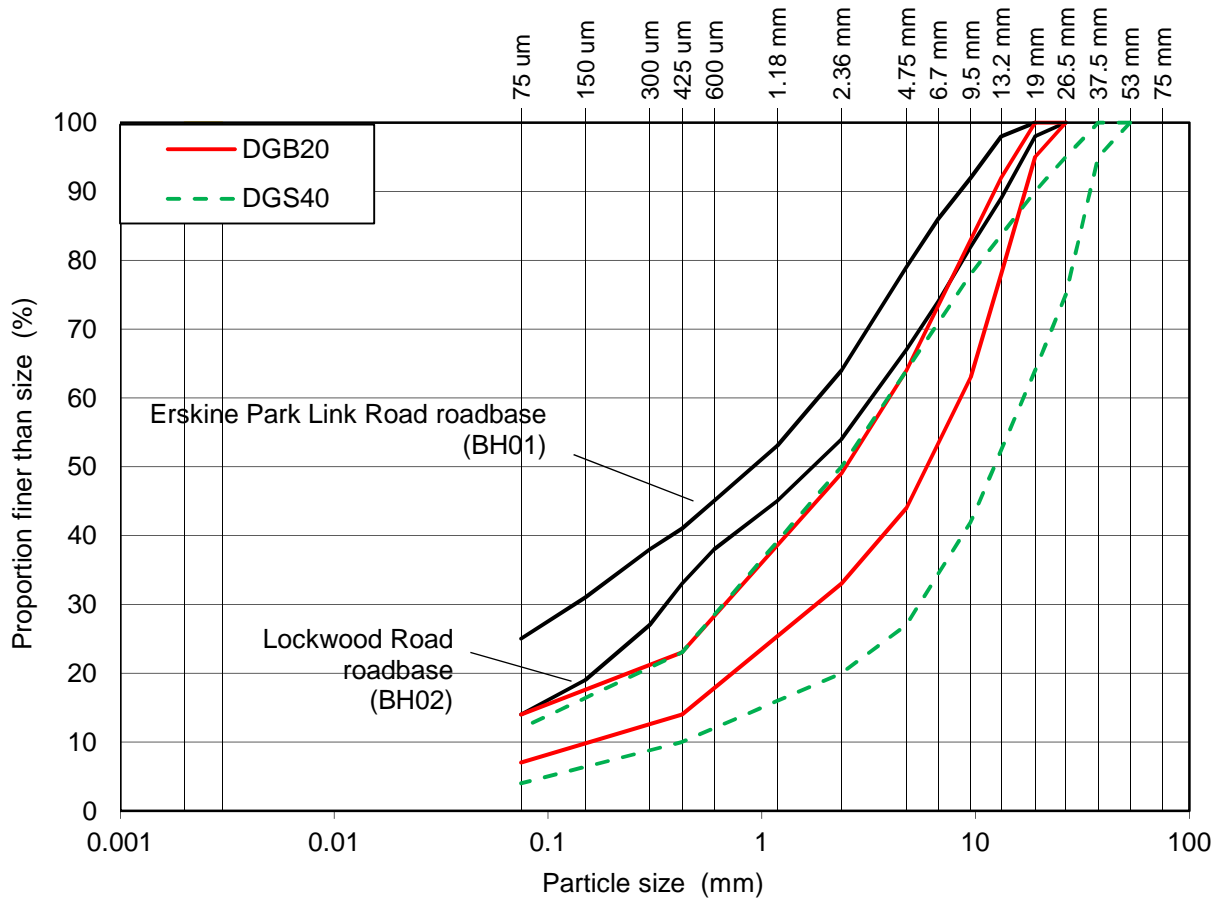
1. Testing performed by Ground Technologies
2. DGB20 and DGS40 grading taken from RMS QA Specification 3051 (Table 3051.1)

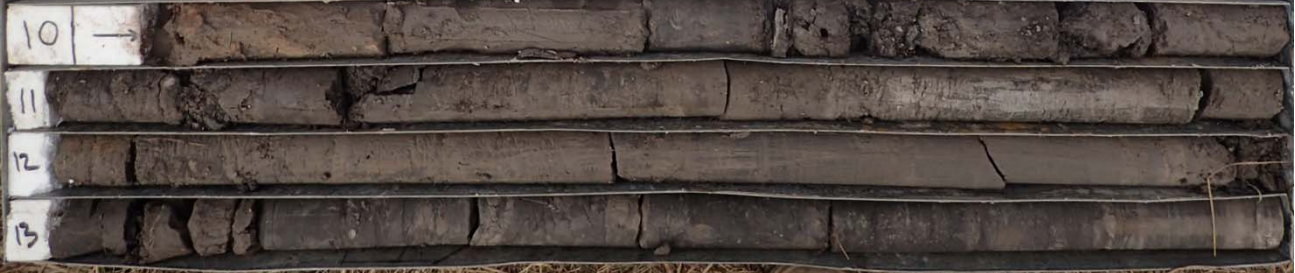
PSM1541.50 BH-A START CORING AT 10.06 m

JOB No.: PSM1541.50 BH ID: BH-A
 PROJECT: WESTERN NORTH-SOUTH LINK
 LOCATION: NORTHERN SITE
 FROM: 14.00 m TO: 15.26 m DATE: 18/5/16

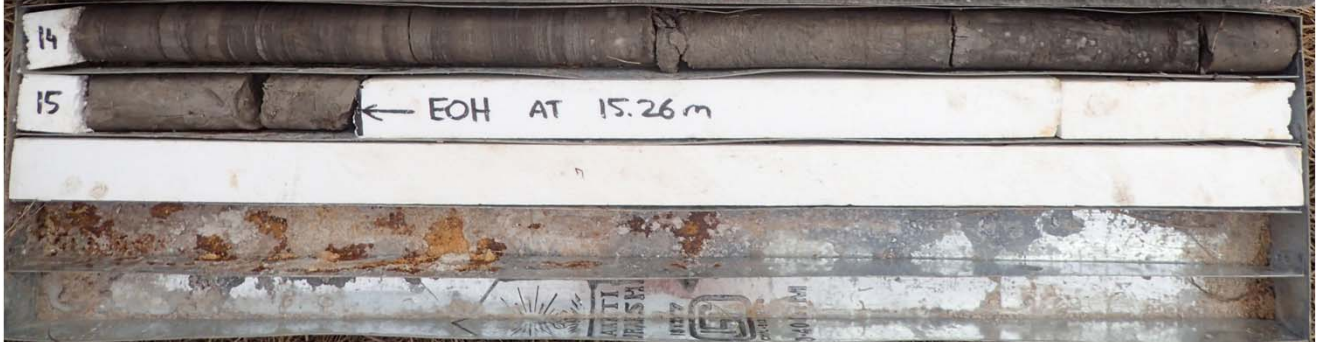
Goodman Property Services (Aust) Pty Ltd
 Western North South Link Road
 Erskine Park, NSW
 CORE PHOTOGRAPHY - BH-A

14
 15 ← EOH AT 15.26 m

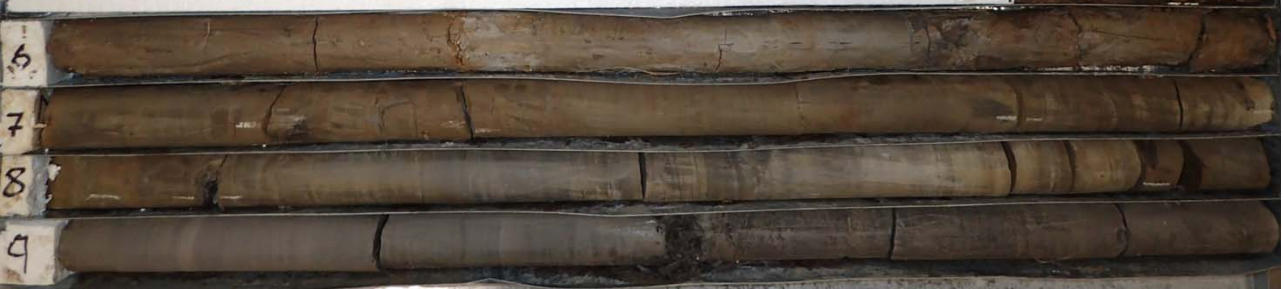
PSM1541.50 BH-B START CORING AT 5.78m

JOB No.: PSM1541.50 BH ID: BH-B
 PROJECT: WESTERN NORTH-SOUTH LINK
 LOCATION: SOUTHERN SITE
 FROM: 10.00m TO: 11.88m DATE: 17/5/16
