Oakdale West Estate, Contamination Appraisal

SITE PLAN Site Condition Report Horsley Park, New South Wales

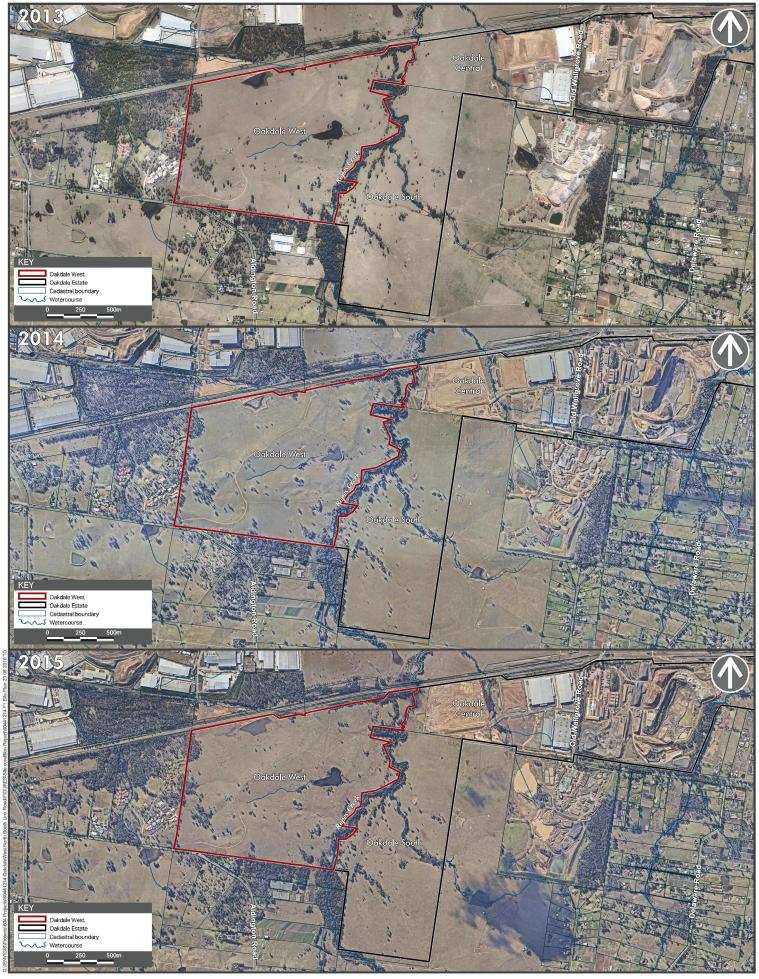
The Site is identified as Lot 11 in Deposited Plan (DP) 1178389, comprises approximately 154 hectares (Ha) and is shown on Figure 1 in **Attachment A**. Goodman intends to develop approximately 89 Ha of the Site for commercial/industrial land use with the remainder to be electricity transmission easements and landscaping (refer to **Attachment A**).

Review of satellite imagery for July 2013 / 2014 / 2015 (refer to Figure 1) indicates no observable changes in Site conditions.
