## SITE AUDIT REPORT AND SITE AUDIT STATEMENT

# Caddens Release Area C, Kingswood, NSW, 2747

**Report Number.** 097623019\_014\_R\_Rev0

## SITE AUDIT REPORT

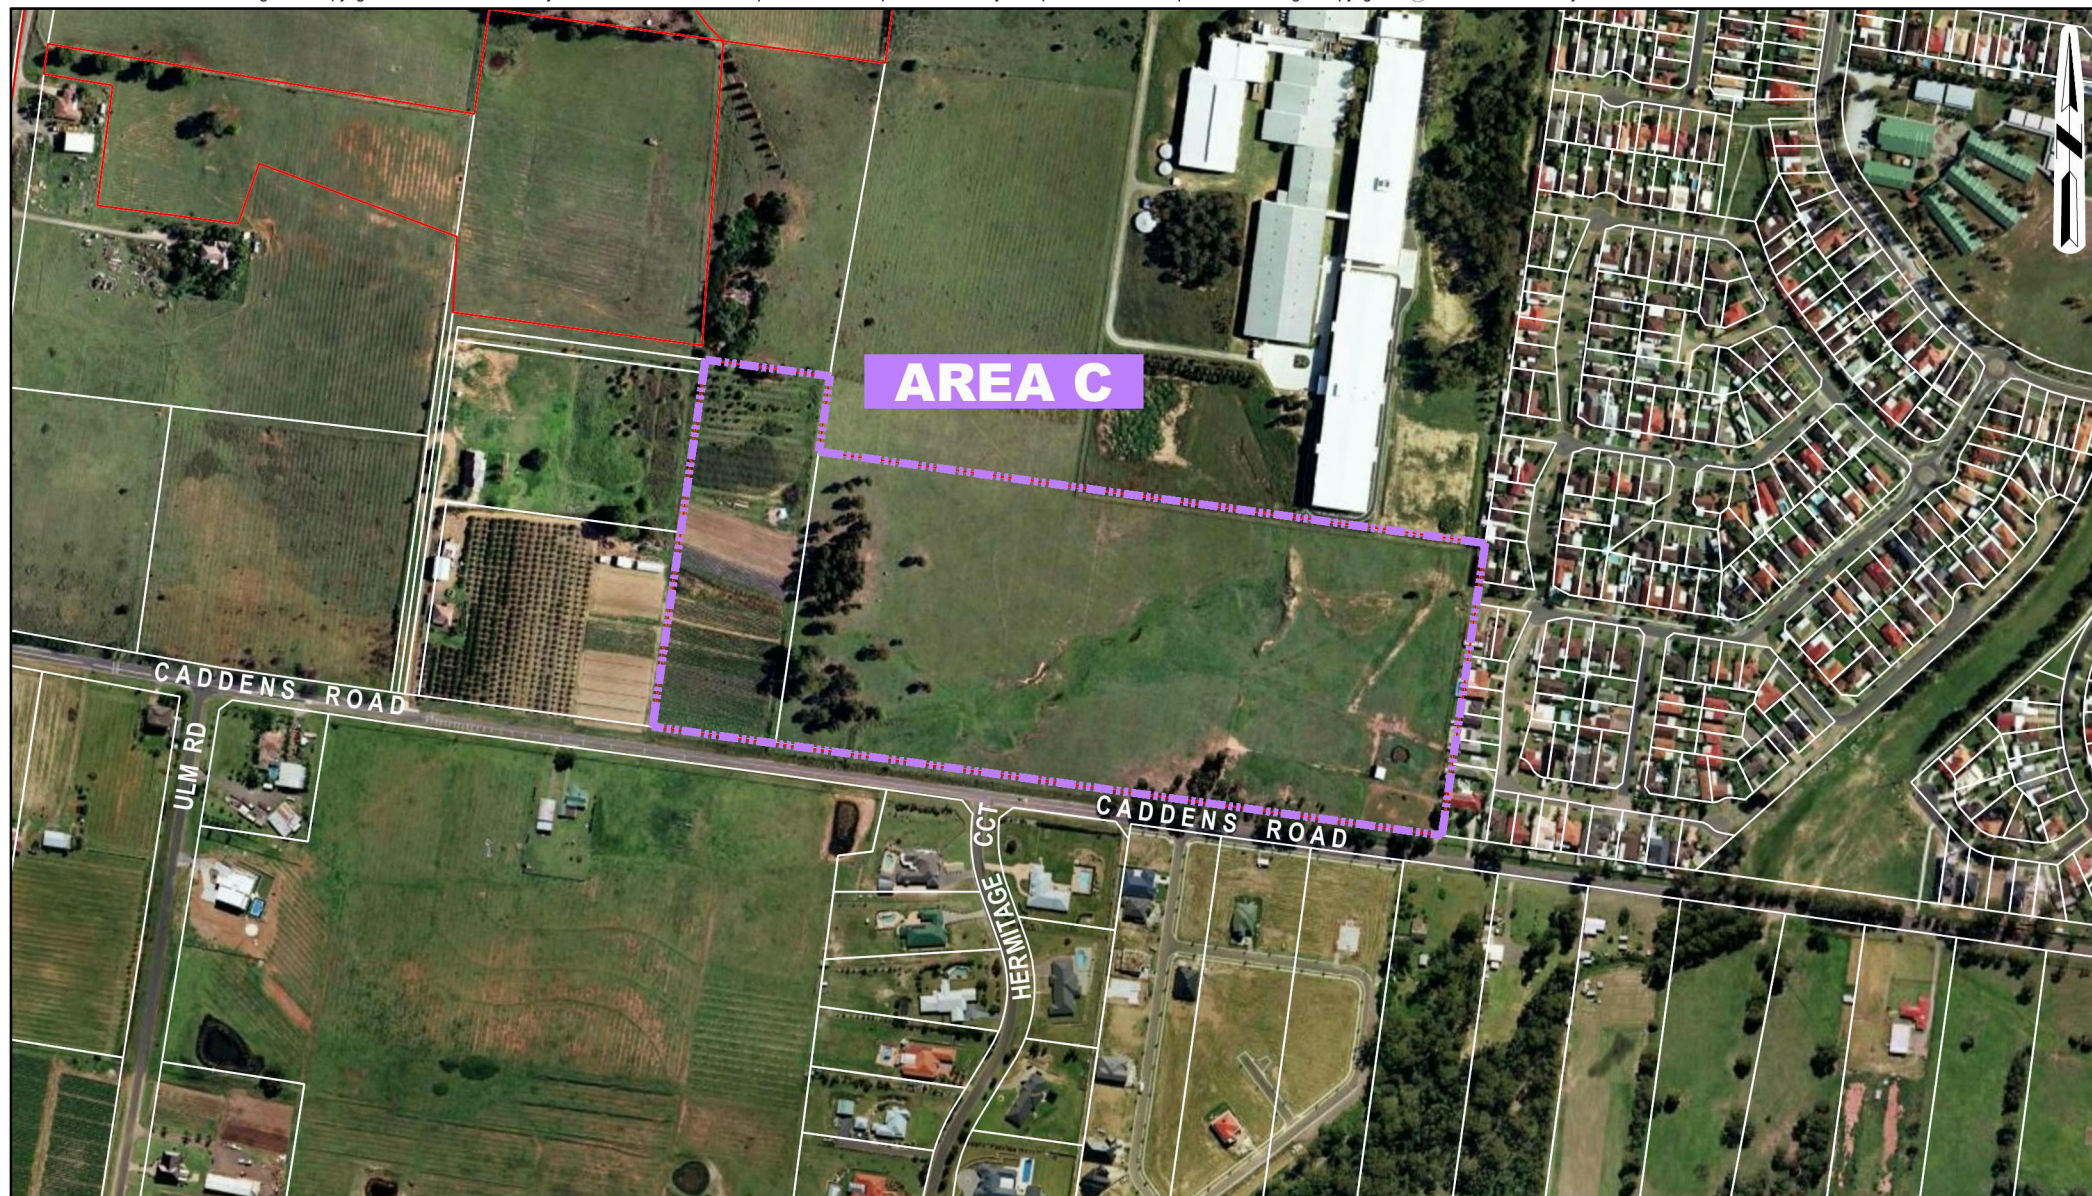
BOUNDARY OF AREA C

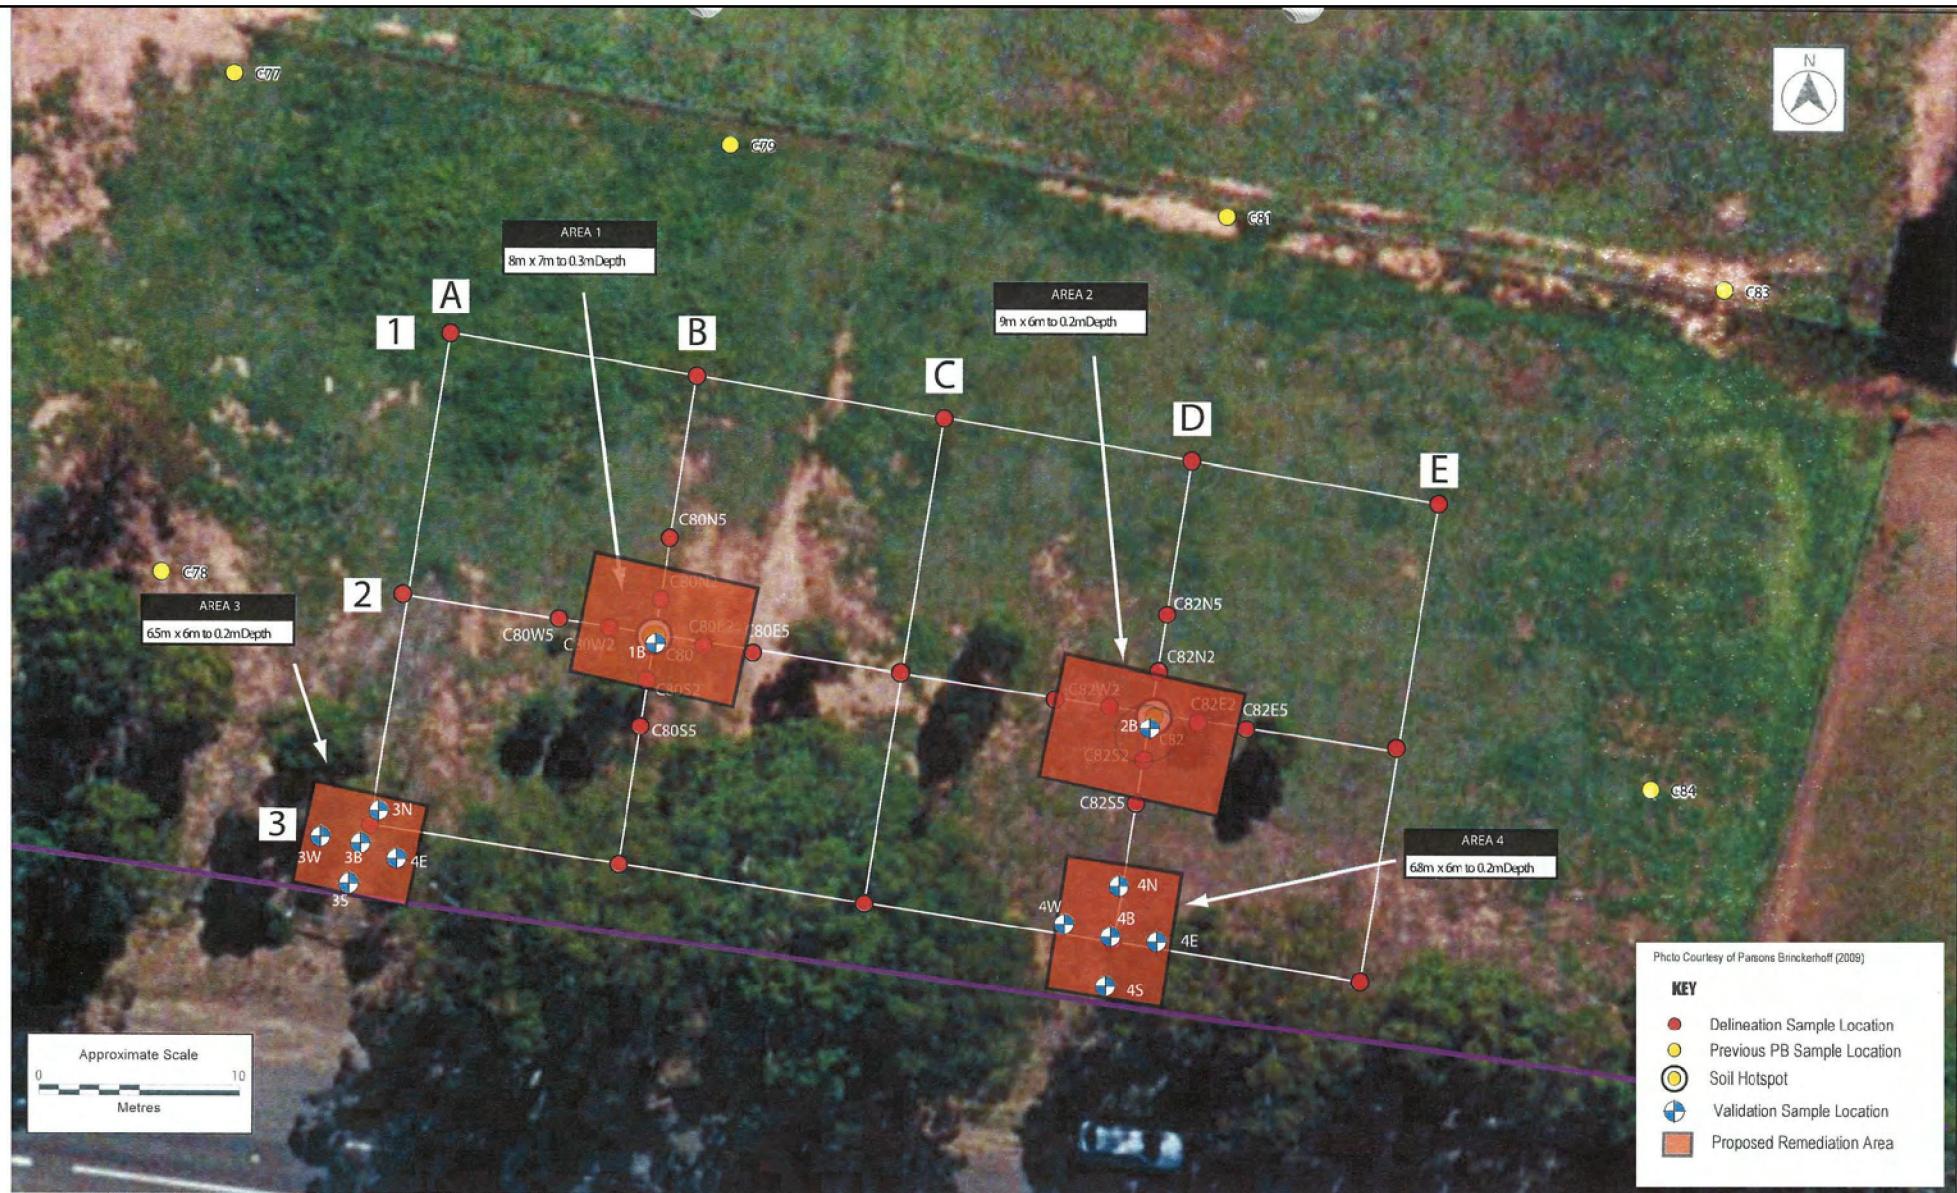
NOTE: Figure sourced from WSP Environment and Energy  
Report: Soil Validation - Caddens Release Area C, Caddens Road, Kingswood, NSW  
Ref 0002171 Validation Draft  
Figure 3 - Remediated Areas and Validation Sample Locations.

The validation works consisted of soil sampling at 12 locations following the excavation of soil from the hotspot areas, as noted in Table 9.

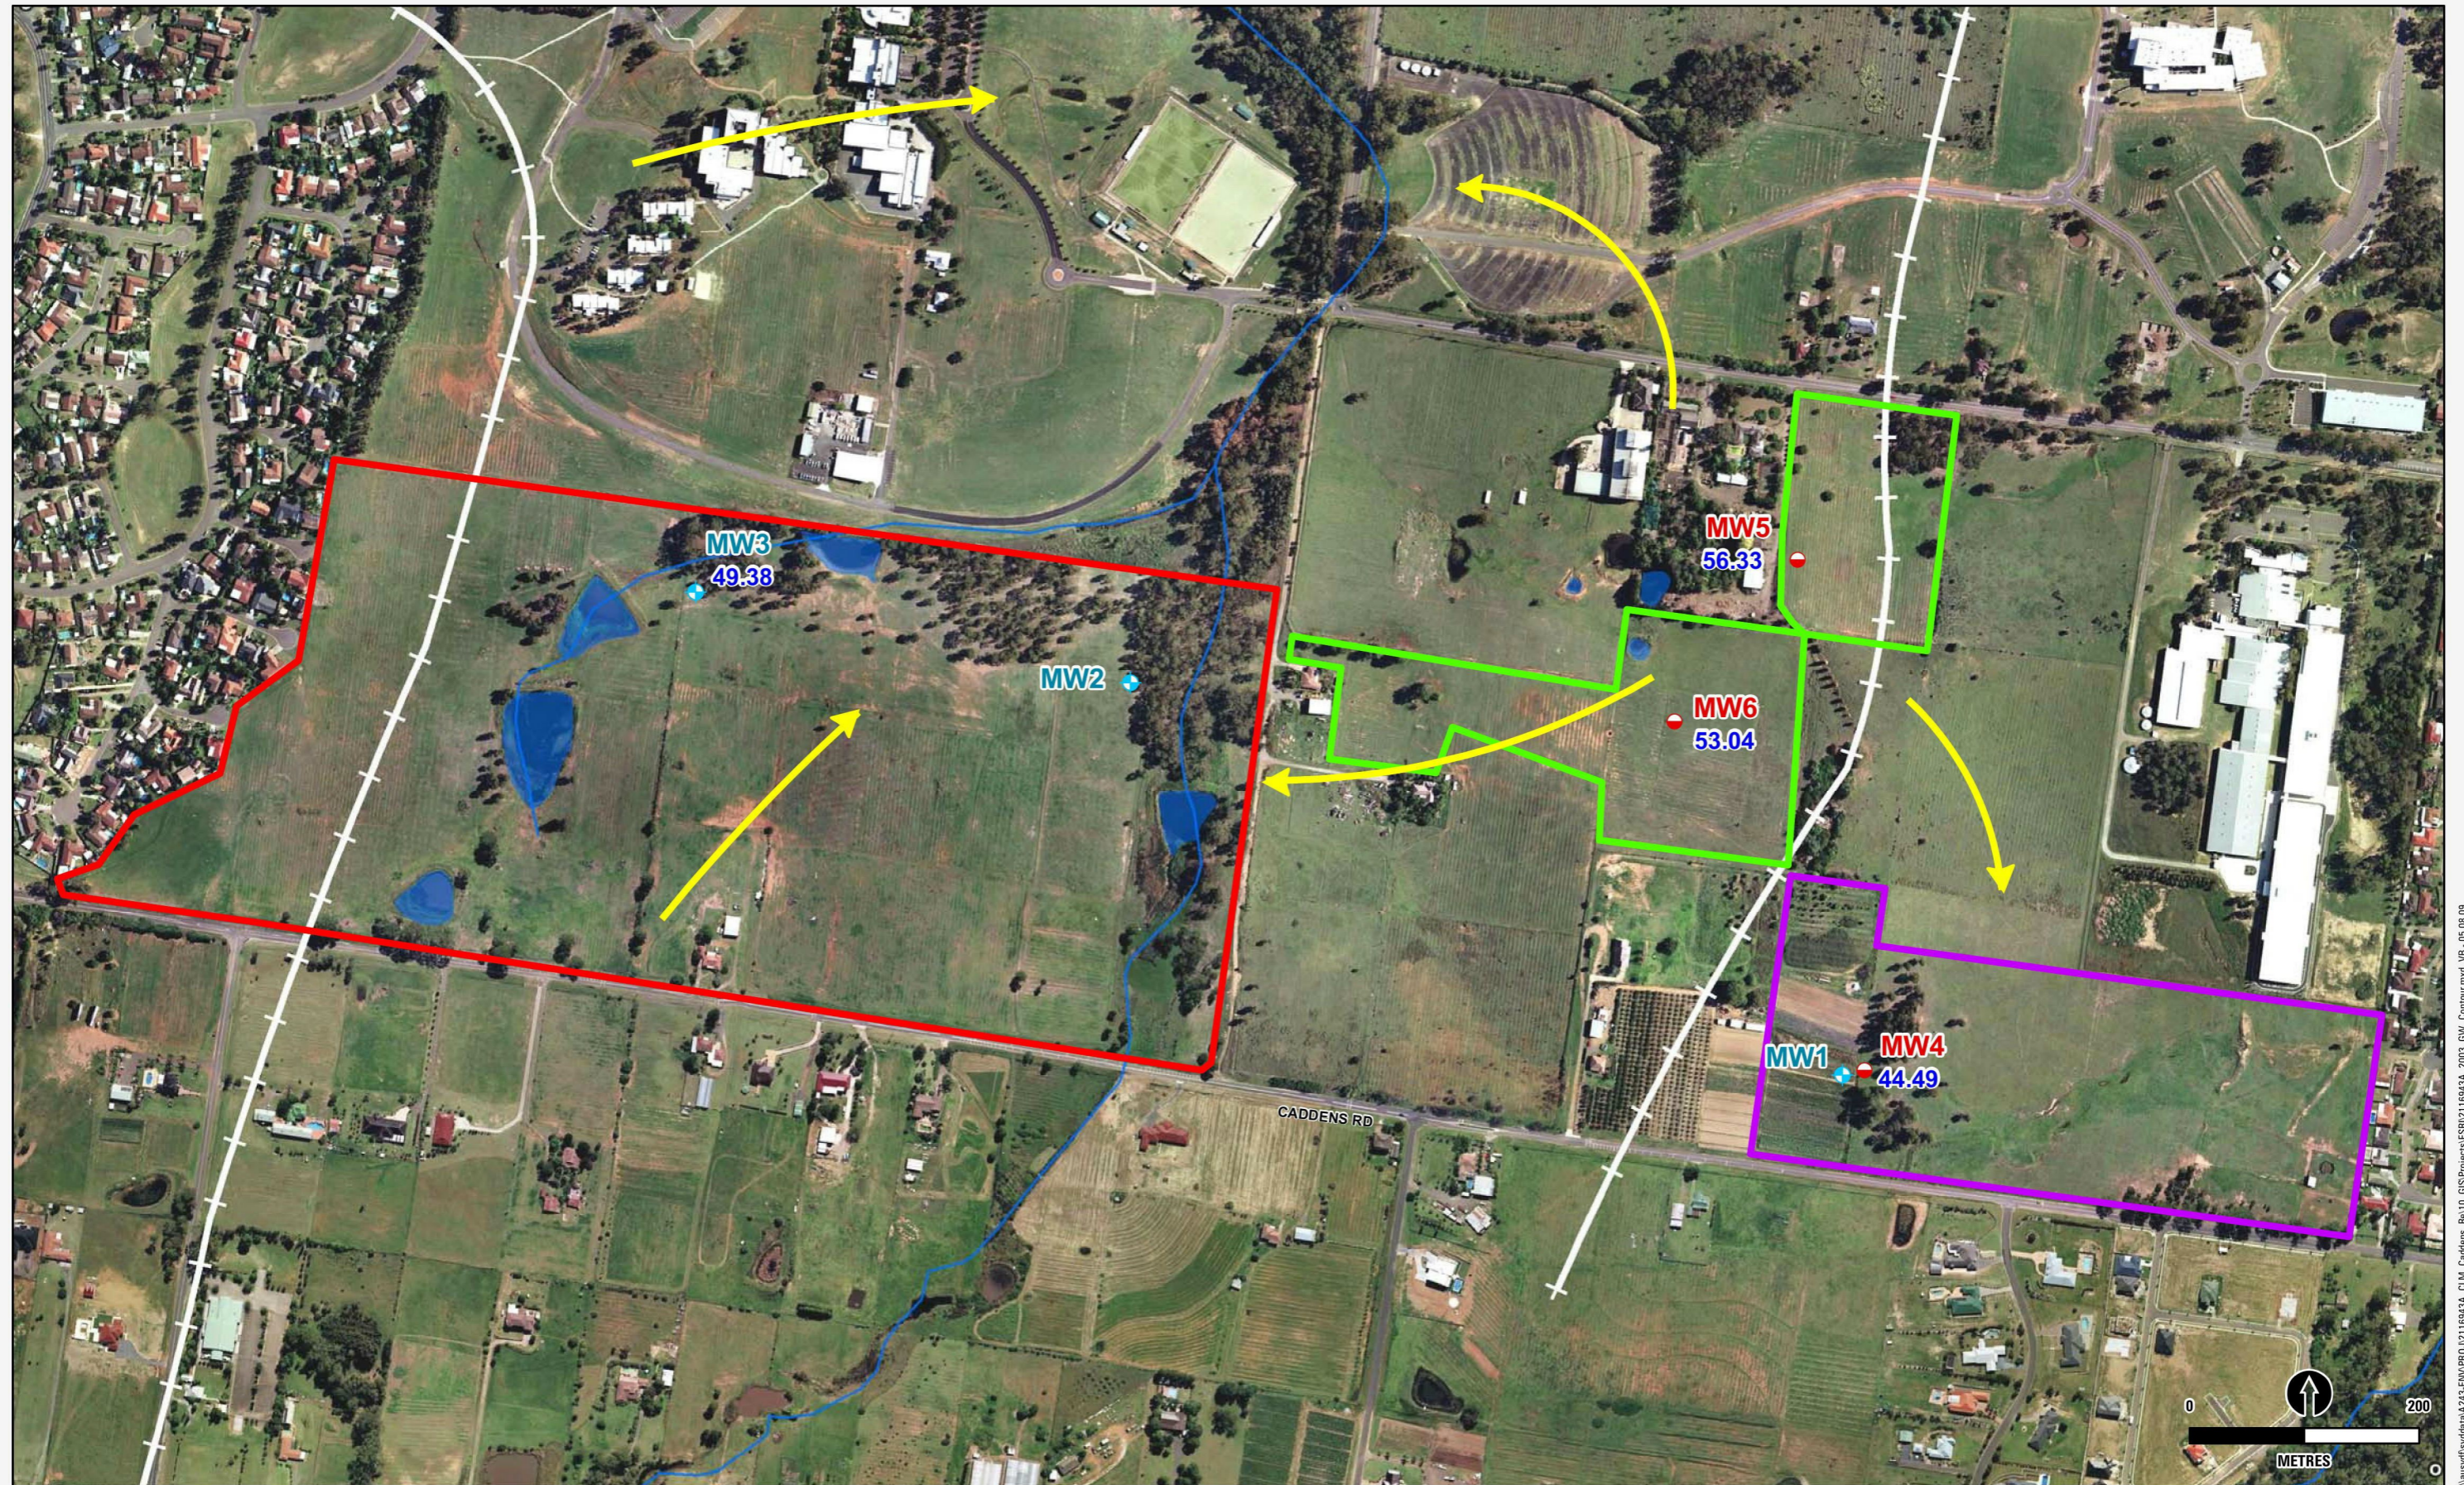
**Figure 12** Groundwater Flow

- Catchment divide
- Inferred groundwater flow direction
- 49.3 Groundwater elevation (mAHD)

#### **4.4 Query 30 relating to Section 8.4 Groundwater conditions**
