Geotechnical Investigation Report

Prepared for Lendlease

Proposed Apartment Developments

Jordan Springs Boulevard, Jordan Springs, NSW 2747

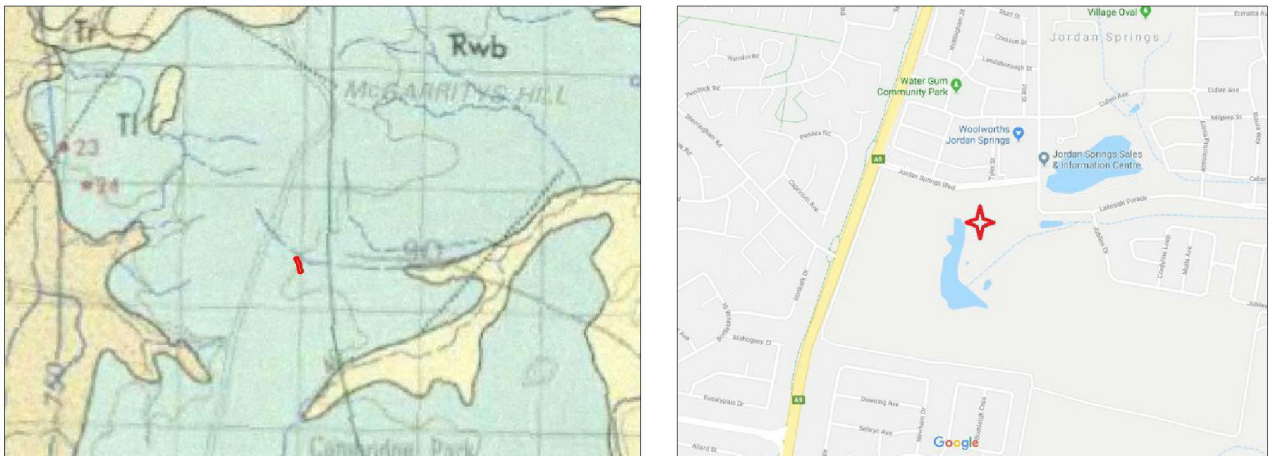
Figure 1- General site locality and geology

Lot 3991 is located in Jordan Springs, approximately 40m west and 90m south of an existing man-made lake on its closest edge. It is a section of a vacant land, which is bounded by Jordan Springs Boulevard to the north and Lakeside Parade to the north and east. There is a sedimentation pond in the eastern portion of the site and a dam along the western side of Lot 3991. Figure 1 shows the general site locality.

The 1:100,000 NSW Department of Mineral Resources Geological Map of the Penrith Region indicates the site is underlain by Bringelly Shale (Rwb) of the Mesozoic dating back to the middle Triassic period. The Bringelly

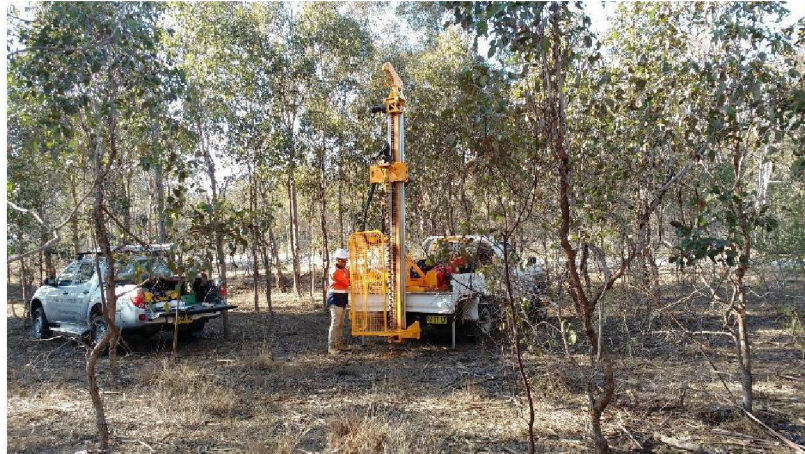
Figure 2 – AG's investigation - drilling BH501

AG's geotechnical site drilling investigation was carried out on 26th July 2018. During the investigation, AG observed the drilling of three (3) boreholes including 2 boreholes (BH501 & BH502) to TC bit refusal and one borehole (BH503) to an approximate depth of 4.1m to install a groundwater monitoring well.

All the boreholes were drilled using a TDL690 drilling rig operated by AG and were advanced with solid flight 100 mm diameter augers with a TC (Tungsten Carbide) drill bit. The approximate locations of the boreholes are shown on the attached sketch plan (refer Drawing No. 6715-GR-2-A).

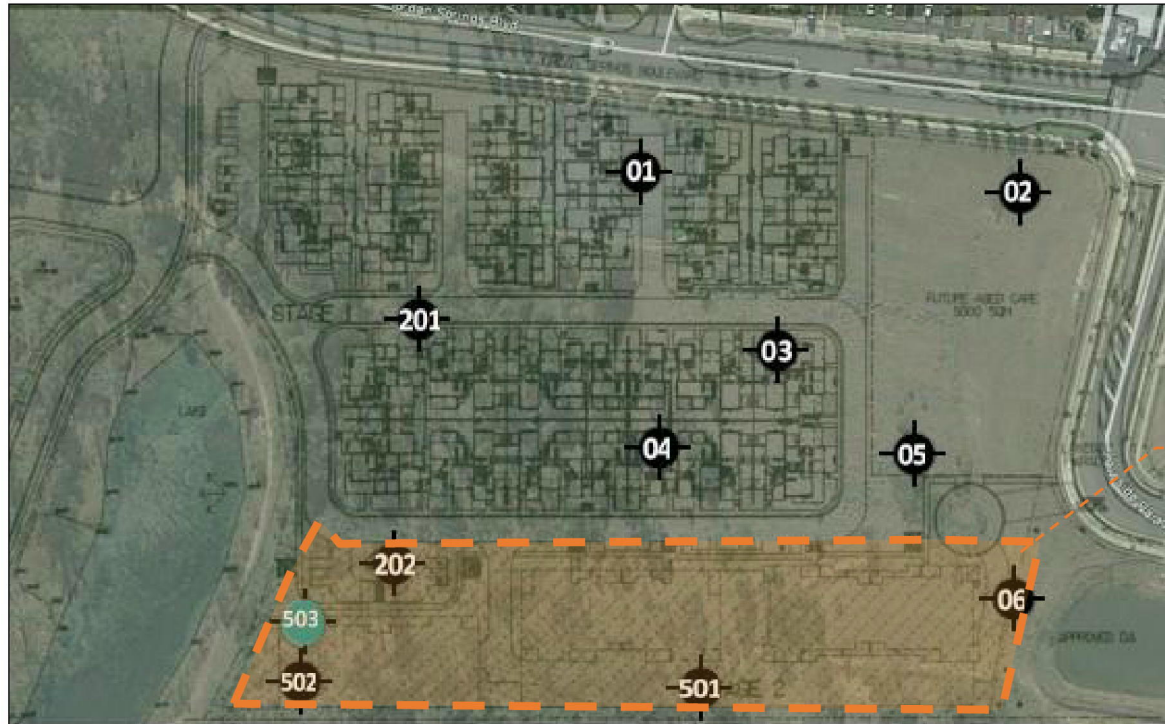
Borehole Location
-

Groundwater Monitoring Location

BH1 to BH6 : AG's investigation 2016
BH201, BH202, BH501 to BH503: AG's investigation 2018
