Legacy Property

Environmental Site Assessment Report

Stage 2 Development
Caddens, NSW

27 October 2016

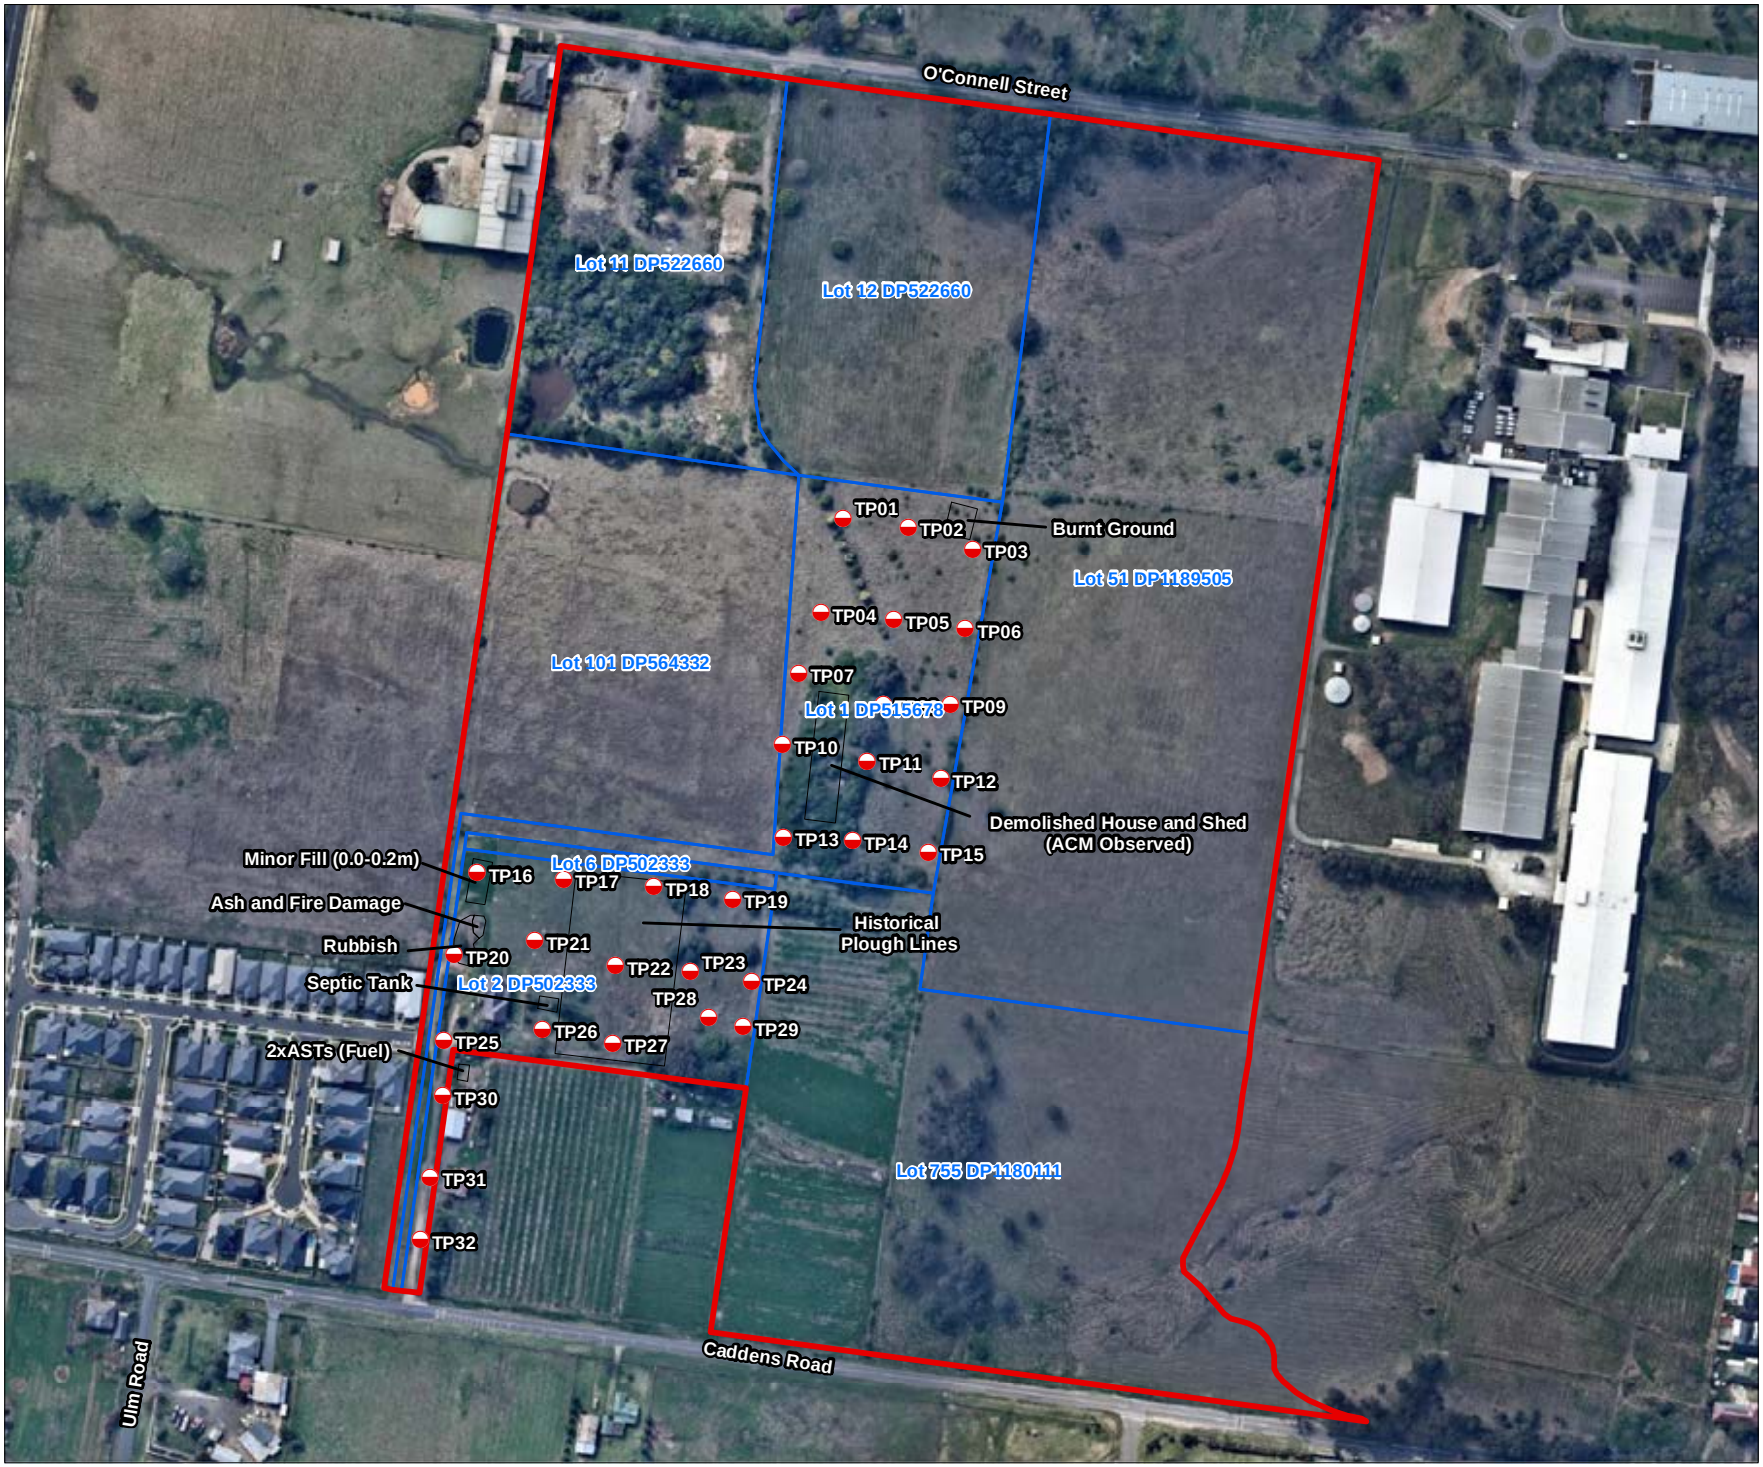
FIGURE 3

Surficial ACM was observed at some locations within the rubble from an historical demolition of onsite structures as indicated on **Figure 3**. Odourous surficial soil was observed within the vicinity of the septic tank identified to the east of the residence on Lot 2.

Visible ACM in the form of fibre cement fragments were observed in the vicinity of the demolished residential building. This poses an unacceptable aesthetic issue which will require management prior to the site being utilised for the proposed land use.
