30 March 2021

RE: PRELIMINARY SITE INVESTIGATION ADDENDUM LETTER: 100 EXPLORERS WAY, ST CLAIR, NSW

Report Type: Preliminary Site Investigation
Site Address: 94 – 100 Explorers Way, St Clair, NSW
Report Number: 1842/ER-1-1
Report Date: 28th April 2015

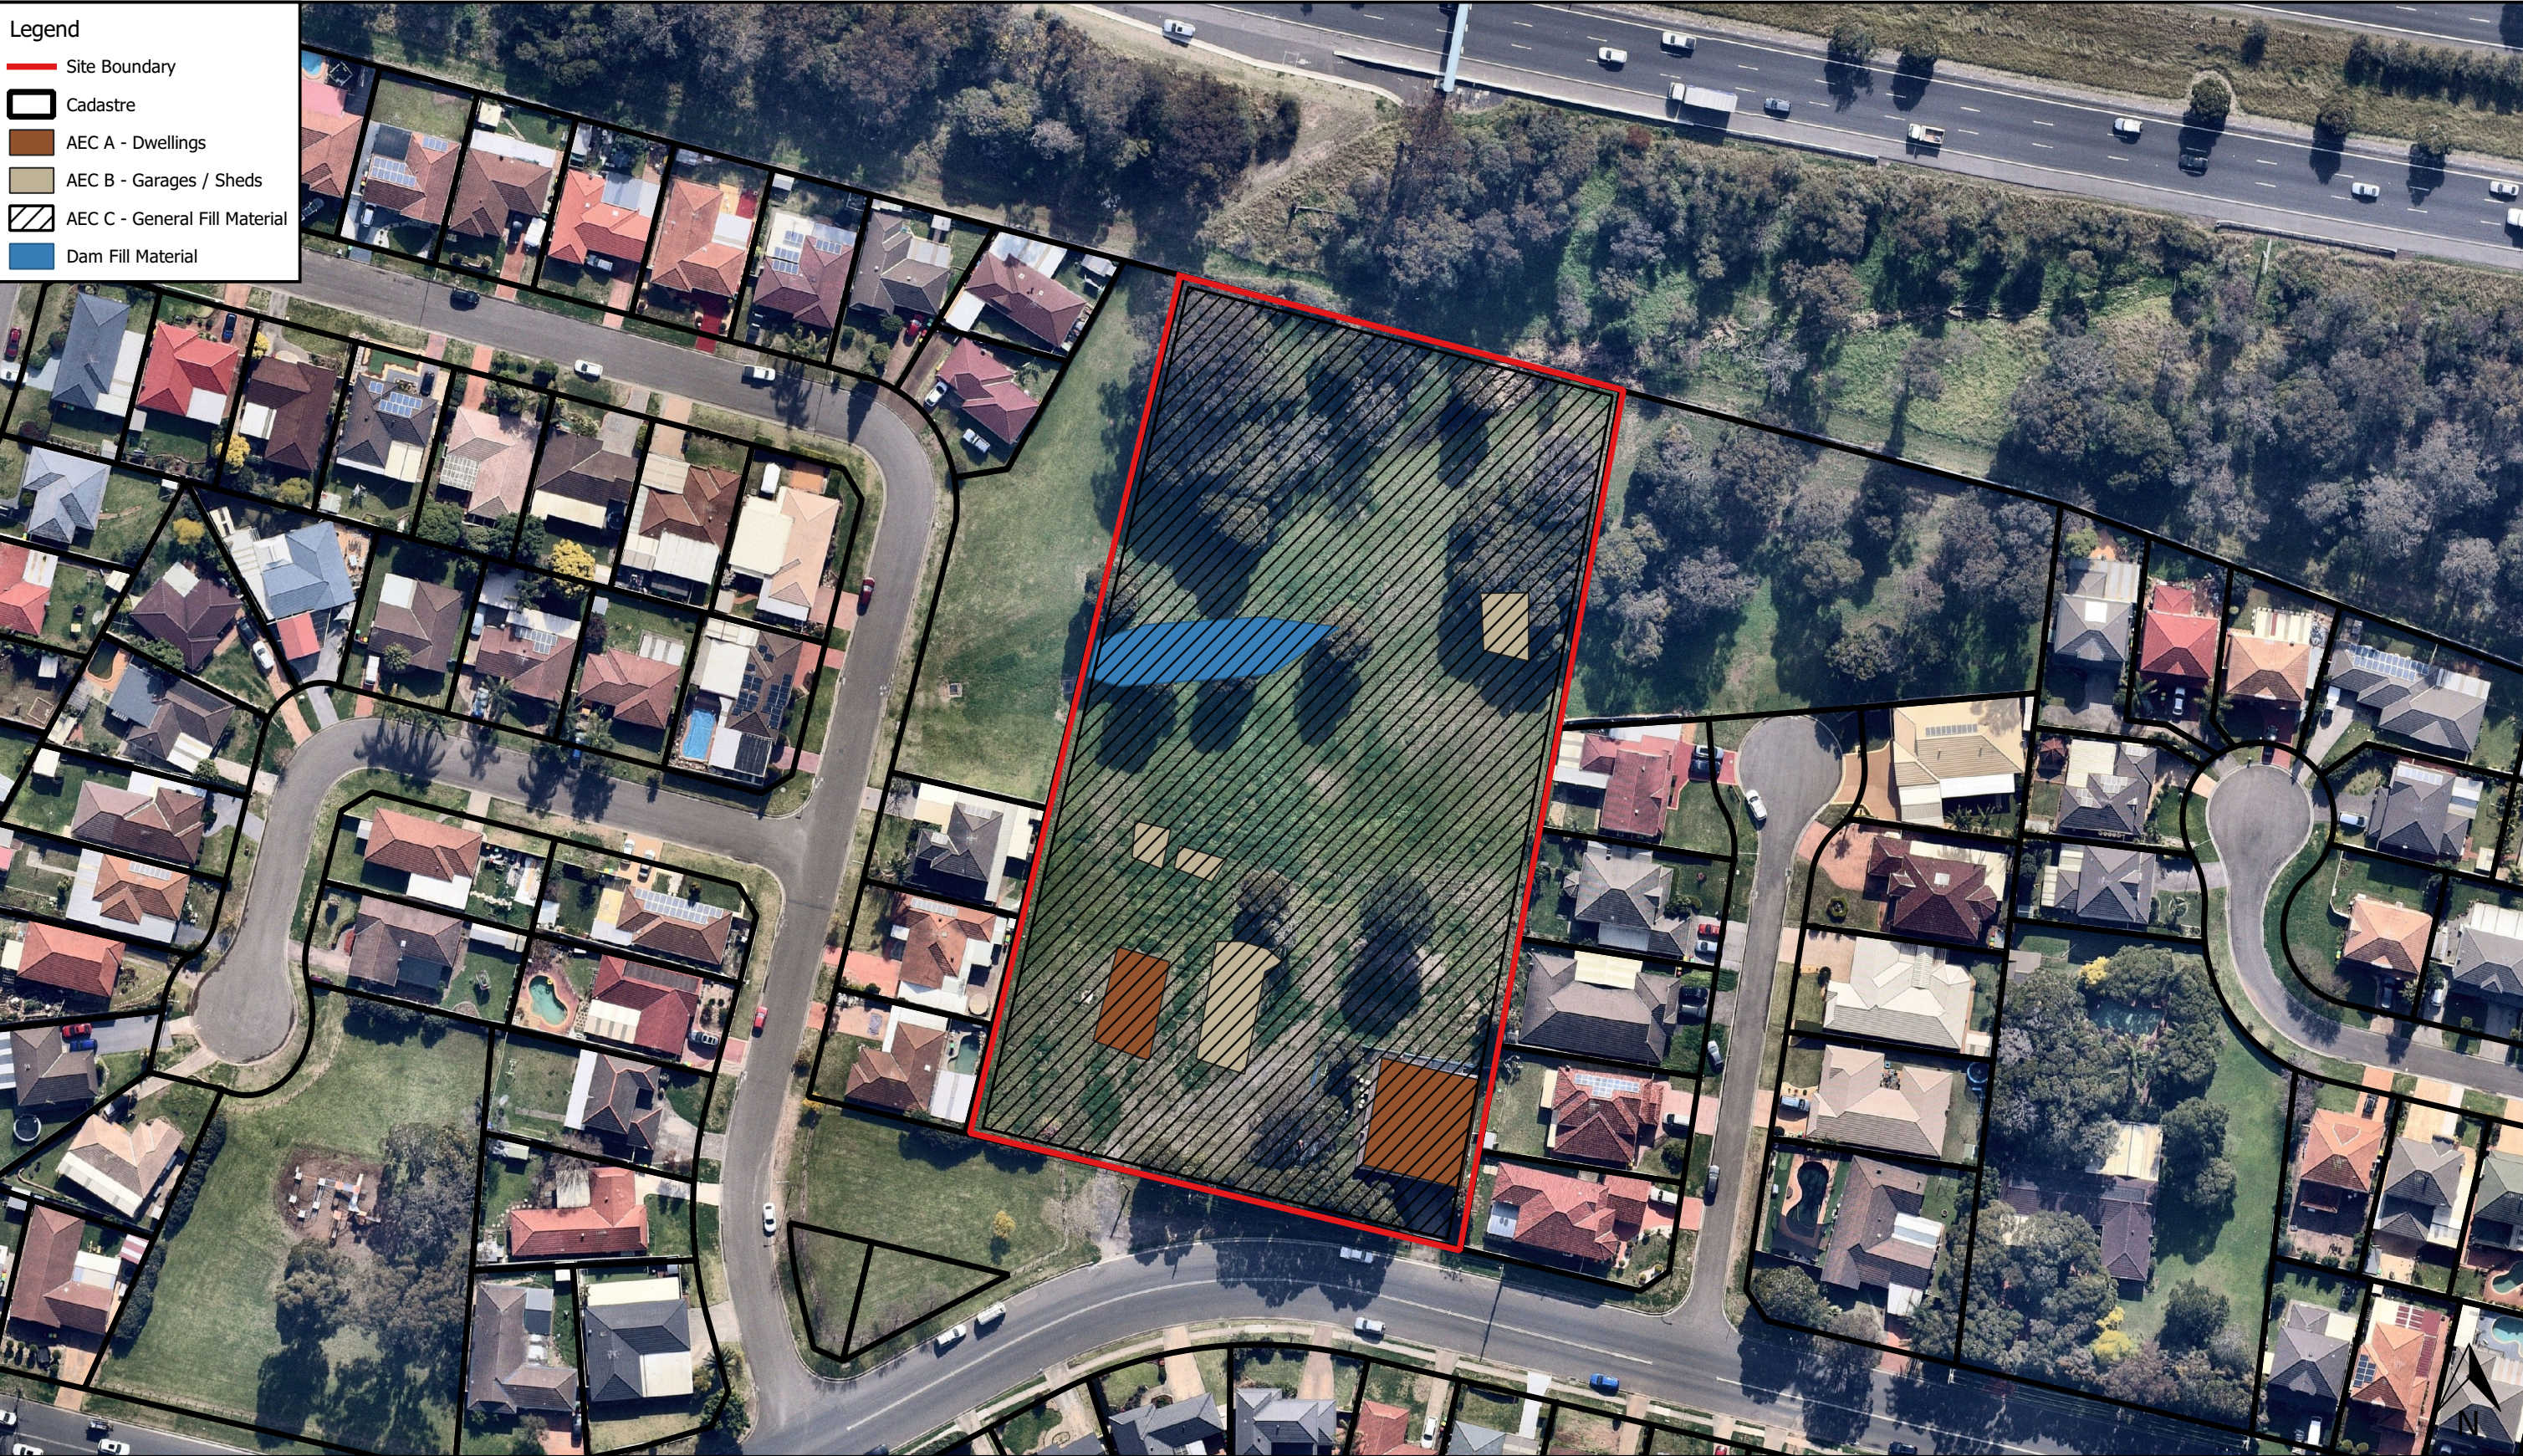
Map Title / Figure:
Aerial Photo - 2020

- Site Boundary
- Cadastre
- AEC A - Dwellings
- AEC B - Garages / Sheds
- AEC C - General Fill Material
- Dam Fill Material
