# TREE INSPECTION REPORT.

**On: Tree Specimen**

**Location: 76 Hobart Street Saint Marys  
NSW 2760**

For GPG Constructions Pty Ltd  
On. 3/5/2021

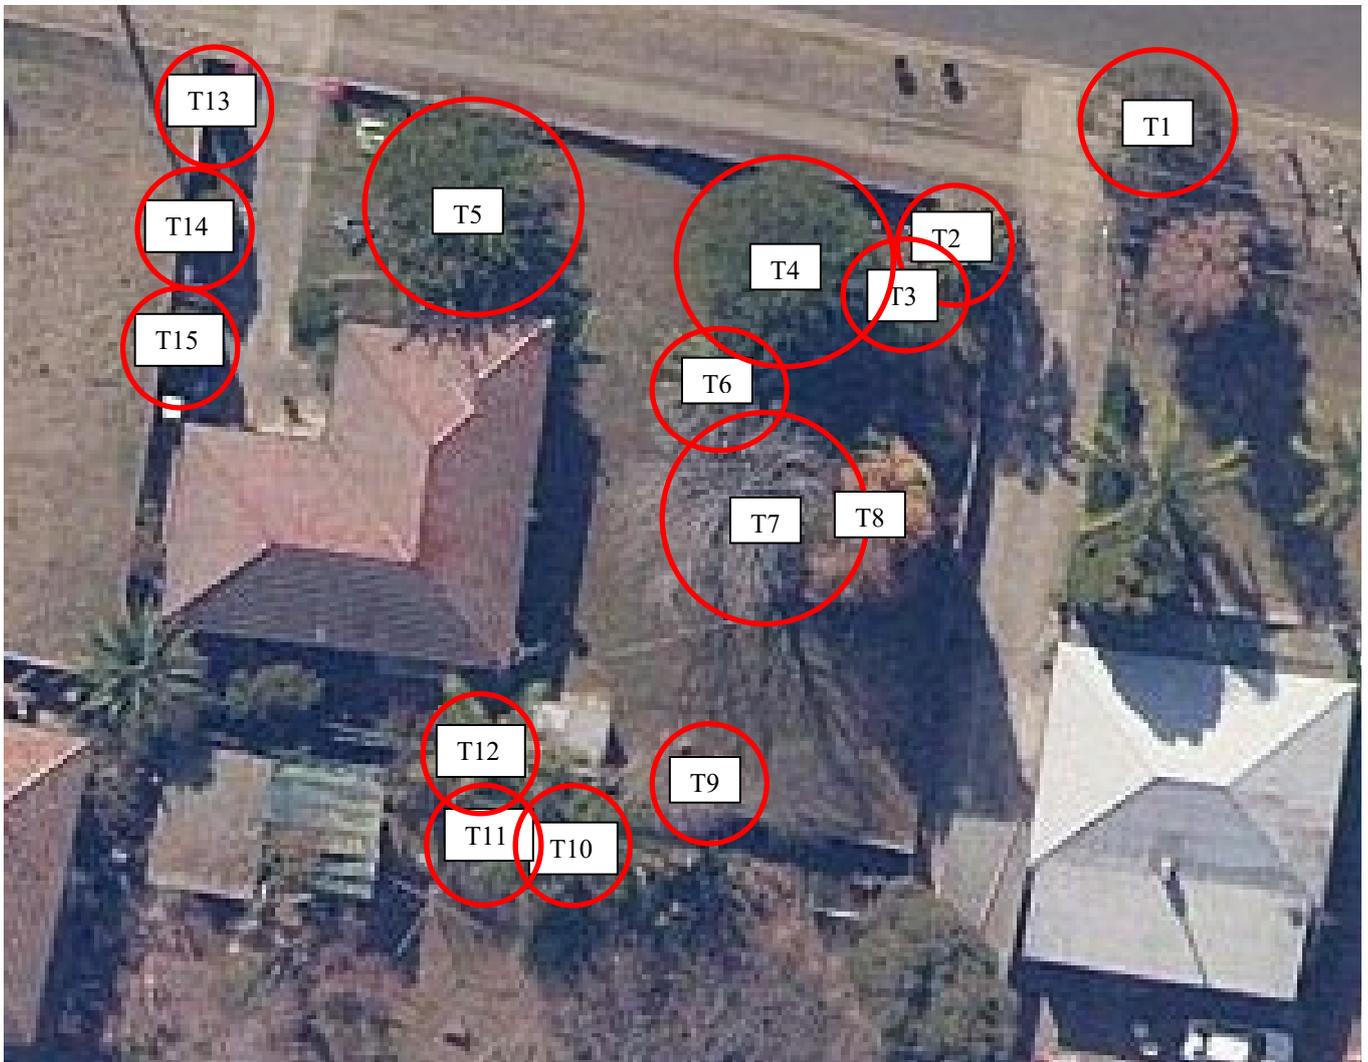
Fig1. Aerial photo of the site from Six Viewer.

2.2 A single storey dwelling is on the Site at present (see Fig 1).

2.3 There are 15 tree specimens growing on or near the Site including 1 street tree on the nature strip to the North of the property. The subject trees are designated T1 to T15 inclusive as depicted in Figure 1.

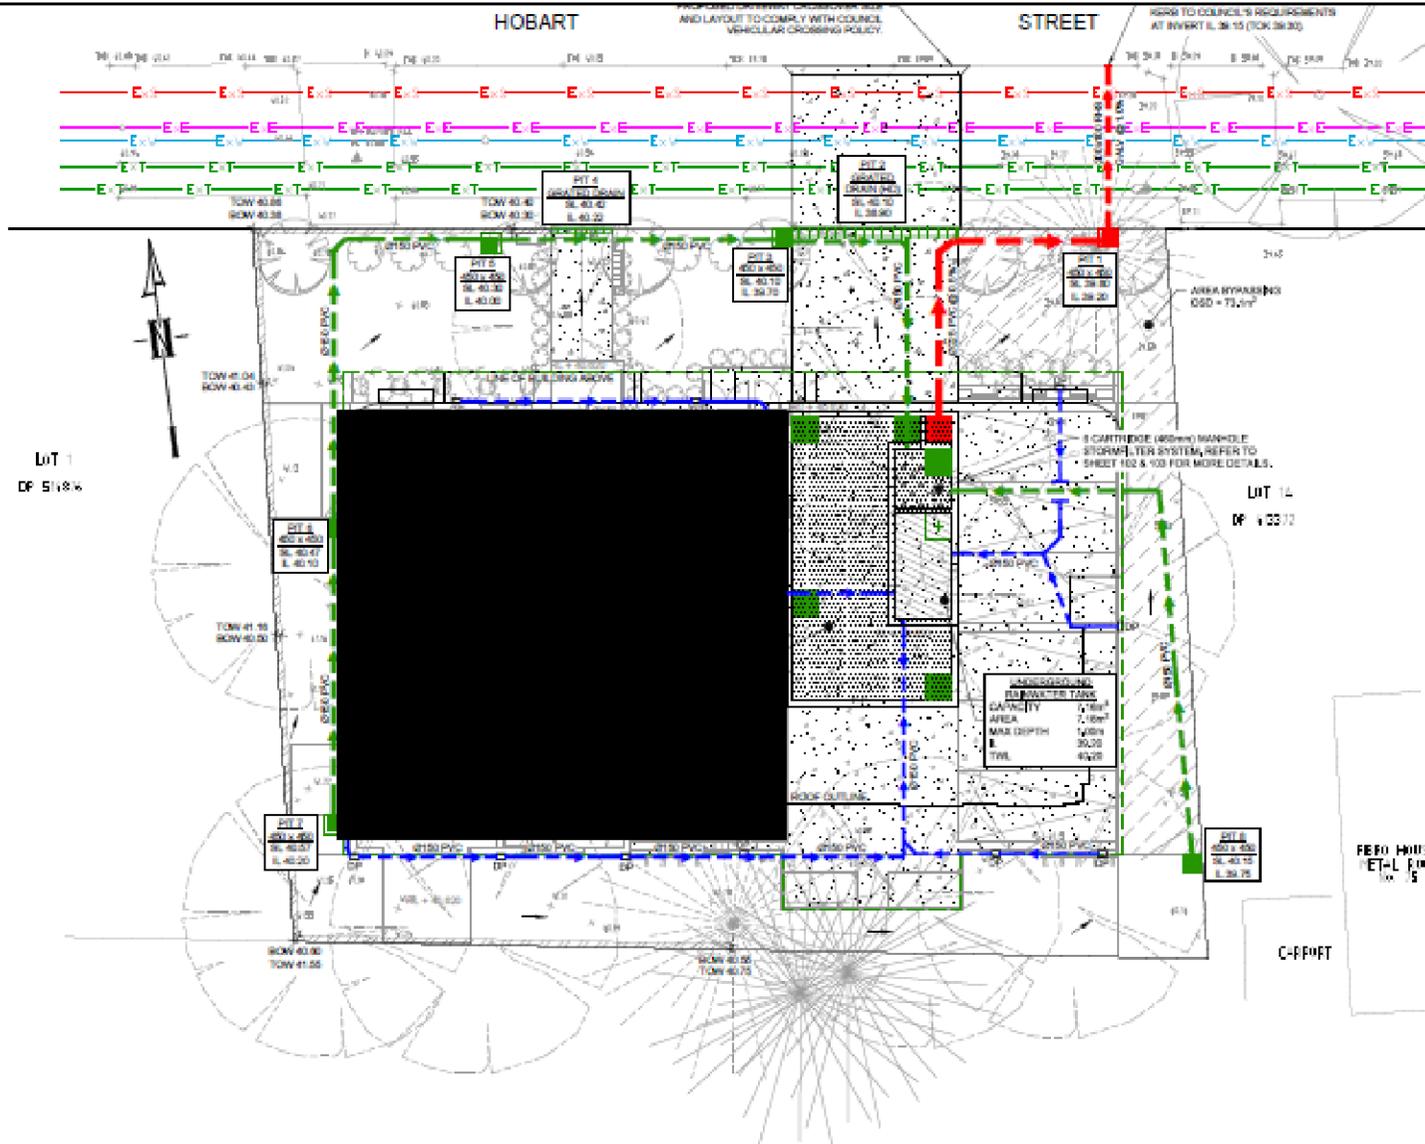
**APPENDIX 2d. Excerpt from Landscaping plan showing the location tree in relation to proposed stormwater pipes and Onsite Stormwater Detention (OSD) basin.**

Tree **T2** will experience a Major encroachment from stormwater pipes to be placed within its TPZ and to be replaced with new tree plantings in the landscaping for the Development (See Appendix 2d).
