Arborist development assessment report

Centro Nepean Station and Woodriff Streets Penrith NSW 2750

> 22nd May 2015 **Draft 1**

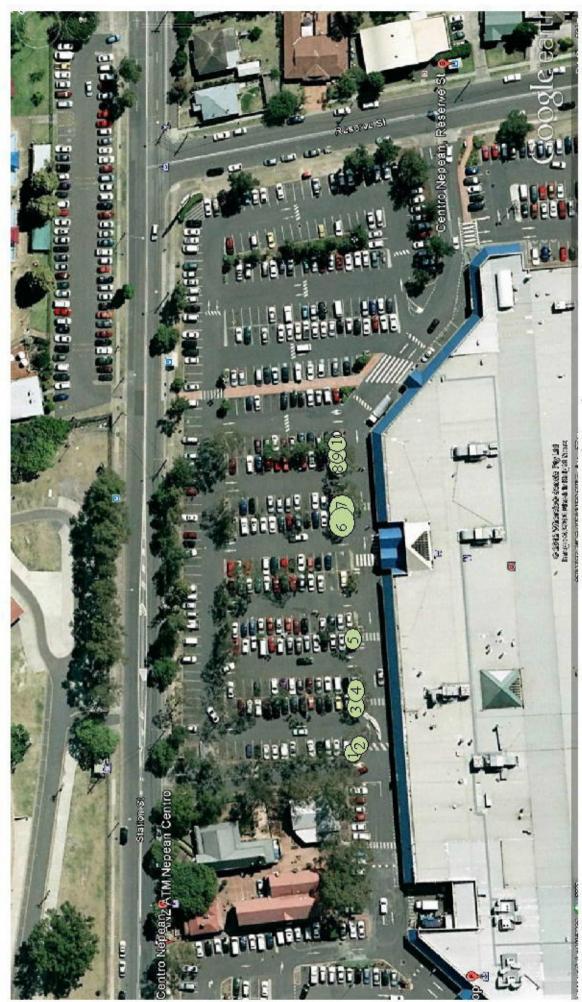
Plan 1

Tree 5 has failed in recent storms. Trees 1-4 and 6-10 are proposed to be removed to allow kerb and gutter replacement works to occur. The tree retention and removal locations can be seen in Plan 2 (Appendix 1).
