# **ABOUT TREES**

**TREE SURVEY & REPORT**

**40-46 EVAN ST & 96-98 LETHBRIDGE ST**

**PENRITH**

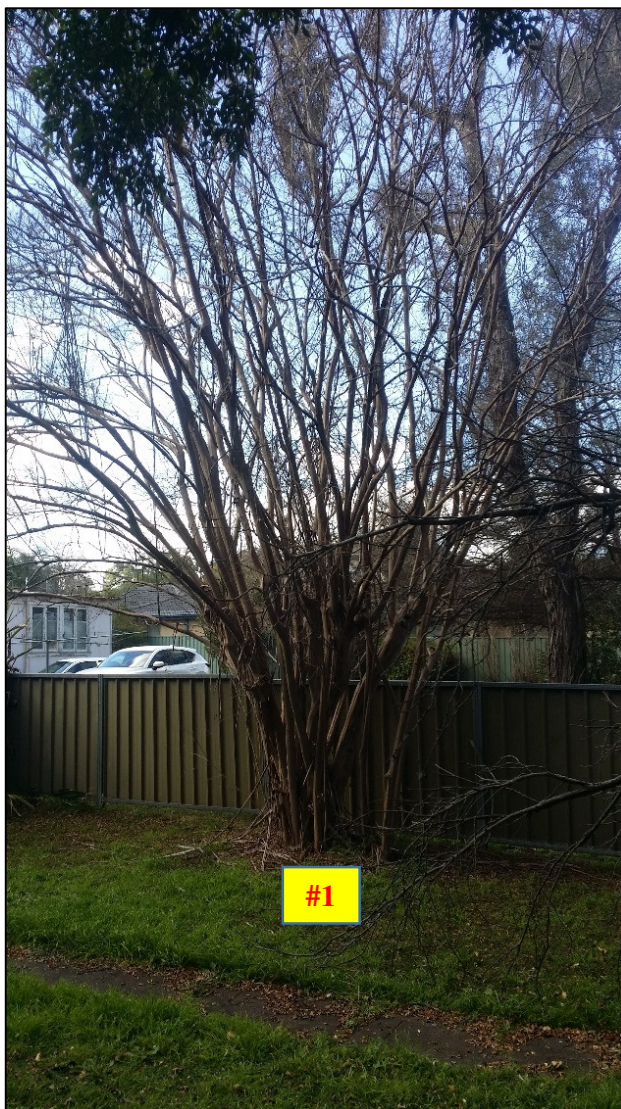
Plate 4 – showing tree No. 1

- Health & Vitality:** Average – this is a deciduous species and was dormant at the time of the inspection. However, an examination of the previous seasons of extension growth indicates that it’s generally healthy and growing vigorously, with no visible symptoms of decline (see Plate 4).
- Tree Form:** – it has formed multiple stems from the rootcrown and these combine to form a codominant canopy that is 7m in height, with a crown spread of 10x10m.
- Structural Condition:** Average, retainable in the long term

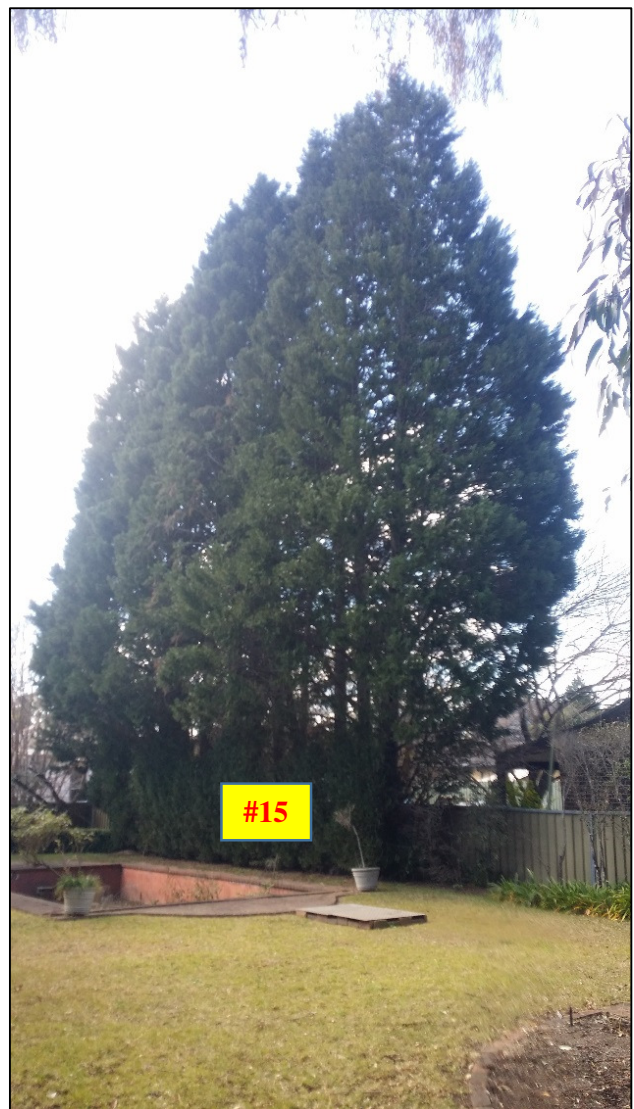
Plate 5 – showing tree No. 15 (mature hedgerow)

- a. **Health & Vitality:** – the foliage of these trees appears to be generally healthy and growing vigorously, with no visible symptoms of decline (see Plate 5).
- b. **Tree Form:** – these trees combine to form a hedgerow with a north/south axis that is 22m in height, and a crown spread of 22x5m
- c. **Structural Condition:** Average

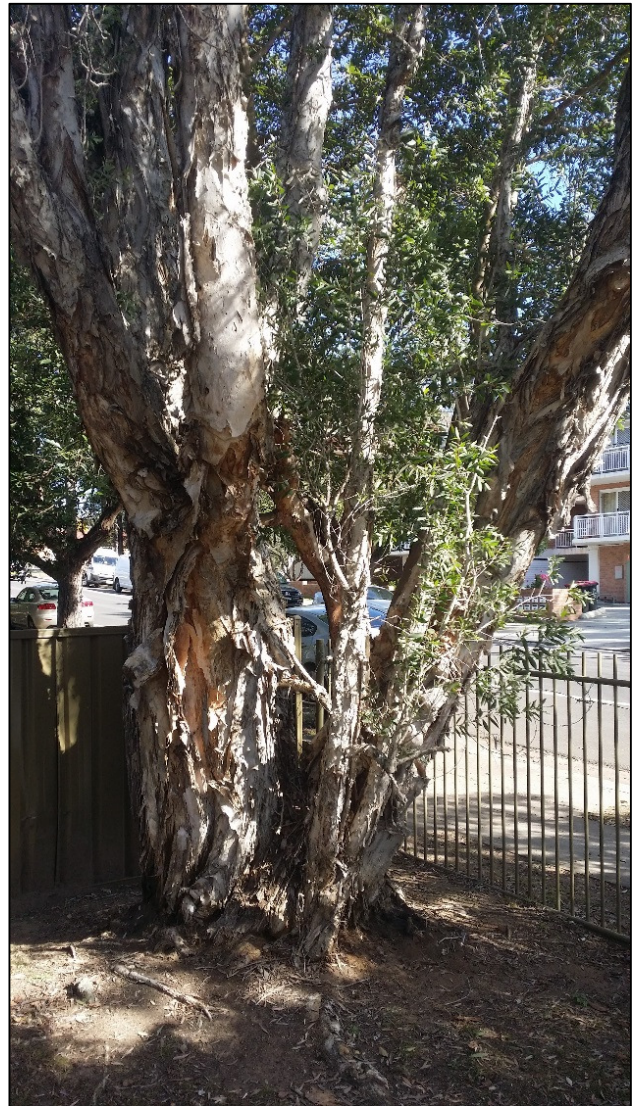
Plate 14 – showing tree No. 28

- a. **Health & Vitality:** Average – the foliage of these trees appear to be generally healthy and growing vigorously, with no visible symptoms of decline (see Plate 14).
- b. **Tree Form:** This tree has formed four codominant stems with DBH's 400 and a codominant canopy that is 15.5m in height, with a crown spread of 11x9m.
- c. **Structural Condition:** Average, retainable in the long term

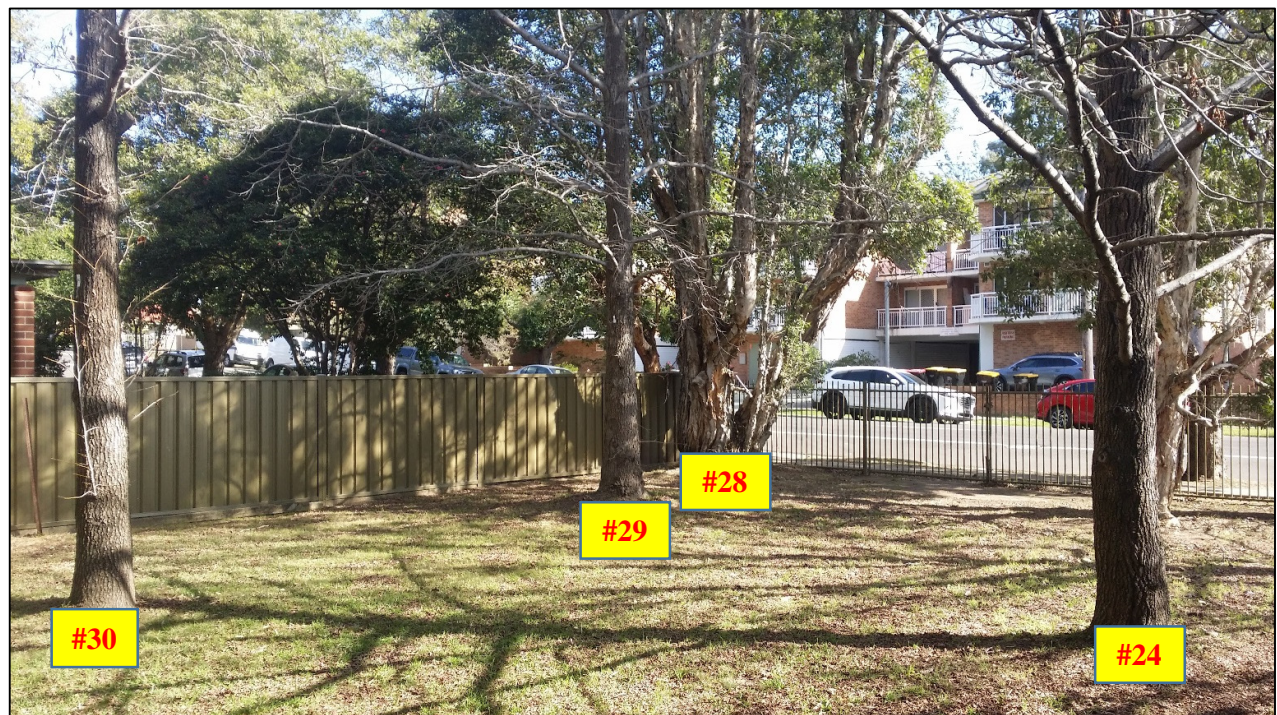
Plate 15 – showing tree No's 24, 28, 29 & 30

- a. **Health & Vitality:** Average – the foliage of these trees appears to be generally healthy and growing vigorously, with no visible symptoms of decline (see Plate 15).
- b. **Tree Form:** These trees have formed single stems with DBH's of 300 & 400mm and codominant canopies that are approximately 12m in height, with a crown spreads of 10x10m.
- c. **Structural Condition:** Average, retainable in the long term

- a. **Health & Vitality:** Average – the foliage of these trees appears to be generally healthy and growing vigorously, with no visible symptoms of decline (see Plates 15 & 16).
- b. **Tree Form:** These trees have formed a single stem with DBH of 300mm and codominant canopies that are 15m in height, with a crown spreads of 10x10m.
- c. **Structural Condition:** Average, retainable in the long term
