# Dilapidation Report

Proposed Works - Jordan Springs Stage 2 Retirement Living

James Sae Siew  
5<sup>th</sup> March 2019  
Revision 1

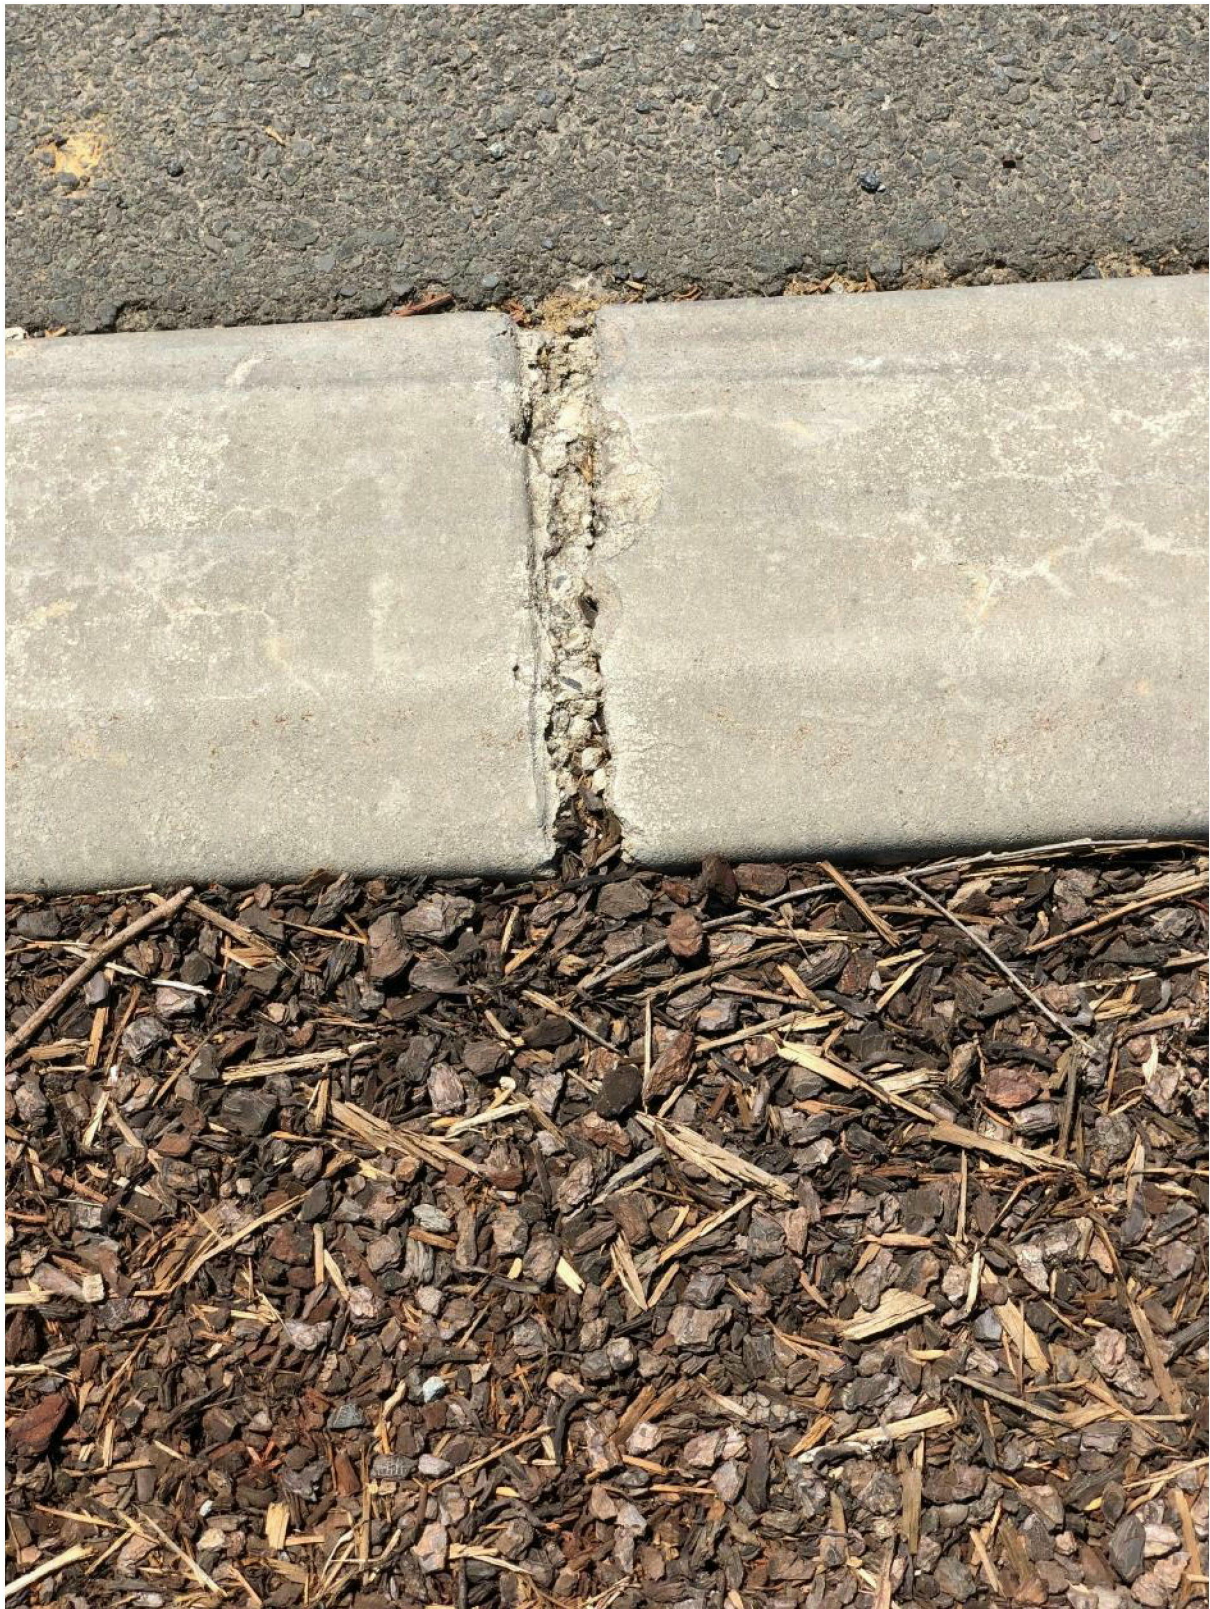
*Figure 18: separation of median strip kerb.*

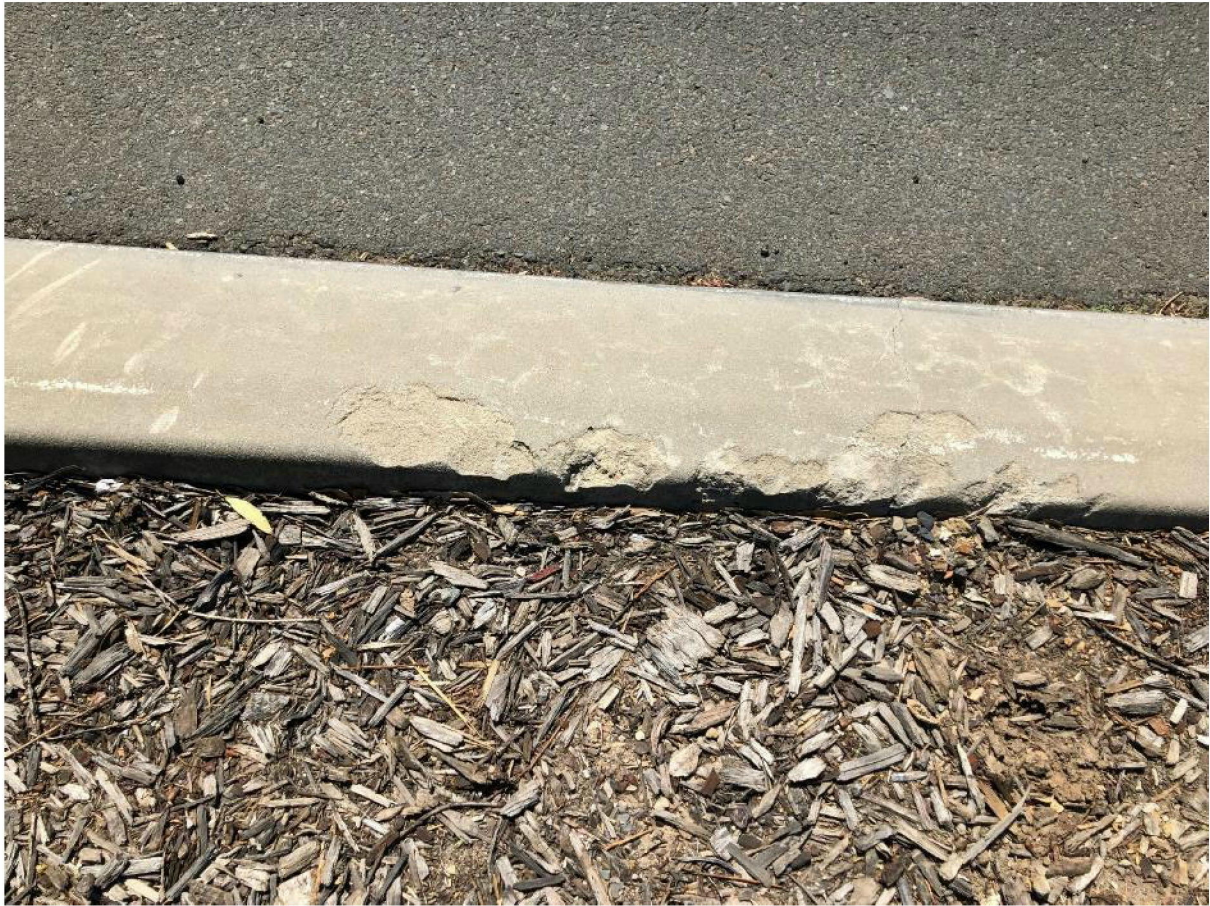
*Figure 20: chips on top of median strip kerb.*

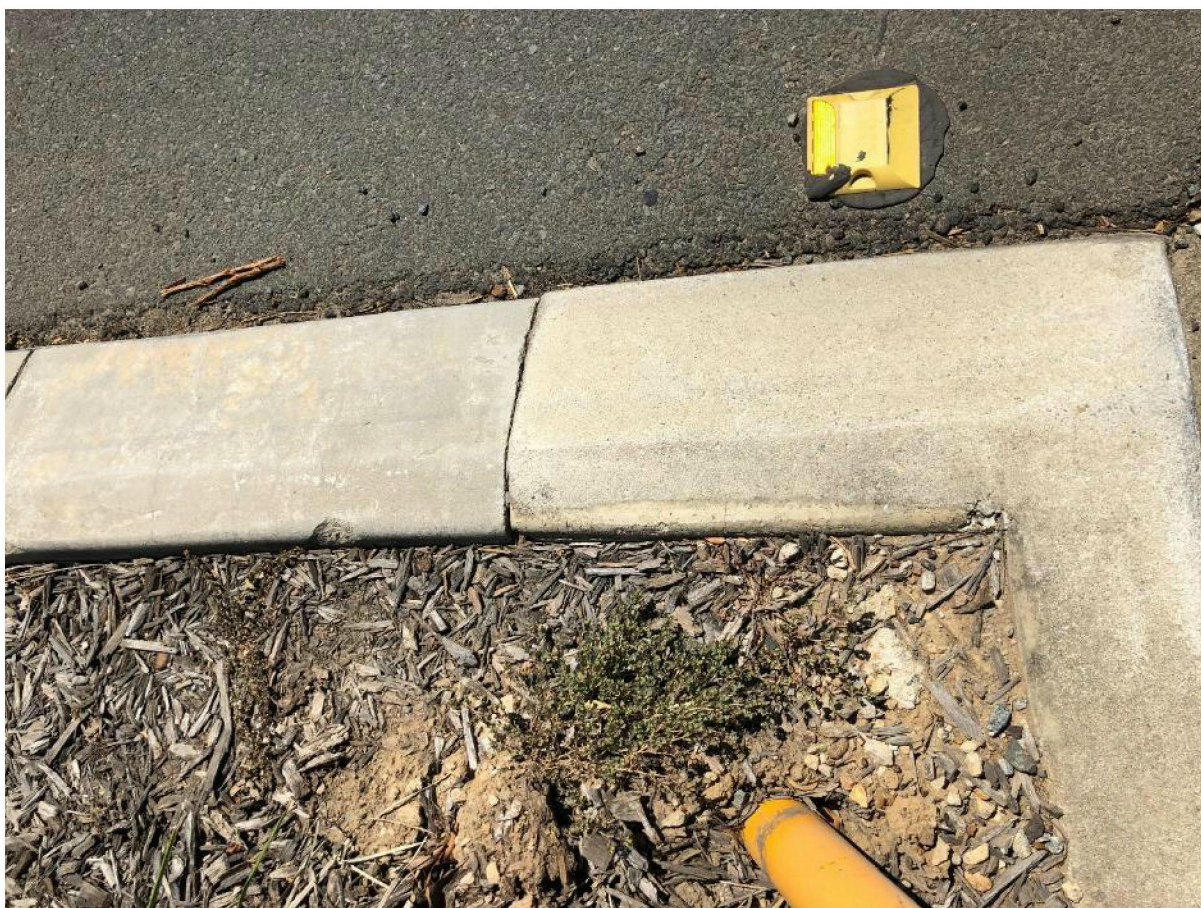
*Figure 26: chips to top of median strip kerb.*

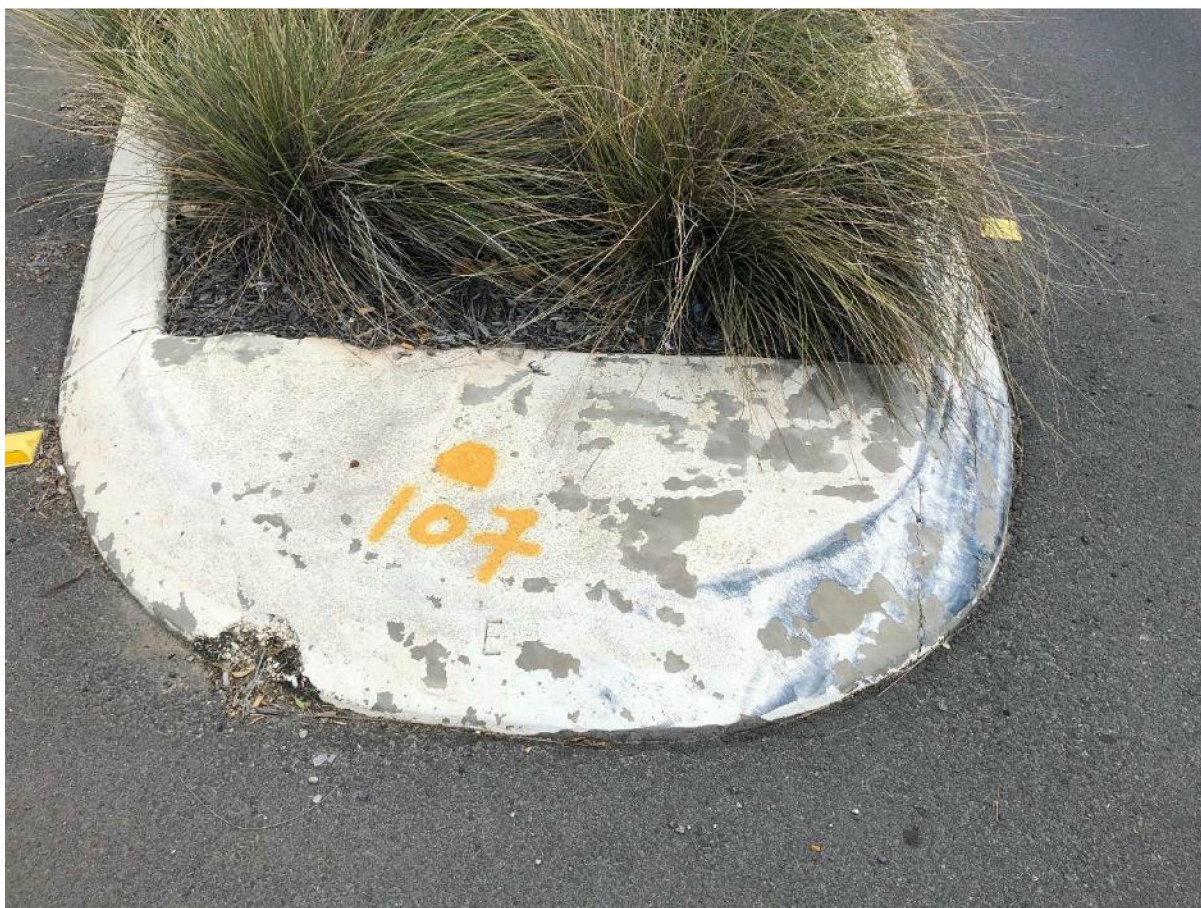
*Figure 39: chip in median strip kerb (facing Lakeside Parade).*

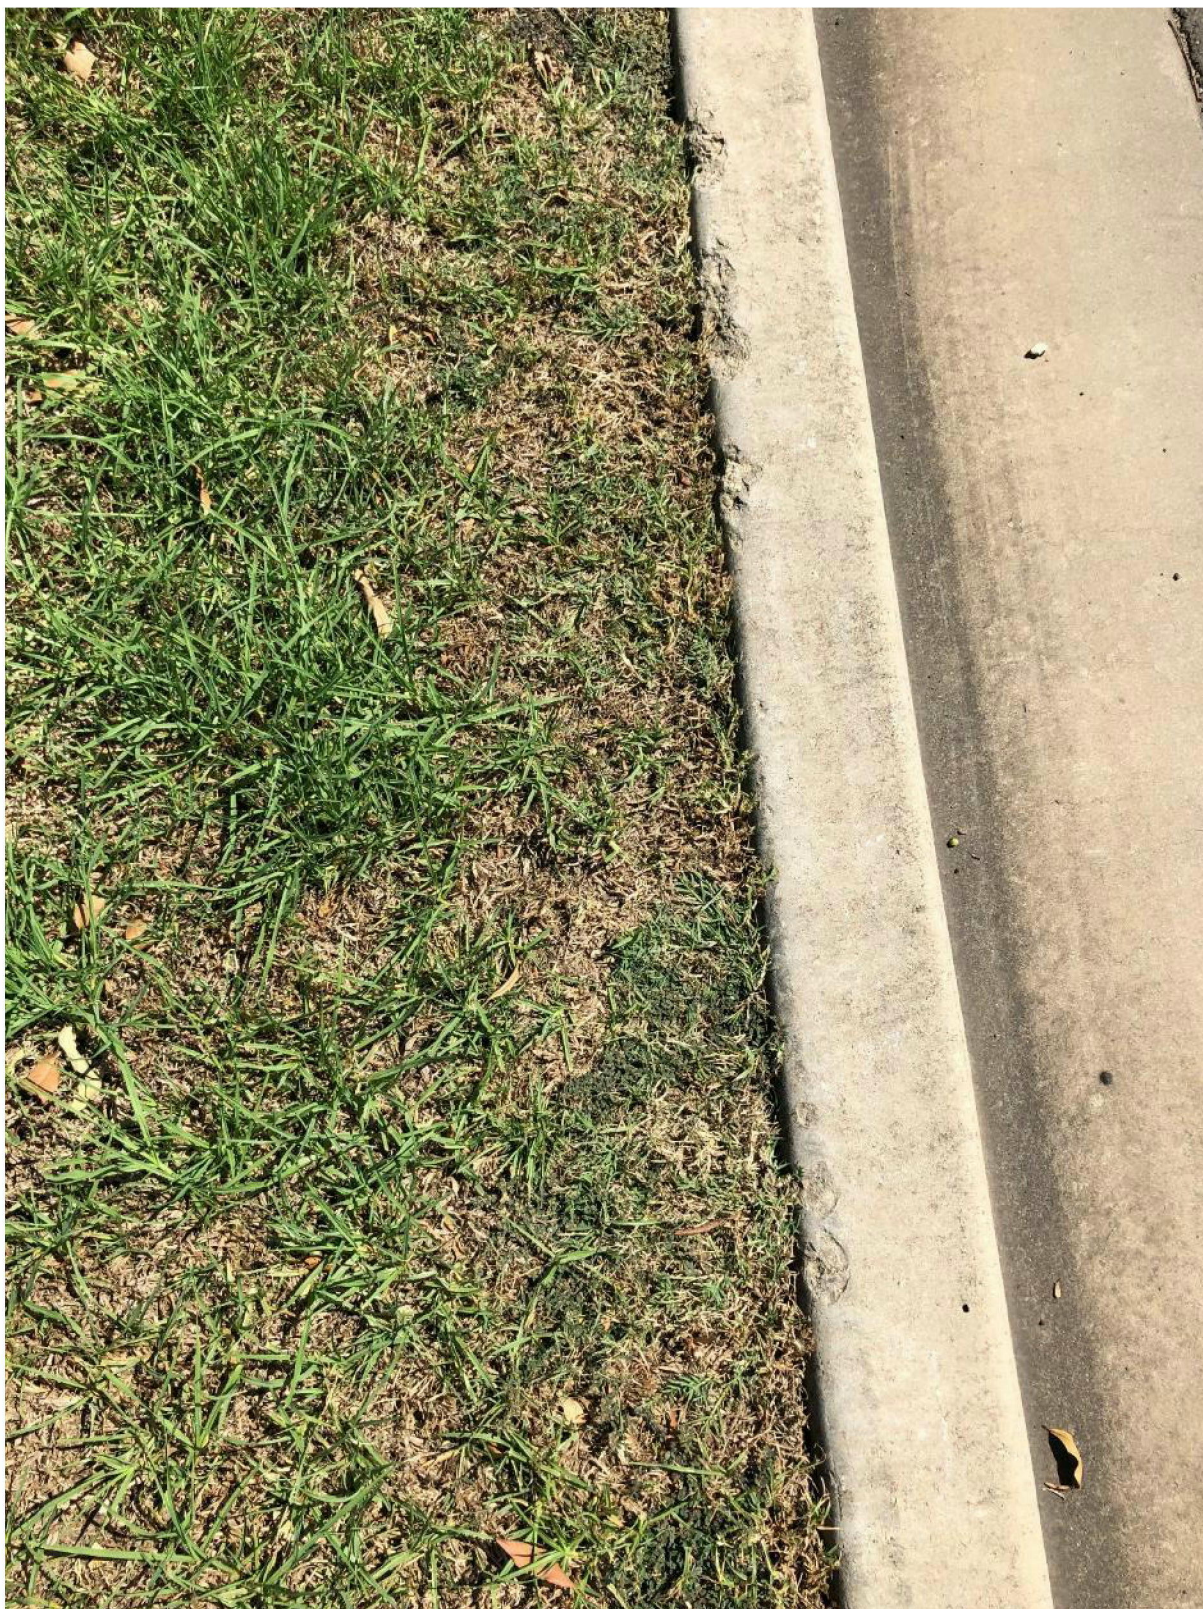
*Figure 40: chips to top of kerb and gutter.*

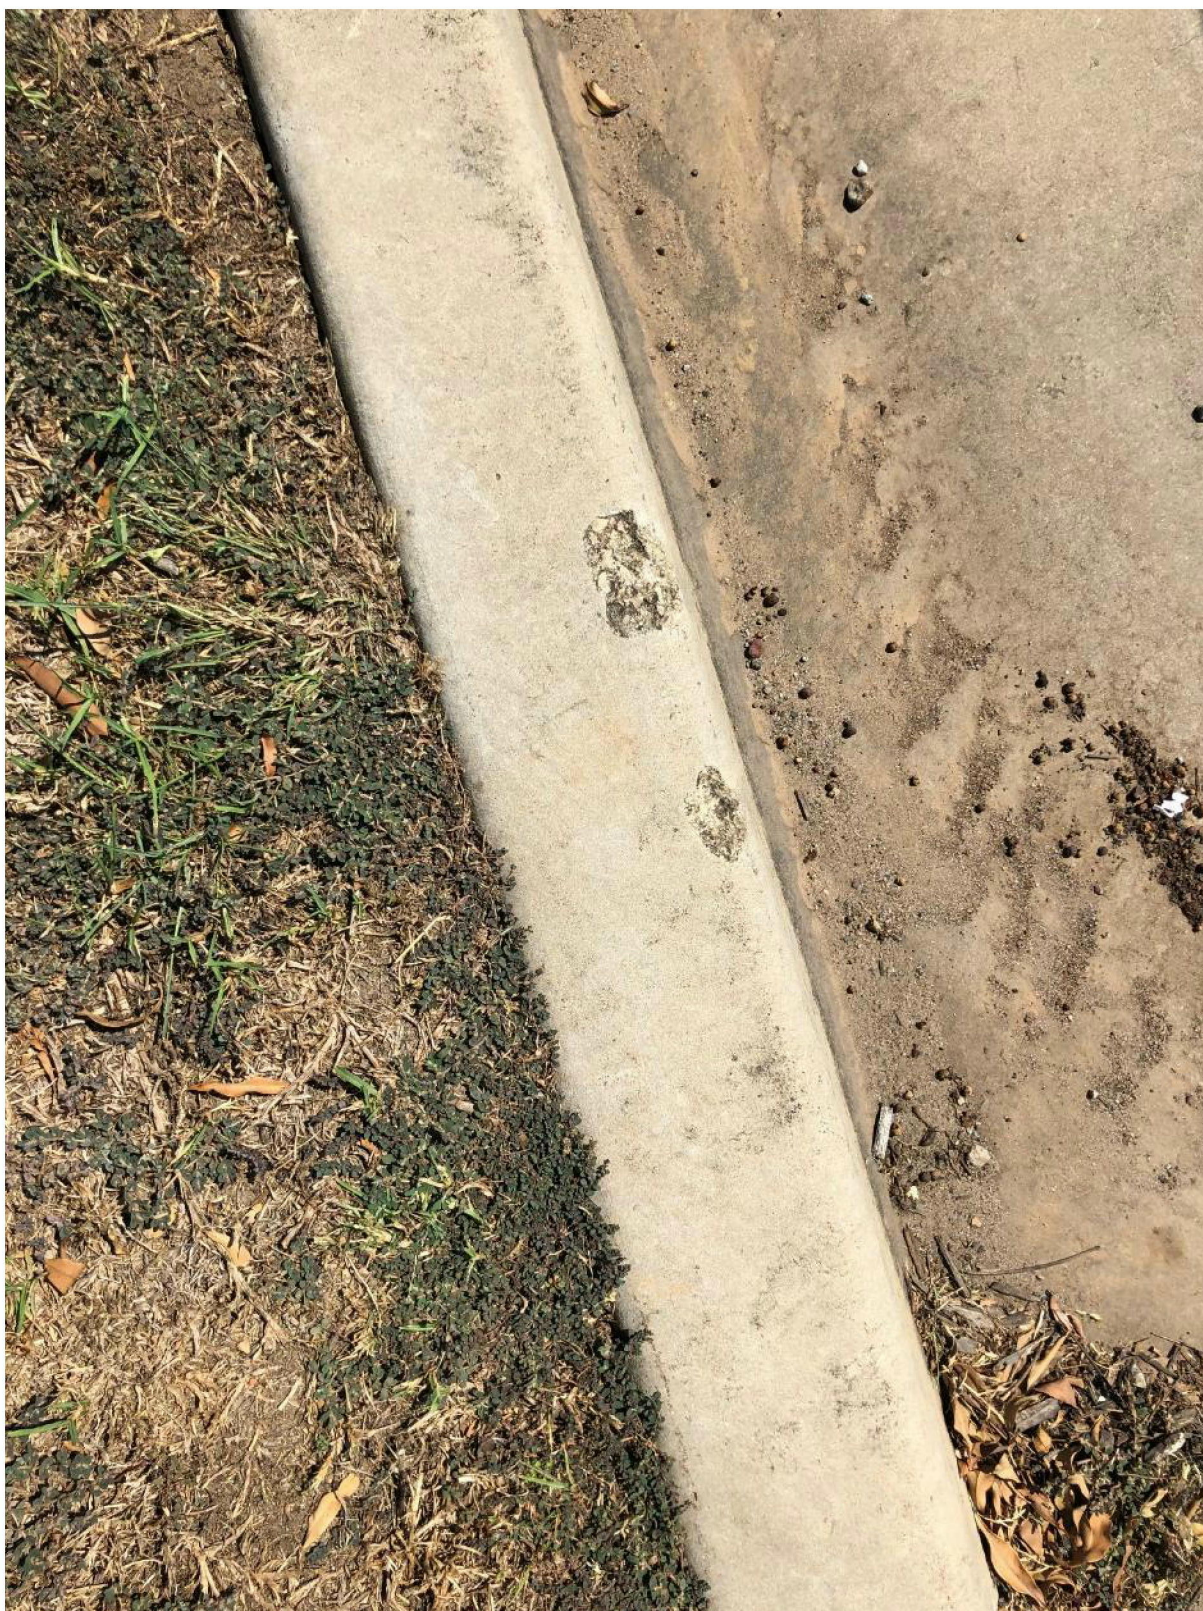
*Figure 41: chips on top of kerb.*

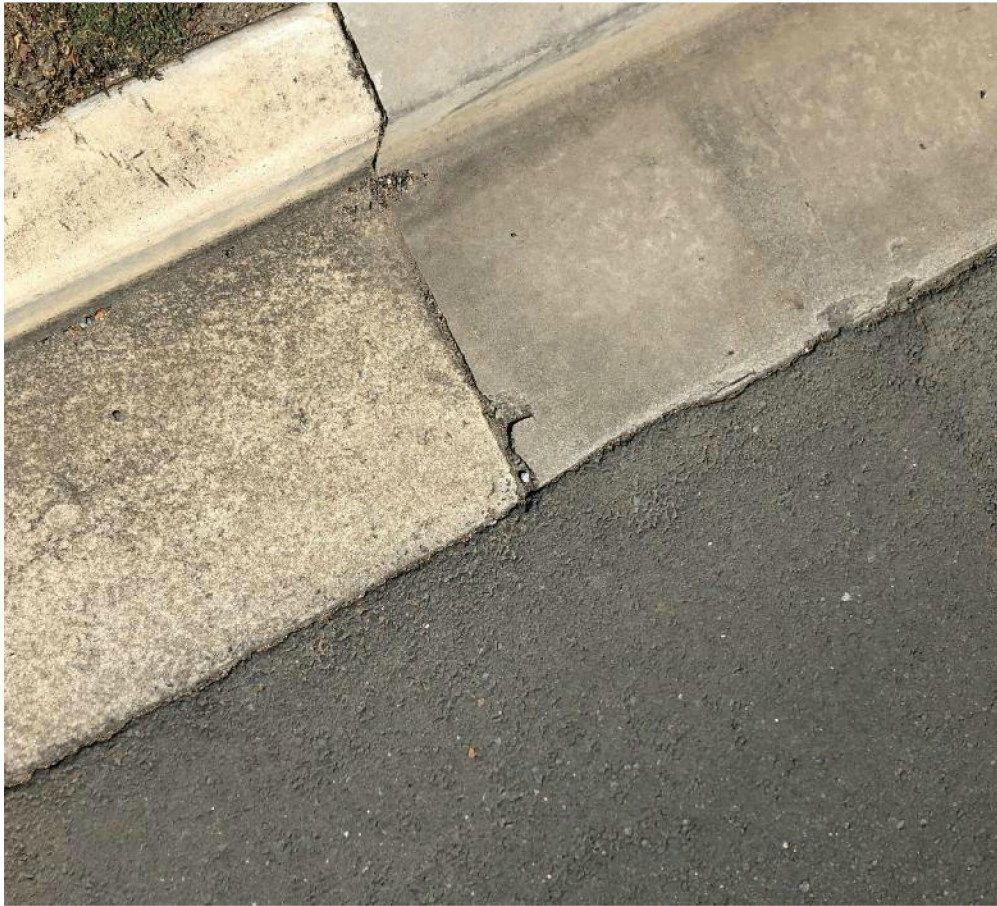
*Figure 42: spalling on edge of construction joint interface on gutter.*

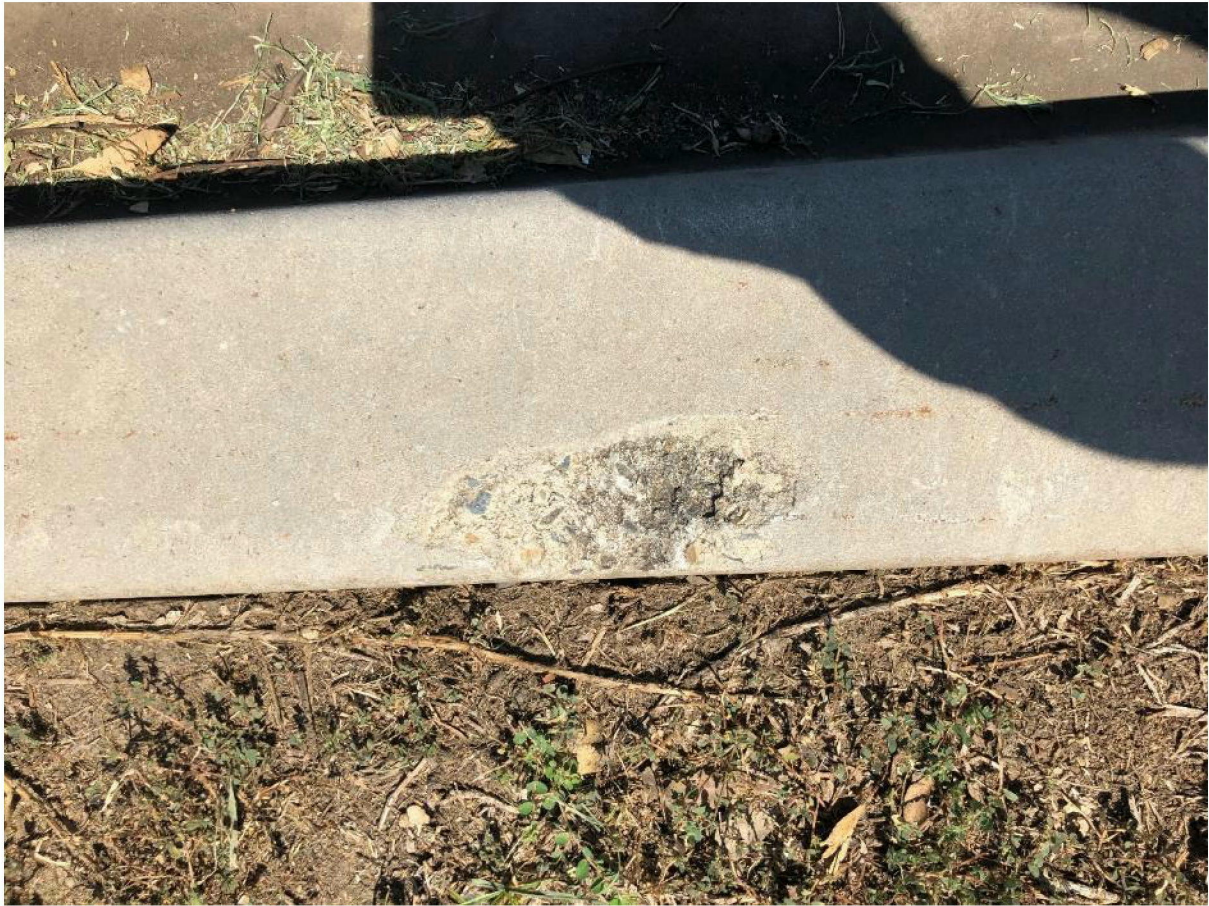
*Figure 75: chip to top of gutter.*

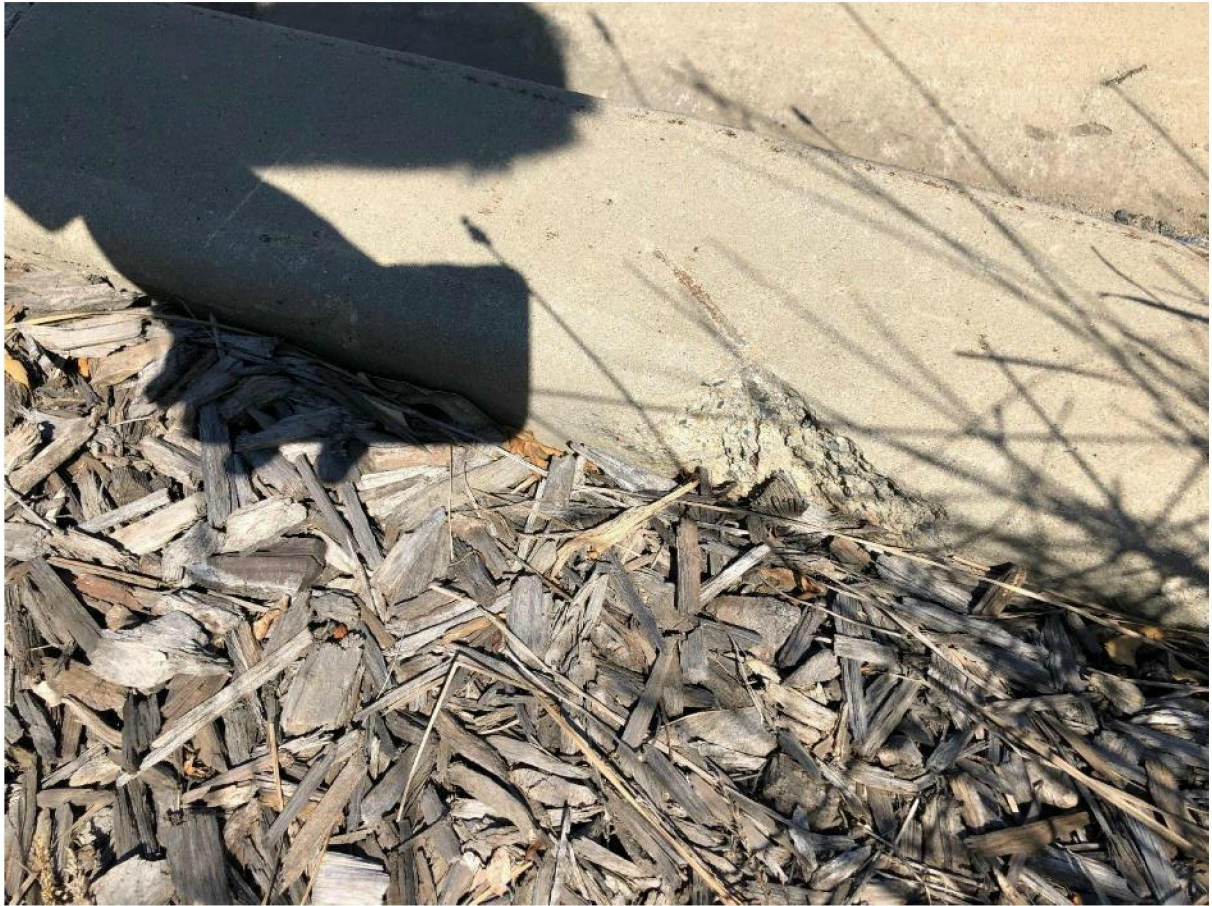
*Figure 80: chip to top of kerb.*

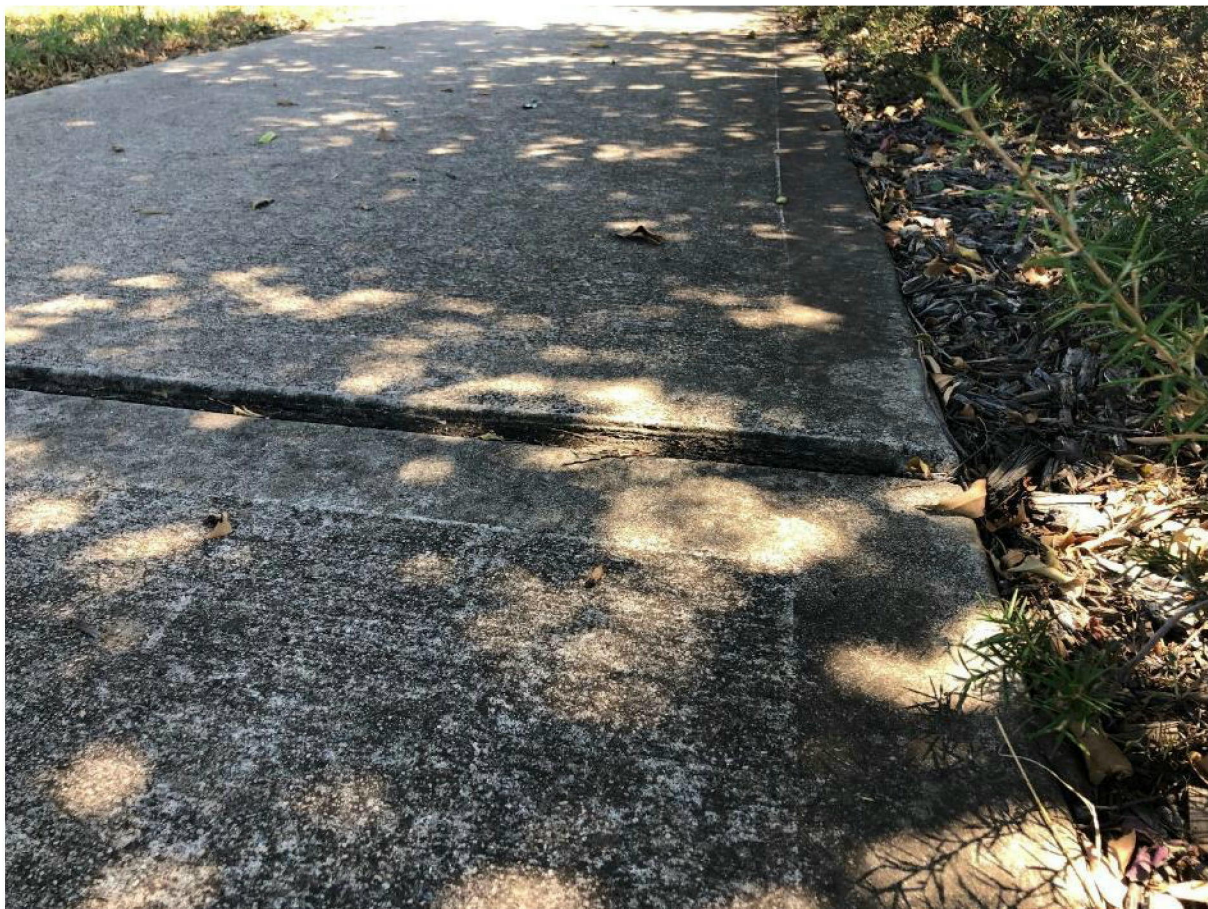
*Figure 84: footpath bay lifted at expansion joint interface.*

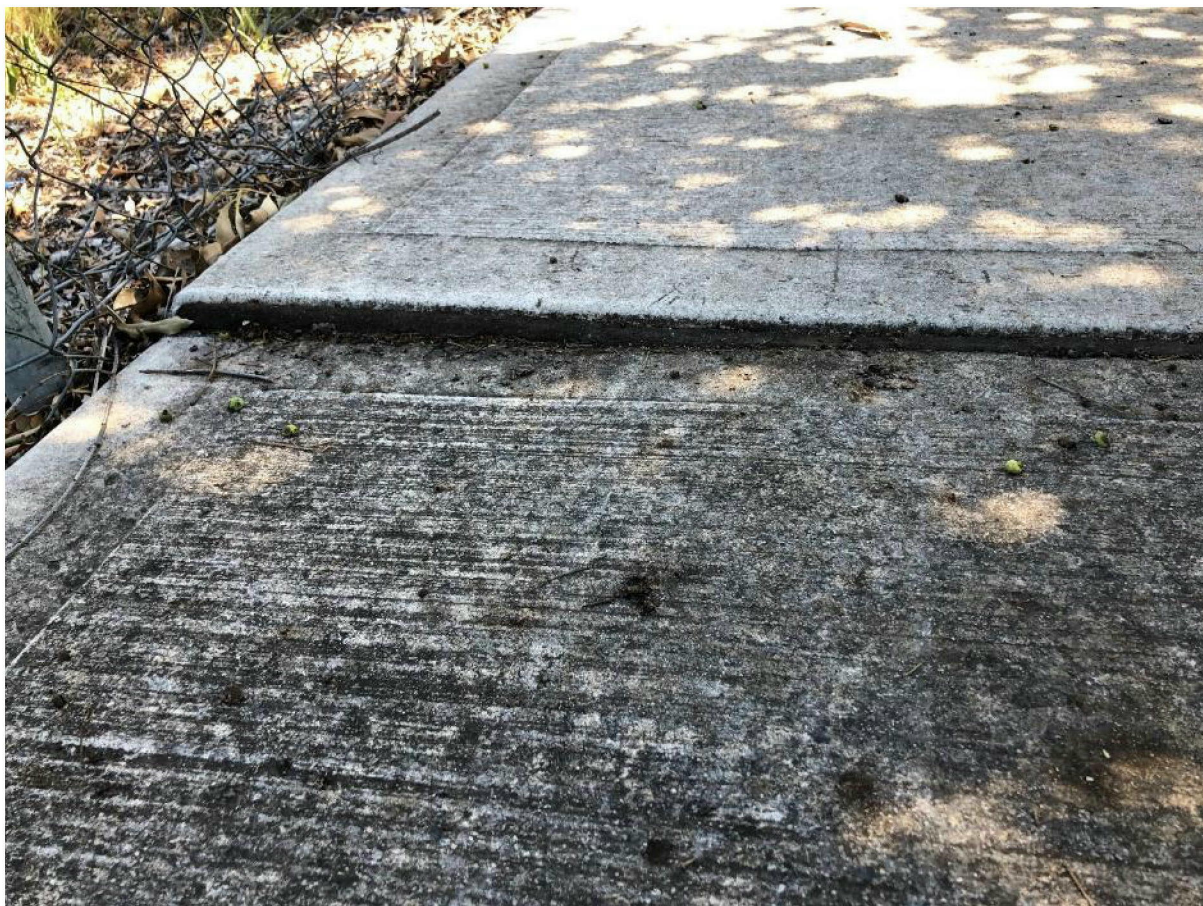
*Figure 87: footpath bay lifted at expansion joint interface.*

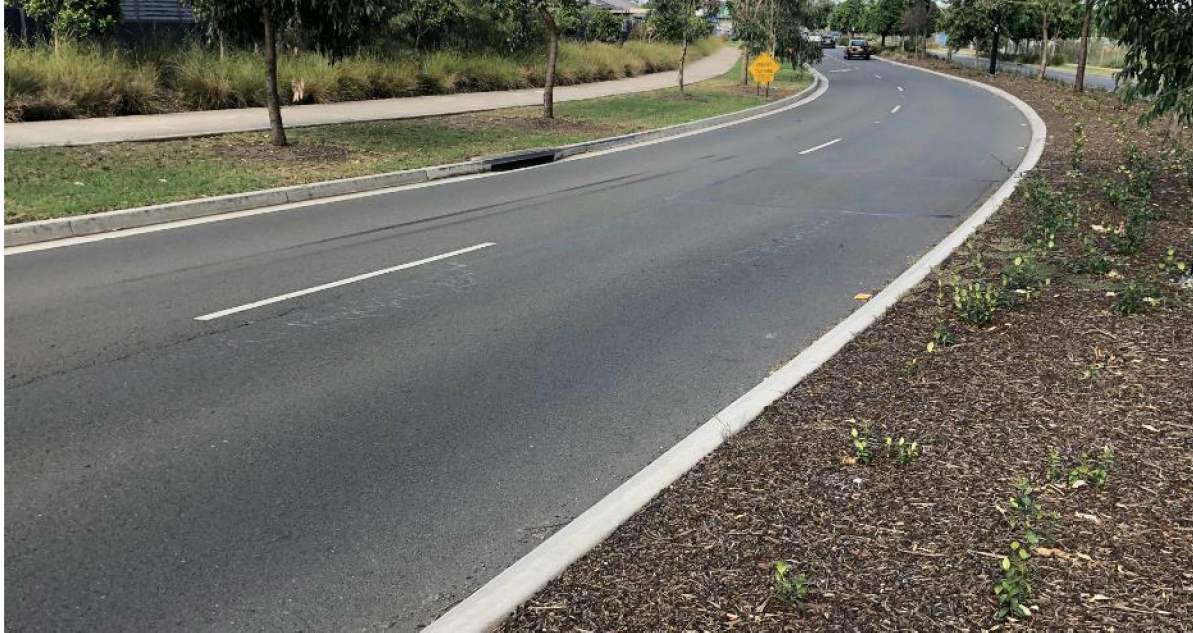
Figure 88: Approx CH250 EB pavement failure (P53)

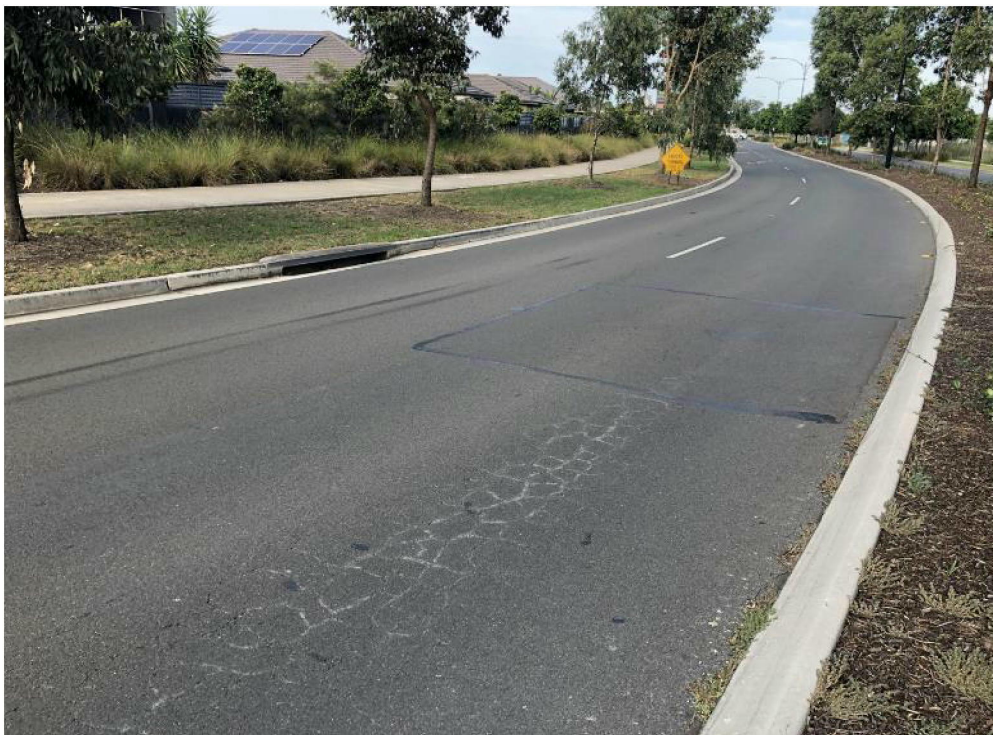
Figure 89: Approx CH255 EB Pavement failure

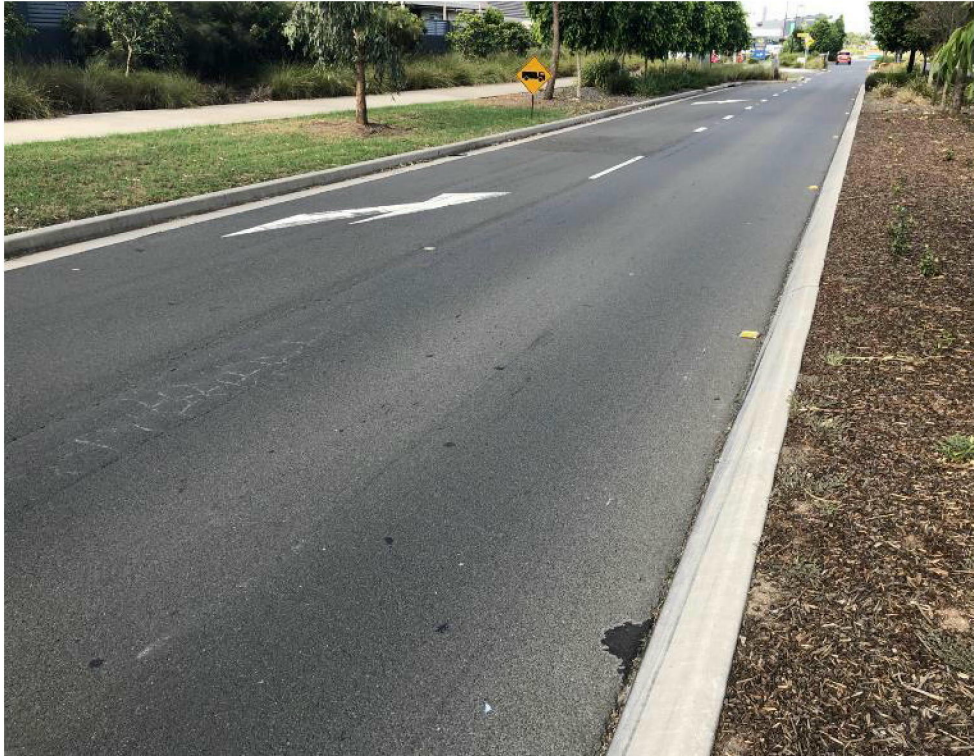
Figure 90: Approx CH300 EB Pavement failure (P66)

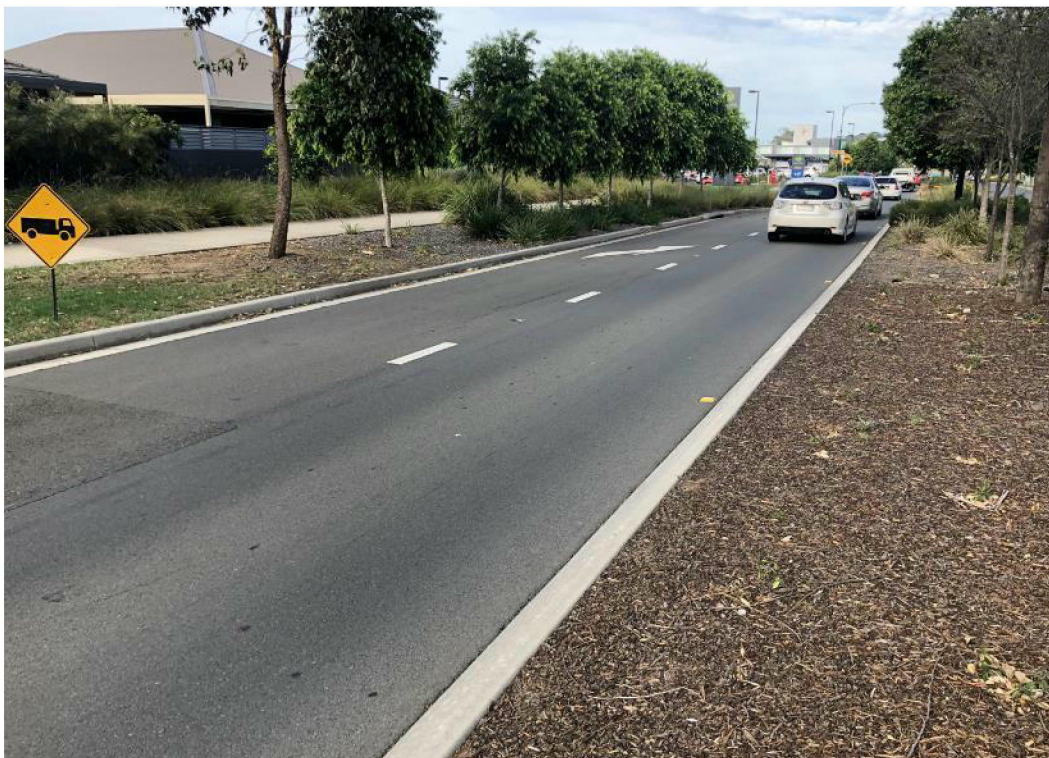
Figure 91: Approx CH320 EB Pavement failure

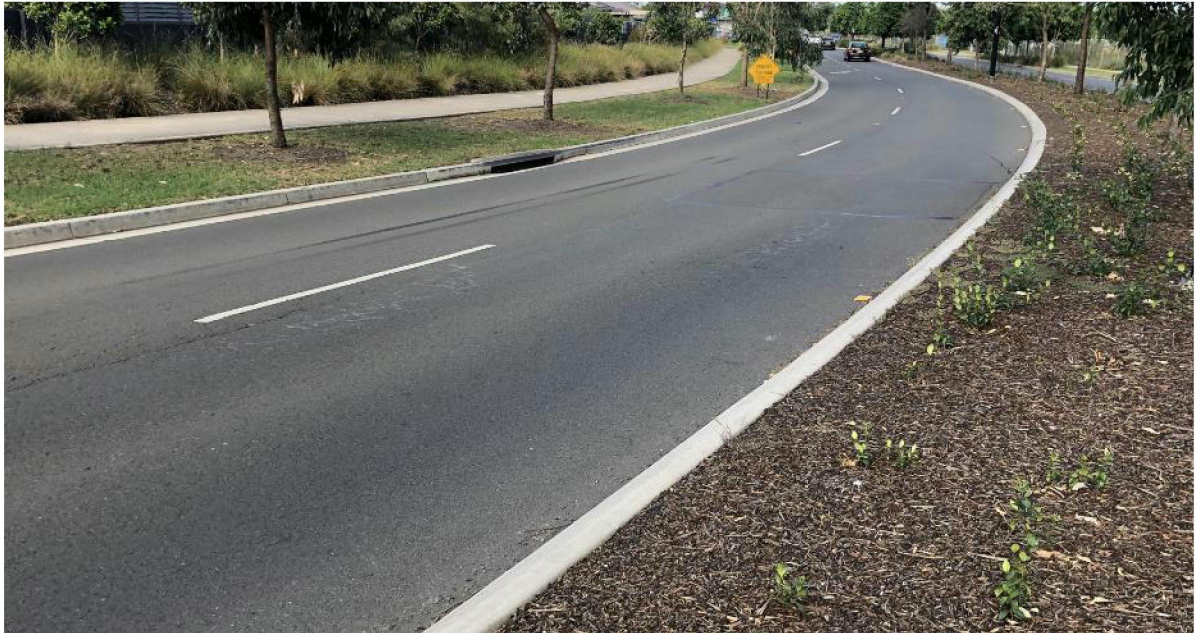
Figure 88: Approx CH250 EB pavement failure (P53)

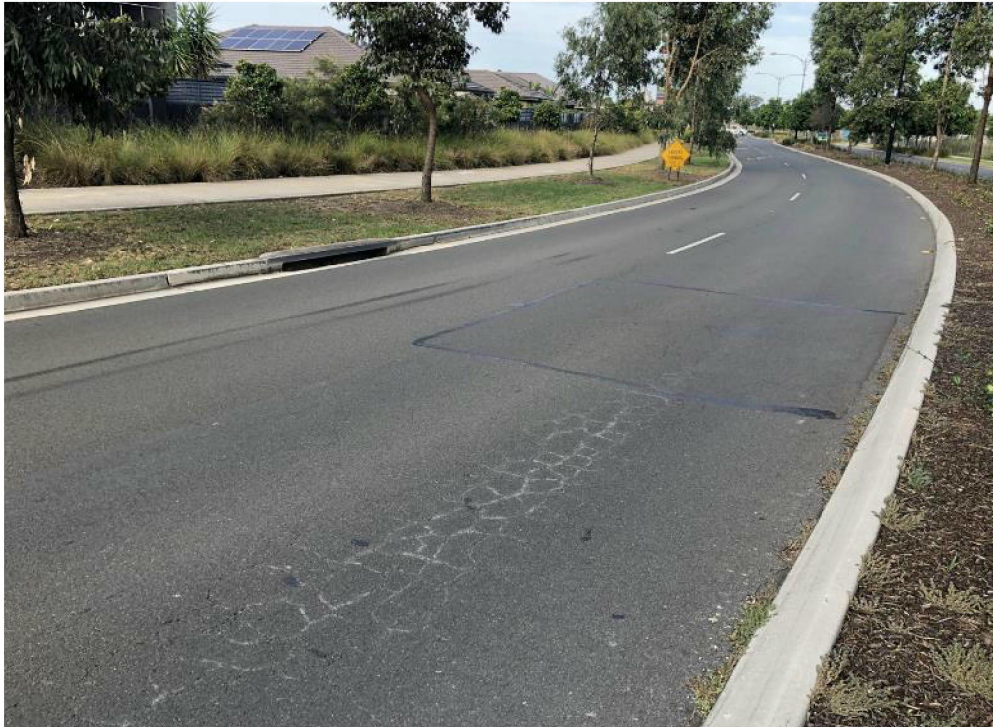
Figure 89: Approx CH255 EB Pavement failure

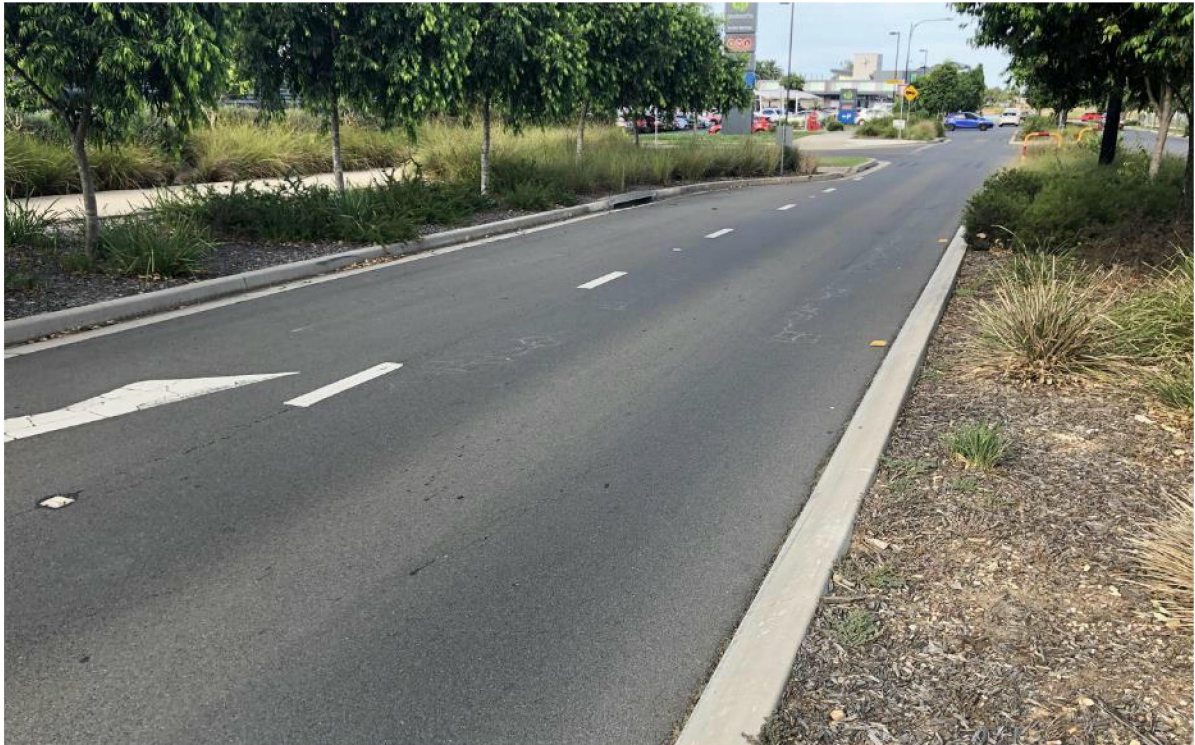
Figure 90: CH325-330 Pavement failure at wheel track (P70)

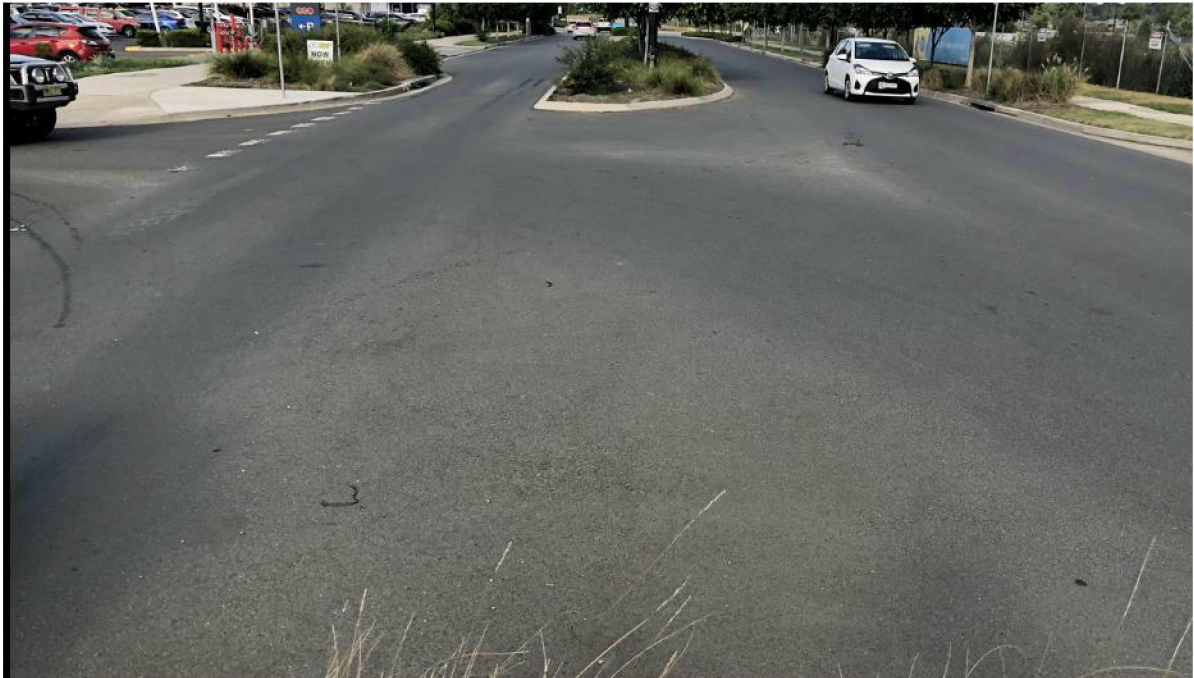
Figure 92: CH475 EB pavement failure at McGarrity Pde (P78)

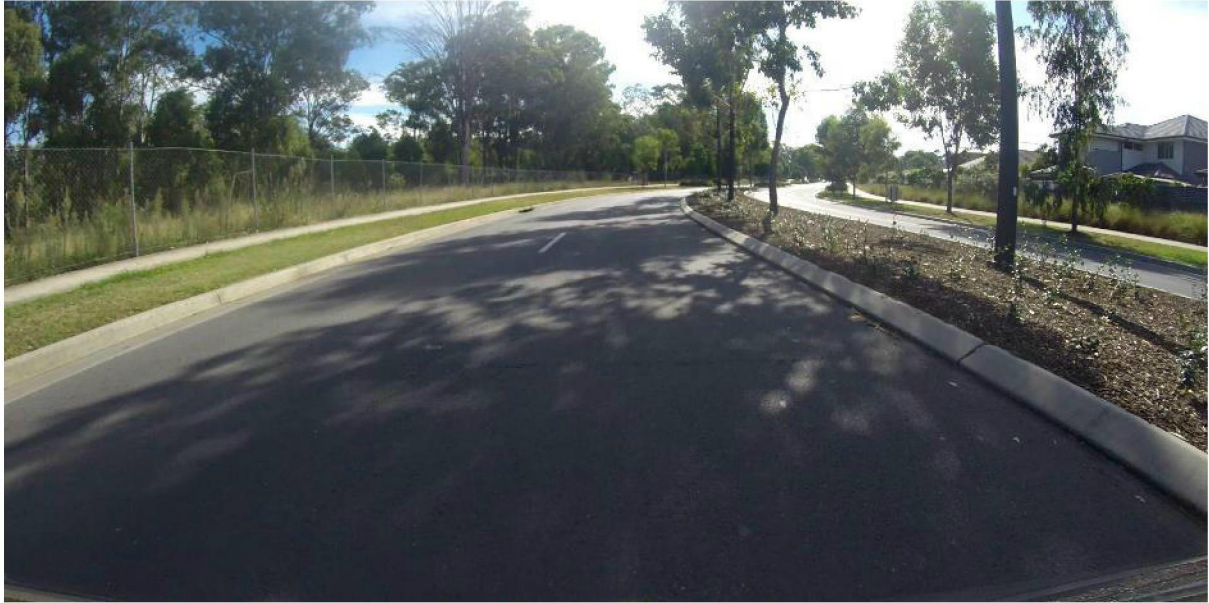
Figure 94: Approx CH200 WB horizontal crack

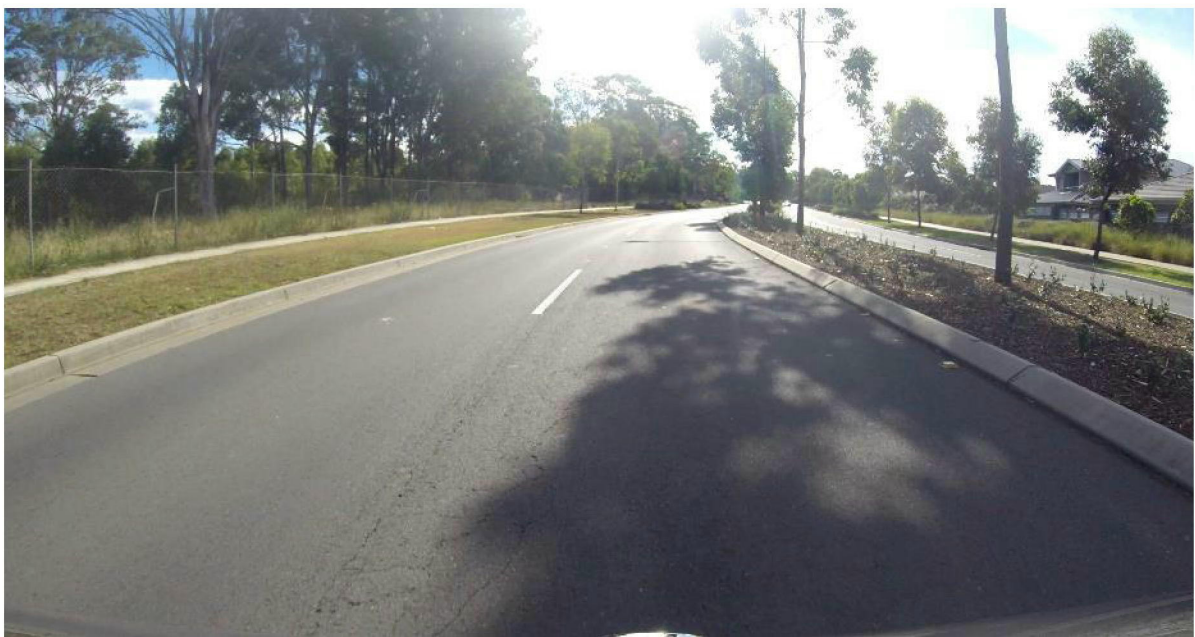
Figure 95: Approx CH210 WB Pavement failure

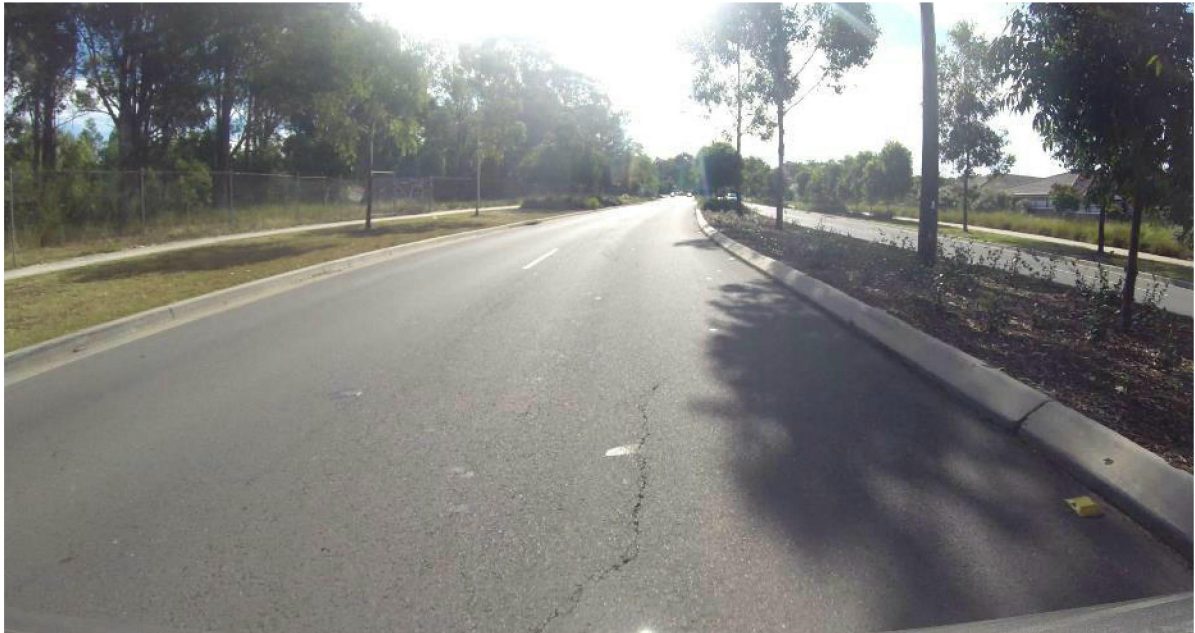
Figure 96: CH250 WB pavement crack/failure
