# Dilapidation Report

Proposed Works - Jordan Springs Stage 2 Retirement Living

James Sae Siew  
5<sup>th</sup> March 2019  
Revision 1

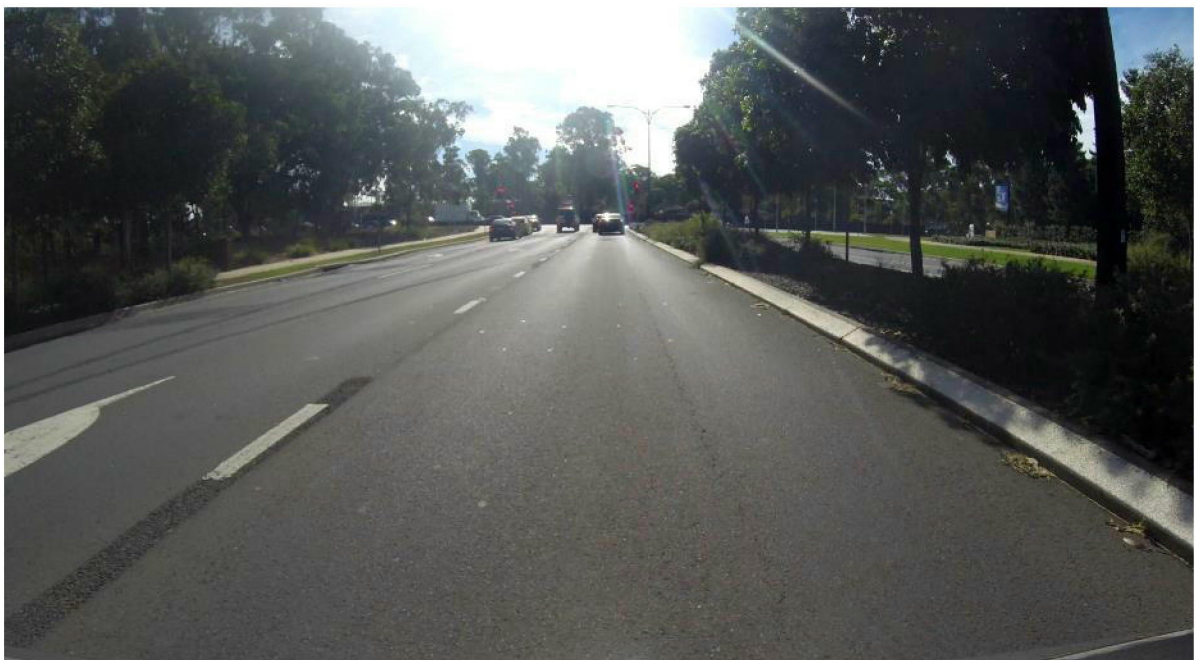
Figure 99: CH440 WB pavement crack/failure
