Hazardous Materials Survey

170 Derby Street

Penrith NSW 2750

E20160-1

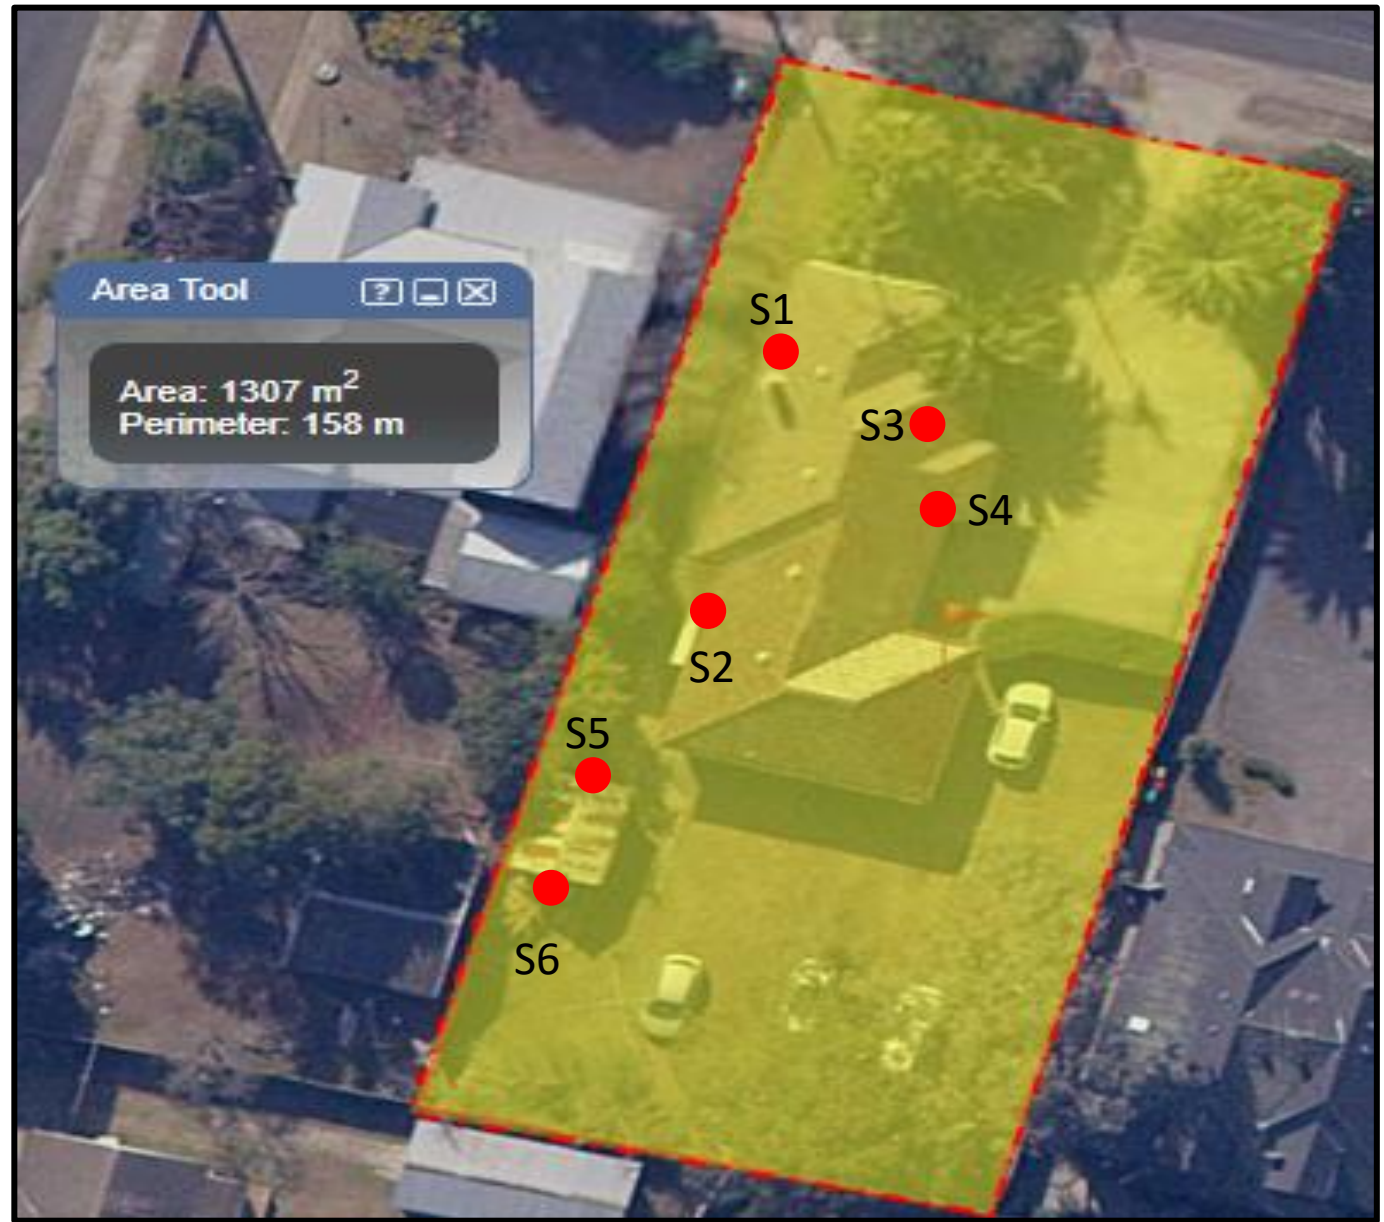
Figure 2	Site Area
Project	170 Derby Street, Penrith, NSW, 2750

Figure 2: Depicts an aerial photo of the site. The total area of this site is approximately 1307m². Six (6) samples were taken from the property. NOTE: "NT" = Not Tested

Sample Name	Lead %w/w	Asbestos
S1	NT	No
S2	0.002	No
S3	0.001	NT
S4	0.002	NT
S5	17	NT
S6	NT	No

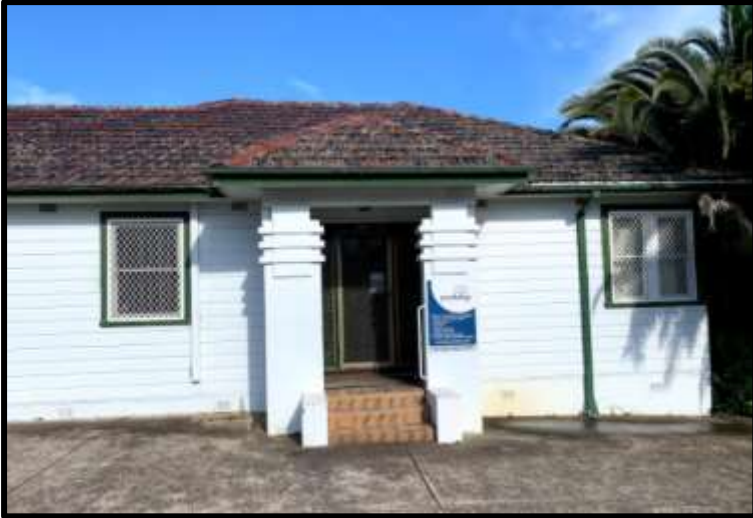
Image 1: Overview image of the site. The site contains a single storey residential property. The site is being used as an Associate Psychology Practice. There is brick base and front pillars, with wooden cladding.

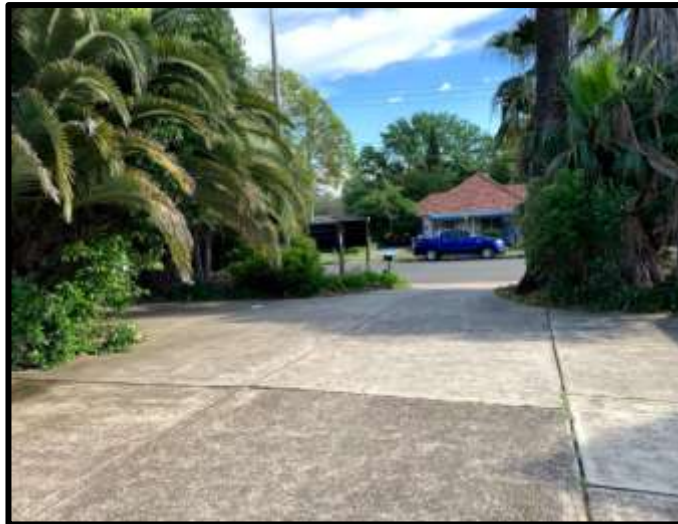
Image 2: Depicts the entrance to the site. The site contains a carpark and vegetation bundled within certain areas of the site. There is a steep elevation near the entrance of the site.
