**TREE SURVEY & REPORT**

**40-46 EVAN ST & 96-98 LETHBRIDGE ST**

**PENRITH**

05/08/19  
Ref. # 2042

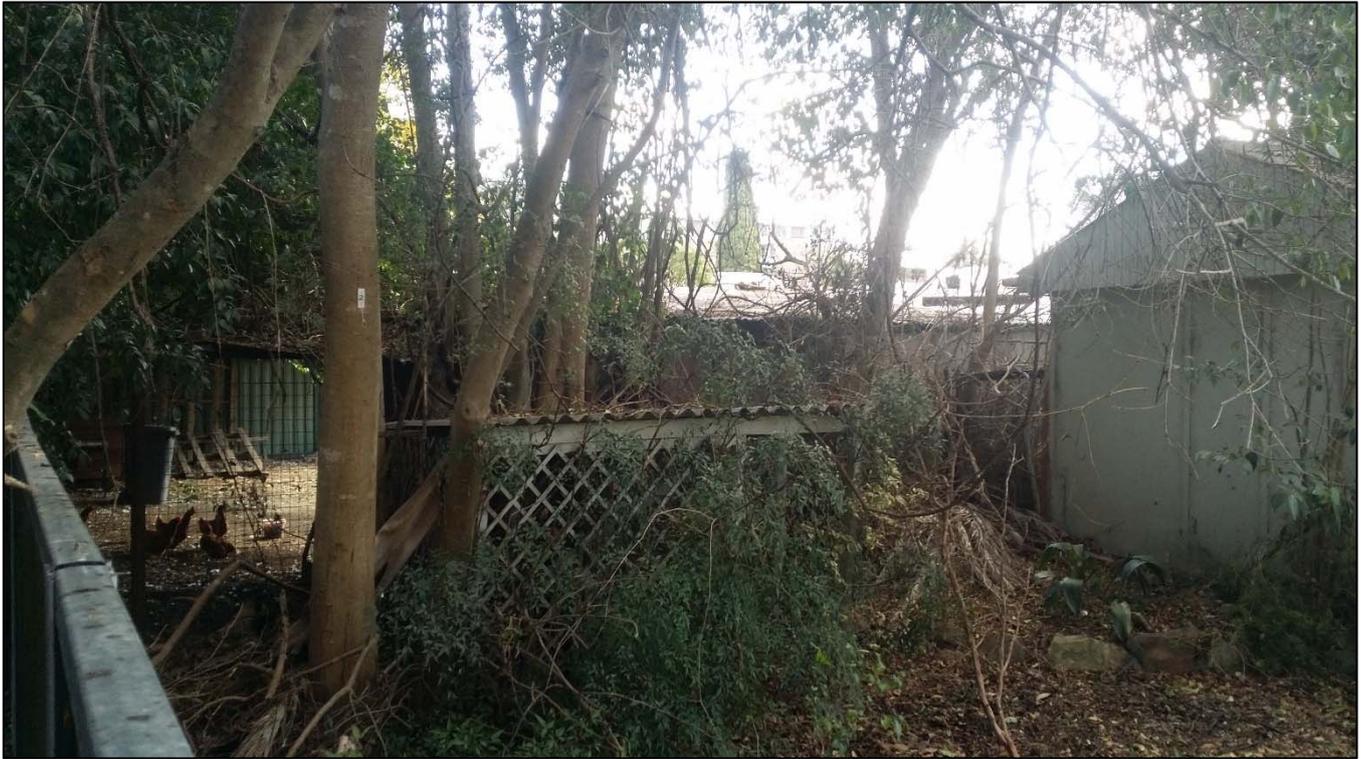
Plate 1 – showing tree No’s 2 – 6 (Privets)

- a. This species is a ‘weed of National Concern in the Sydney Region – harmful to human health and the environment, and is listed as an exempt in Penrith DCP 2014 (see Plate 1).
- b. These trees should be removed

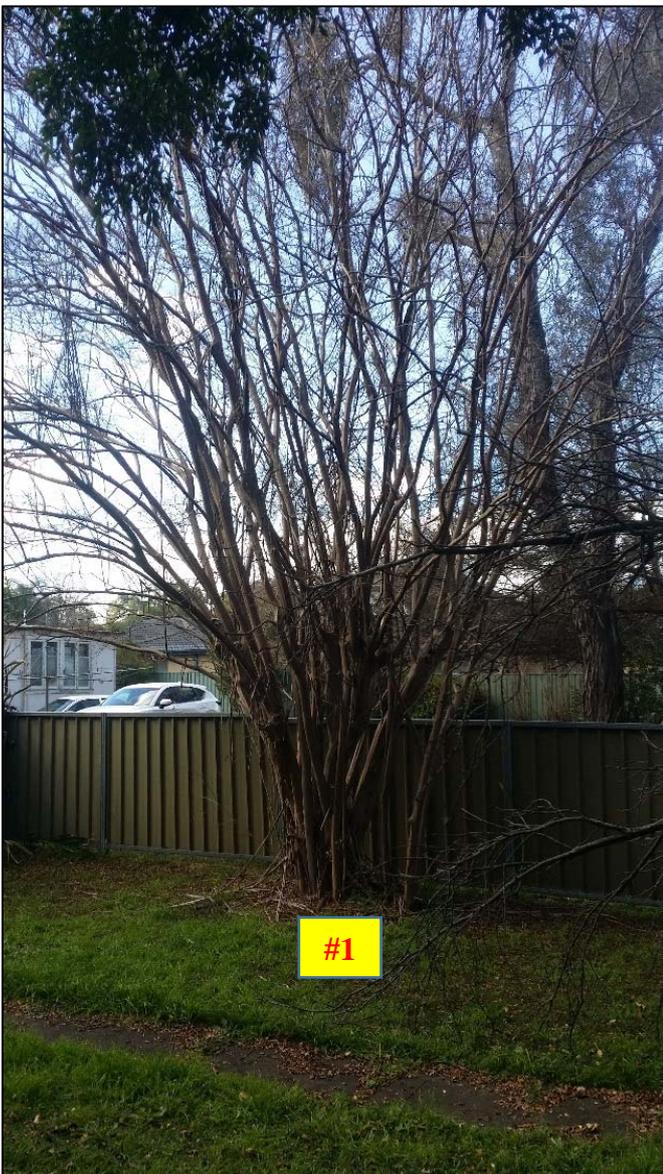
Plate 4 – showing tree No. 1

- a. **Health & Vitality:** Average – this is a deciduous species and was dormant at the time of the inspection. However, an examination of the previous seasons of extension growth indicates that it’s generally healthy and growing vigorously, with no visible symptoms of decline (see Plate 4).
- b. **Tree Form:** – it has formed multiple stems from the rootcrown and these combine to form a codominant canopy that is 7m in height, with a crown spread of 10x10m.
- c. **Structural Condition:** Average, retainable in the long term

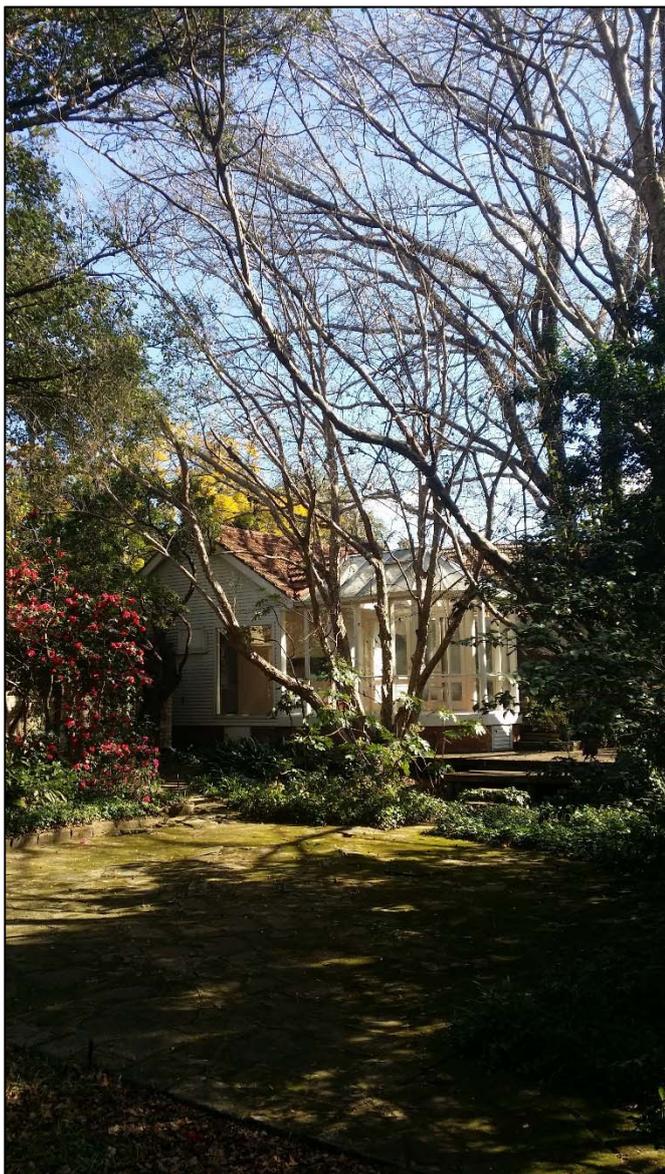
Plate 36 – showing tree 84

- Health & Vitality:** Average – this is a deciduous species and was dormant at the time of the inspection. However, an examination of the previous seasons of extension growth indicates that it's generally healthy and growing vigorously, with no visible symptoms of decline (see Plate 35).
- Tree Form:** This tree has formed a single stem with DBH of 900mm and a large dominant canopy that is 22m in height, with a crown spread of 28x32m.
- Structural Condition:** Poor – some of the wide spreading branches of this tree are receiving mechanical support from the dwelling within its dripline. The proposed demolition of the dwelling will remove this support, and will expose them and others to unaccustomed wing loading. This will significantly increase their failure potentials. Retainable for 0 – 5 years

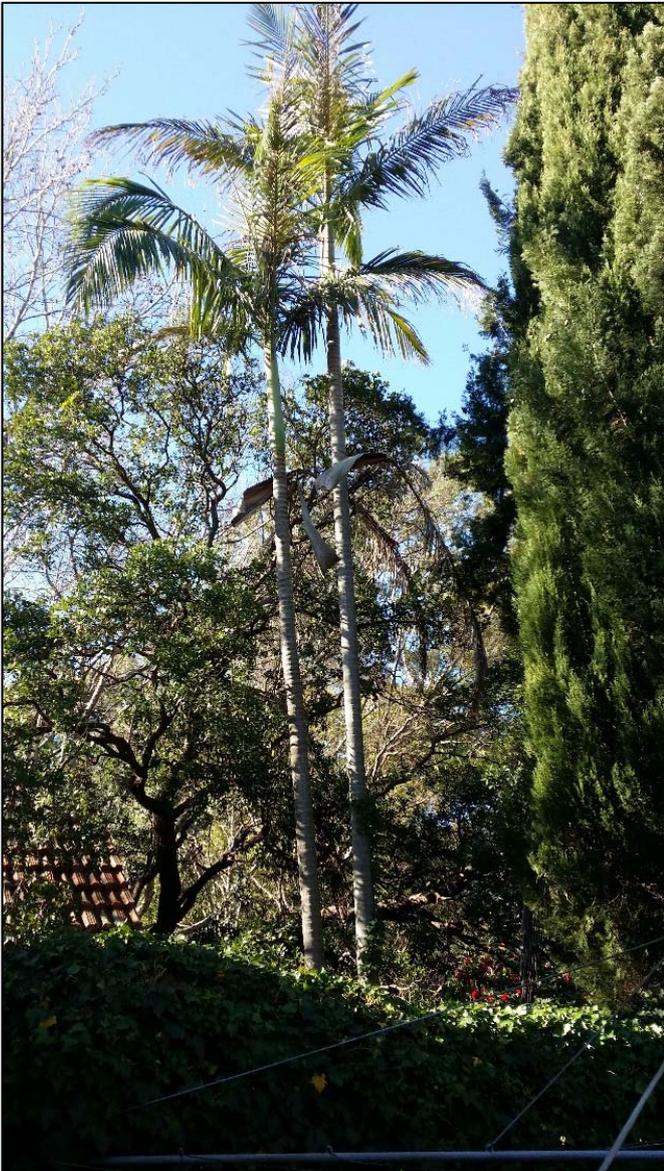
Plate 38 – showing tree 87

- Health & Vitality:** – the foliage of this tree appears to be generally healthy and growing vigorously, with no visible symptoms of decline (see Plate 38).
- Tree Form:** This tree is comprised of two stem with DBH's of 150mm, with a canopy that is 8m in height, with a crown spread of 4x4m.
- Structural Condition:** Average, retainable in the long term

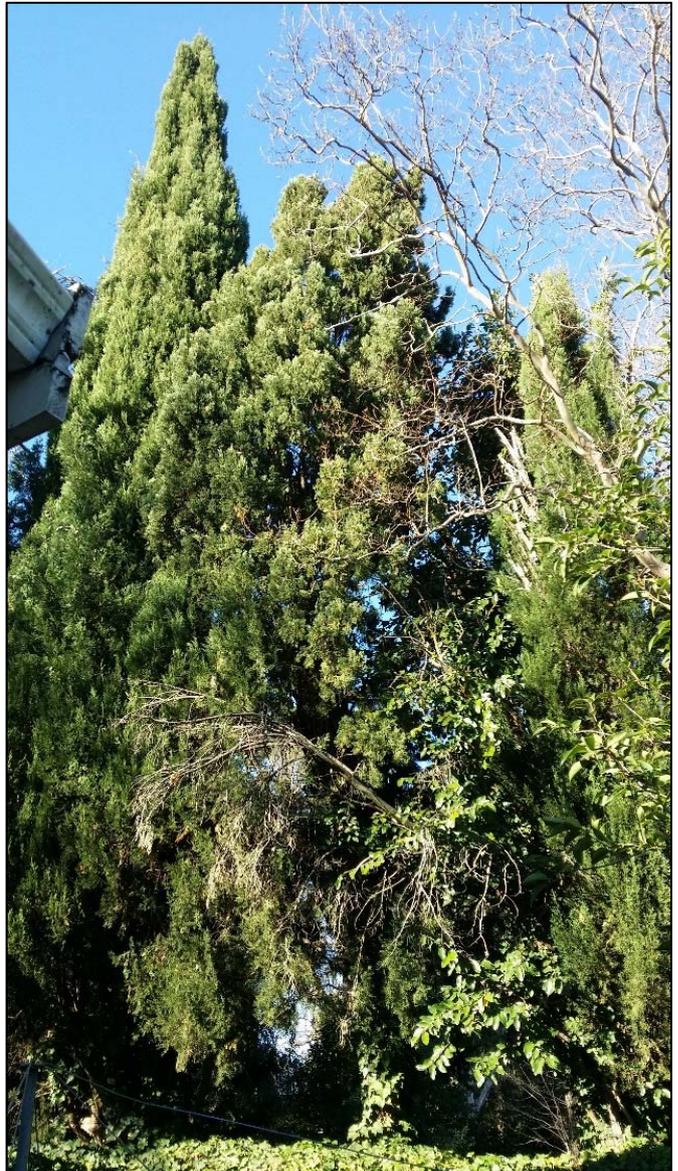
Plate 39 – showing tree No's 88 - 90

- Health & Vitality:** Average – the foliage of these trees appears to be generally healthy and growing vigorously, with no visible symptoms of decline (see Plate 39).
- Tree Form:** These trees form a hedgerow with a north/south axis that is 10 - 12m in height, with a crown spread of 6x3m.
- Structural Condition:** Fair, retainable in the medium term

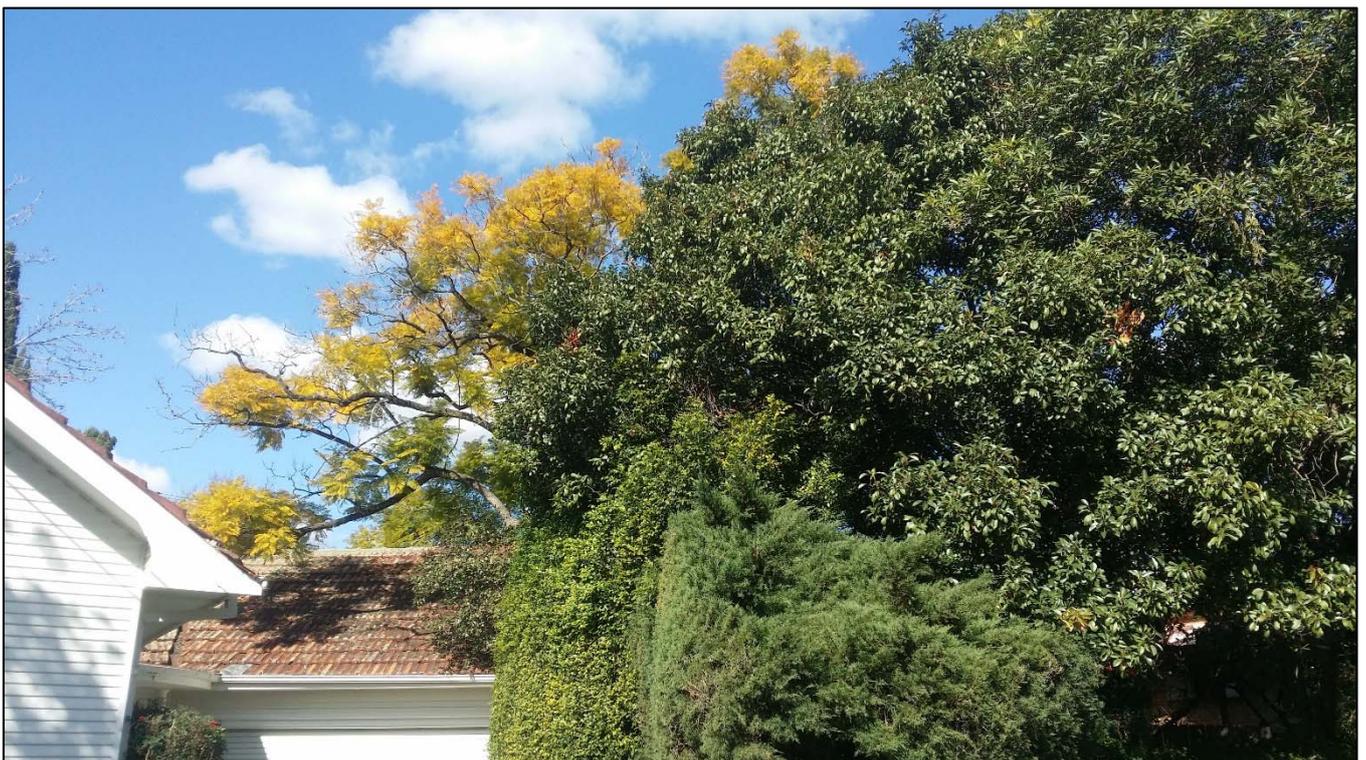
Plate 40 – showing trees 91 - 93

- Health & Vitality:** Low – Twig and branch dieback in the outer canopy of this tree is indicative of declining health and vitality (see Plate 40).
- Tree Form:** – it has formed a single stem with DBH of 500mm and a dominant canopy that is 14m in height, with a crown spread of 15x13m.

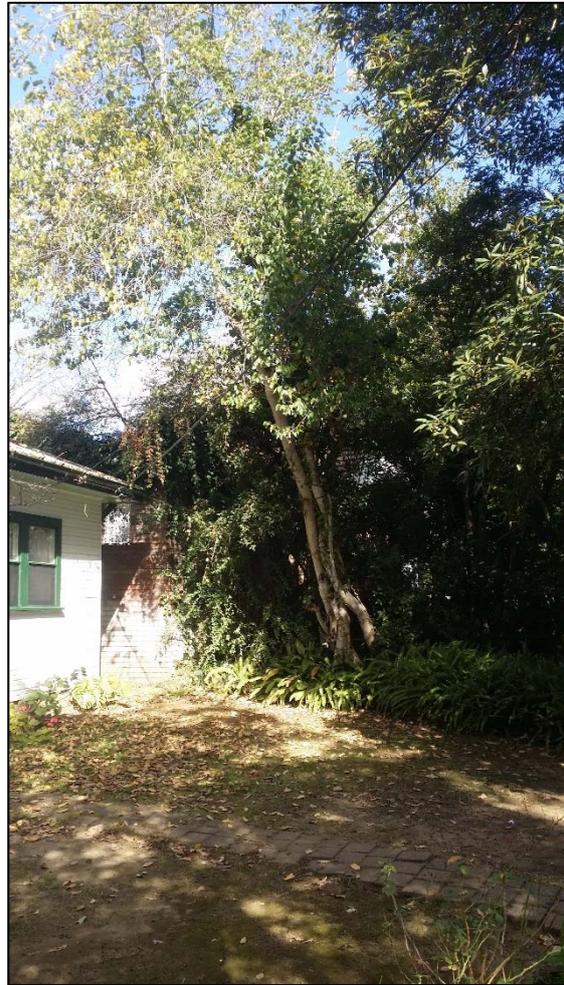
Plate 42 – showing tree 98

- a. **Health & Vitality:** Average – the foliage of this tree appears to be generally healthy and growing vigorously, with no visible symptoms of decline (see Plate 42).
- b. **Tree Form:** This tree has formed three codominant stems with DBH’s of 150mm and a codominant, asymmetrical canopy with a bias towards the east that is 14m in height, with a crown spread of 11x9m.
- c. **Structural Condition:** Fair – retainable in the long term

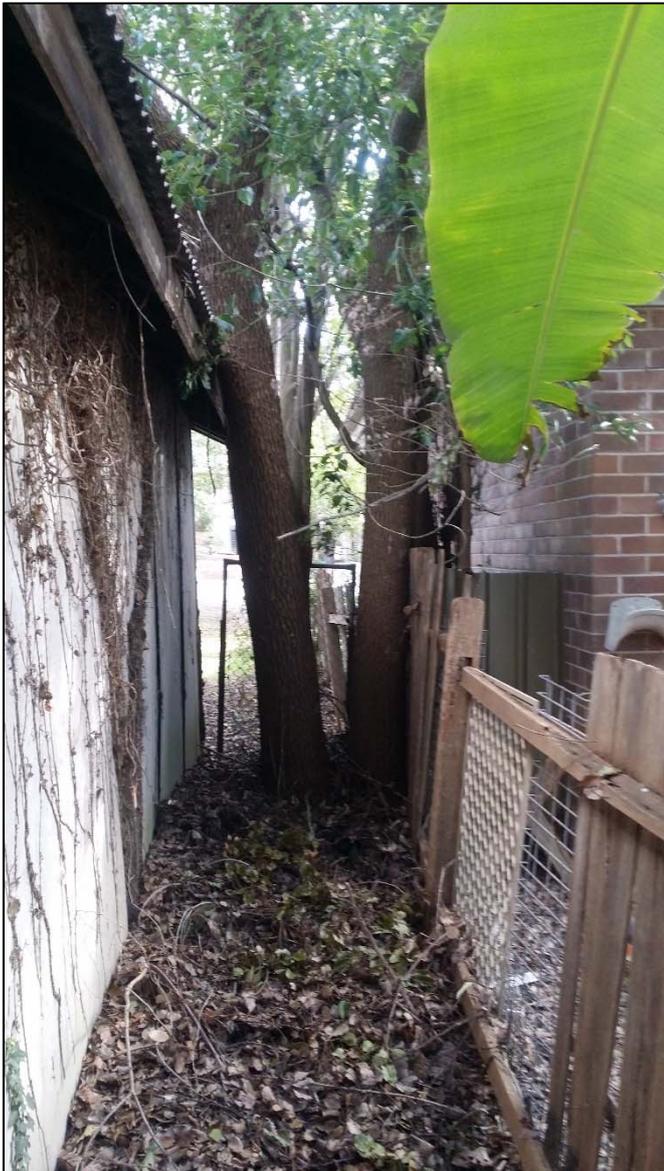
Plate 46 – showing tree No. 107

- a. **Health & Vitality:** Average – the foliage of these tree appears to be generally healthy and growing vigorously, with no visible symptoms of decline (see Plates 46 & 47).
- b. **Tree Form:** They form a codominant row of street trees that is 13m in height, with average crown spread of 6x6m.
- c. **Structural Condition:** Average – retainable in the long term

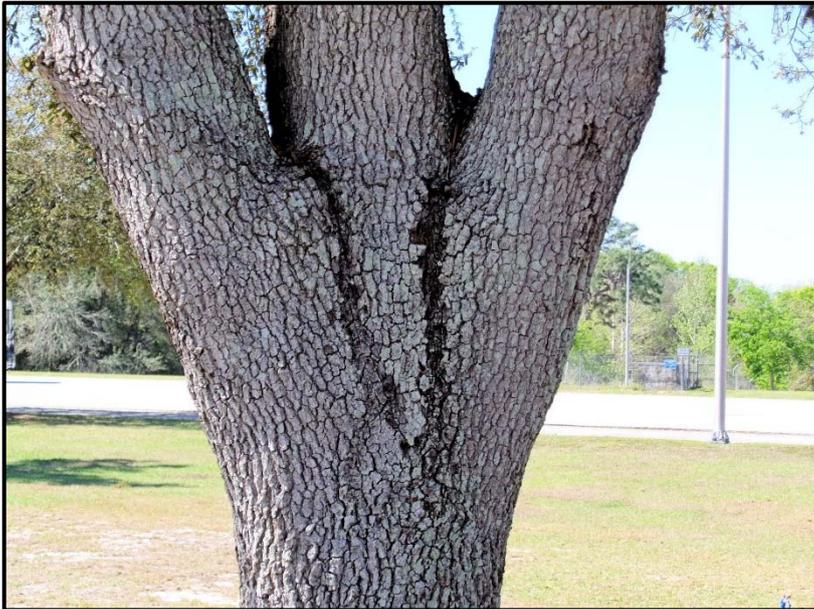
These are usually caused by storm damage, lopping or a genetic predisposition of the species or individual. They usually occur where two or more branches of about equal size arise at approximately the same level on the trunk, especially if the angle of attachment is narrow, and the branches are too close together.

Figure 2 – showing weak junction

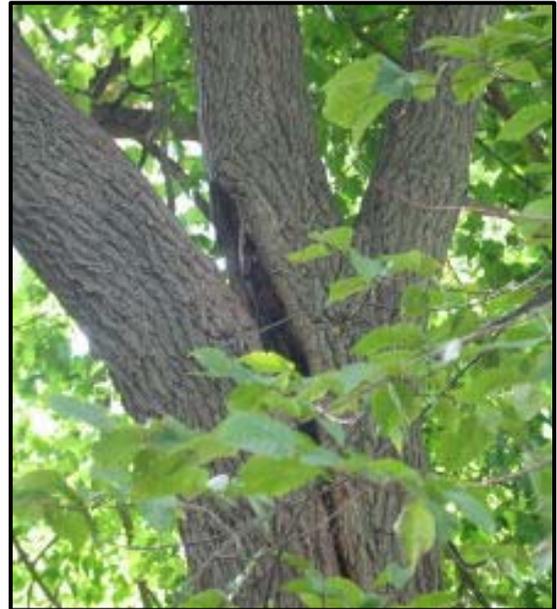
Figure 3 – partially failed weak junction
