30 March 2017

# Oakdale West Estate, Contamination Appraisal

SITE PLAN Site Condition Report Horsley Park, New South Wales

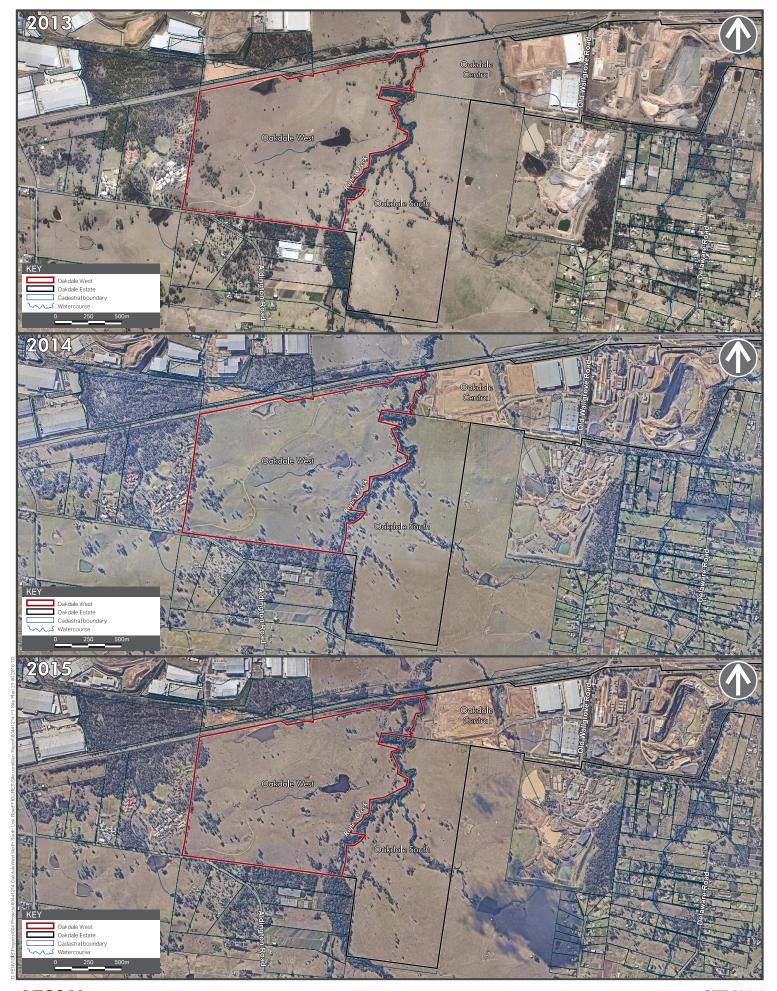
Review of satellite imagery for July 2013 / 2014 / 2015 (refer to Figure 1) indicates no observable changes in Site conditions.
