TREE INSPECTION REPORT.

**Location: 6 Edna Street Kingswood
NSW 2747**

TREEHAVEN ENVIRONSCAPES.
128 Showground Road Castle Hill. NSW 2154

For Designcorp
On. 28/10/2020

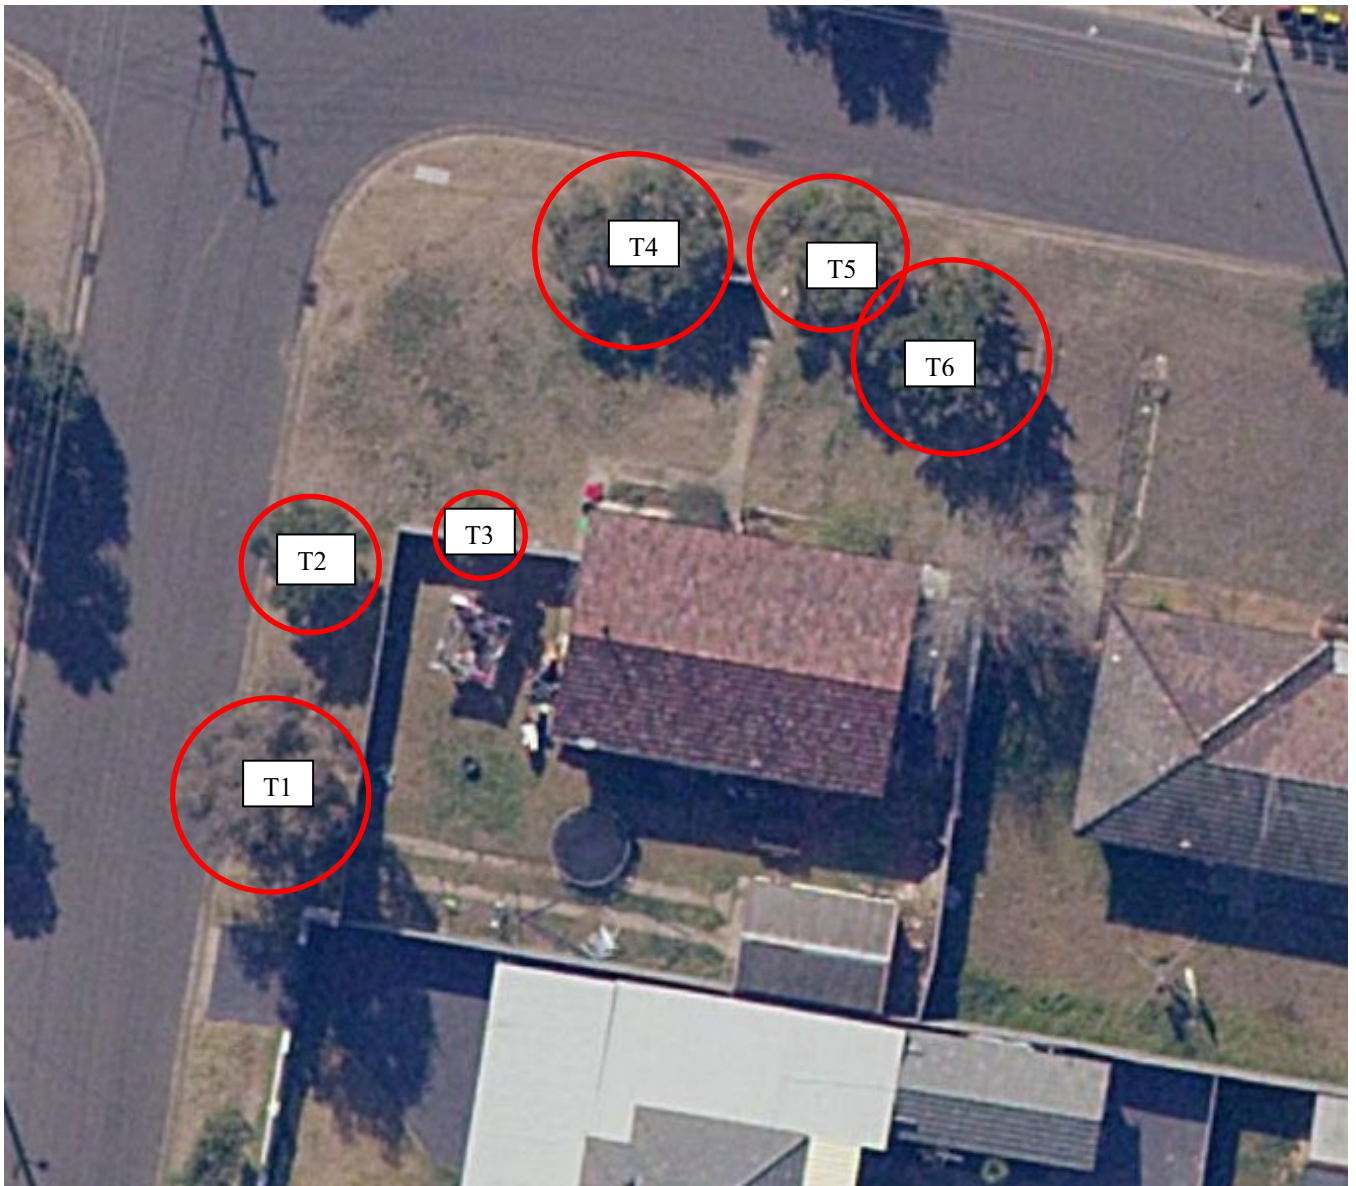
Fig1. Aerial photo of the site from Six Viewer.

2.3 There are 2 tree specimens growing on the Site and 4 street trees on the nature strip to the North and East of the property. The subject trees are designated **T1** to **T6** inclusive as depicted in Figure 1.
