WSA assessment

Date: 8/02/2014	Asset owner's job ref.:	Asset Owner: jk williams	Operator : m crocker	Section number: 2	Pipe Asset Id: 37/2 to 37/3
Time of inspection: 07:35:32	Cleaning: cleaned	Standard: WSA 05-2008 2.2	LRP Ins	Conduit Unit Length	Method of Inspection Television Camera

Town: Suburb: jordan springs Street: road 5 Asset Location	Catchment: Asset Owner: jk williams Precipitation.: Flow control No measures	US MH: 37/2 Survey Dir: downstream DS MH: 37/3 Inspect Lenght : 6.62 m
---	---	---

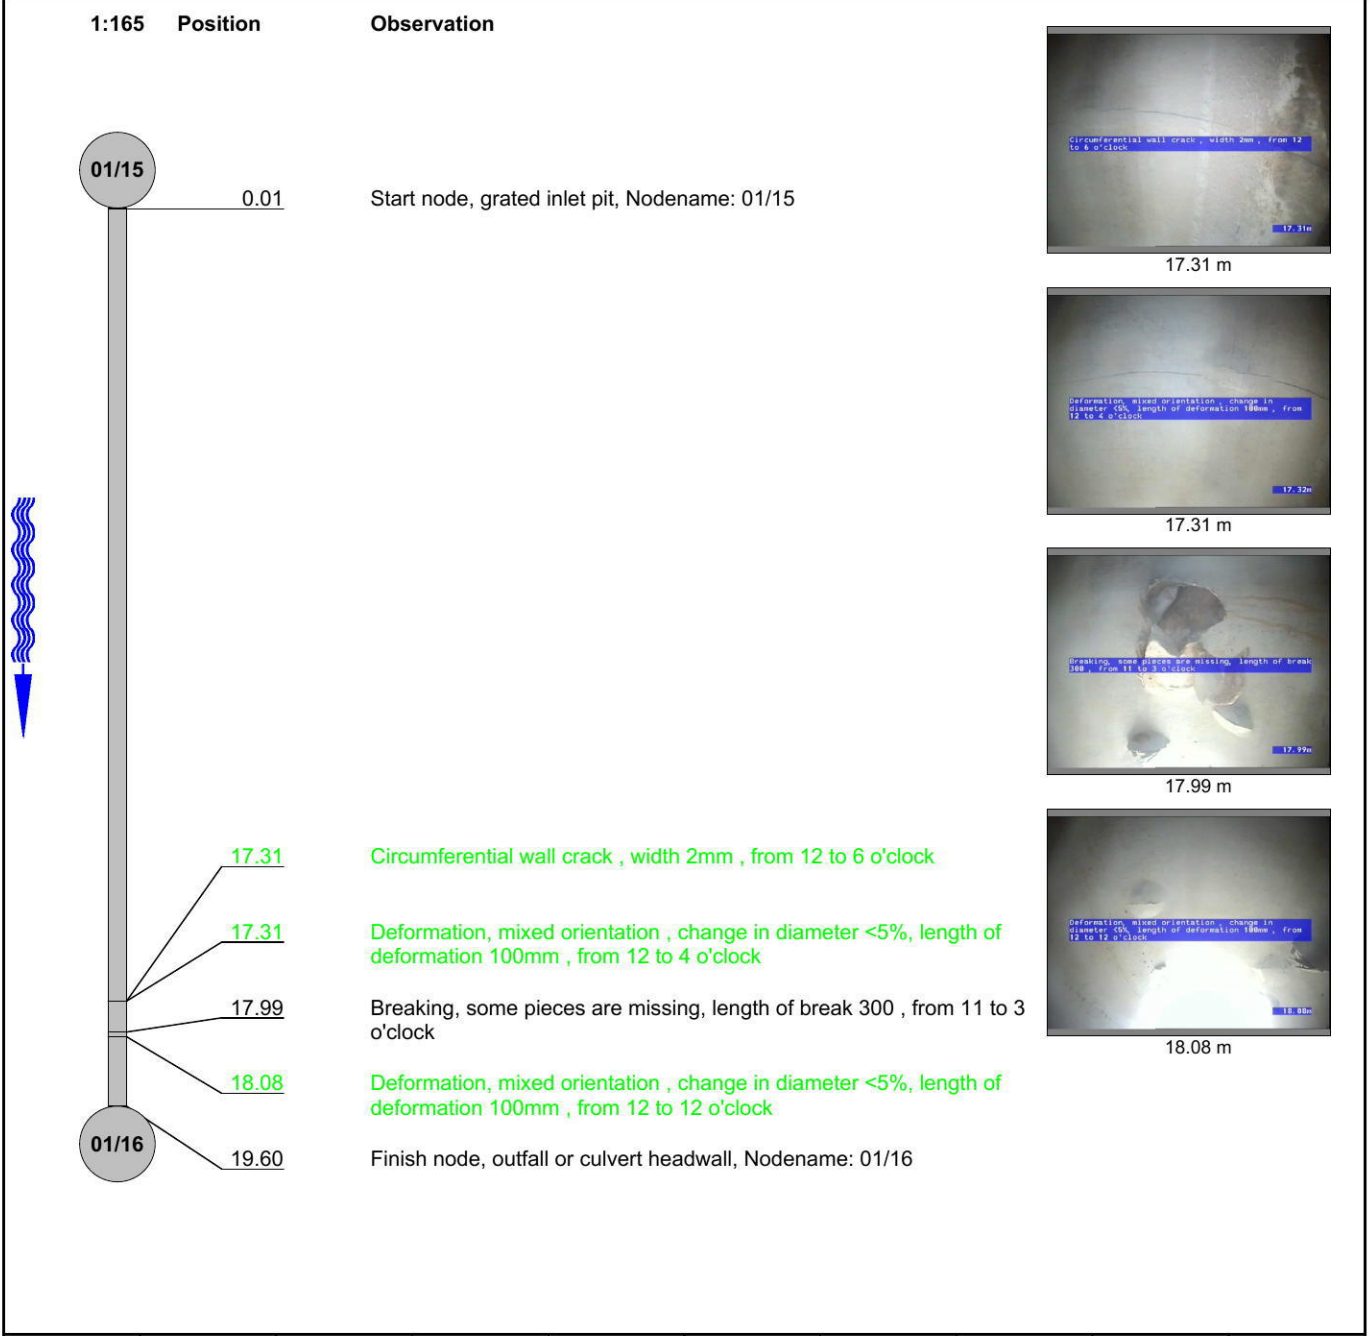
STR no def	STR peak	STR mean	STR total	STR grade	SER no def	SER peak	SER mean	SER total	SER grade
4	63	3.21	63	5	0	0	0	0	1

Photo: 35_1_2_08022014_125944_A.JPG
 17.31m, Circumferential wall crack , width 2mm , from 12 to 6 o'clock

Photo: 35_1_4_08022014_130025_A.JPG
 17.99m, Breaking, some pieces are missing, length of break 300 , from 11 to 3 o'clock
