# PRELIMINARY TREE INSPECTION REPORT.

**On:** Tree Specimens

**Location:** 110-112 Mt Vernon Rd Mount  
Vernon. NSW 2178

For Superior Home Solutions  
On. 30/11/2017

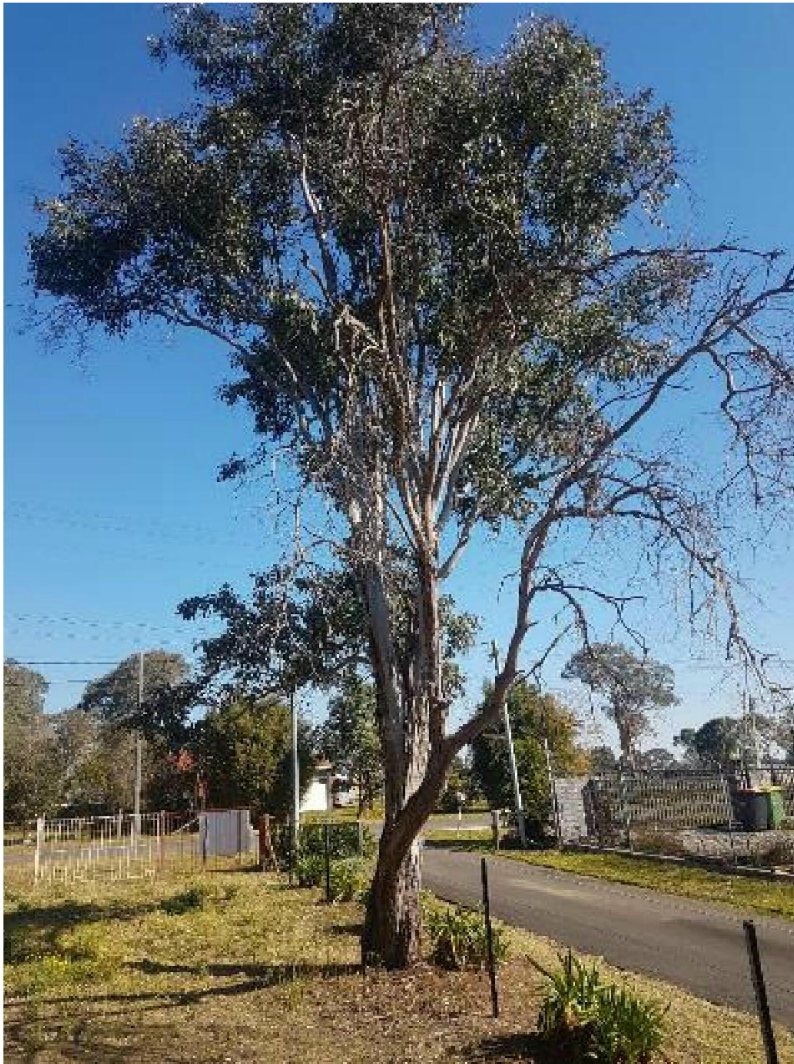
Fig 2. Photo of T1 a *Eucalyptus amplifolia*

Specimen name	Est. Height	Diameter DBH* DGH**	Crown	Comments	SULE ***	TPZ	SRZ
T1 <i>Eucalyptus amplifolia</i> Common name 'Cabbage Tree Gum' Age class. 30 years See Fig. 2.	12m	1 x 21cm 1 x 43cm 58cm at the base	N 4m E 3m S 3m W 3m	An endemic tree common to the Western Sydney region and a member of Cumberland Plains Forest community. The tree is growing in the front of the property to the South West of the Site. At the time of inspection the specimen was in good condition. There were no significant pathogens nor signs of mechanical damage. The tree has a dead stem to the North of its main trunk.	C1	5.74m	2.63m
T2 <i>Eucalyptus molucanna</i> Common name 'Grey box' Age class. 40 years See Fig. 3.	16m	1 x 18cm 1 x 32cm 53cm at the base	N 4m E 5m S 4m W 2m	An endemic tree common to the Western Sydney region and a member of Cumberland Plains Forest community. The tree is growing in the front of the property to the South West of the Site. At the time of inspection the specimen was in poor condition. There were no significant pathogens nor signs of mechanical damage. The tree has mainly epicormic growth in its canopy and appears to be recovering from some dieback assumed to be from the Psyllid outbreak in Western Sydney.	C1	4.4m	2.5m

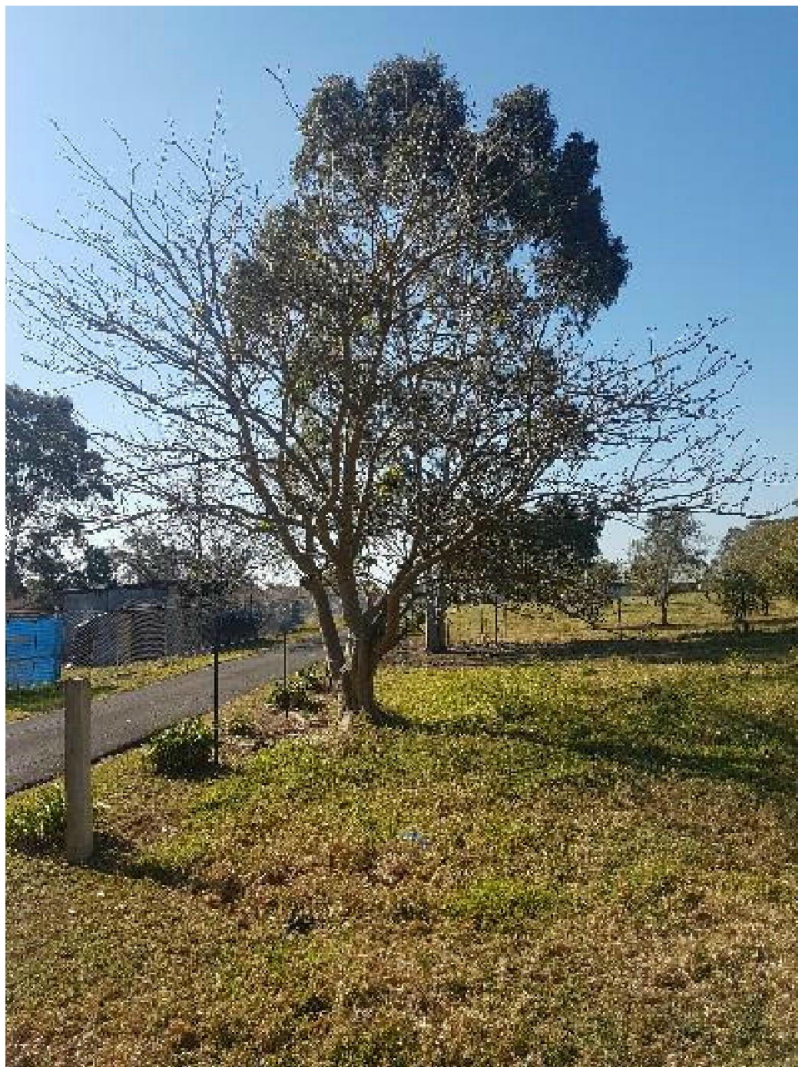
Fig 8 . Photo of T7 an *Erythrina crista-galla*

T7 <i>Erythrina cristagalli</i> Common name 'Coral Tree' Age class. 40 years See Fig. 8.	8m	1 x 14cm 1 x 18cm 1 x 22cm 1 x 27cm 49cm at the base	N 2m E 1m S 1m W 2m	An exotic tree endemic to South America. The tree is growing near the boundary to the West of the Site. At the time of inspection the specimen was in good condition with no significant pathogens nor signs of mechanical damage. The tree has 3 stems separating at approx. 0.3m which meet in a 'V' shaped stem junction at the base of the main stem. The specimen is widely recognised as having weedy properties.	B3	5m	2.45m
T8 <i>Corymbia citriodora</i> Common name 'Lemon scented gum' Age class. 40 years See Fig. 9.	14m	1 x 26cm 1 x 28cm 56cm at the base	N 4m E 4m S 4m W 4m	A native tree belonging to Northern NSW and Queensland. The tree is growing in the South East corner of the Site. At the time of inspection the specimen was in good health and condition with co dominant stems meeting in a 'V' shaped stem junction at approx. 500mm from the ground. There was no significant pathogens or defects apparent at the time of inspection.	A1	4.59m	2.59m

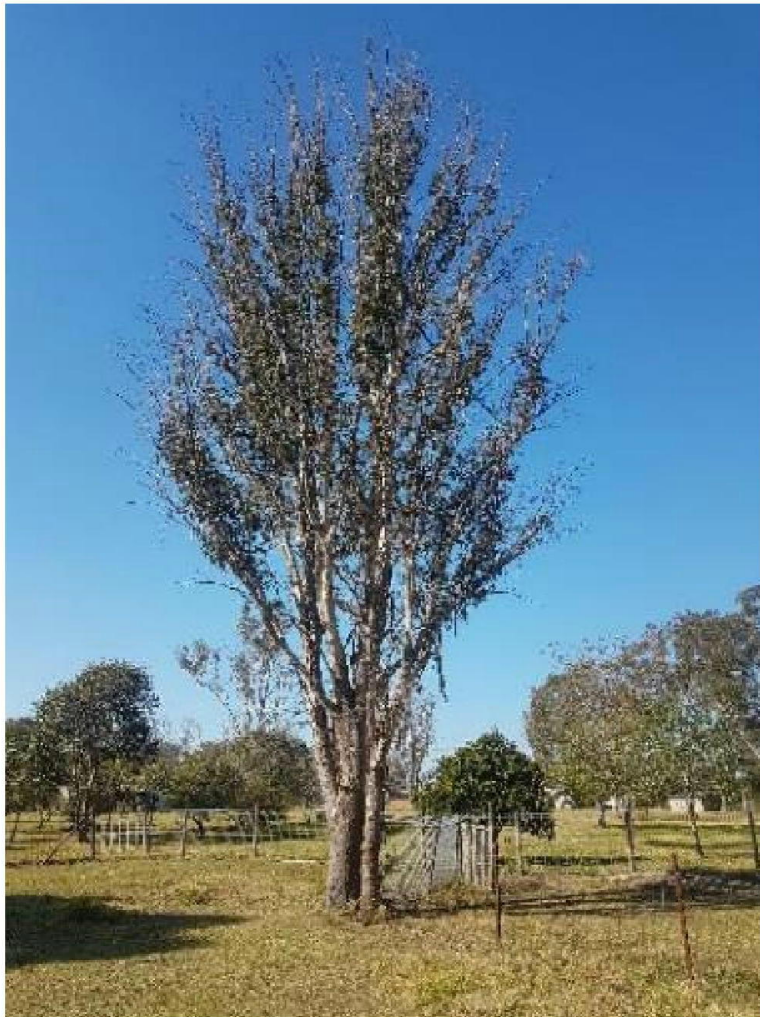
Fig 10. Photo of T9 a *Eucalyptus molucana*

T9 <i>Eucalyptus molucanna</i> Common name 'Grey box' Age class. 40 years See Fig. 10.	14m	1 x 25cm 1 x 45cm 77cm at the base	N 3m E 3m S 3m W 3m	An endemic tree common to the Western Sydney region and a member of Cumberland Plains Forest community. The tree is growing centrally on the property in the Southern portion of the Site. At the time of inspection the specimen was in poor condition. There were no significant pathogens nor signs of mechanical damage. The tree has mainly epicormic growth in its canopy and appears to be recovering from some dieback assumed to be from the Psyllid outbreak in Western Sydney.	C1	6.18m	2.97m
T10 <i>Corymbia citriodora</i> Common name 'Lemon scented gum' Age class. 50 years See Fig. 11.	18m	50cm 63cm at the base	N 7m E 6m S 6m W 5m	A native tree belonging to Northern NSW and Queensland. The tree is growing in the South East corner of the Site. At the time of inspection the specimen was in good health and condition with approx. 5% dead wood in the crown. There was no significant pathogens or defects.	A1	6m	2.72m

6.1. It is recommended that trees **T3, T4, T5, T9, T10, T11, T12, T13, T14, T24, T26, T27, T28, T30, T32, T33, T34, T35, T36, T37, T38 T39 & T43** be removed and replaced with suitable endemic species elsewhere on the Site.

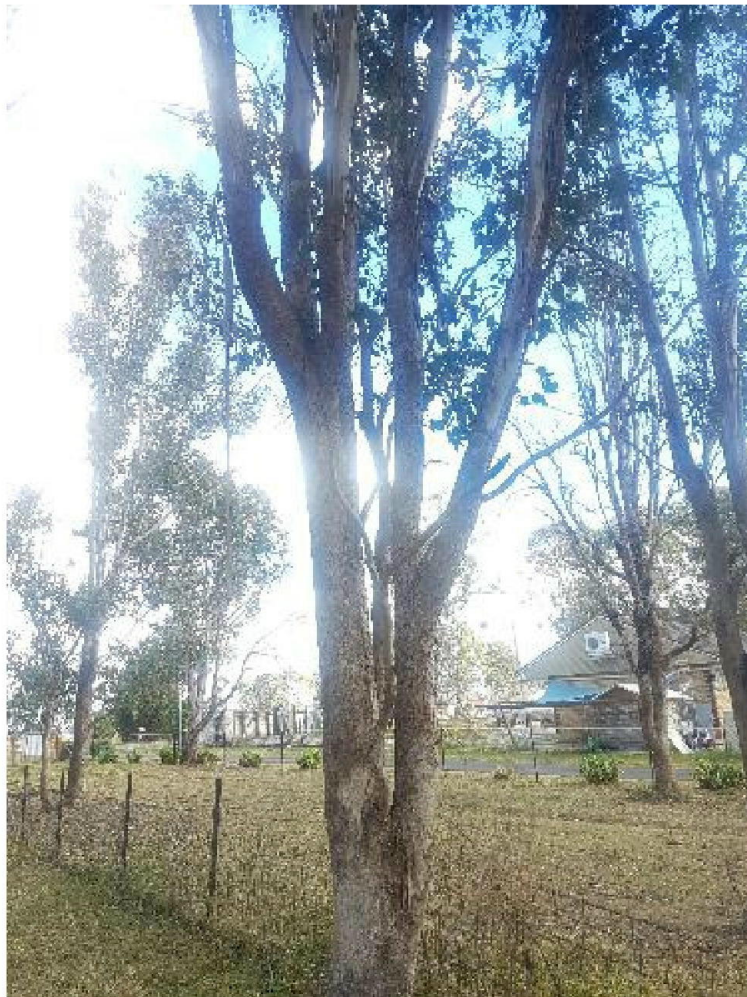
Fig 14. Photo of T12B a *Eucalyptus molucana*

has mainly epicormic growth in its canopy and appears to be recovering from some dieback assumed to be from the Psyllid outbreak in Western Sydney.			
T12B <i>Eucalyptus molucanna</i> Common name 'Grey box' Age class. 40 years See Fig. 14.	12m	25cm 27cm at the base	N 2m E 1m S 0m W 0m	An endemic tree common to the Western Sydney region and a member of Cumberland Plains Forest community. The tree is growing centrally on the property in the Southern portion of the Site. At the time of inspection the specimen was in poor condition. There were no significant pathogens nor signs of mechanical damage. The tree has mainly epicormic growth in its canopy and appears to be recovering from some dieback and appears to be recovering from some dieback assumed to be from the Psyllid outbreak in Western Sydney. The tree has a bias in its crown to the North East.	C1	3m	2.88m
T13 <i>Eucalyptus molucanna</i> Common name 'Grey box' Age class. 40 years See Fig. 15.	14m	1 x 26cm 1 x 28cm 57cm at the base	N 2m E 3m S 4m W 4m	An endemic tree common to the Western Sydney region and a member of Cumberland Plains Forest community. The tree is growing centrally on the property. At the time of inspection the specimen was in poor condition with 20% deadwood in the crown. There were no significant pathogens nor signs of mechanical damage. The tree has mainly epicormic growth in its canopy and appears to be recovering from some dieback assumed to be from the Psyllid outbreak in Western Sydney.	C1	4.59m	2.61m

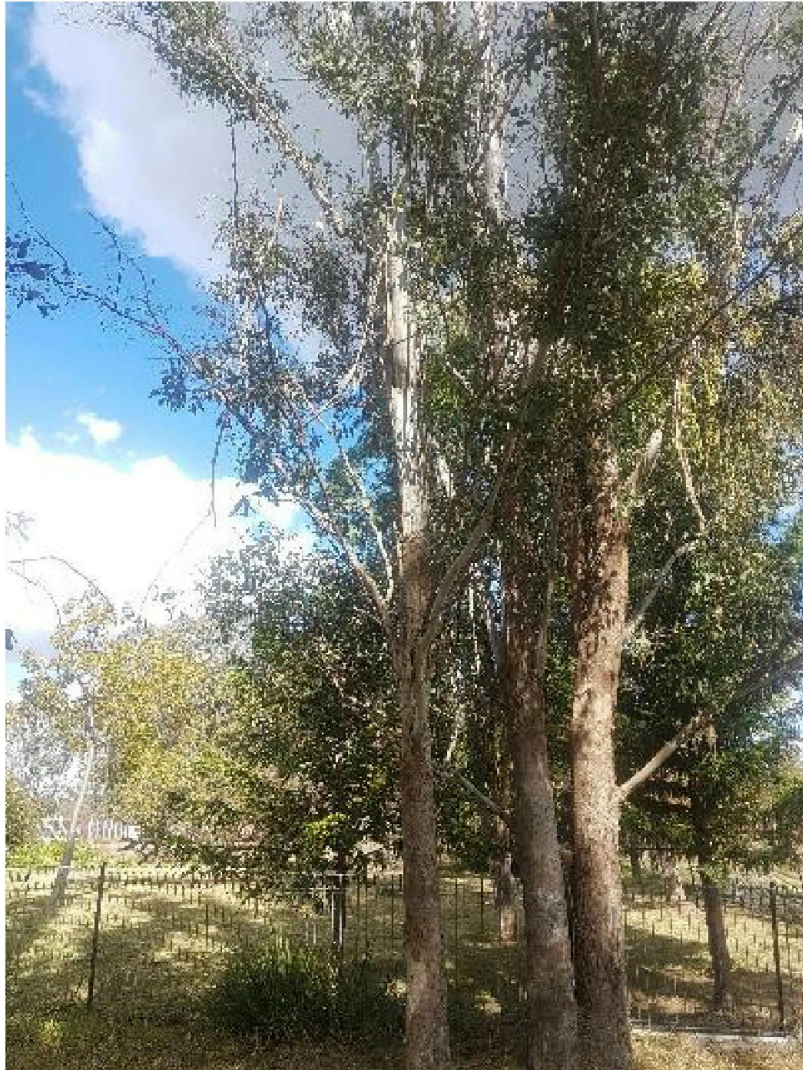
Fig 16. Photo of T14 a *Eucalyptus molucana*

T14 <i>Eucalyptus molucanna</i> Common name 'Grey box' Age class. 40 years See Fig. 16.	10m	21cm 26cm at the base	N 0m E 2m S 2m W 2m	An endemic tree common to the Western Sydney region and a member of Cumberland Plains Forest community. The tree is growing centrally on the property in the Southern portion of the Site. At the time of inspection the specimen was in poor condition with 20% deadwood in the canopy. There were no significant pathogens nor signs of mechanical damage. The tree has mainly epicormic growth in its canopy and appears to be	C1	6.18m	2.97m

recovering from some dieback assumed to be from the Psyllid outbreak in Western Sydney.			
T15 <i>Eucalyptus molucanna</i> Common name 'Grey box' Age class. 40 years See Fig. 17.	16m	1 x 29cm 1 x 32cm 46cm at the base	N 3m E 3m S 3m W 3m	An endemic tree common to the Western Sydney region and a member of Cumberland Plains Forest community. The tree is growing centrally on the property in the Southern portion of the Site. At the time of inspection the specimen was in poor condition with 20% deadwood in the canopy and some Mistletoe. There were no significant pathogens nor signs of mechanical damage. The tree has mainly epicormic growth in its canopy and appears to be recovering from some dieback assumed to be from the Psyllid outbreak in Western Sydney.	C1	5.18m	2.39m
T16 <i>Melia azederach</i> Common name 'White cedar' Age class. 10 years See Fig. 18.	3m	5cm 7cm at the base	N 1m E 1m S 1m W 1m	An endemic tree common to creeks and rivers in the Sydney region. The tree is growing centrally on the property in the Southern portion of the Site. At the time of inspection the specimen was in good condition. There were no significant pathogens nor signs of mechanical damage.	A5	2m Min TPZ	1.5m Min SRZ

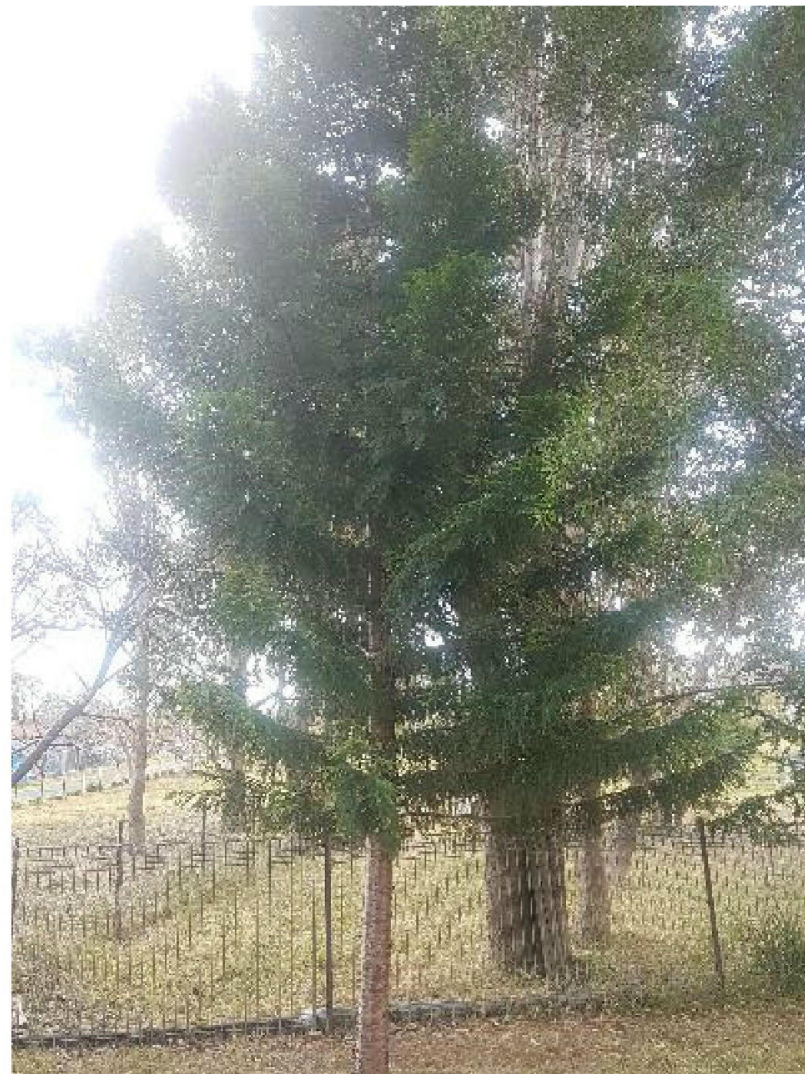
Fig 19. Photo of T17 an *Araucaria heterophylla*

T17 <i>Araucaria heterophylla</i> Common name 'Norfolk Island Pine' Age class. 10 years See Fig. 19.	9m	15cm 18cm at the base	N 1m E 1m S 1m W 1m	A native tree common to Norfolk Island. The tree is growing centrally on the property in the Southern portion of the Site. At the time of inspection the specimen was in good condition. There were no significant pathogens nor signs of mechanical damage.	A1	2m Min TPZ	1.5m Min SRZ
T18 <i>Araucaria bidwillii</i> Common name 'Monkey Puzzle Tree'	4m	10cm 14cm at the base	N 1m E 1m S 1m W 1m	A native tree common to Northern Queensland. The tree is growing centrally on the property in the Southern portion of the Site. At the time of inspection the specimen was in good condition. There were no significant pathogens but the tree roots appear to be girdled.	A5	2m Min TPZ	1.5m Min SRZ

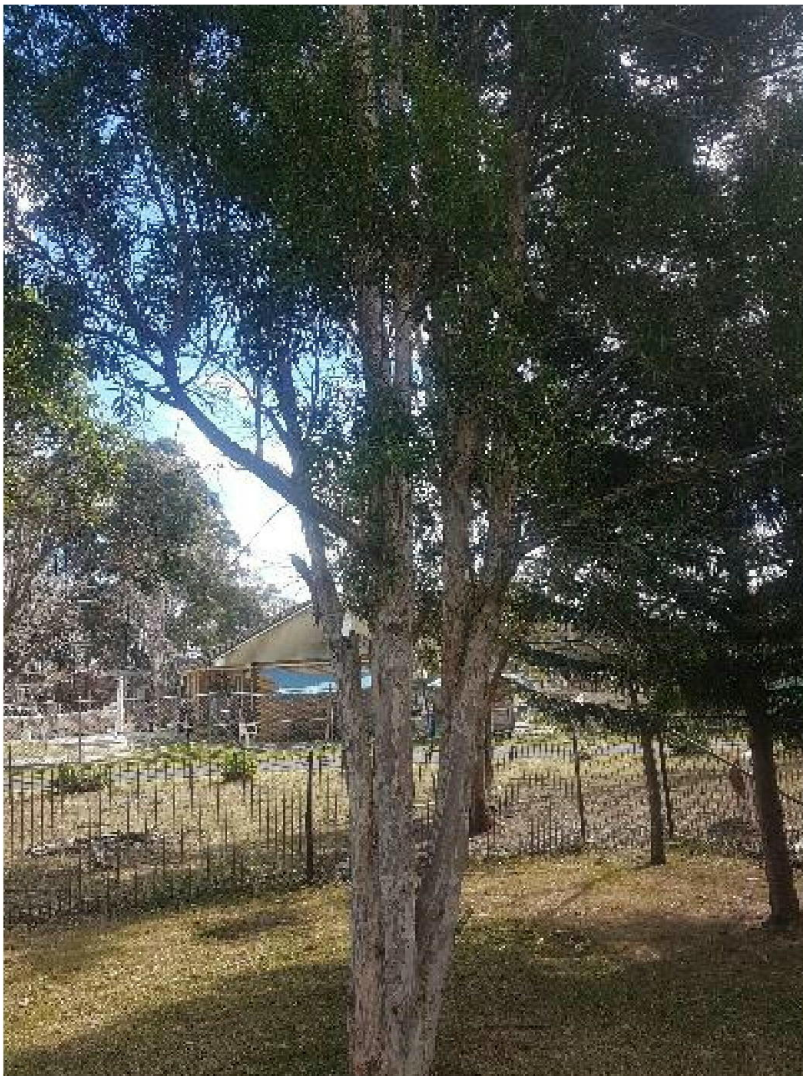
Fig 22. Photo of T19 a *Melaleuca quinquinervia*

Age class. 10 years See Figs. 20 & 21.							
T19 <i>Melaleuca quinquineria</i> Common name 'Broadleaved Paperbark' Age class. 10 years See Fig. 22 & 23.	8m	2 x 12cm 2 x 14cm 25cm at the base	N 3m E 3m S 3m W 2m	A native tree common to estuarine areas of the NSW coast. The tree is growing centrally on the property in the Southern portion of the Site. At the time of inspection the specimen was in poor condition. There was two large <i>Ganoderma</i> bracket fungus on the main stem and the tree has 4 co dominant stems meeting in 'V' shaped stem junctions.	A5	3.13m	2.38m
T20 <i>Lophostemon confertus</i> Common name 'Brushbox" Age class. 20 years See Fig. 24.	9m	1 x 10cm 1 x 19cm 37cm at the base	N 3m E 3m S 3m W 3m	A native tree endemic to Northern NSW and Queensland. The tree has been planted in the center in the southern portion of the Site. At the time of inspection the specimen was in good condition with no significant pathogens or defects. The tree has co dominant stems meeting in a 'V' shape at 1.1m from the ground.	A1	2.58m	2.18m

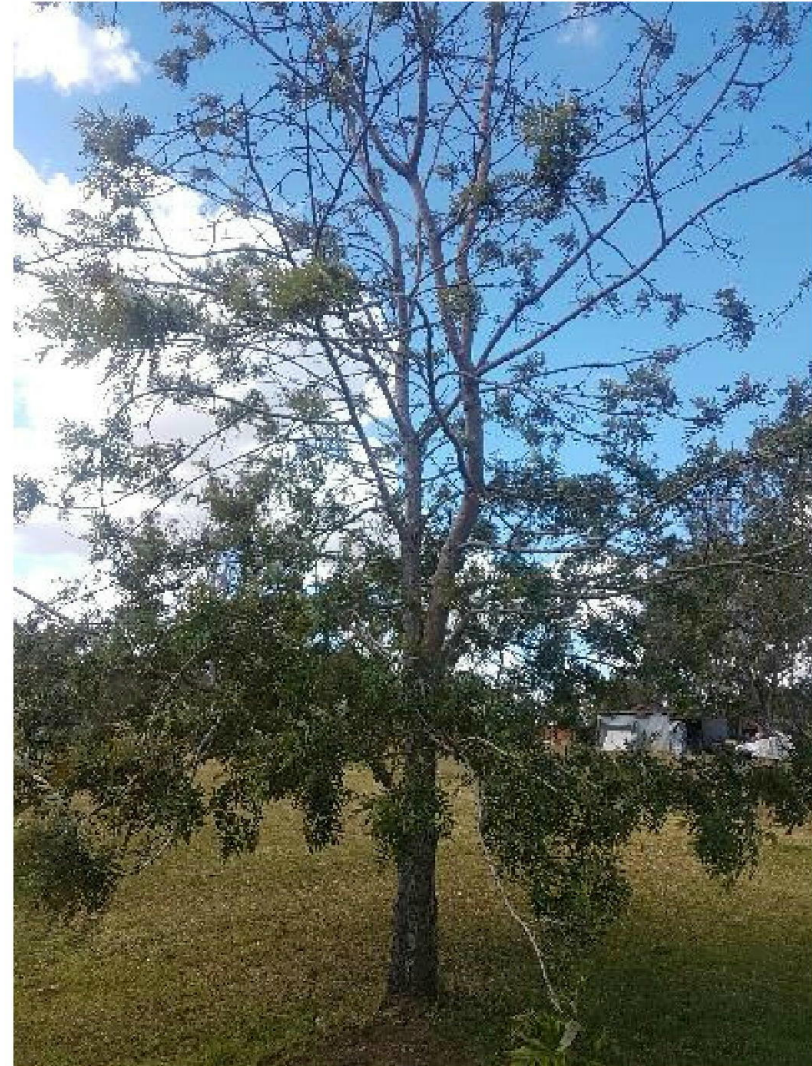
Fig 50. Photo of T42 a *Grevillea robusta*.

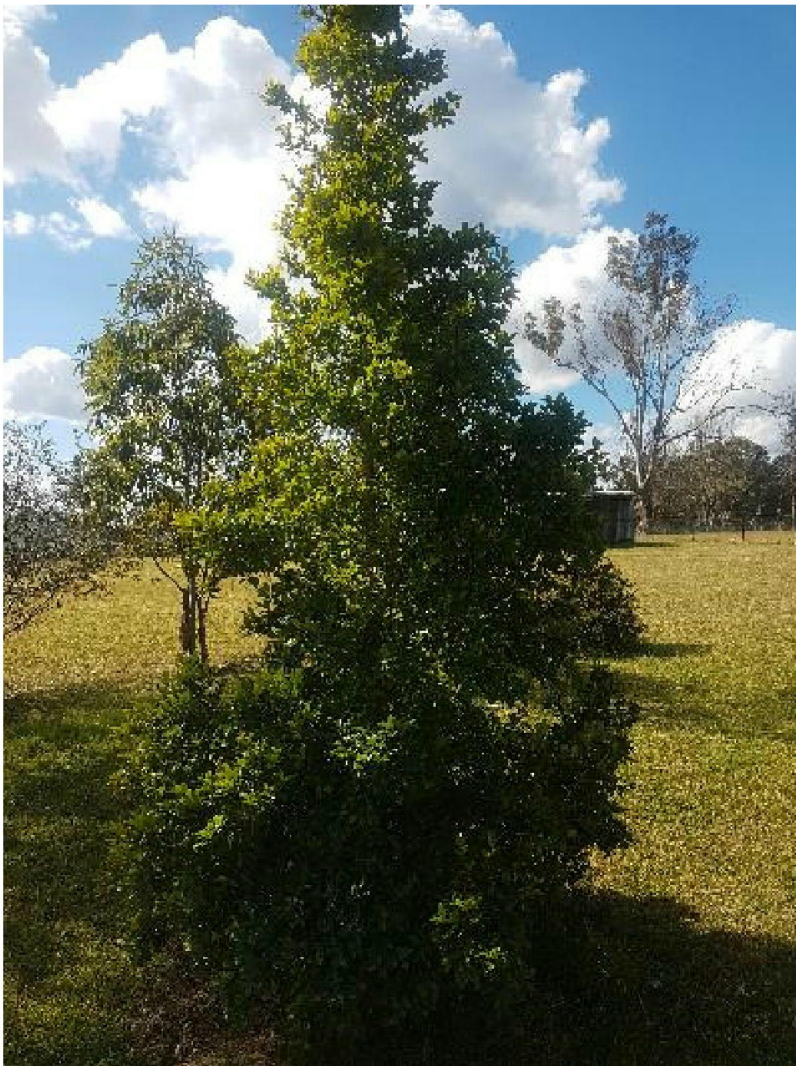
Fig 51 Photo of T43 *Grevillea robusta*

T43 <i>Grevillia robusta</i> Common name 'Silky Oak' Age class. 30 years See Fig. 51.	10m	21cm 28cm at the base	N 3m E 3m S 3m W 3m	A native tree endemic to Northern NSW and Queensland. The tree has been planted in the center to the West of the Site. At the time of inspection the specimen was in good condition with no significant pathogens or defects. The tree has co dominant stems meeting in a 'V' shape at 2m from the ground.	A1	2.52m	1.94m
T44 <i>Syzygium australe</i> Common name 'Lilli Pilli' Age class. 5 years See Fig. 52.	3m	6cm 8cm at the base	N 0.5m E 0.5m S 0.5m W 0.5m	A native tree usually found in littoral rainforest in coastal NSW. The tree is growing near the boundary to the Southeast corner of the Site. At the time of inspection the specimen was in good condition with no significant pathogens nor signs of mechanical damage.	A1	2m Min TPZ	1.5m Min SRZ

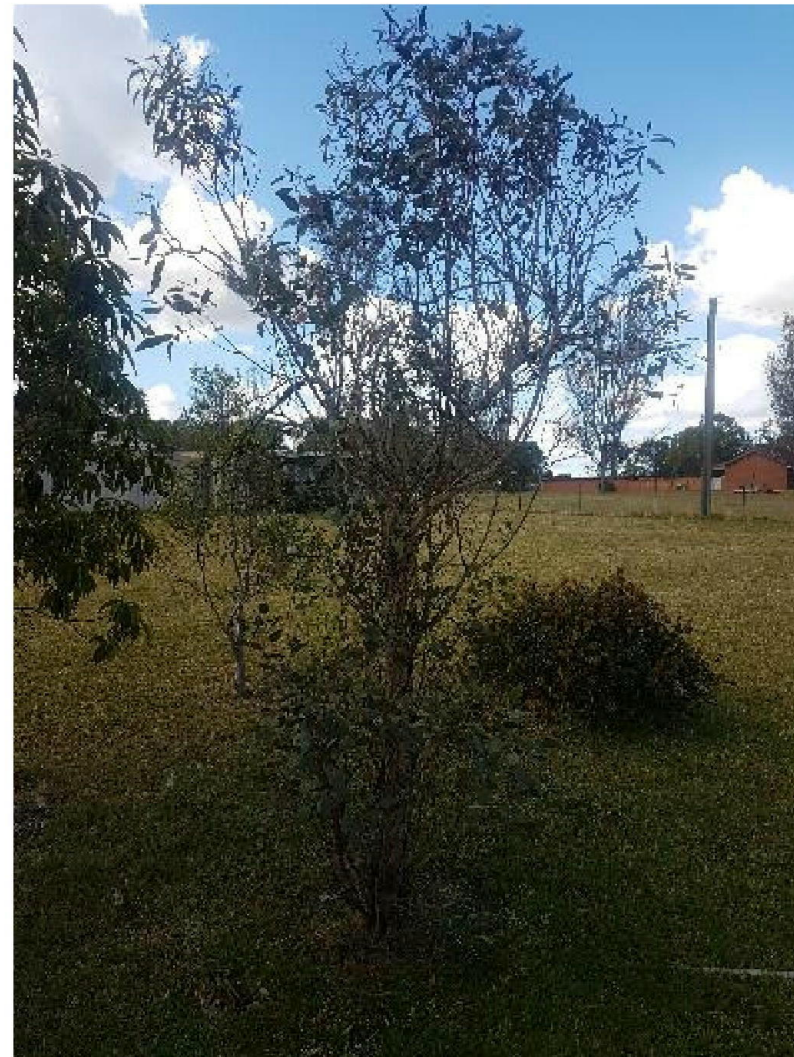
Fig 52. Photo of T44 a *Syzygium australe*.

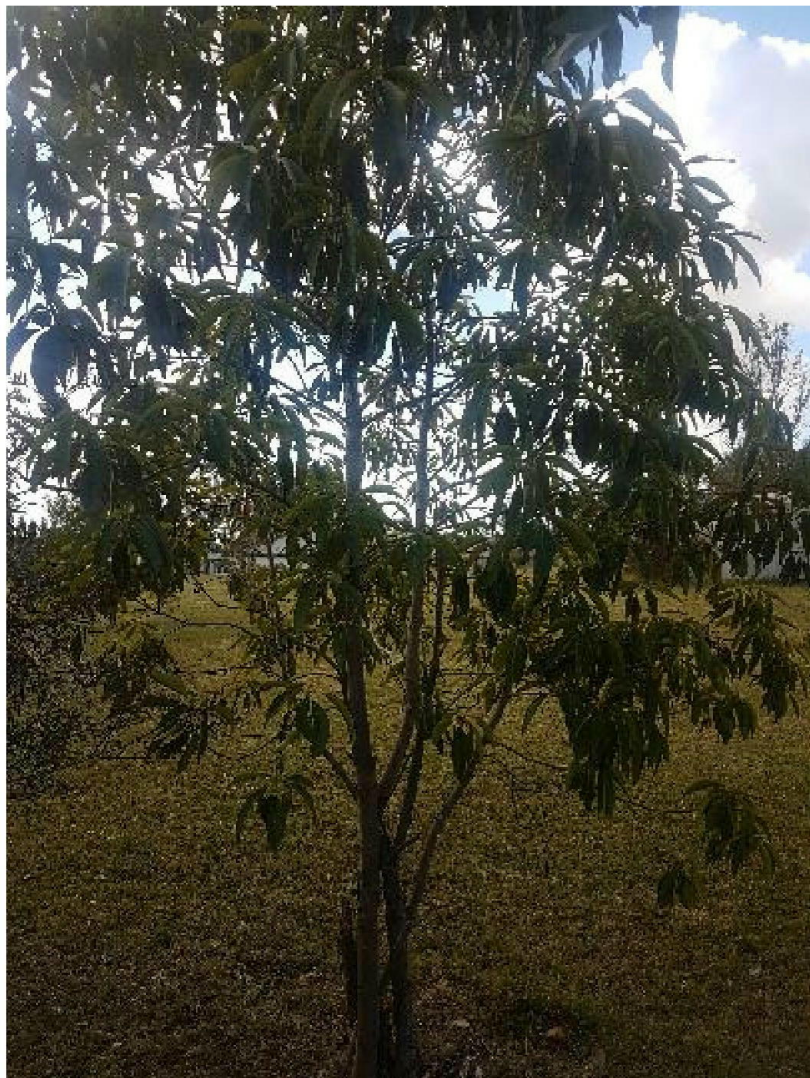
T45 <i>Eucalyptus spp</i> Common name 'gum' Age class. 40 years See Fig. 53.	3m	8cm 10cm at the base	N 3m E 3m S 2m W 4m	A native tree planted in the 'Grove' towards the Northern border of the property. At the time of inspection the specimen was in poor health and condition having been subjected formative damage in that the main stem is truncated at approx. 1.5m from the ground. Foliage on the tree is sparse and largely comprised of epicormic regrowth.	A5	2m Min TPZ	1.5m Min SRZ
T46 <i>Lophostemon confertus</i> Common name 'Brushbox' Age class. 20 years See Fig. 54.	4m	5cm 7cm at the base	N 1m E 1m S 1m W 1m	A native tree endemic to Northern NSW and Queensland. The tree has been planted in the 'Grove' towards the Northern border of the property. At the time of inspection the specimen was in reasonable condition and comprising of 3 stems arising from the <i>Lignotuber</i> of a failed main stem.	A5	2m Min TPZ	1.5m Min SRZ

Fig 53. Photo of T45 a small *Eucalyptus*.

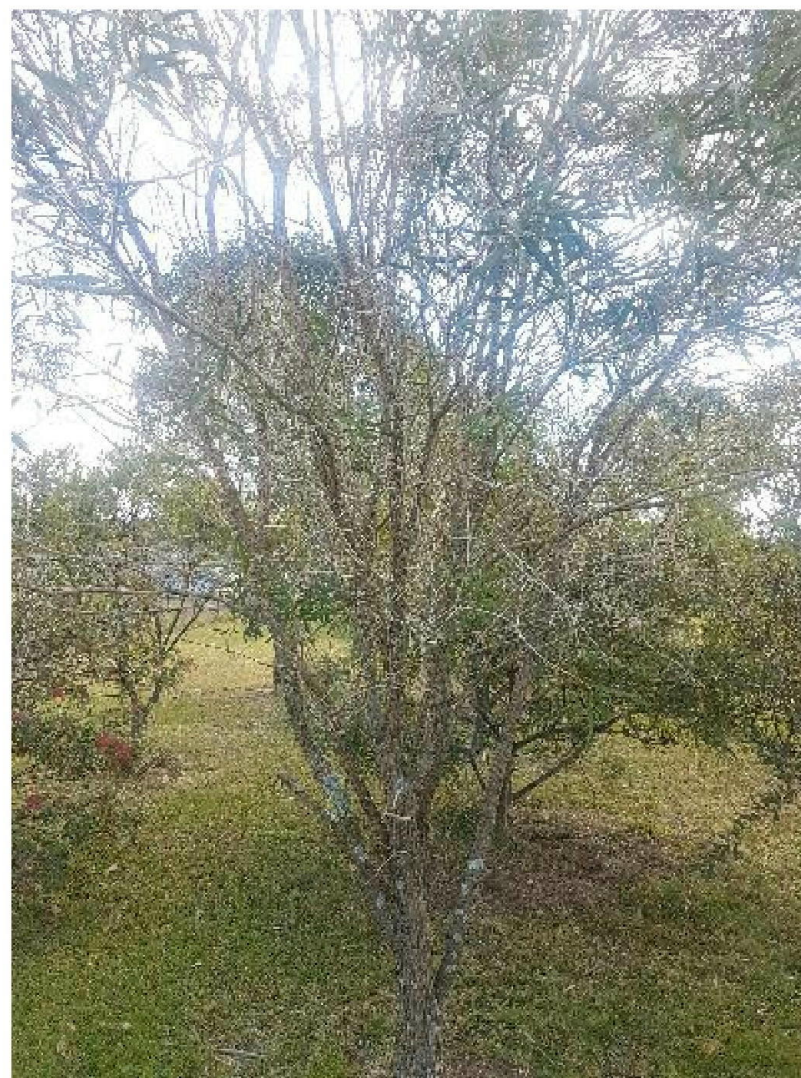
Fig 54. Photo of T46 a *Lophostemon confertus*

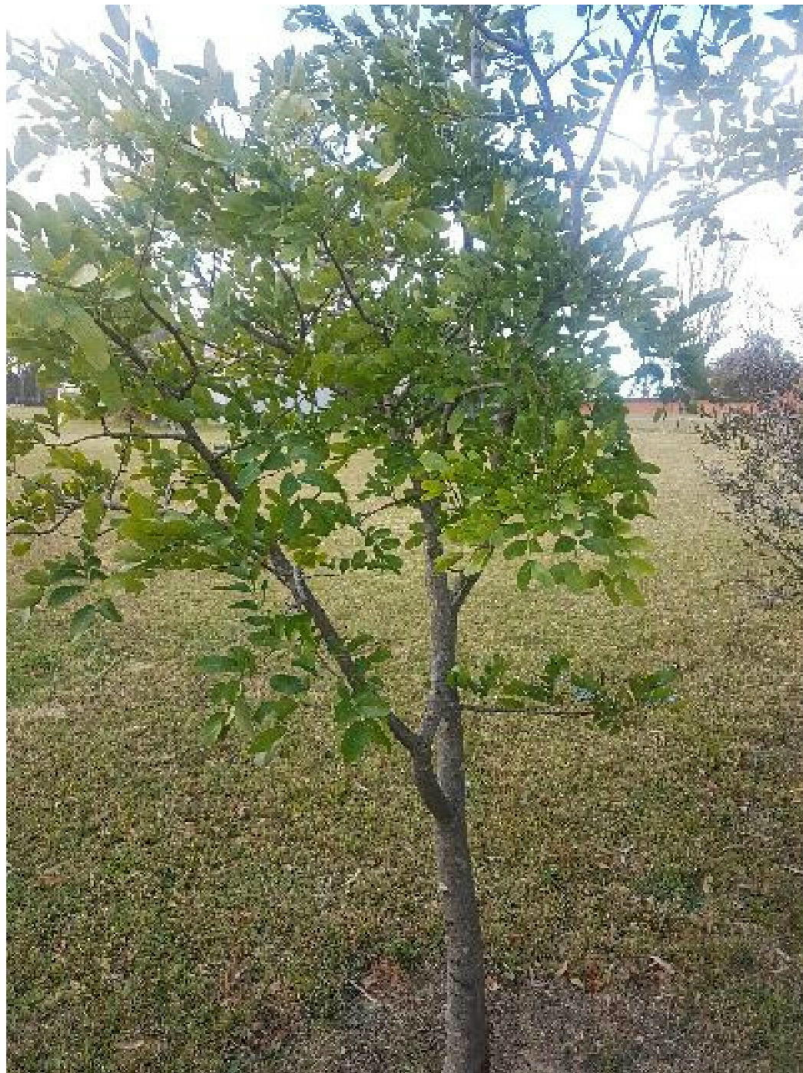
T47 <i>Callistemon viminalis</i> Common name 'Tuckeroo' Age class. 20 years See Fig. 55.	4m	Multi stemmed 12cm at the base	N 1m E 1m S 1m W 1m	A native tree endemic to Northern NSW and Queensland. The tree has been planted in the 'Grove' towards the Northern border of the property. At the time of inspection the specimen was in good condition with no significant pathogens or defects.	A5	2m Min TPZ	1.5m Min SRZ
T48 <i>Cupaniopsis anacardioides</i> Common name 'Tuckeroo' Age class. 20 years See Fig. 56.	3m	15cm 22cm at the base	N 1m E 2m S 2m W 2m	A native tree endemic to Northern east coast of NSW and Queensland. The tree has been planted in the 'Grove' towards the Northern border of the property. At the time of inspection the specimen was in good condition with no significant pathogens or defects.	A5	2m Min TPZ	1.5m Min SRZ
T49 <i>Corymbia gummifera</i> Common name 'Red Bloodwood' Age class. 20 years See Fig. 57.	4m	2 x 4cm 2 x 6cm 12cm at the base	N 1m E 1m S 1m W 1m	A native tree endemic to the Sydney region and occurring in coastal strips along Eastern NSW and Queensland. The tree has been planted in the 'Grove' towards the Northern border of the property. At the time of inspection the specimen was in good condition with no significant pathogens, defects nor mechanical injury.	A5	2m Min TPZ	1.5m Min SRZ

Fig 55. Photo of T47 a *Callistemon viminalis*.

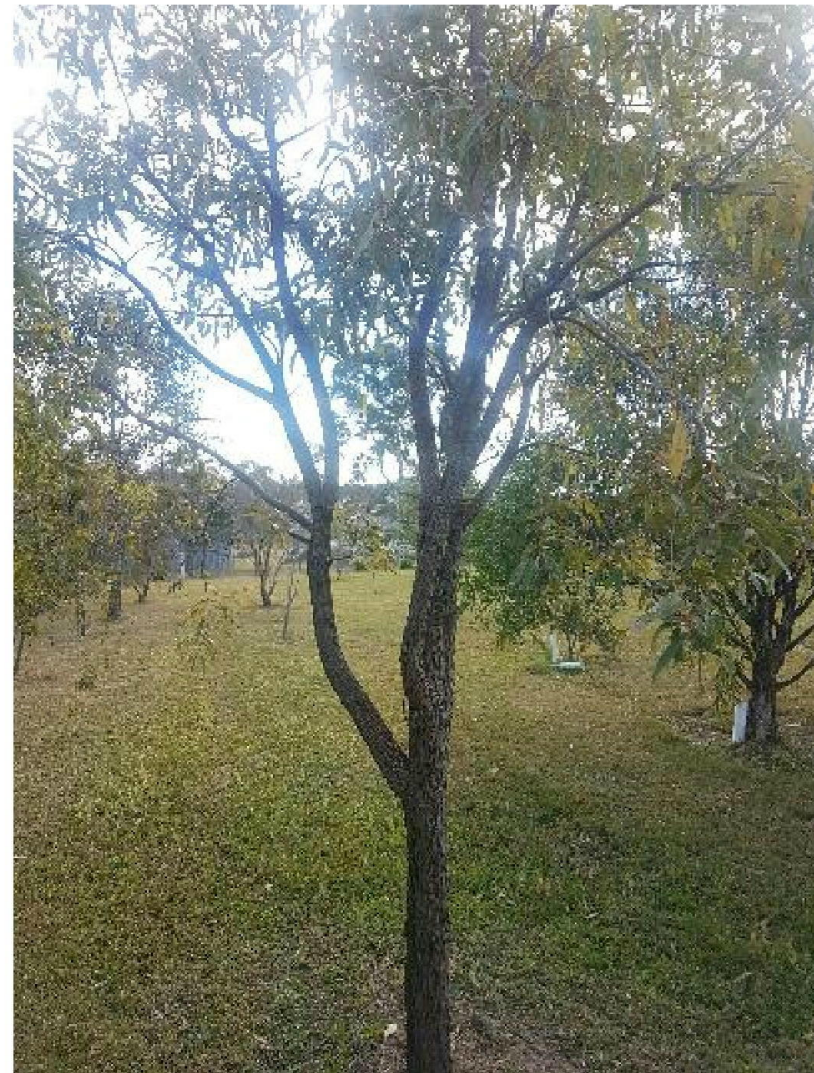
Fig 56. Photo of T48 a *Cupaniopsus anacardioides*.

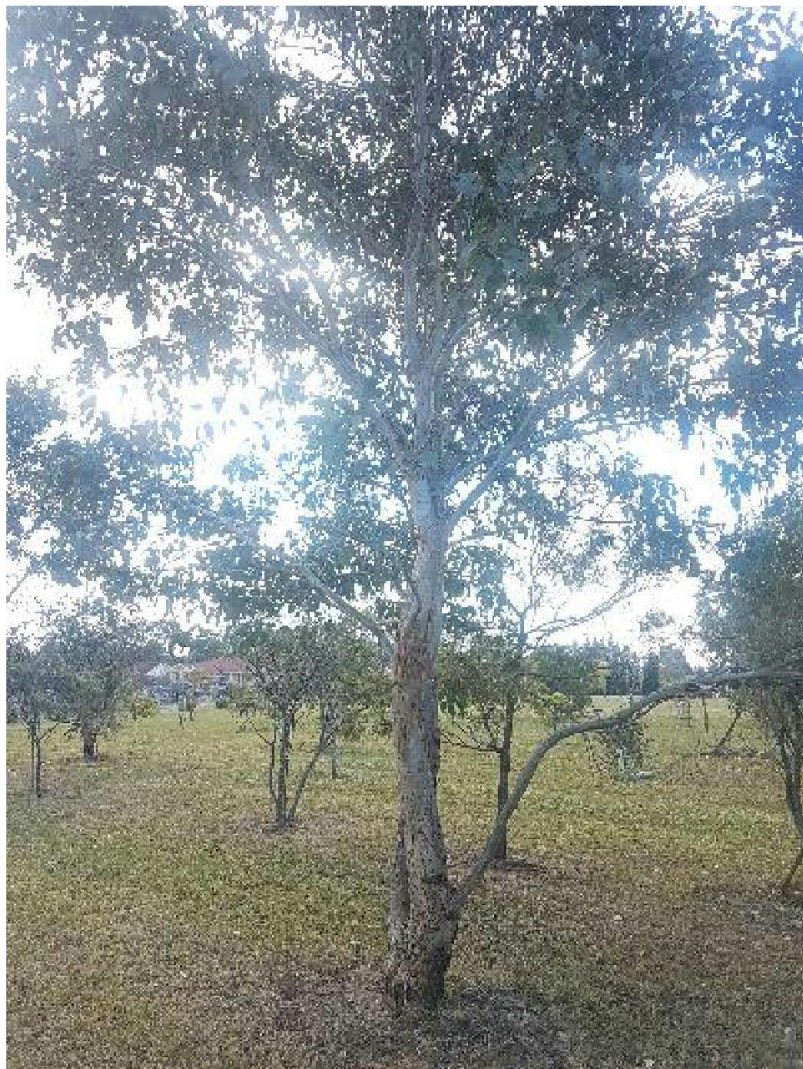
Fig 57. Photo of T49 a *Corymbia gummifera*.

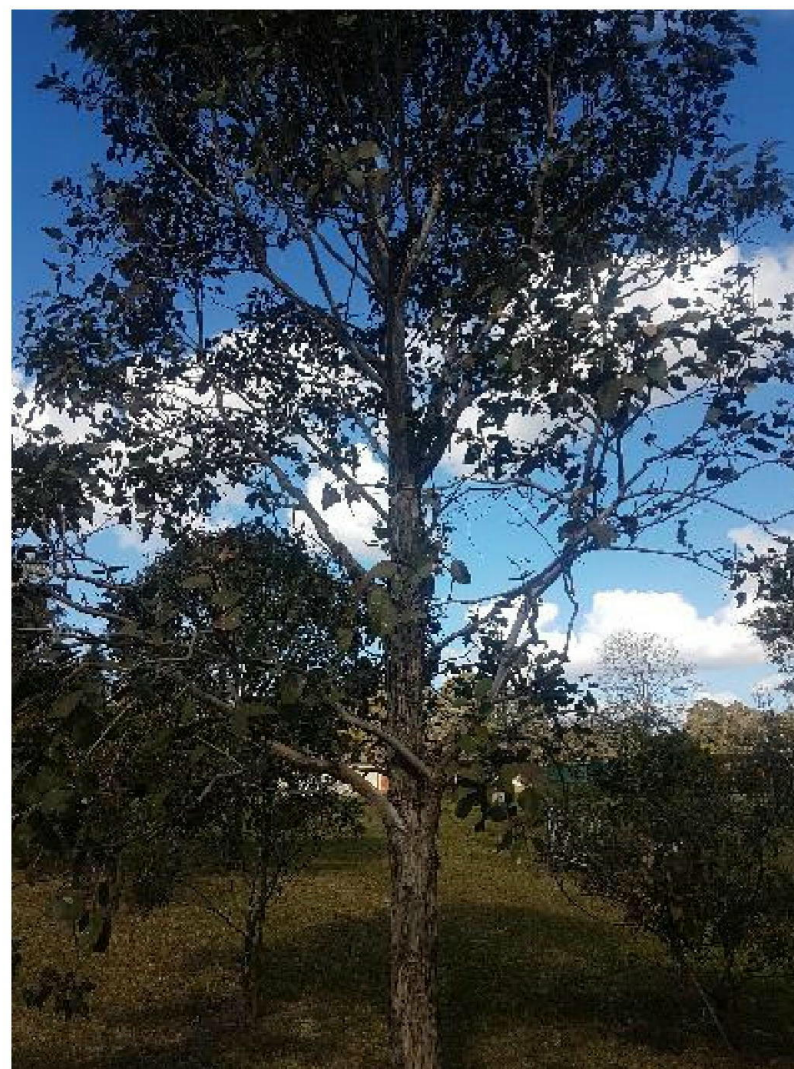
T50 <i>Eucalyptus torelliana</i> Common name 'Gadaga' Age class. 20 years See Fig. 58.	7m	1 x 12cm 1 x 16cm 29cm at the base	N 3m E 3m S 2m W 4m	A native tree belonging to Northern NSW and Queensland. The tree is growing near the Western side of the existing dwelling. At the time of inspection the specimen was in good health and condition.	A4	2.4m	1.97m
T51 <i>Eucalyptus torelliana</i> Common name 'Gadaga' Age class. 20 years See Fig. 59.	7m	19cm 22cm at the base	N 3m E 3m S 2m W 4m	A native tree belonging to Northern NSW and Queensland. The tree is a planted specimen located in the 'Grove' towards the Northern boundary of the Site.. At the time of inspection the specimen was in good health and condition.	A4	2.28m	1.75m
T52 <i>Melaleuca saligna</i> Common name 'Broadleaved Paperbark' Age class. 10 years See Fig. 60.	4m	Multiple stems 25cm at the base	N 1m E 1m S 1m W 2m	A native tree common to low-lying river flats and damp creeks of the NSW coast. The tree is a planted specimen located in the 'Grove' towards the Northern boundary of the Site. At the time of inspection the specimen was in reasonable condition with sooty mould on the lower stems and branches.	A5	2m Min TPZ	1.5m Min SRZ

Fig 58. Photo of T50 a *Eucalyptus torelliana*

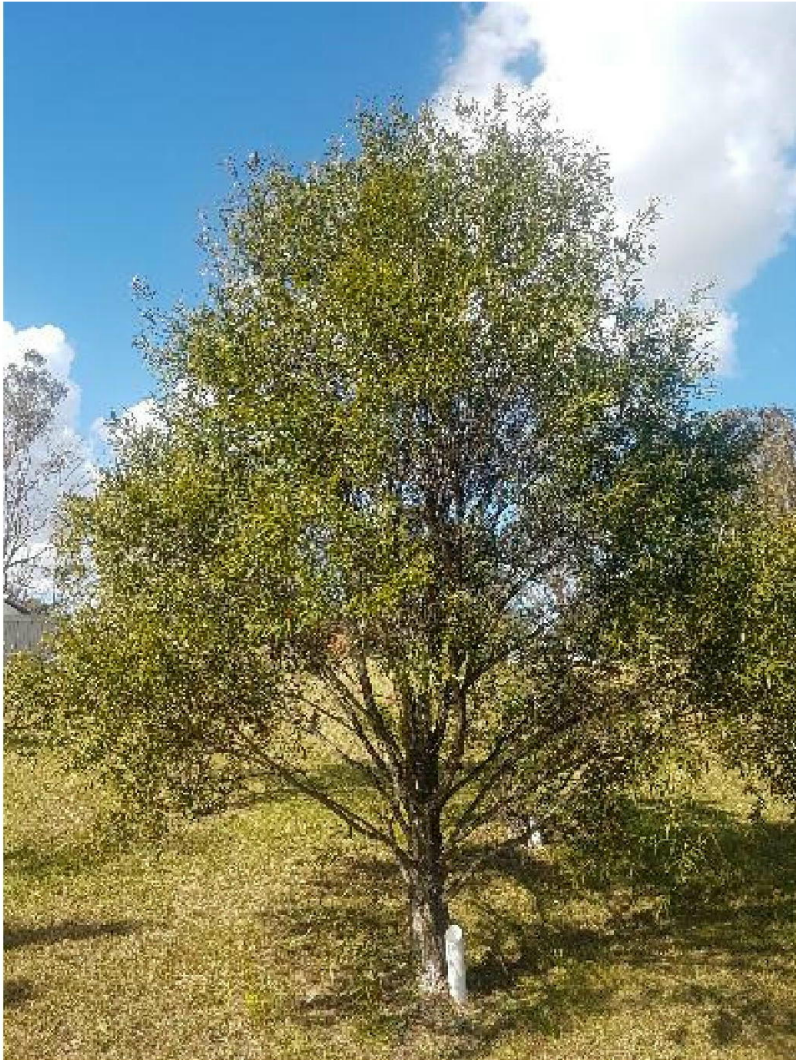
Fig 59. Photo of T51 a *Eucalyptus torelliana*.
