Lenore Drive, Erskine Park Hot Spot Assessment December, 2019

Complete Petro-Chemical Consulting
Services Pty Ltd

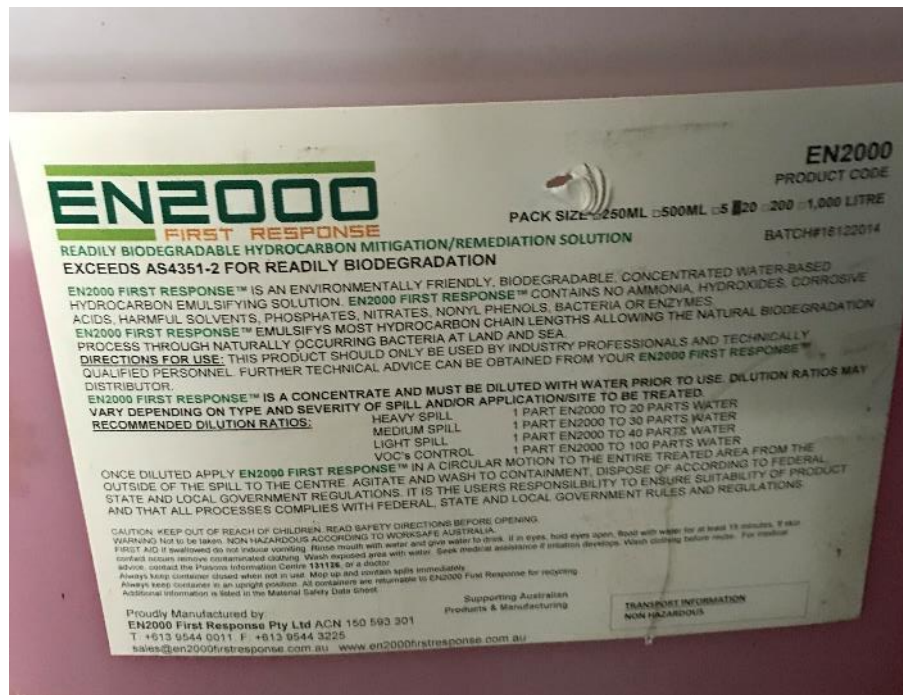
The positioning of the two remaining hotspots are easily identifiable on approach to the entrance to the site off Lenore Drive, by the yellow marker paint, however, for accuracy the hotspots are 6200 mm west and 2500 mm south of intersection of the site boundaries to Lenore Drive.

EN 2000 has been widely used and is a successful method of hydrocarbon mitigation on small manageable areas.
