Dana Bina Pty Ltd &
Midpoint Investments Pty Ltd

Geotechnical Investigation Report

Proposed Development at:
31 Santley Crescent & 2A Bringelly Road
Kingswood NSW 2747

G21551-1

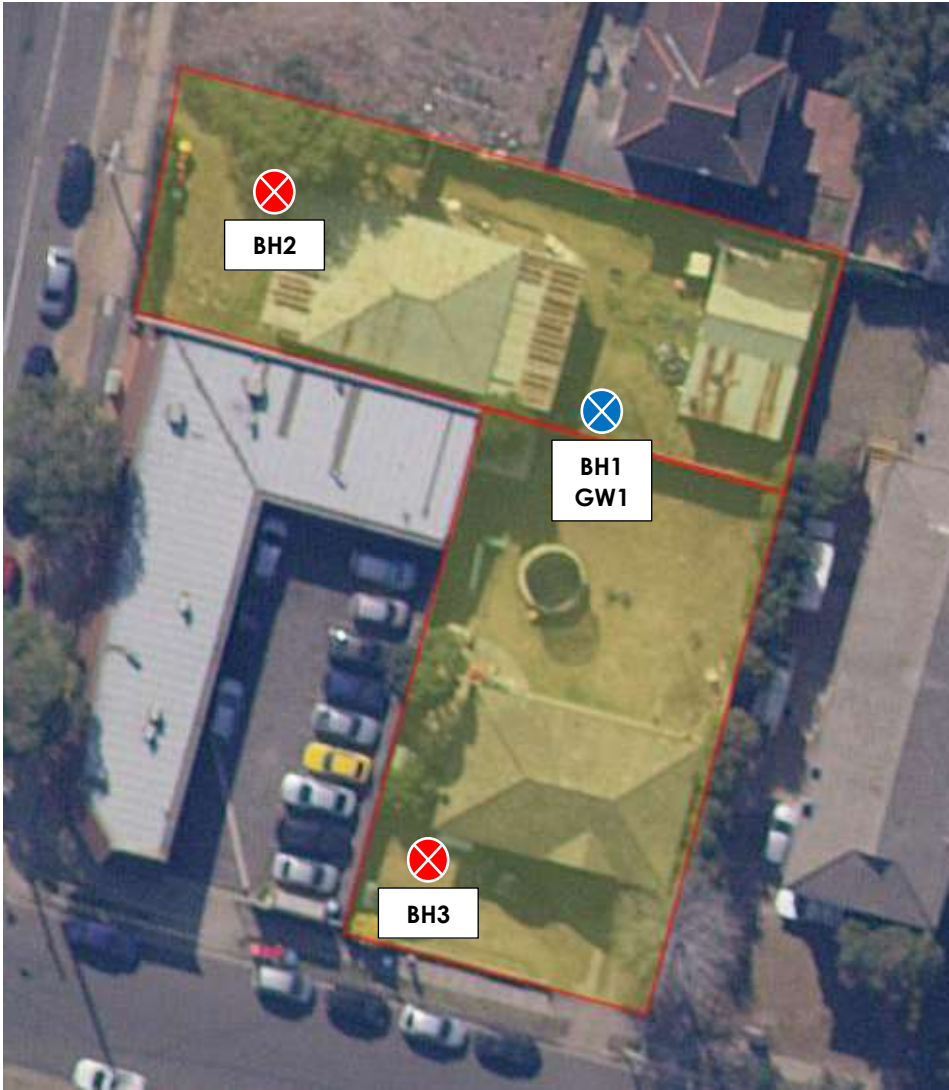
Approximate Borehole/Standpipe Piezometer Location

Figure 1 Site Plan	Geotechnical Investigation	Drawn: GA/PG	 
	Job No.: G21551-1	Dana Bina Pty Ltd & Midpoint Investments Pty Ltd	Date: 29/09/2021	
		31 Santley Crescent & 2A Bringelly Road Kingswood NSW 2747	Scale: NTS

- The approximate locations of the boreholes and standpipe piezometer are shown on **Figure 1, Appendix B** of this report
- Collection of soil and rock samples during drilling for the following laboratory testing required:

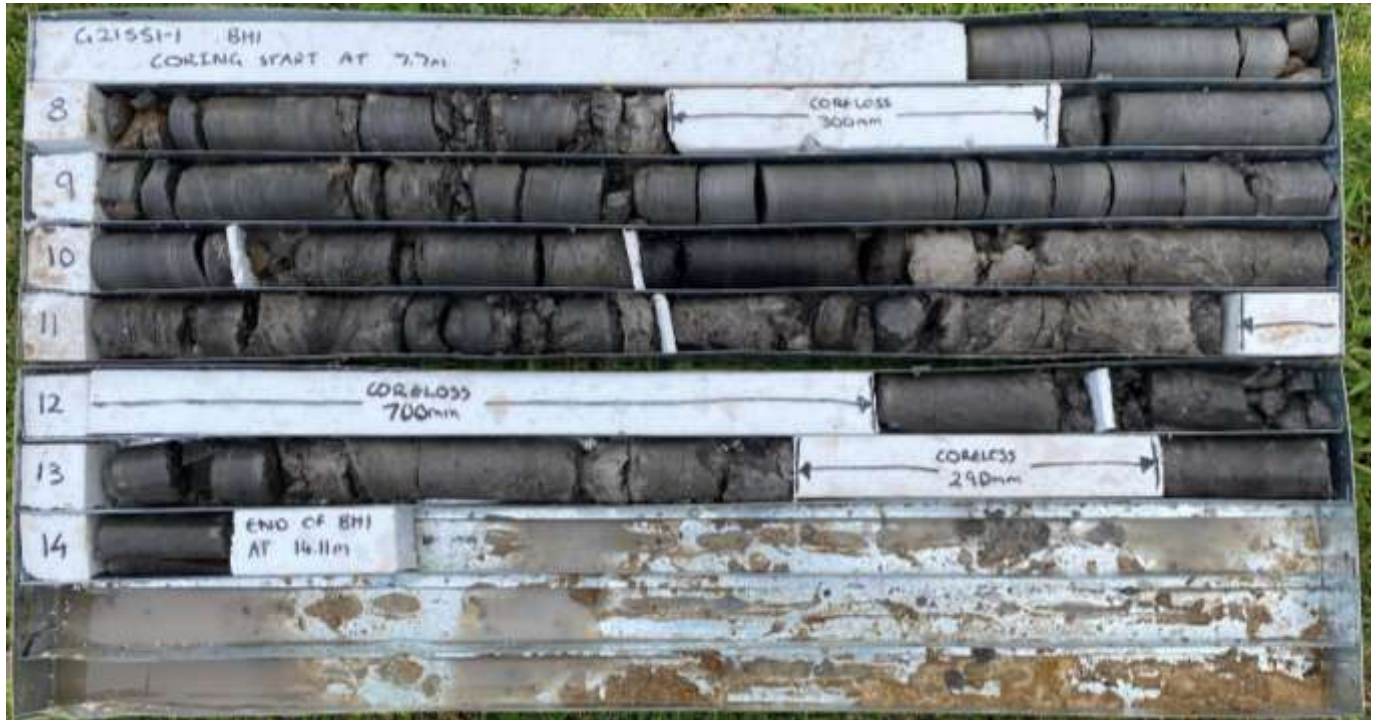
BOREHOLE BH1 CORING STARTS FROM 7.7m to 14.11m bgl

Geotechnical Investigation	Borehole Core Box Photographs
	Dana Bina Pty Ltd & Midpoint Investments Pty Ltd	Job No.: G21551-1
	31 Santley Crescent & 2A Bringelly Road Kingswood NSW 2747	Date: 29/09/2021

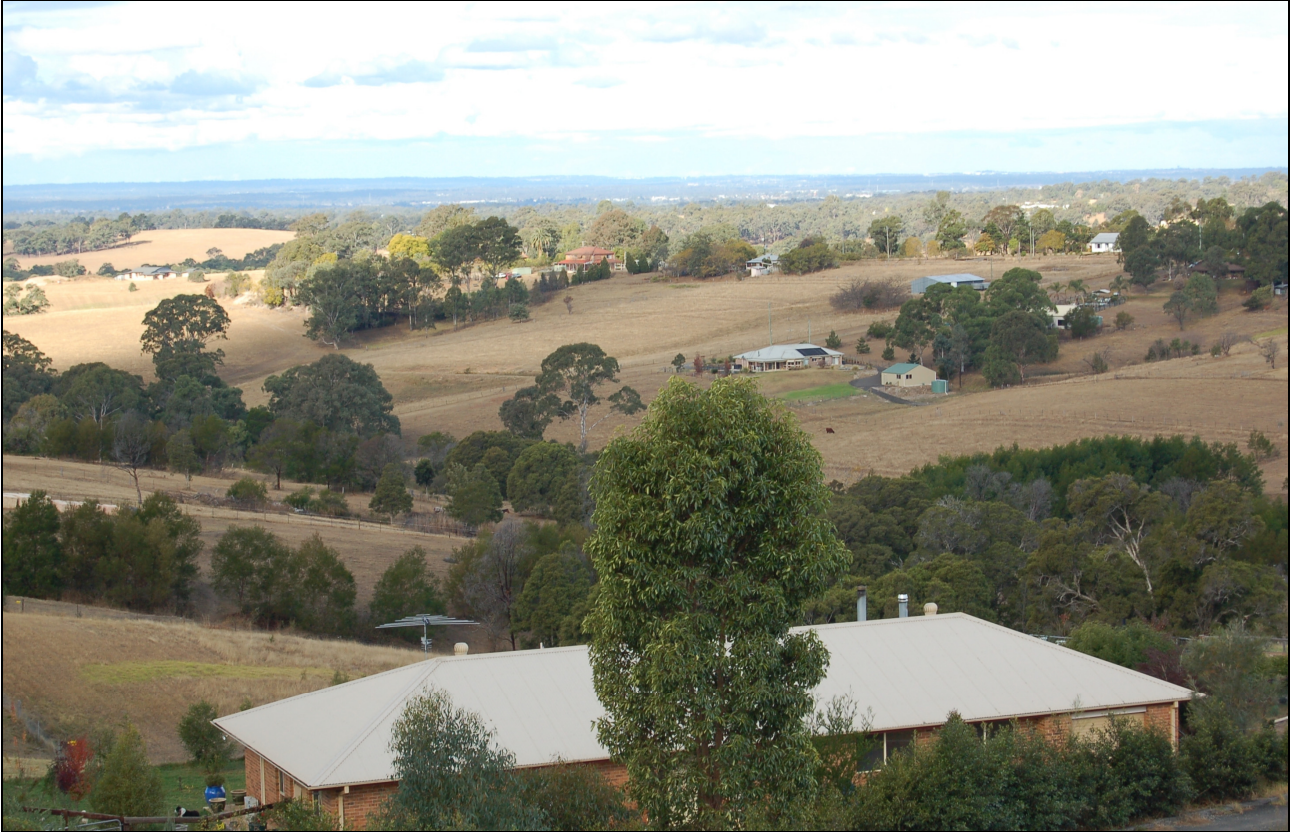
Landscape—undulating to rolling low hills on Wianamatta Group shales, often associated with Minchinbury Sandstone. Local relief 50–80 m, slopes 5–20%. Narrow ridges, hillcrests and valleys. Extensively cleared tall open forest (wet sclerophyll forest).

Soils—shallow (<100 cm) dark Podzolic Soils (Dd3.51) or massive Earthy Clays (Uf6.71) on crests; moderately deep (70–150 cm) Red Podzolic Soils (Dr2.11, Dr2.41, Dr3.11) on upper slopes; moderately deep (<150 cm) Yellow Podzolic Soils (Dy4.22) and Prairie Soils (Gn3.26) on lower slopes and drainage lines.

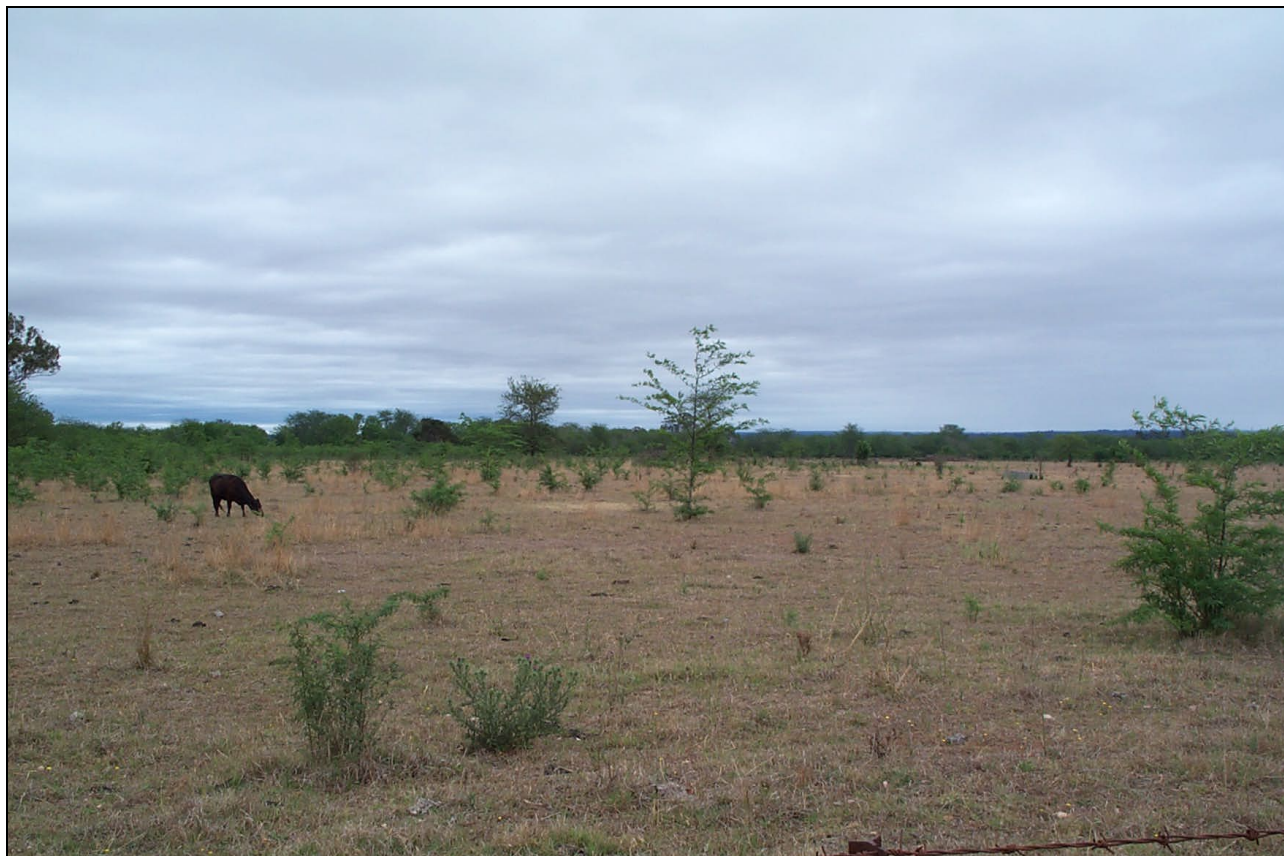
Landscape—floodplains, valley flats and drainage depressions of the channels on the Cumberland Plain. Usually flat with incised channels; mainly cleared.

Soils—often very deep layered sediments over bedrock or relict soils. Where pedogenesis has occurred Structured Plastic Clays (Uf6.13) or Structured Loams (Um6.1) in and immediately adjacent to drainage lines; Red and Yellow Podzolic Soils (Dr5.11, Dy2.41, Dr2.21) are most common terraces with small areas of Structured Grey Clays (Gn4.54), leached clays (Uf4.42) and Yellow Solodic Soils (Dy4.42, Dy5.23).
