Hillsong Church Greater West Development 1 Water Street, Werrington, NSW

Preliminary Salinity Assessment

Our ref: 4064-R1
2 March 2017

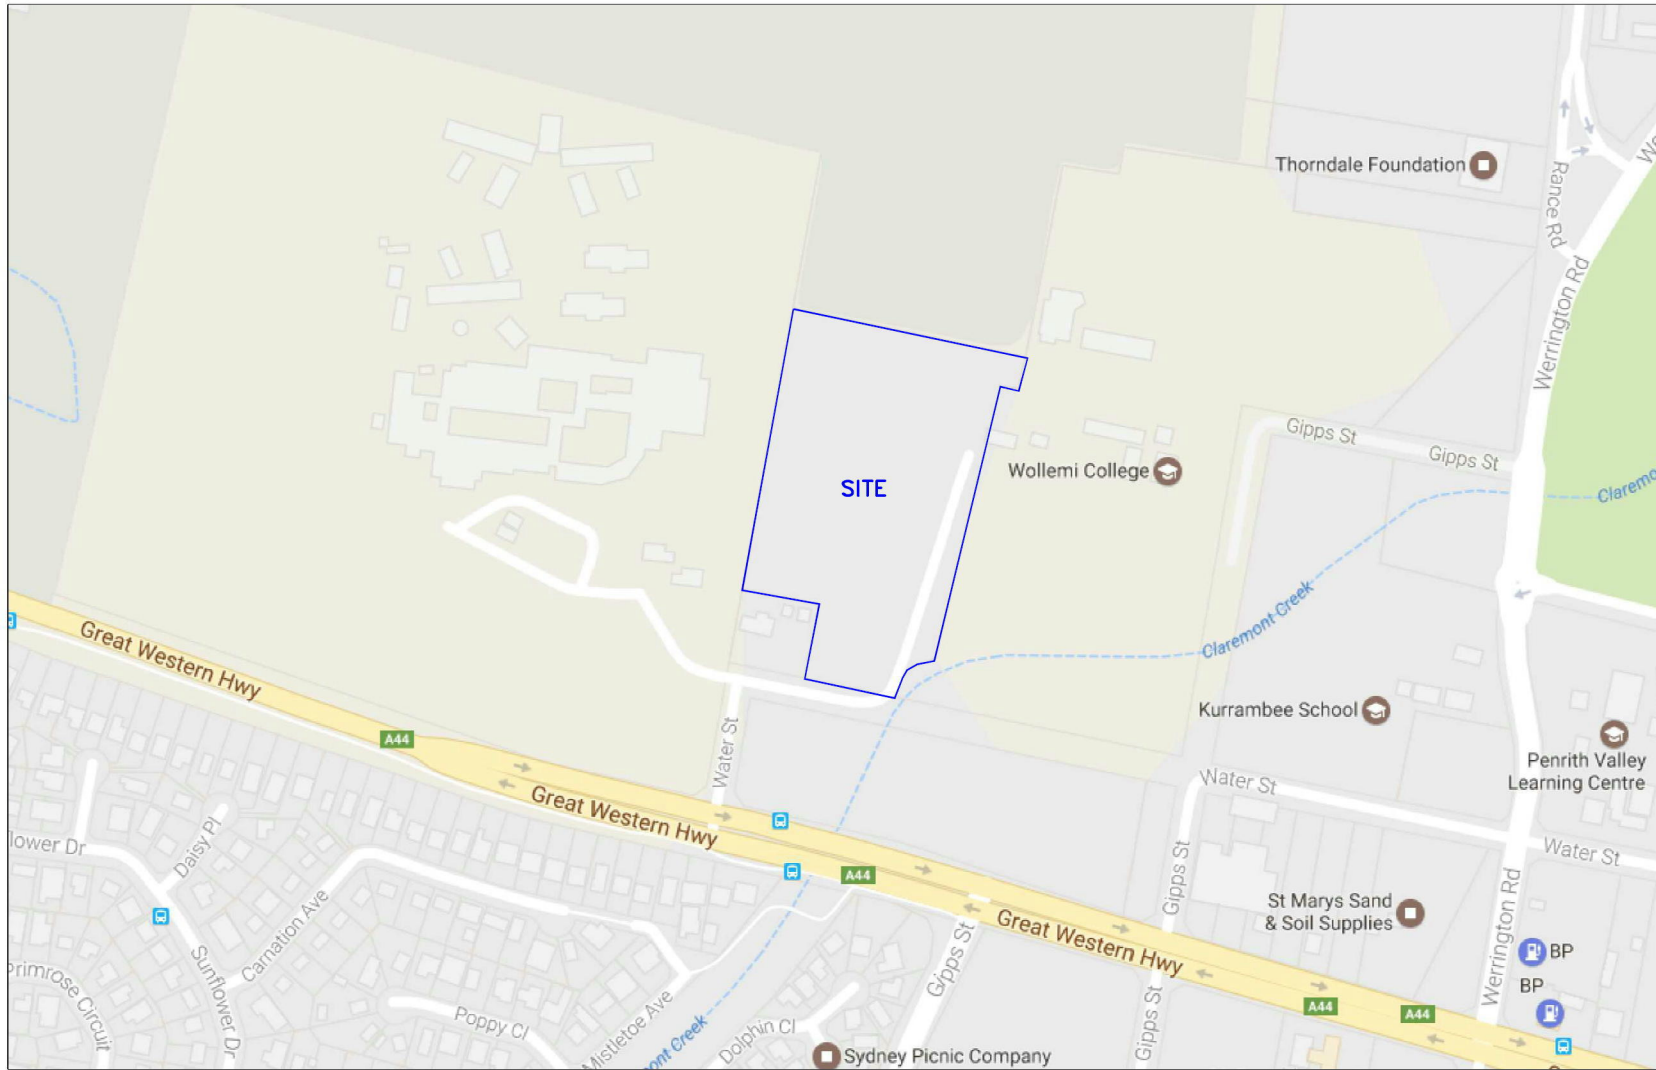
Figure 1 – Site Locality

APPROXIMATE ONLY –
SUBJECT TO DETAIL SURVEY.

SOURCE: "GOOGLE MAPS"

The site is located off Old Western Highway between the Cobham Remand centre and Wollemi School, as shown in Figure 1. It is roughly rectangular and has a street frontage with the unpaved section of Water Street for about 50m. The block is about 158m wide and is about 192m deep. A vacant grassland borders the site to the north.
