RAFZAN
Consulting Engineers

BOREHOLE & LABORATORY TEST REPORT

LOT 338 FORESTWOOD DRIVE GLENMORE PARK

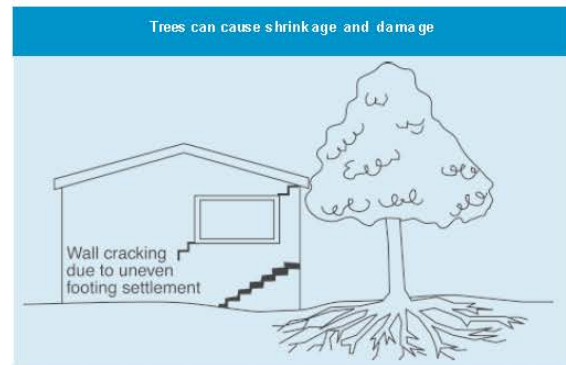
As the moisture absorption process completes its journey to the innermost areas of the building, the internal footings will rise. If the spread of moisture is roughly even, it may be that the symptoms will temporarily disappear, but it is more likely that swelling will be uneven, creating a difference rather than a disappearance in symptoms. In buildings with timber flooring supported by bearers and joists, the isolated piers will rise more easily than the strip footings or piers under walls, creating noticeable doming of flooring.

As the weather pattern changes and the soil begins to dry out, the external footings will be first affected, beginning with the locations where the sun's effect is strongest. This has the effect of lowering the external footings. The doming is accentuated and cracking reduces or disappears where it occurred because of dishing, but other cracks open up. The roof lines may become convex.
