# Asbestos Building Materials Register

## Penrith City Council

**Anchor House – Penrith Regional Gallery  
8 River Road  
EMU PLAINS NSW 2750**

**Report Number: 10546.01.ASSR**

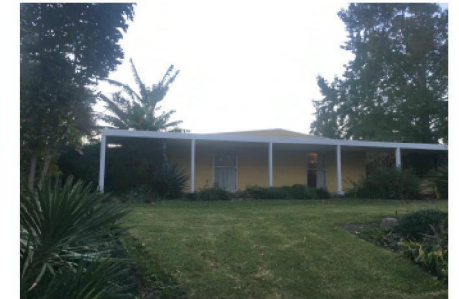
Asset Photo

ID	Location	Material Type	Sample No.	Analysis Result	Extent	Condition	Friability	Disturbance Potential	Risk Status	Re-inspect Date	Control Priority	Control Recommendation	Removed	Photos
<b>Exterior</b>														
1	Eastern side Awning - Ceiling	Fibre Cement Sheeting	10546/AS02	Negative No Asbestos Detected	-	-	-	-	-	-	-	-	-	Photo 1
