Universal Property Group Pty Ltd

Preliminary Salinity and Geotechnical  
Assessment:  
326-330 Caddens Road and 27 Kent  
Road, Claremont Meadows, NSW

P1605186JR02V01  
August 2016

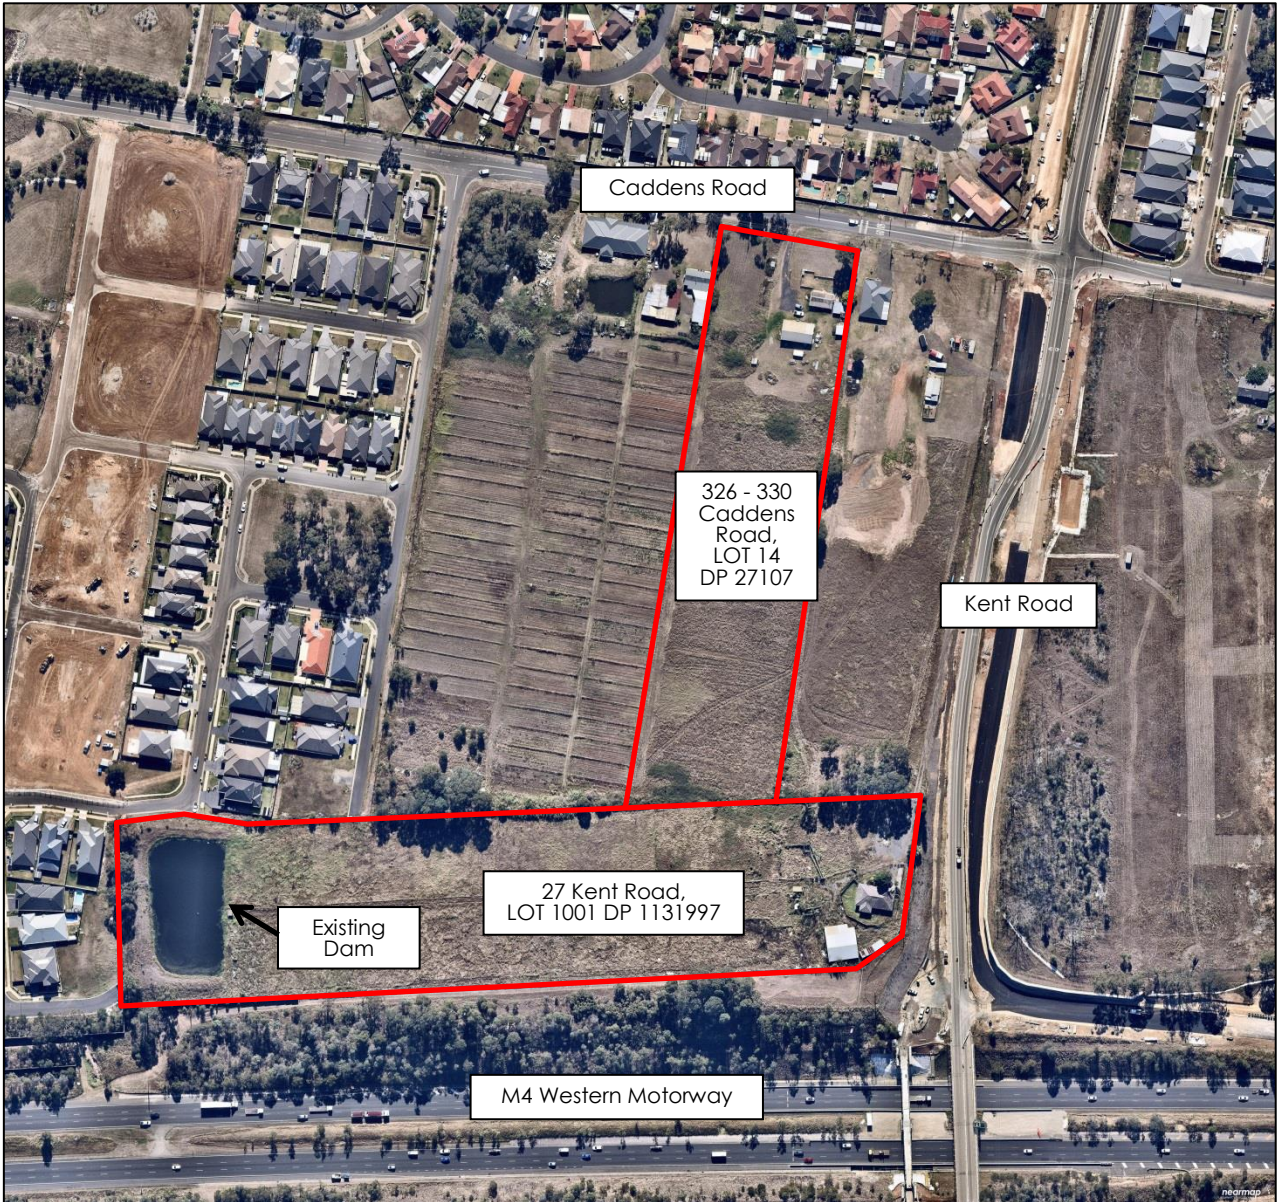
<b>Martens &amp; Associates Pty Ltd</b> ABN 85 070 240 890		<b>Environment   Water   Wastewater   Geotechnical   Civil   Management</b>	
Drawn:	GMT	<b>SITE AND EXISTING DAM LOCATION</b> <b>326 - 330 Caddens Road and 27 Kent Road, Claremont</b> <b>Meadows, NSW</b> (Source: Nearmap)	Drawing No:
Approved:	RE		<b>FIGURE 1</b>
Date:	25.08.2016		
Scale:	Not to Scale		File No: P1605186JR02V01

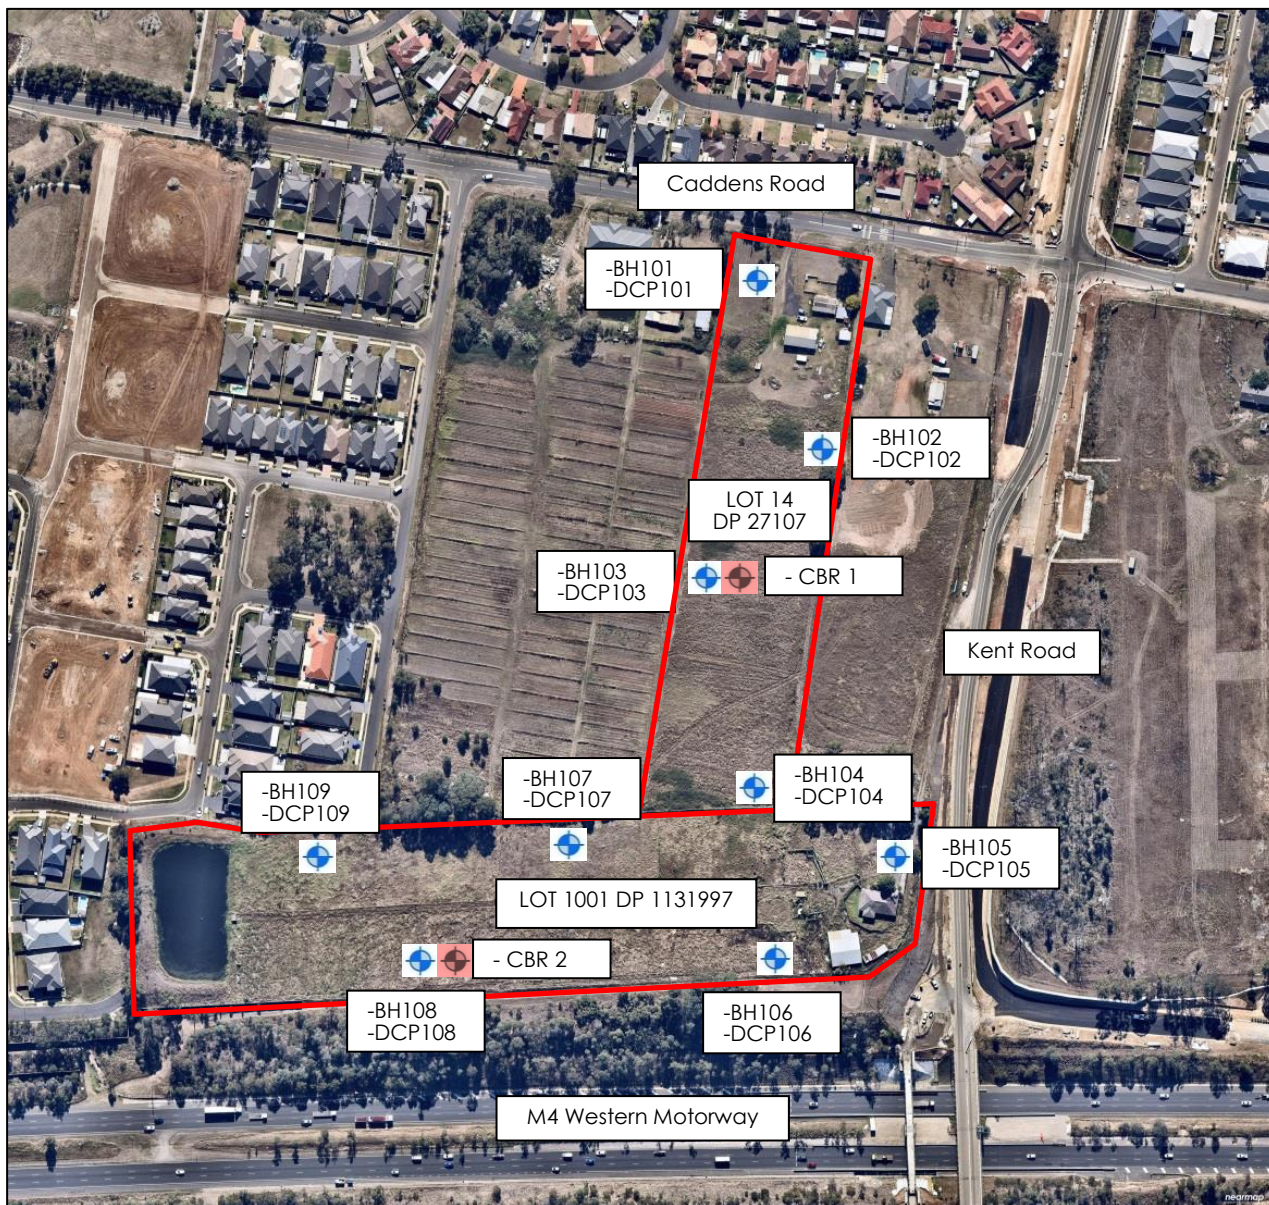
- - - Approximate site boundary
- Indicative borehole, DCP test location
- Indicative CBR sampling location

Martens & Associates Pty Ltd    ABN 85 070 240 890		Environment   Water   Wastewater   Geotechnical   Civil   Management	
Drawn:	GMT	<b>GEOTECHNICAL TESTING LOCATION PLAN</b> <b>326 - 330 Caddens Road and 27 Kent Road, Claremont Meadows, NSW</b> (Source: Nearmap)	Drawing No:
Approved:	RE		<b>FIGURE 2</b>
Date:	25.08.2016		File No: P1605186JR02V01
Scale:	Not to Scale

Table 2 summarises encountered subsurface materials and conditions, inferred from borehole and DCP test results, to investigation termination depth. Encountered conditions are described in more detail on borehole logs, Attachment B, and associated explanatory notes,
