## Preliminary Site Investigation

**40-42 Mamre Road, St Marys NSW 2760**

Prepared For:	V Homes Developments Pty Ltd
Reference:	21-1155
Date:	07 May 2021

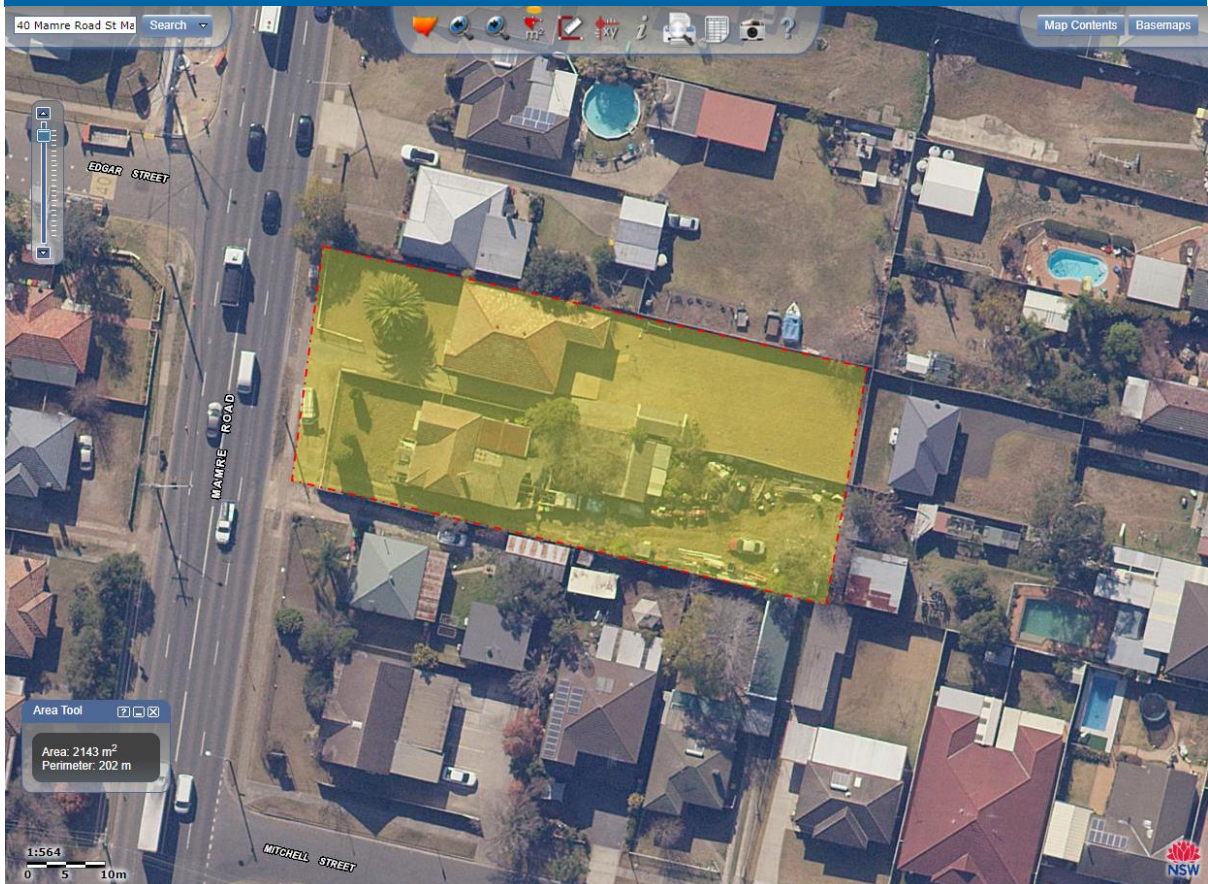
Figure 2: Aerial photograph of the subject site and surrounding areas – source [www.maps.six.nsw.gov.au](http://www.maps.six.nsw.gov.au)

The study sites are 40-42 Mamre Road, St Marys NSW 2760 (Figure 1). Both sites can be identified as rectangular shaped allotments surrounded by low density residential properties on all boundaries. Figure 2 shows an aerial photograph of the site and the surrounding land.
