Report on Phase 1 Contamination Assessment with Limited Sampling

> Fernhill Estate Eastern Precinct Mulgoa Road, Mulgoa

> Project 71706.01 June 2013

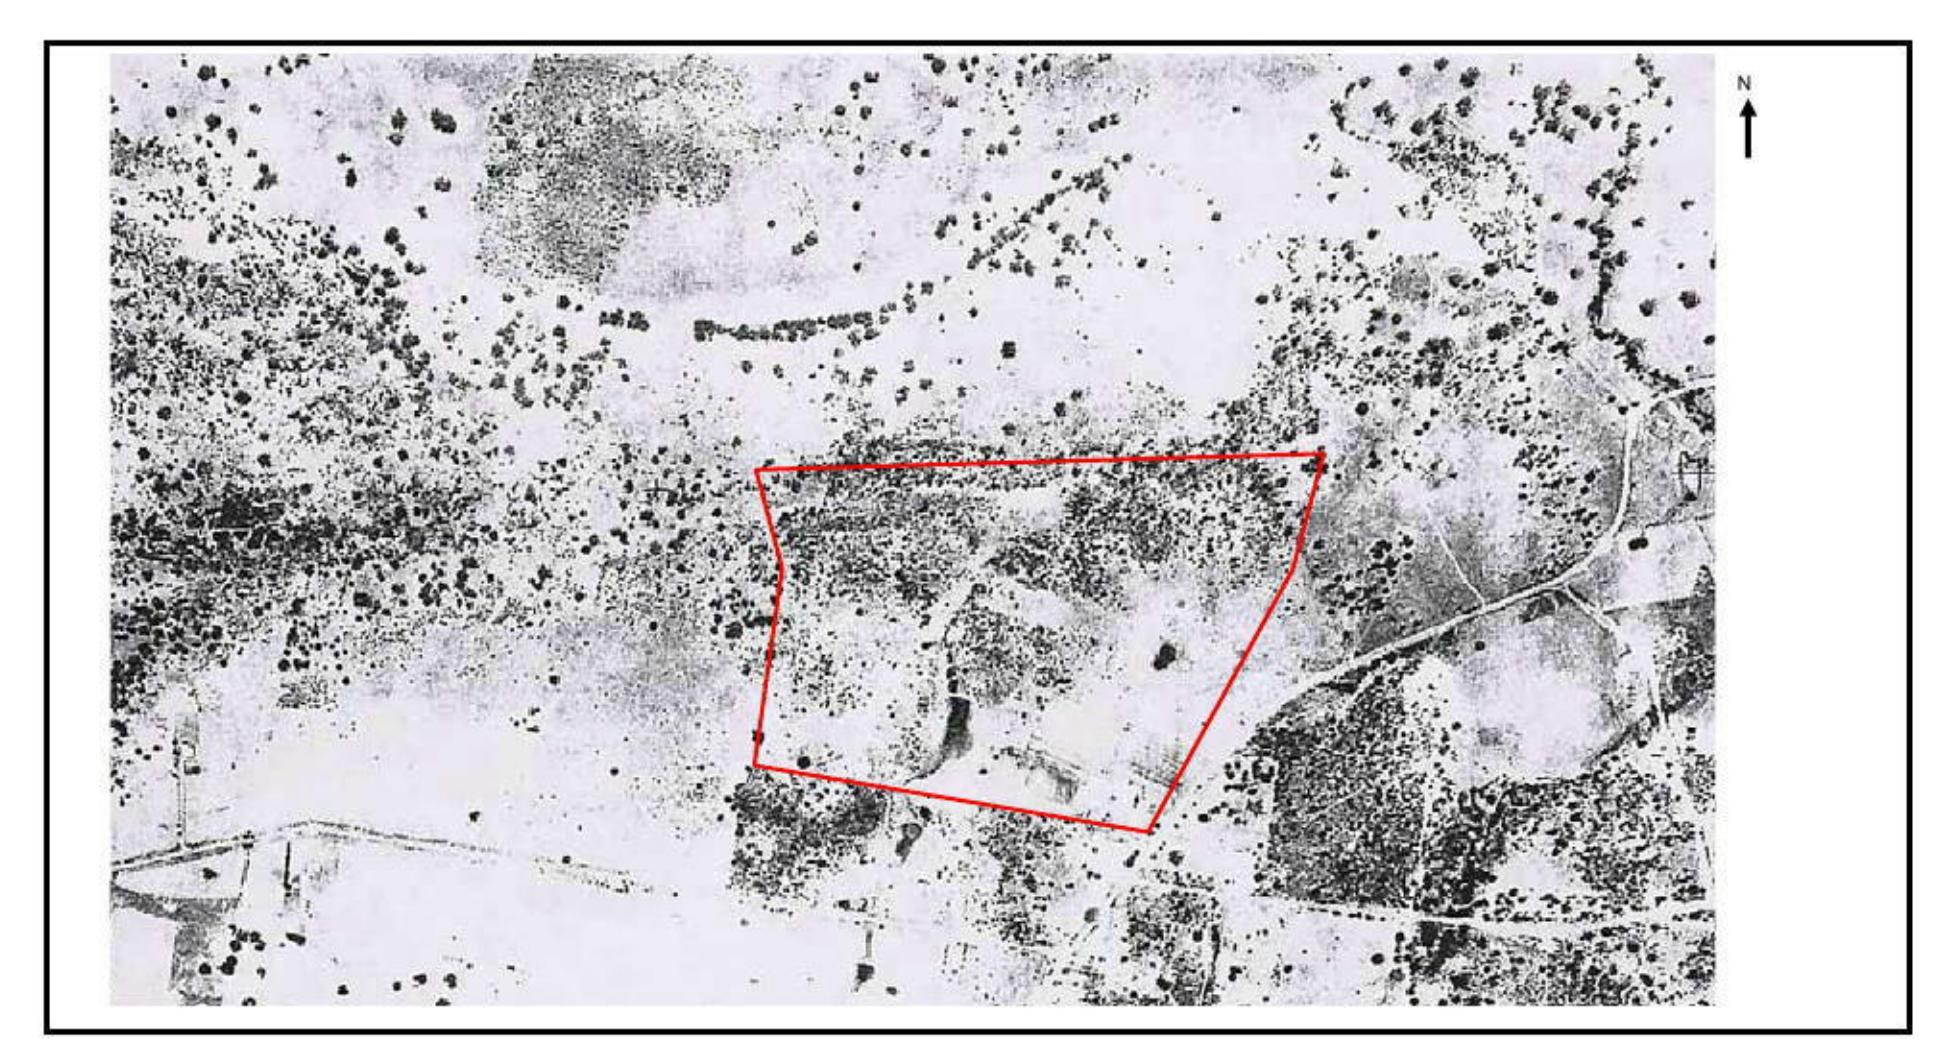
- 1947 The site appears to be within an area of rural land use. Due to the poor quality of the 1947 image, it is unclear whether there are any structures present within the subject site, however there may be a couple of dwellings in the south-eastern corner, near what appear to be agricultural/market gardens. There is a body of water observed within the site area in the vicinity of where Dam 2 is currently located. The remainder of the site is observed to be covered by sparse bushland. A creek runs along to northern boundary of the site. Mulgoa Road does not appear to yet extend along the eastern boundary of the site.

Project Suburb/Location:	Mulgoa	August 2010	CON NU BARAN
Project Address:	Owston Estate - Eastern Precinct	71706	Plate 1: 1947 Image
Project Title:	Phase 1 Contamination Assessment	Project

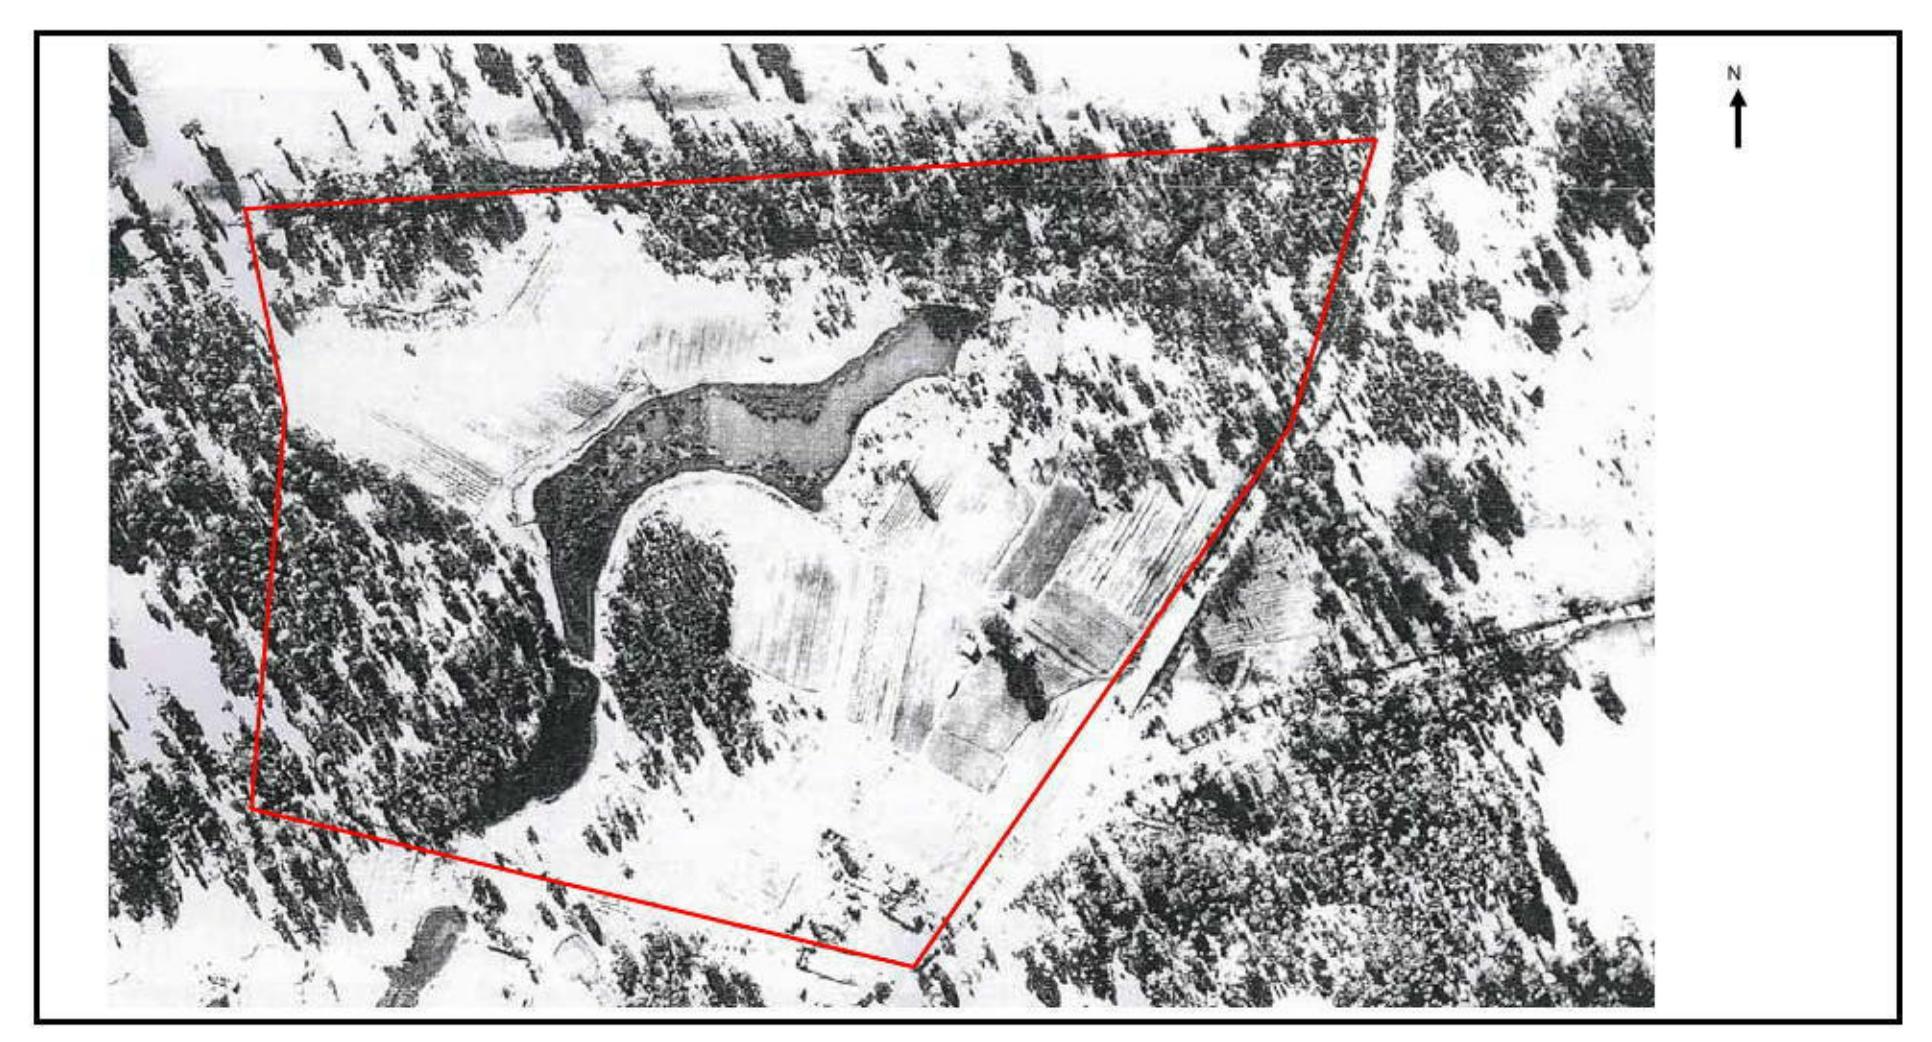
- 1961 The site appears further developed since the 1947 image, with the presence of the two
 dams resembling current site conditions. The bushland in the north-western and central areas of
 the site have been cleared to make way for cultivated agricultural fields. The presence of a few
 small buildings is noted within the central east area amongst the fields, as well as a few small
 buildings located in the south-eastern corners. The surround land use appears similar to the
 1947 image, with the addition of Mulgoa Road along the site's eastern boundary.

Project Address:	Owston Estate - Eastern Precinct	71706	Plate 2: 1961 Image
Project Suburb/Location:	Mulgoa	August 2010	
		db	Douglas Partners

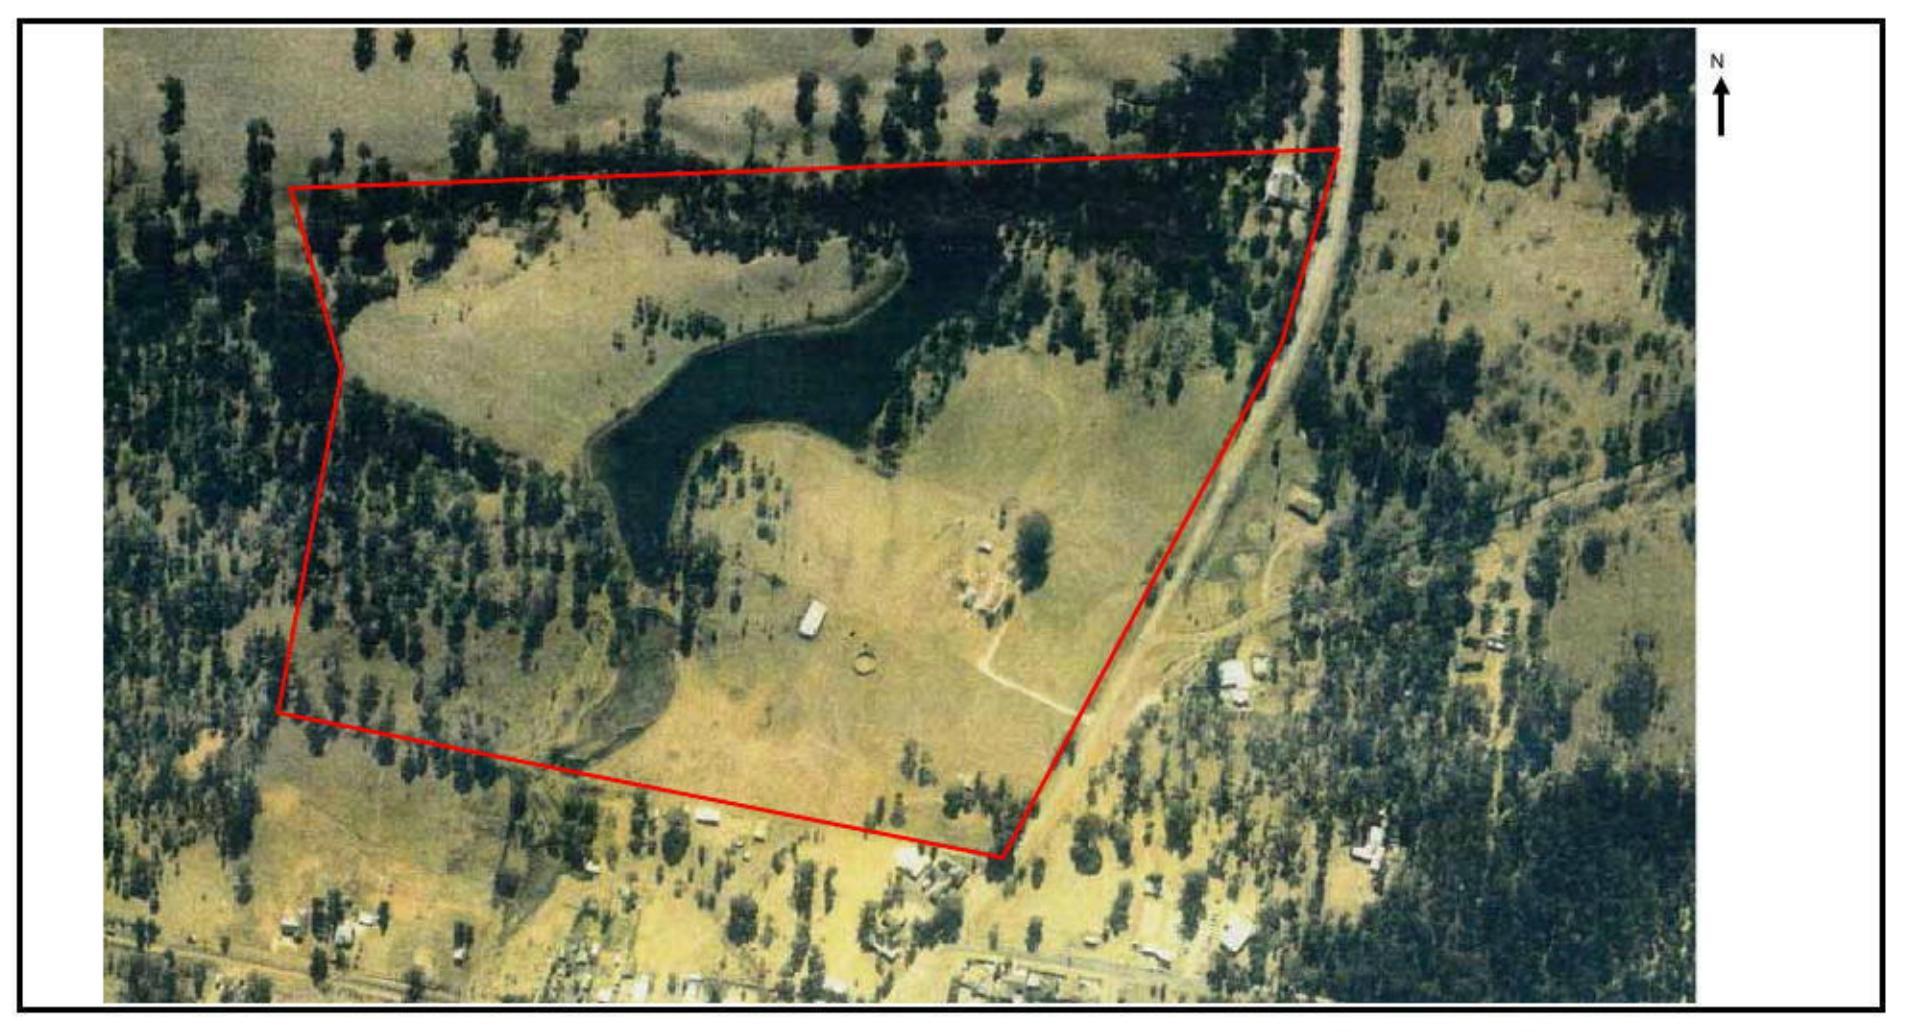
- 1986 The majority of the buildings that were located in the south-eastern corner of the site appear to have been removed, as well as one of the buildings in the central area of the site near the eastern boundary. There has been the addition of a rectangular structure near the centre of the site, between the circular marking and the dams. The bushland in the western half of the site appears more sparse. A few additional dwellings are observed to the south and east of the site, with what appears to be residential land use at the southern end of the image.

Project Title:	Phase 1 Contamination Assessment	Project	
Project Address: Project Suburb/Location:	Owston Estate - Eastern Precinct Mulgoa	71706 August 2010	Plate 5: 1986 Image
.ar

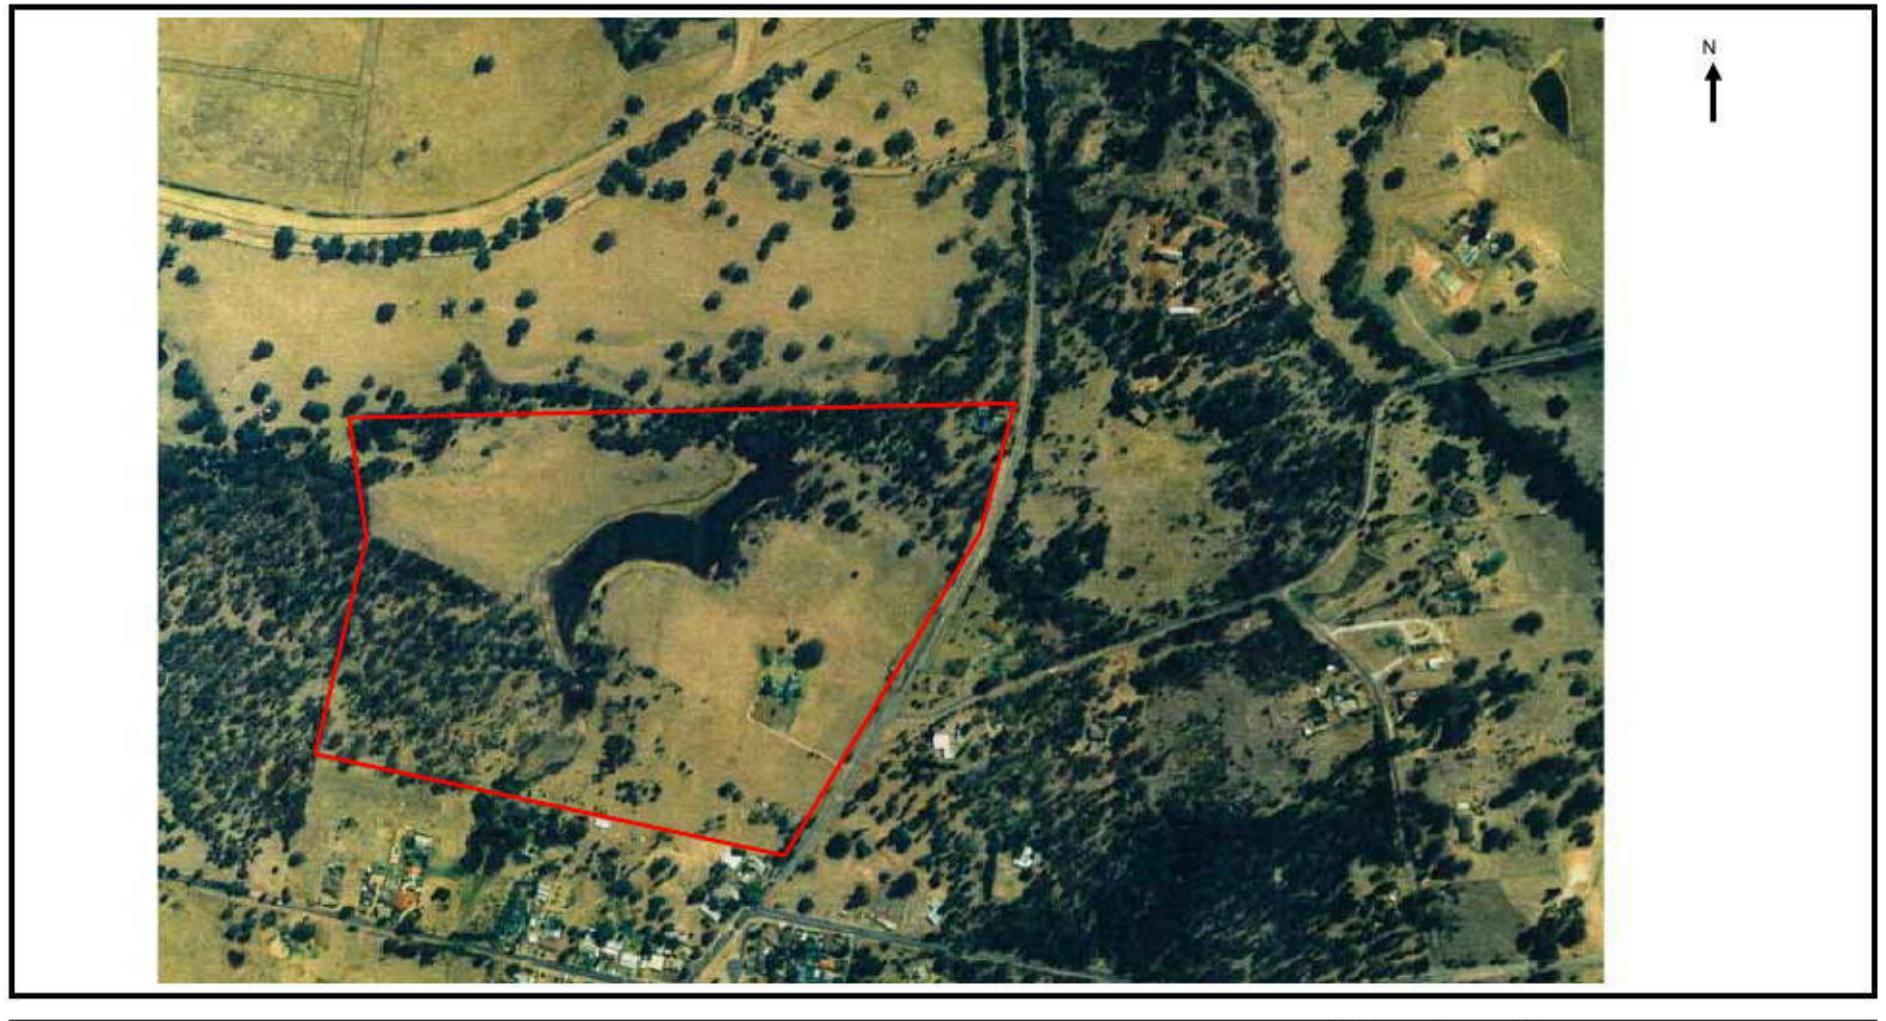
- 1994 The site appears generally similar to the 1986 image, however it appears that all but one of the buildings in the south-eastern corner, including the added structure that was first observed in the 1986 image, have been removed. The circular mark is also missing, and a few trees have been planted within the south-eastern area. The rectangular building that was present in the 1986 image near the dirt road within the central east part of the site appears to have been removed, with the addition of a new grey-roofed building, which appears to be a house on the other side of the dirt road. The surrounding land appears similar to observations made in the 1986 image, with the addition of a few buildings to the south of the site.

Project Title:	Phase 1 Contamination Assessment	Project	
Project Address:	Owston Estate - Eastern Precinct	71706	Plate 6: 1994 Image
Project Suburb/Location:	Mulgoa	August 2010	CODE NOT BEAM

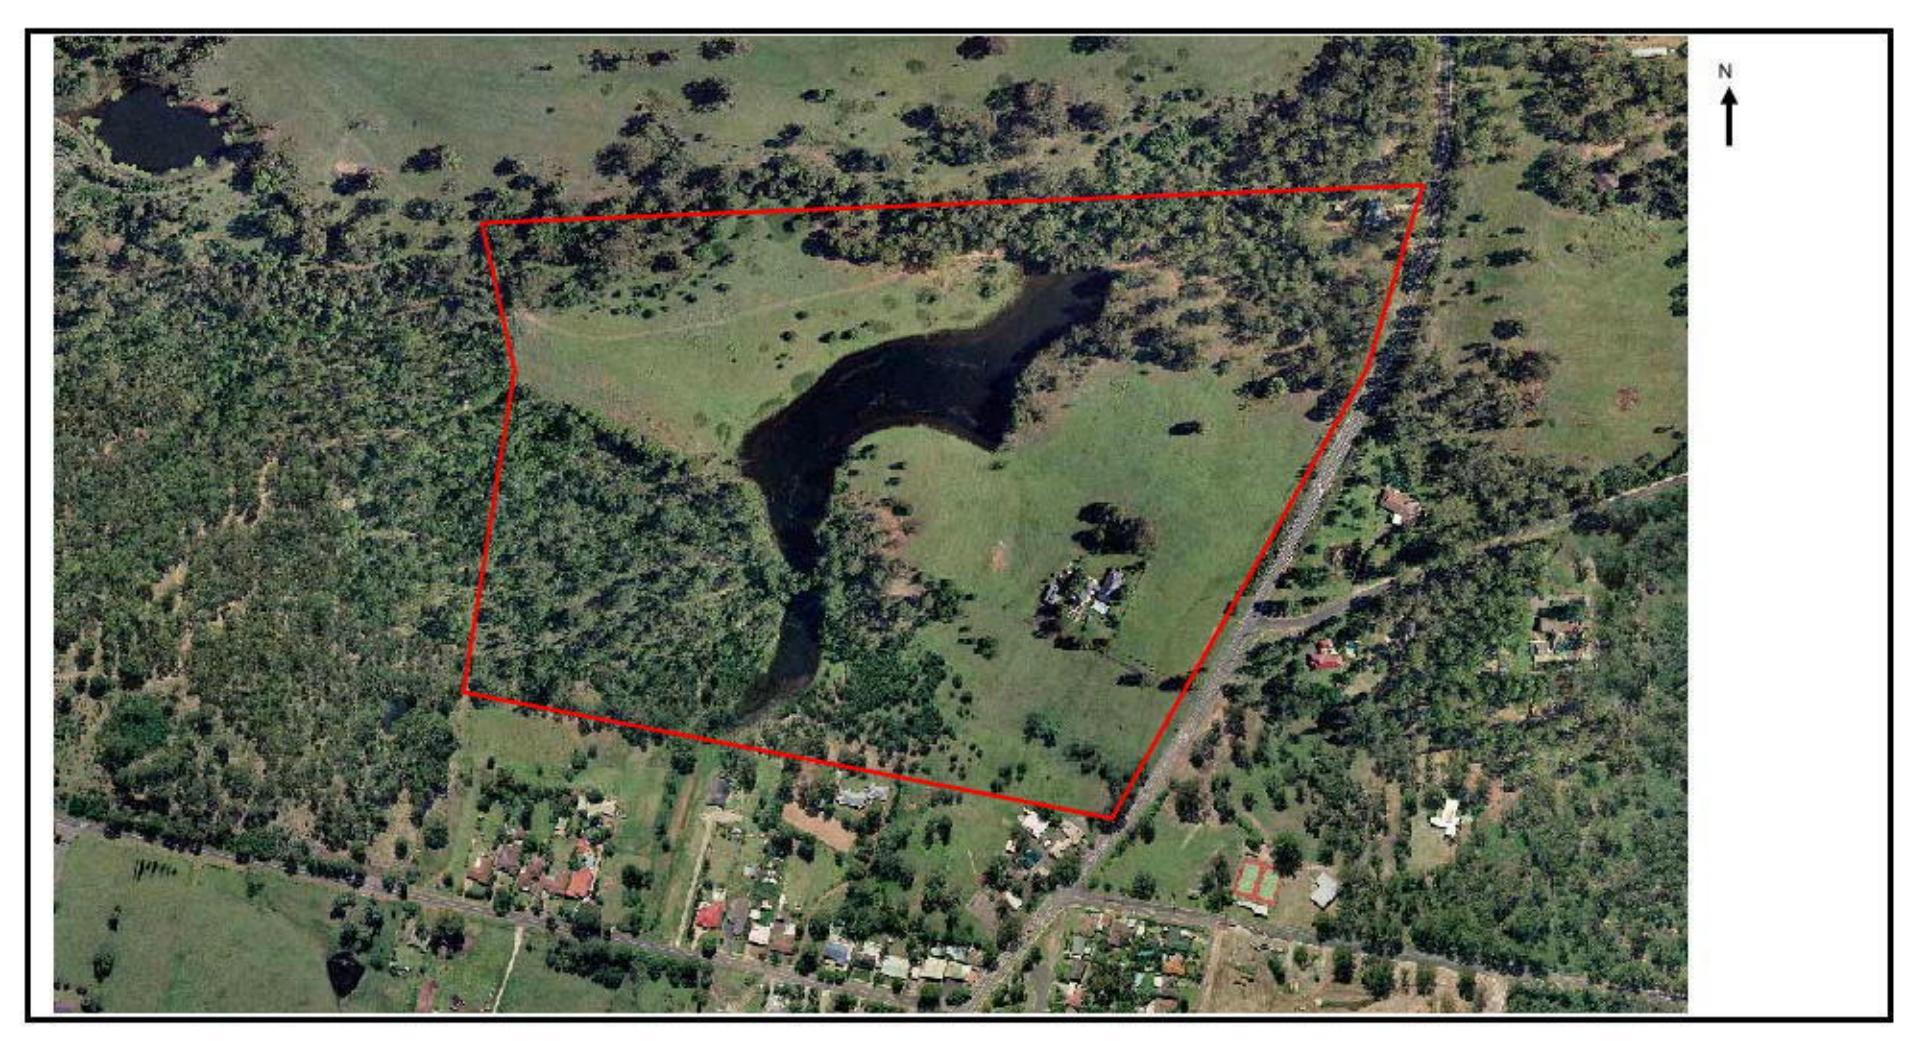
- 2009 (most current) The subject site and the surrounding lands do not appear significantly
 different to observations made in the 1998 image, although there appears to be a few more
 structures near the residential dwelling. The one remaining structure in the south-eastern corner
 of the site appears to have been removed. Further development is observed to the south of the
 site, with the addition of more rural residential buildings as well as a sports court to the south-east
 of the site. Generally the area has not been changed significantly.

Project Address: Owston Estate - Eastern Precinct 71706 Plate 8: 2009 Current August 2010	Project Address: Project Suburb/Location:	Owston Estate - Eastern Precinct Mulgoa	71706 August 2010	Plate 8: 2009 Current Ima
---	--	--	----------------------	---------------------------

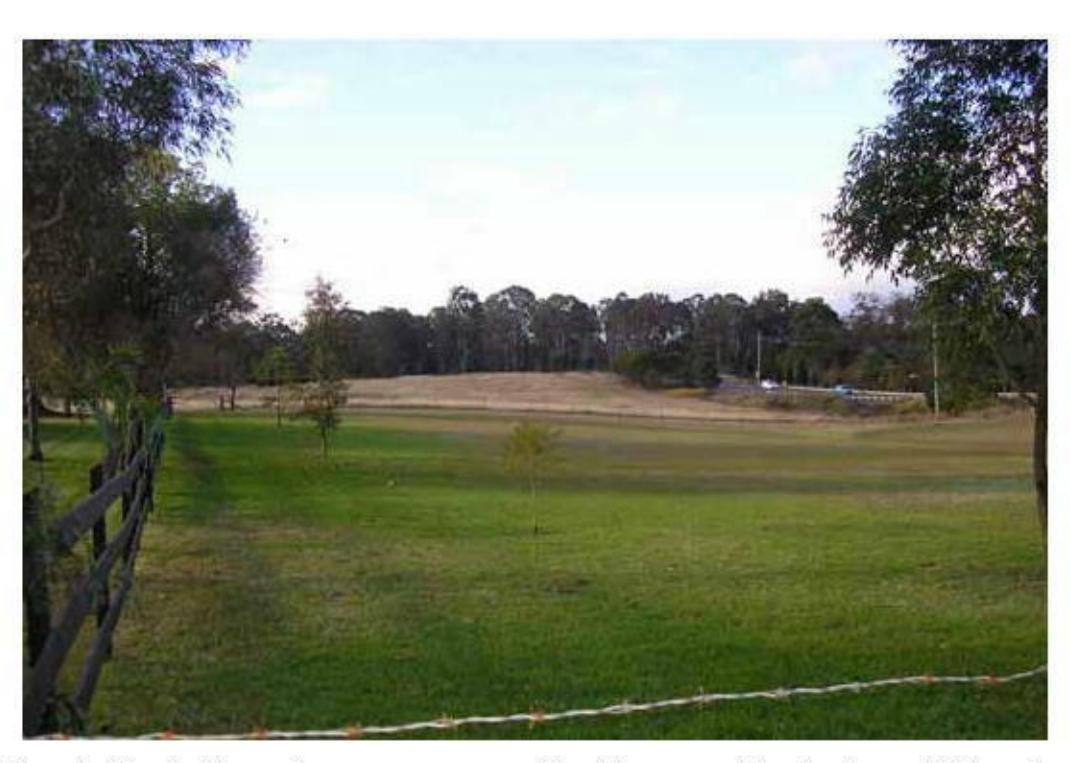
Photo 1 - View looking north across eastern part of Lot 1 between existing dwelling and Mulgoa Road

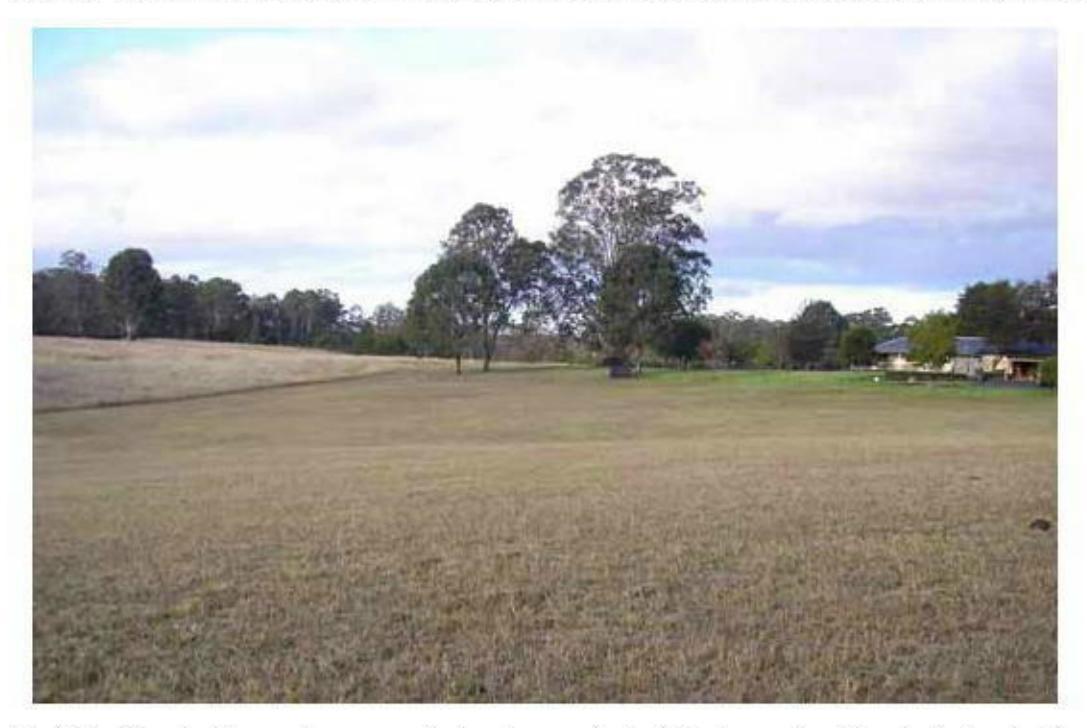
Photo 2 - View looking east across central eastern part of Lot 1 between Dam 1 and existing dwelling
