RE: OAKDALE WEST ESTATE – KEMPS CREEK, NSW GEOTECHNICAL INVESTIGATION

OAKDALE WEST ESTATE KEMPS CREEK GEOTECHNICAL INVESTIGATION

PSM1541-123R

NOVEMBER 2015

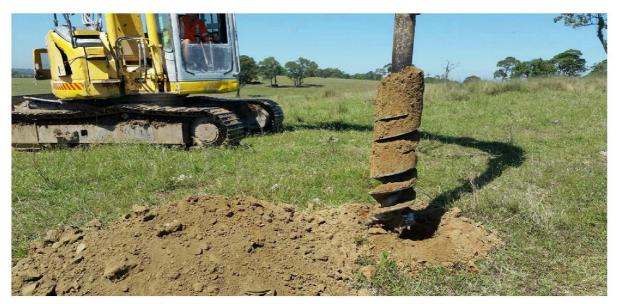
Photo 1: 14 tonne excavtor with pendulum auger at BH09 south

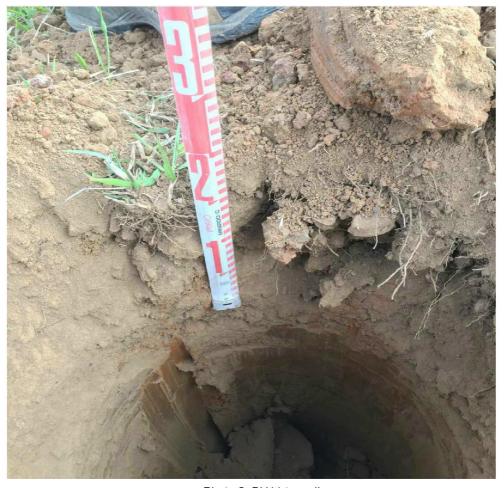
Photo 2: BH11 topsoil

- The depth of TOPSOIL unit across the site is between 0.1 m and 0.5 m.
- Due to the nature of the ground conditions, the BEDROCK unit may include layers with low strength (hard capping) overlying extremely low strength that may exhibit soil like properties.

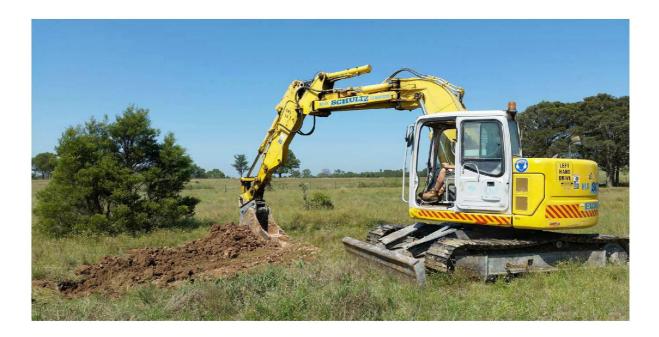
Photo 3: 14 tonne excavtor at TP13 looking south

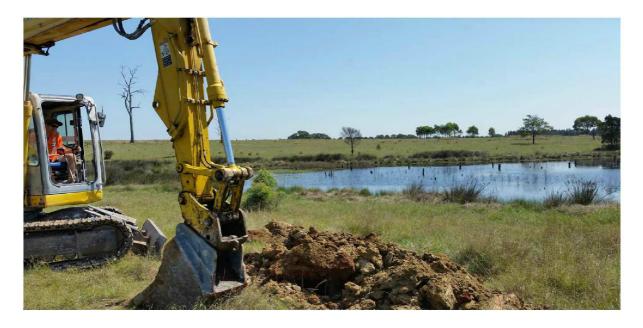
Photo 4: 14 tonne excavtor at TP14 looking north east

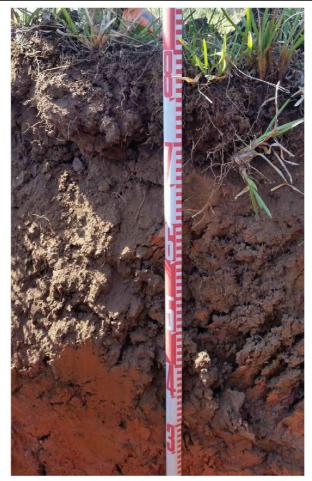
Photo 5: TP08 Topsoil

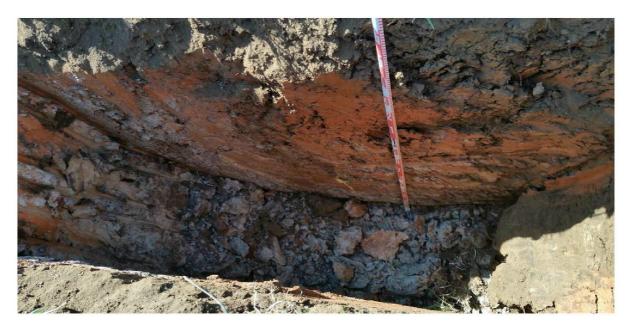
Photo 6: TP08 Profile

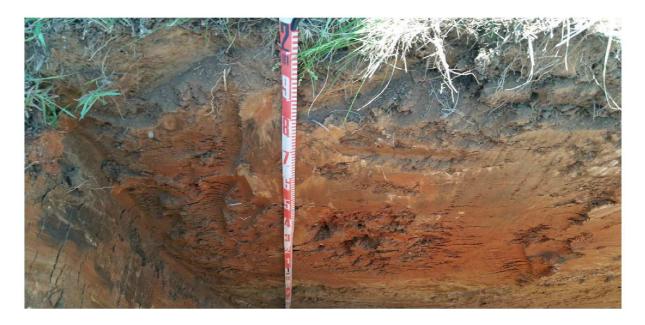
Photo 7: TP18 Profile

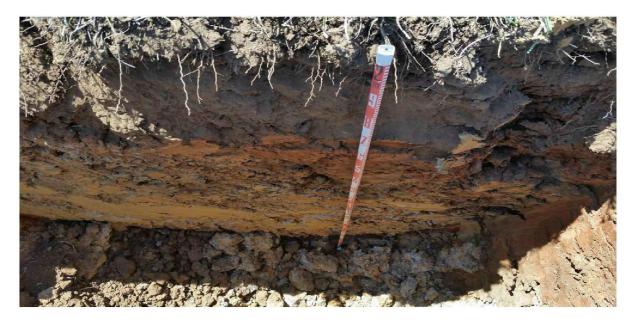
Photo 8: TP24 Profile

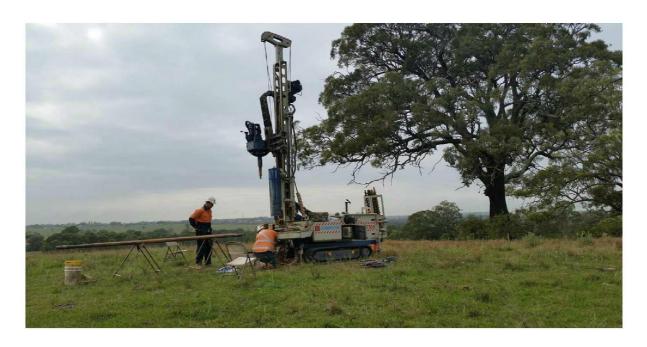
Photo 13: BH14 Drill rig set up looking east

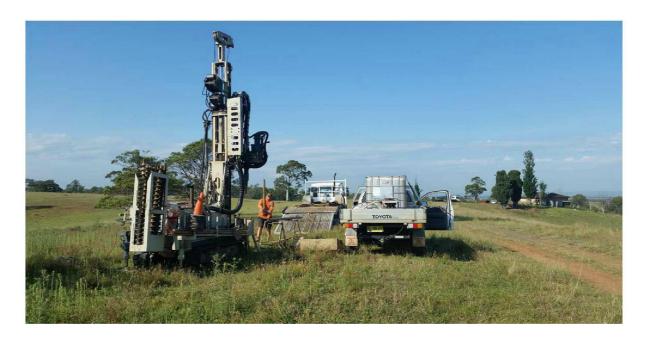
Photo 14: BH15 Drill rig set up looking south
