Maryland Development Company Pty Ltd  
Contamination Management Plan

Central Precinct and Dunheved Precinct,  
Llandilo NSW

24 January 2018  
43352/61064 (Rev 3)  
JBS&G

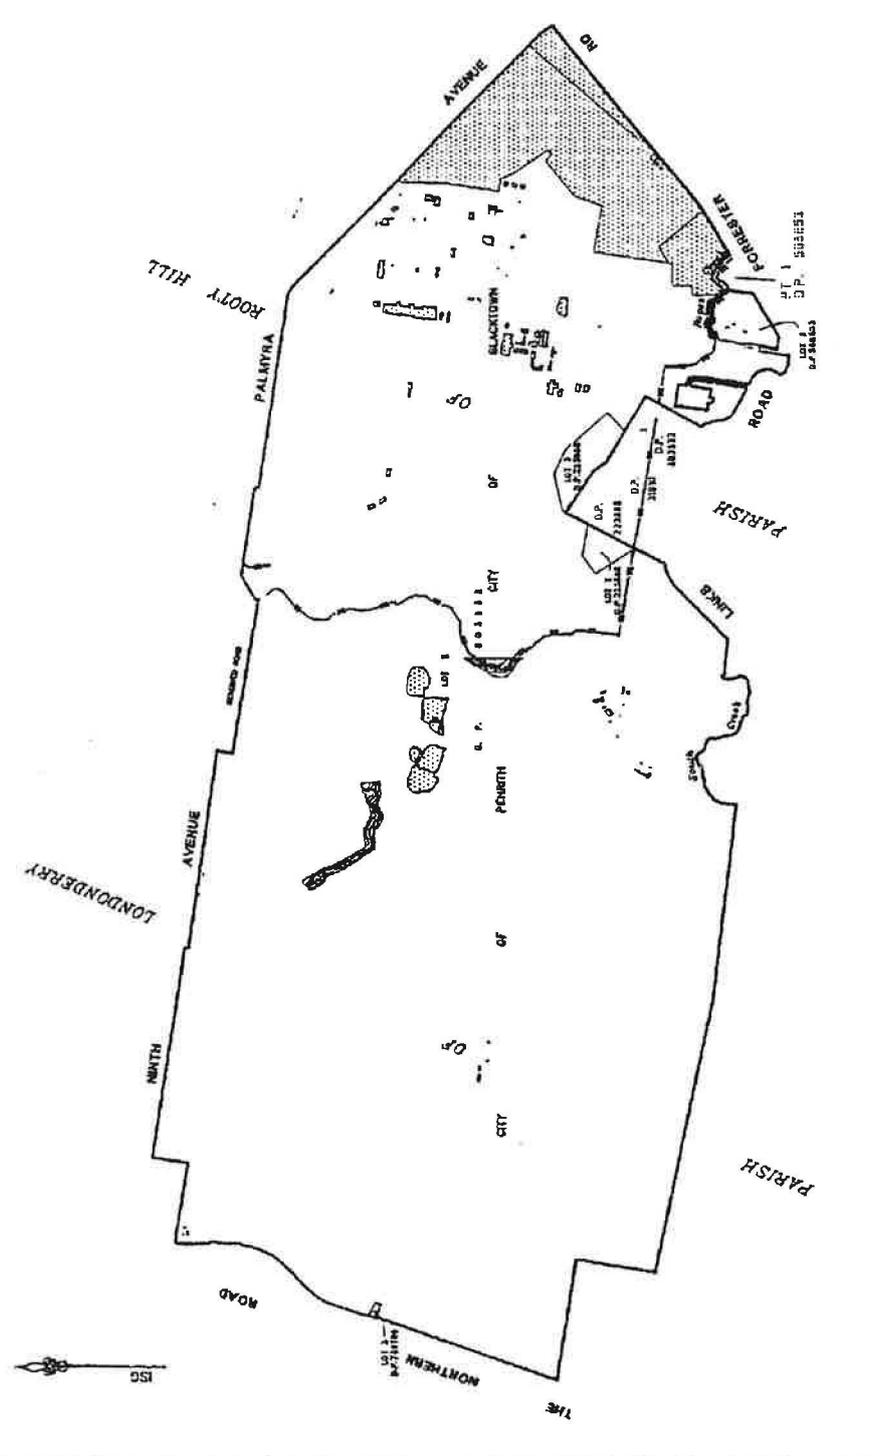
SHADED AREAS ARE EXCLUDED FROM  
 AUDIT STATEMENT CHK001/1

NOTE:  
 GEOMETRY SHOWN AS SUPPLIED BY ADI LIMITED TO DATE  
 OF ISSUE 10.3.1998  
 FOR SITE DETAILS ON EXCLUDED AREAS PLEASE REFER TO  
 DRAWINGS:  
 5467-123  
 5467-125  
 5467-126  
 5467-127  
 5467-128  
 5467-129  
 5467-130  
 5467-131  
 5467-132  
 5467-133  
 5467-134  
 5467-135
