Geotechnical Testing Services

Ground Technologies Pty Ltd

RE: Geotechnical Investigation at Panthers North Precinct, Mulgoa Road, Penrith NSW.

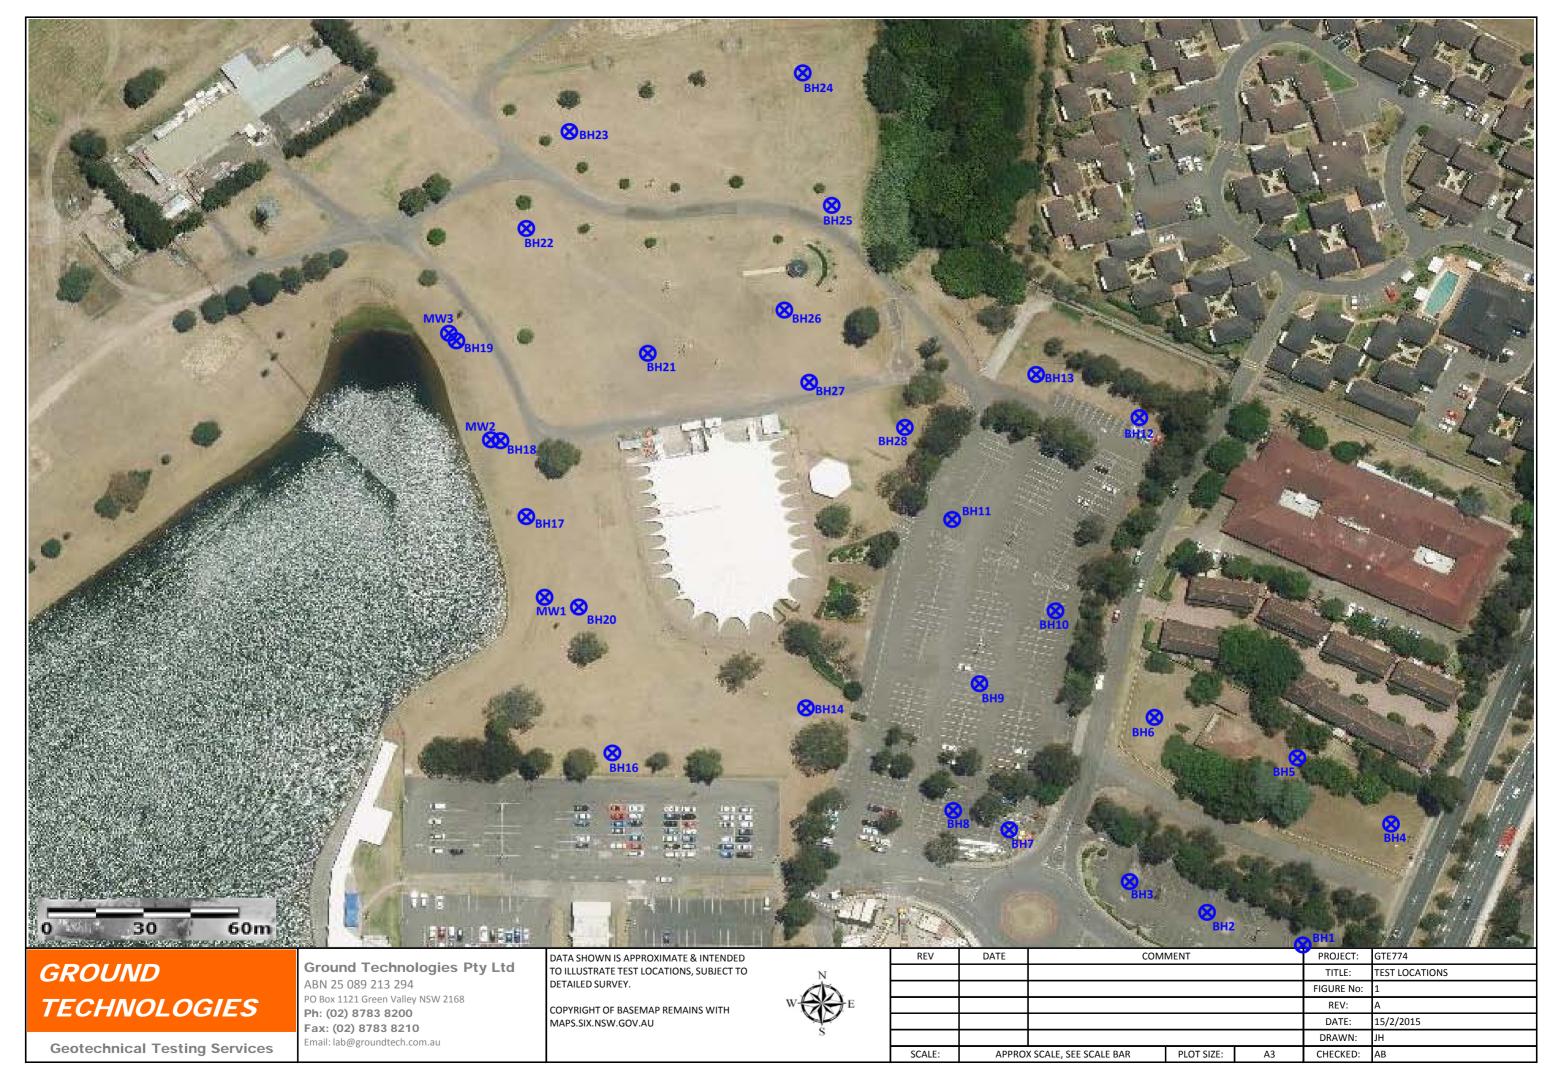
Figures

Fieldwork was undertaken between the 10th and 24th February 2016 and included drilling sixteen (16) boreholes using Ground Technologies 4WD Toyota Landcruiser Solid Flight Auger Drill Rig, and ten (10) boreholes using a track mounted Hanjin D&B drilling rig. Standard Penetration Testing (SPT) was undertaken within selected boreholes and three groundwater monitoring wells were installed. Borehole locations are shown on Figure 1 in Appendix A. Full borehole logs are supplied within Appendix B.

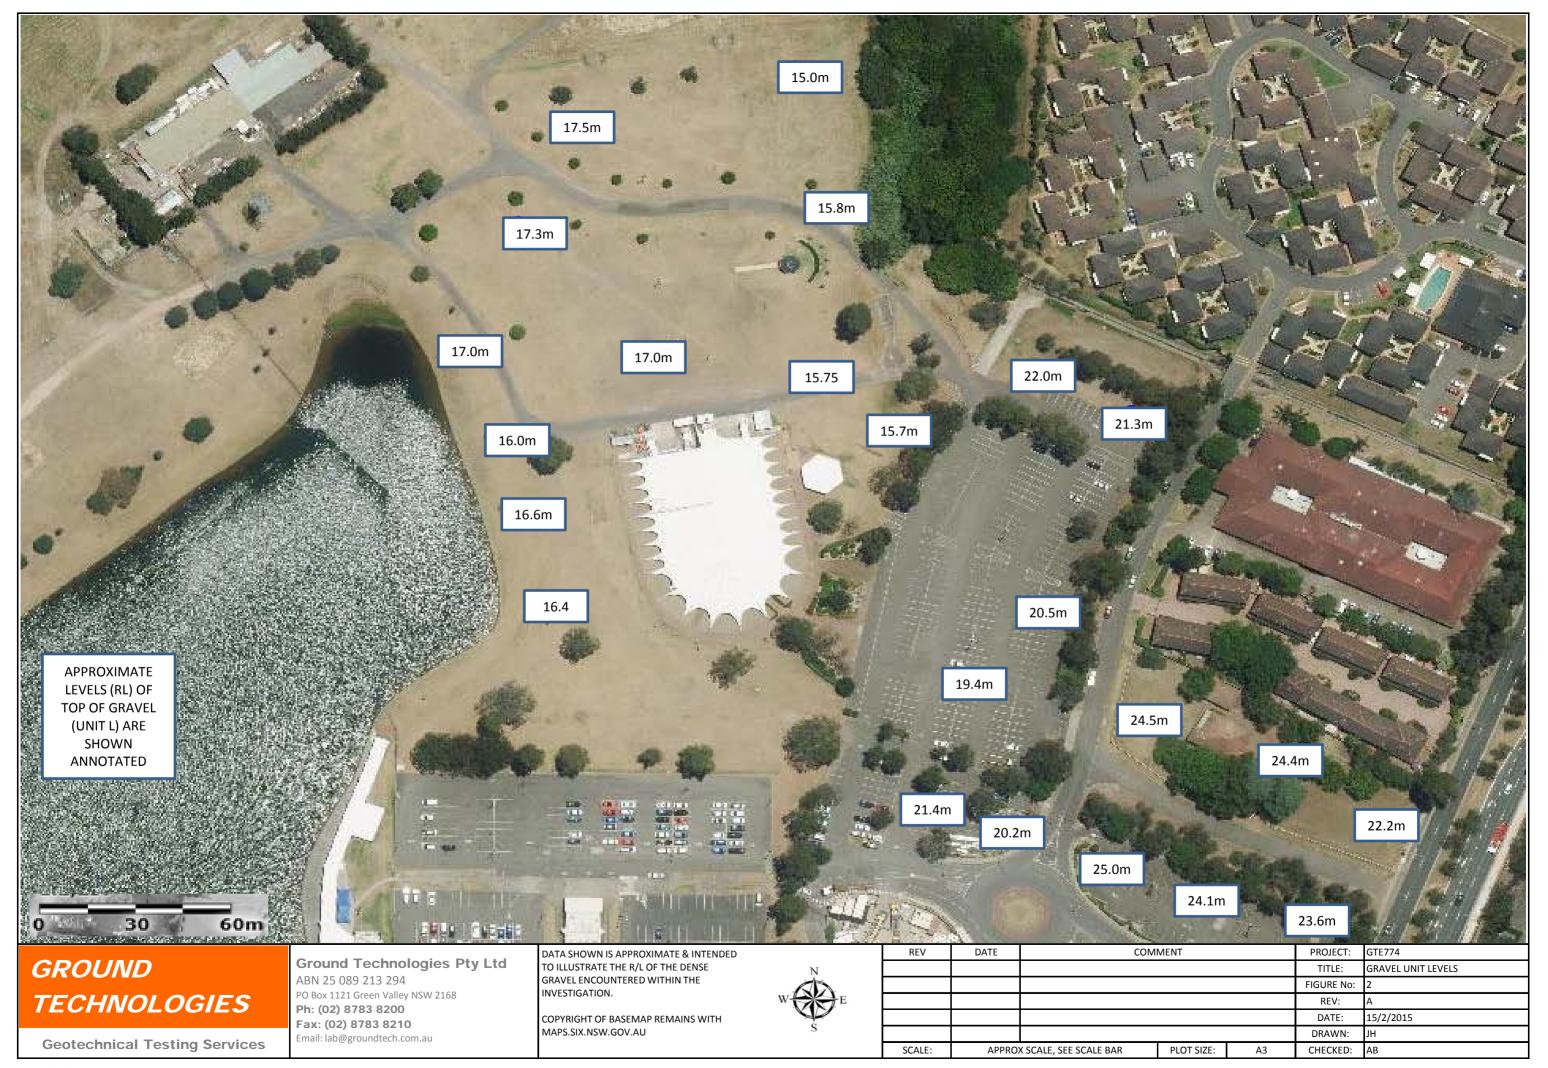
Given the potential for soft and saturated soils to be encountered within the natural sands and clays, it is anticipated that all significant loads from the super structure will be passed to the dense gravel (Unit L) as a founding stratum. The depth to this material is detailed in table 4 and levels in Figure 2 in Appendix A.

We recommend piled structures be founded on the dense gravel layer denoted as Unit L, detailed in Section 3.1 and table 4 of this report. As the natural gravel is a cohesionless material, the depth of overburden material exerting a surcharge on the foundation material will impact the end bearing capacity of the pile, as will the depth of groundwater. The design of foundation systems shall be proportioned using a maximum allowable bearing pressure in accordance with Table 8. It is advised based on local experience that it would not be practicable to socket piles greater than 1m depth into the dense gravel layer, as the larger gravels will jam the augers of drill rigs.

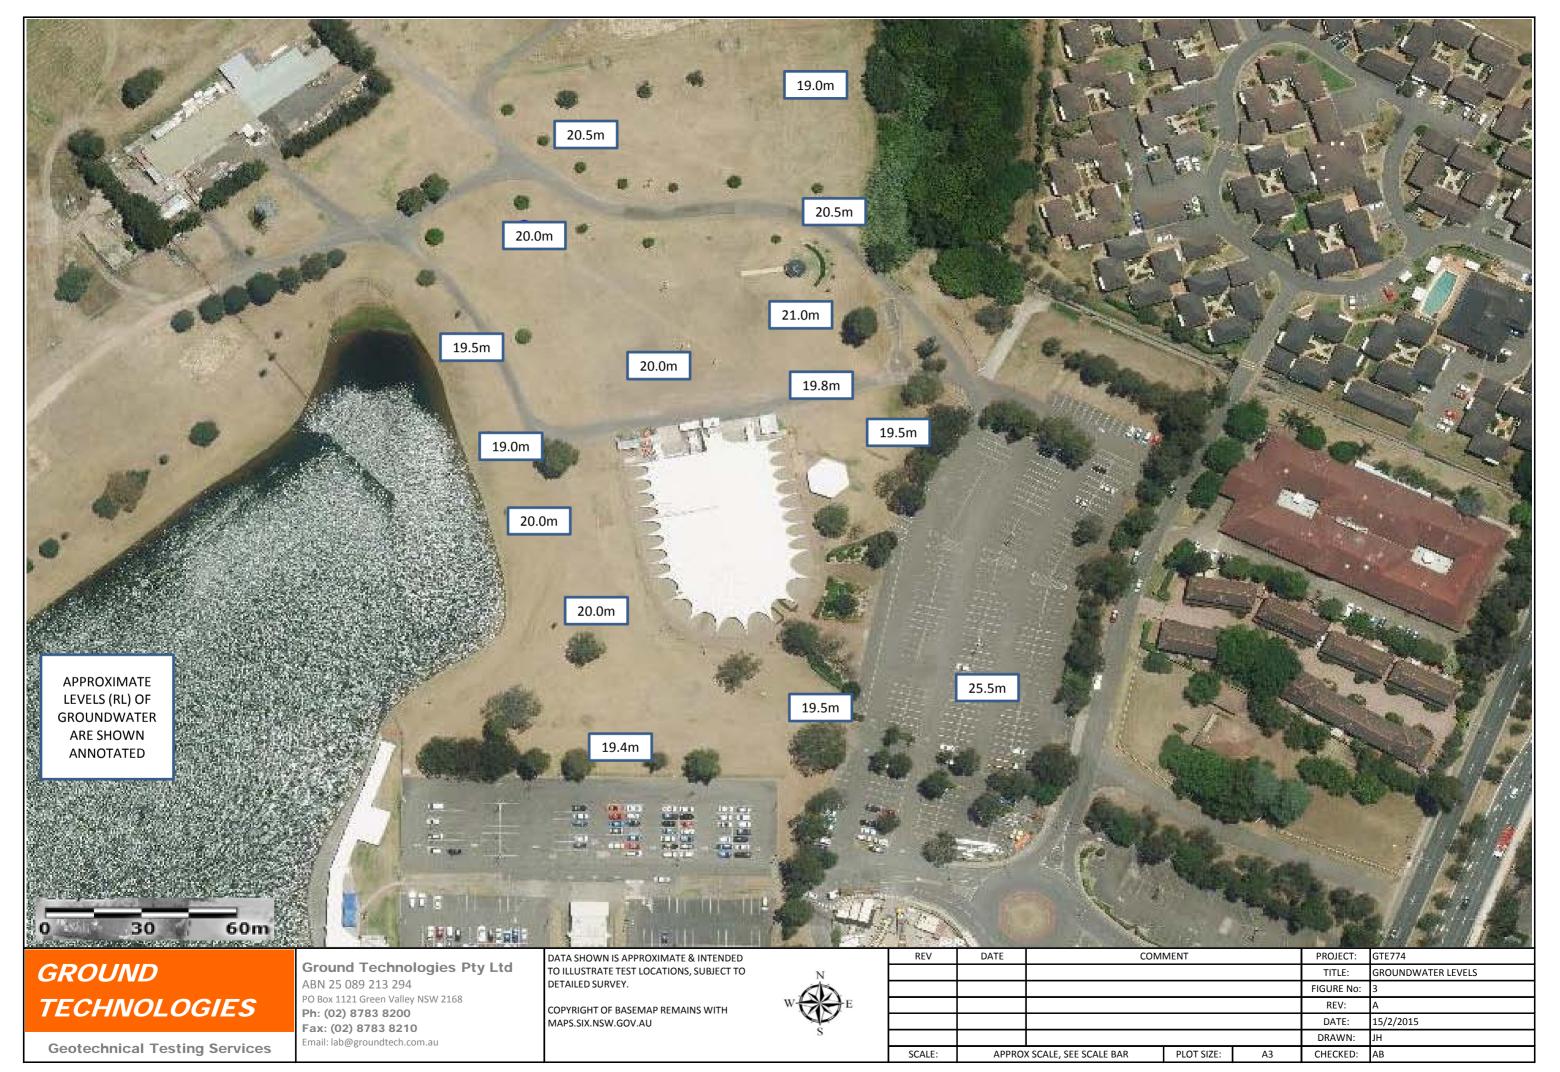
Groundwater was observed in only one borehole (BH9) on the eastern part of the site and in all boreholes in the western and north-western part of the site, at depths ranging from 5.0 to 6.5m below existing ground surface levels. The depth of Groundwater is detailed in table 5 and levels in Figure 3 in Appendix A.

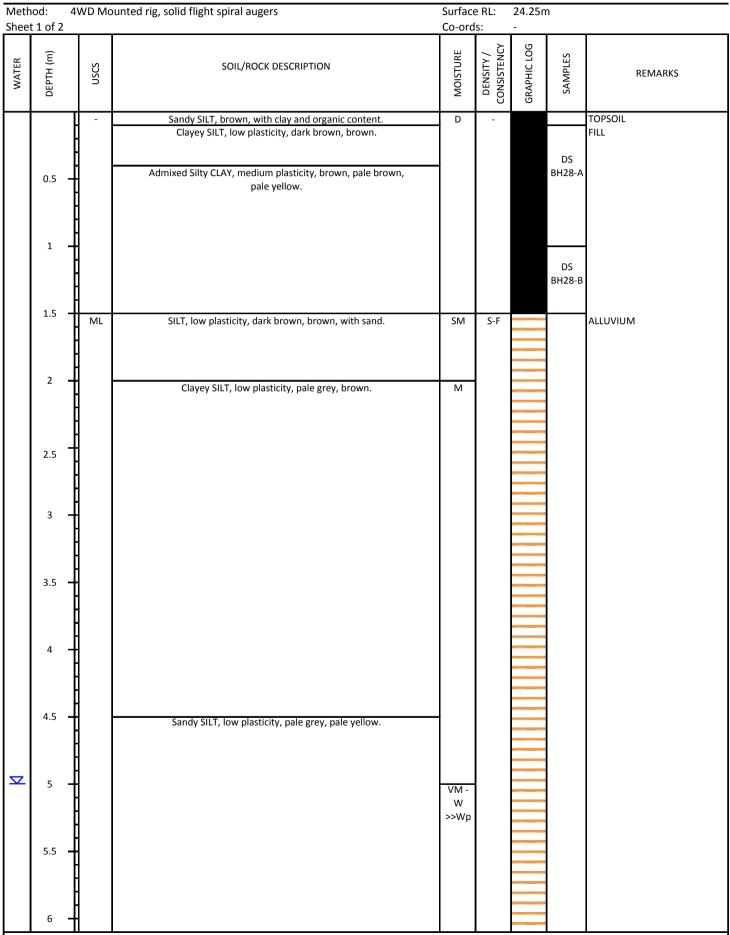
BH28

Project: No.: GTE774 Date of Drilling: 18/02/2016 Mulgoa Road, Penrith Location: Logged by:

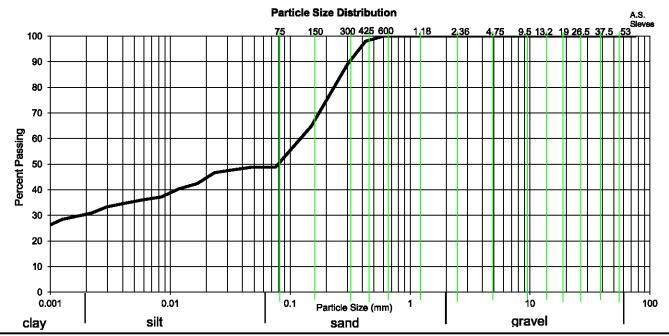
4.75 mm	100		Moisture (Content	%	AS1289 2.1.1	ND		
2.36 mm	100		Sample History:				Air Dried		
1.18 mm	100		Preparation Method:			Dry sieved			
600 um	100		Crumbling / Curling of linear shrinkage: NA				NA		
425 um	98		Linear shrinkage mould length:			NA			
300 um	89		ND = not determined NO = not obtainab			able NP = non plastic			
150 um	65		Notes	Dispersion:	mecha	nical / hydromter	: g/l		
75 um	49			Sampling : A	\S1289	1.2.1 (6.5.3)			
hydrometer values			Material pr	operties					
33 _{um}	48			GRAVEL (CONTE	ENT =	0	%	
17 um	42			SAND COI	NTEN	ſ =	52	%	
12 _{um}	40		SILT CONTENT =			18	%		
8 um	37			CLAY CON	NTENT	-	30	%	
6 um	36		_					_	
1 um	25

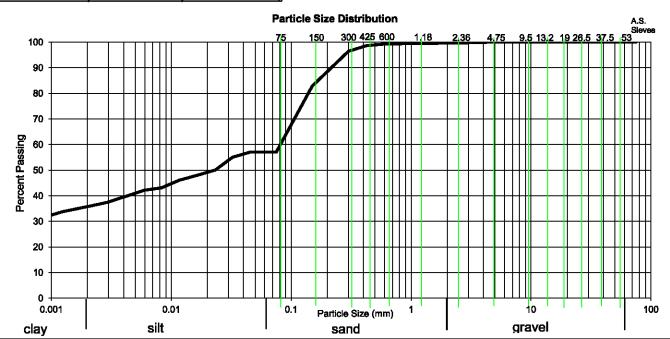
2.36 mm	100		Sample History:			Air Dried		
1.18 mm	100		Preparation Method:			Dry sieved		
600 um	99		Crumbling / Curling of linear shrinkage:			NA		
425 um	99		Linear shrinkage mould length:			NA		
300 um	96		ND = not determ	ble NP = non	plastic			
150 um	83		Notes Dispersion : mechanical / hydromter: g/l					
75 um	57		Sampling : AS1289 1.2.1 (6.5.3)					
hydrometer values			Material properties					
32 _{um}	55		GRAVEL CONTENT =			0	%	
17 um	48		SAND COI	43	%			
12 _{um}	46		SILT CONTENT =			21	%	
8 um	43		CLAY CONTENT =			36	%	
6 um	42							
l 1 um l	31

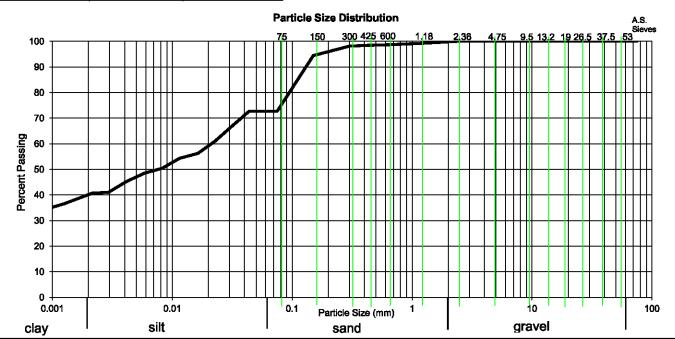
Particle Size D	Distribution	AS1289 3.6.3	Consistency Limits and Moisture Content				
Sieve Size	% Passing	Specification	Test		Method	Result	Spec.
19.0 mm	100		Liquid Limit	%	AS1289 3.1.2	ND	
13.2 mm	100		Plastic Limit	%	AS1289 3.2.1	ND	
9.5 mm	100		Plasticity Index	%	AS1289 3.3.1	ND	
6.7 mm	100		Linear Shrinkage	%	AS1289 3.4.1	ND	
4.75 mm	100		Moisture Content	%	AS1289 2.1.1	ND	
2.36 mm	100		Sample History:	Air Dried			
1.18 mm	99		Preparation Method:	Dry sieved			
600 um	99		Crumbling / Curling of line				
425 um	98		Linear shrinkage mould le	NA			
300 um	98		ND = not determ	ıble NP = non	plastic		
150 um	94		Notes Dispersion:	: g/l			
75 um	73		Sampling : AS1289 1.2.1 (6.5.3)				
hydrometer values			Material properties			_	
32 _{um}	67			GRAVEL CONTENT =		0	%
16 um	56		SAND COI	27	%		
11 um	54		SILT CON			33	%
8 um	50		CLAY CONTENT =			40	%
6 um	48						
1 um	34
