Regional Basin I

Surface Water Quality

June 2018

Lendlease

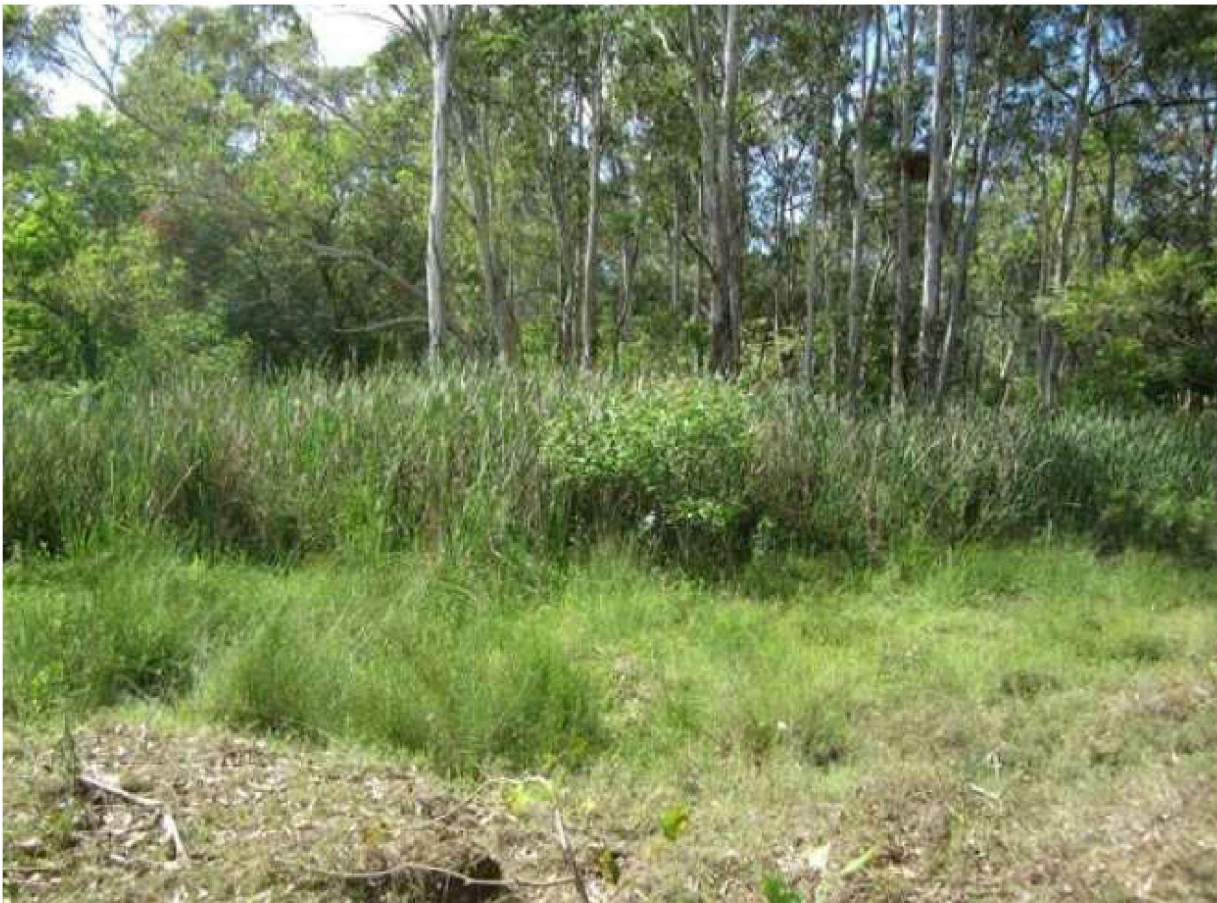
Plate 1 – Basin I location – Weedy Freshwater Wetland (Cumberland Ecology, 2017)

Downstream at the unnamed waterway adjacent to Basin I, the unnamed tributary is classified as Type 2 – moderately sensitive fish habitat (DPI 2013) as it is a fourth order stream with a defined channel, and the provision of some instream habitat including overhanging riparian vegetation and instream woody snags limited instream habitat (Plate 1).
