**RE: OAKDALE WEST ESTATE – KEMPS CREEK, NSW
GEOTECHNICAL INVESTIGATION**

OAKDALE WEST ESTATE KEMPS CREEK GEOTECHNICAL INVESTIGATION

PSM1541-123R

NOVEMBER 2015

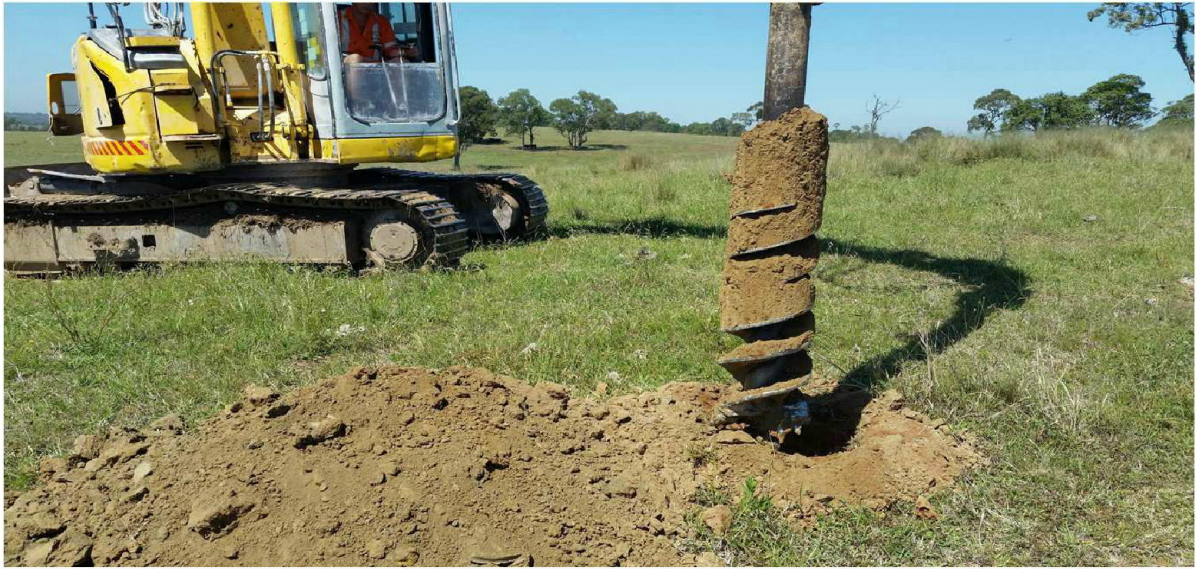
Photo 1: 14 tonne excavator with pendulum auger at BH09 south

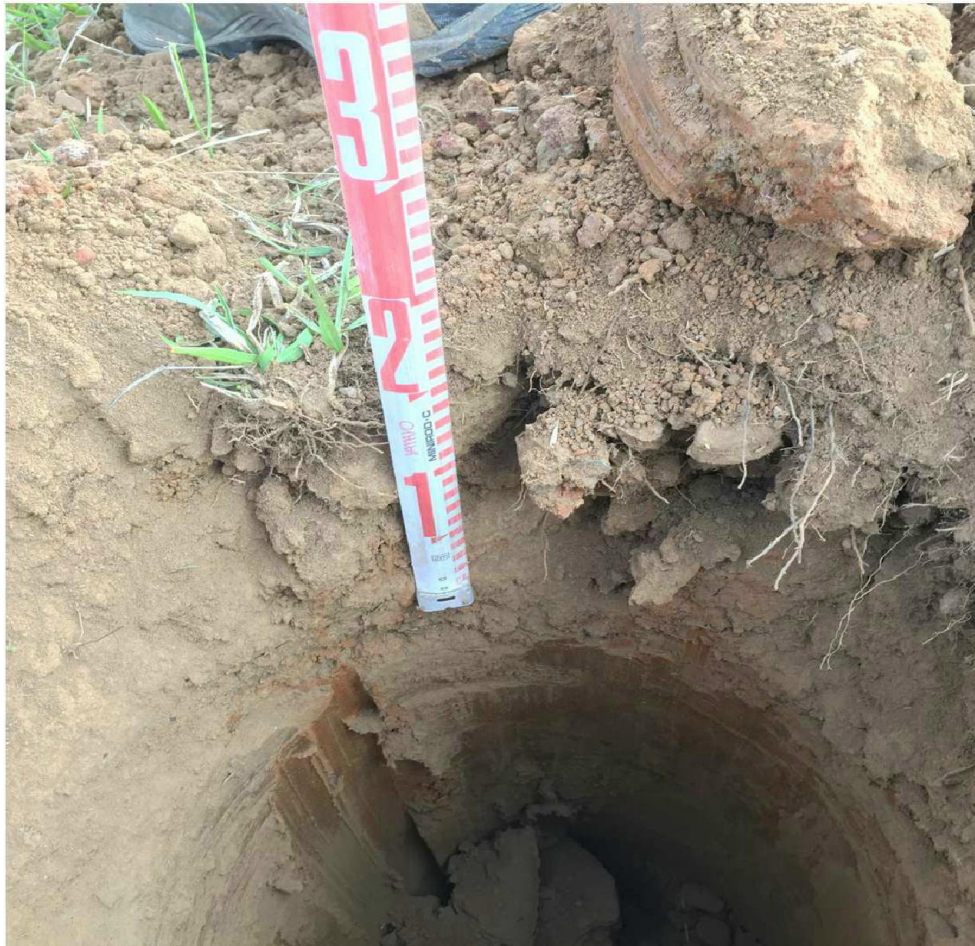
Photo 2: BH11 topsoil

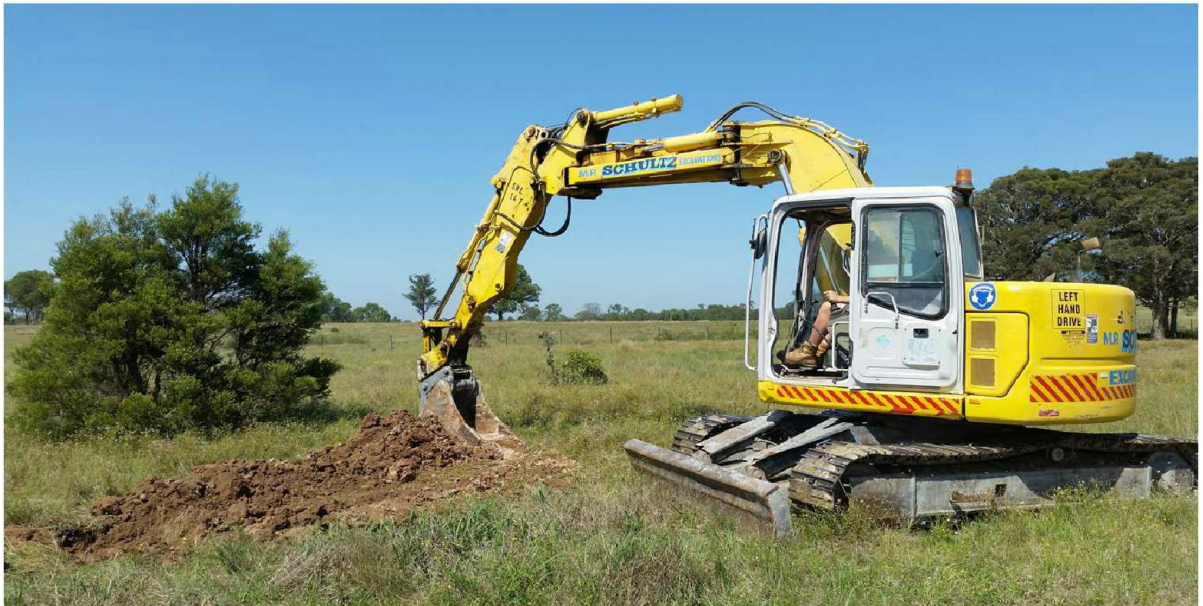
Photo 3: 14 tonne excavator at TP13 looking south

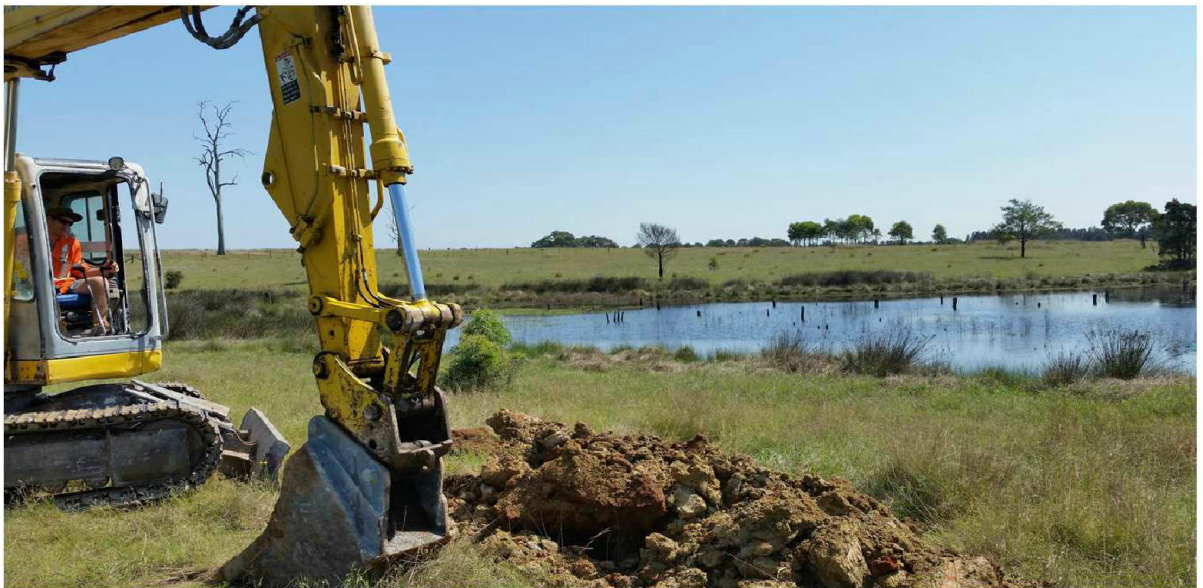
Photo 4: 14 tonne excavator at TP14 looking north east

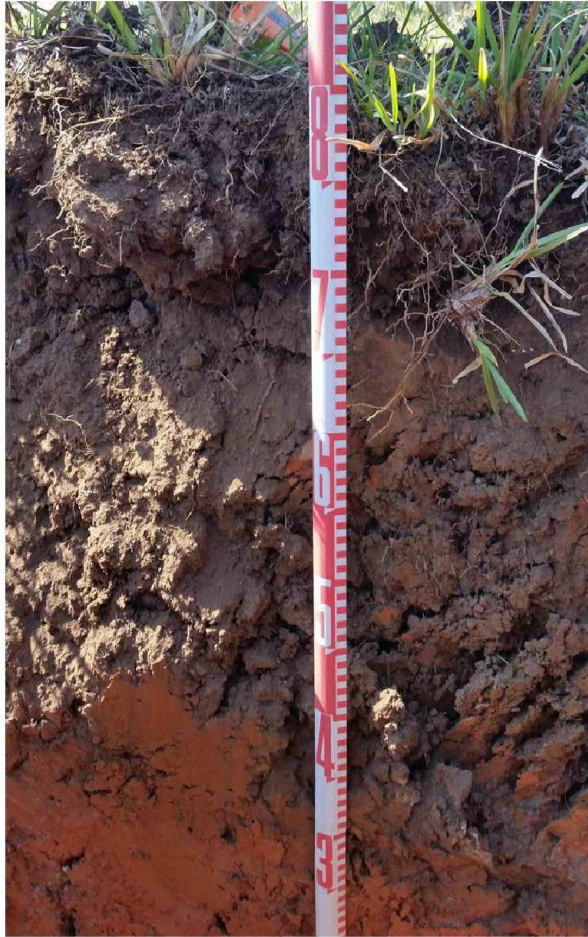
Photo 5: TP08 Topsoil

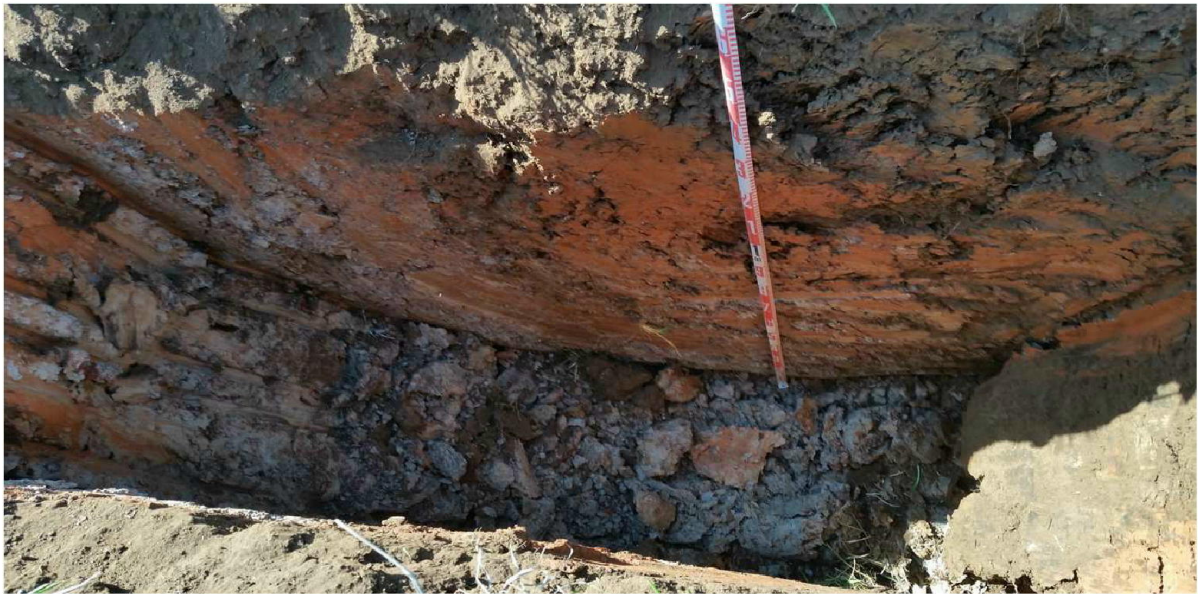
Photo 6: TP08 Profile

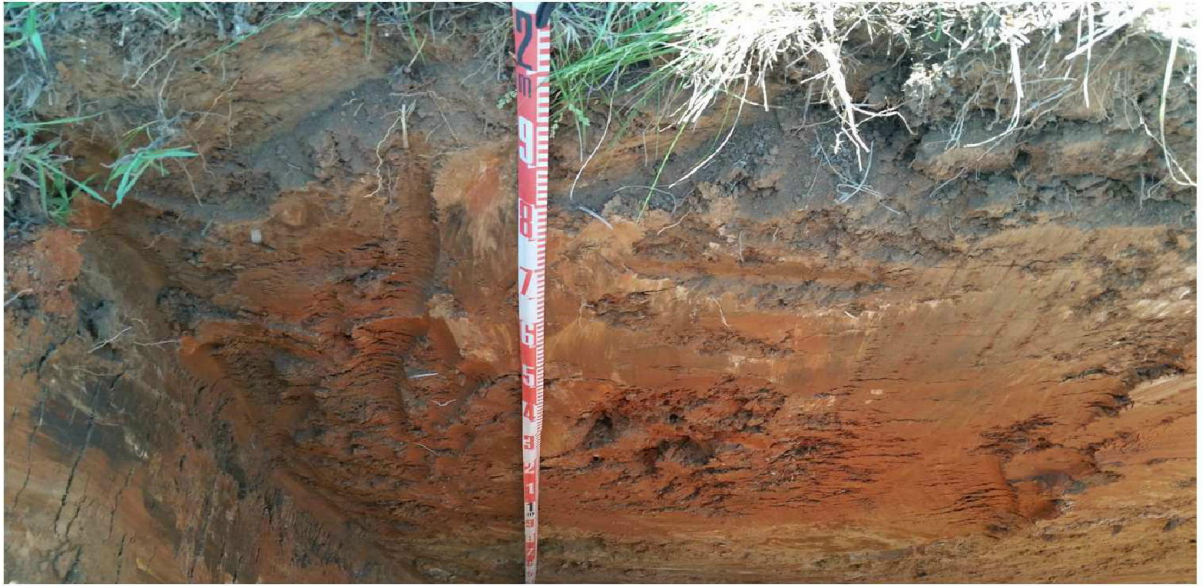
Photo 7: TP18 Profile

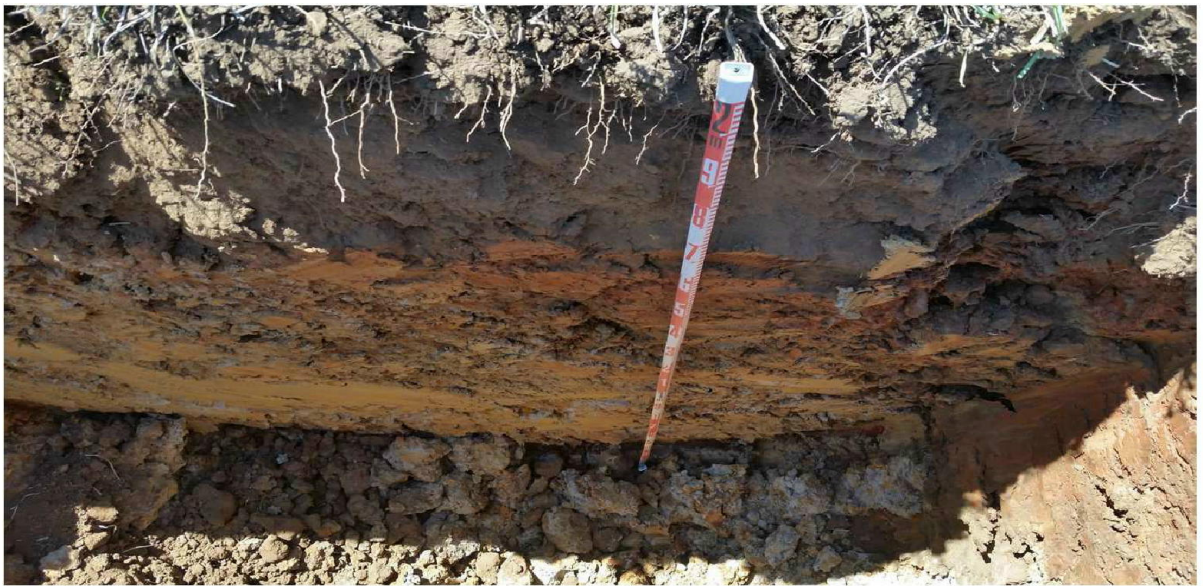
Photo 8: TP24 Profile

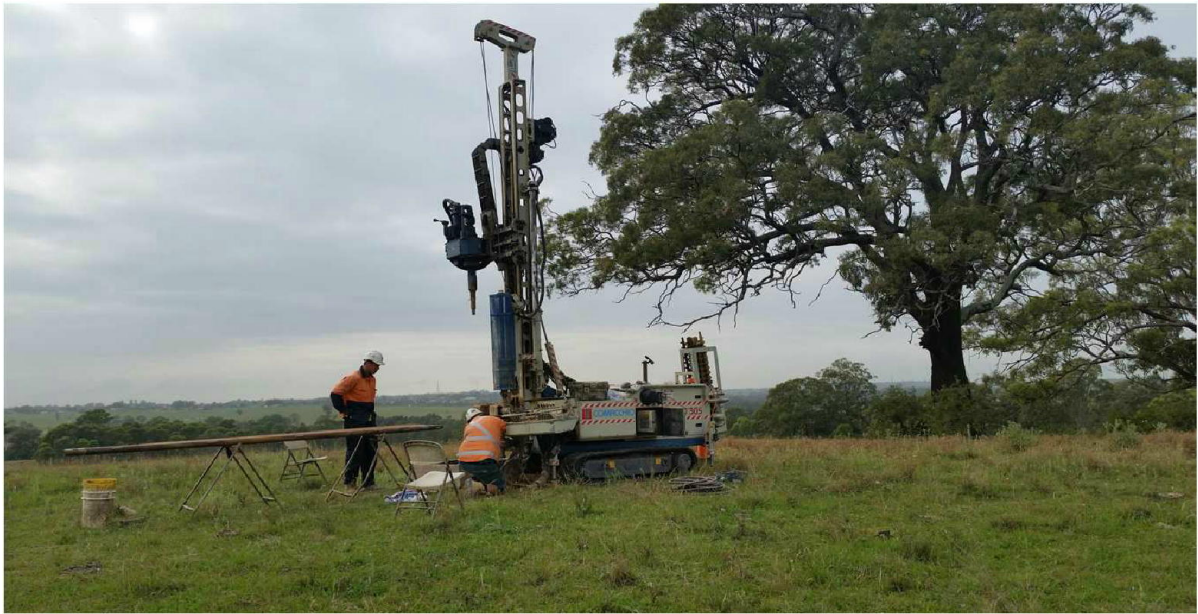
Photo 13: BH14 Drill rig set up looking east

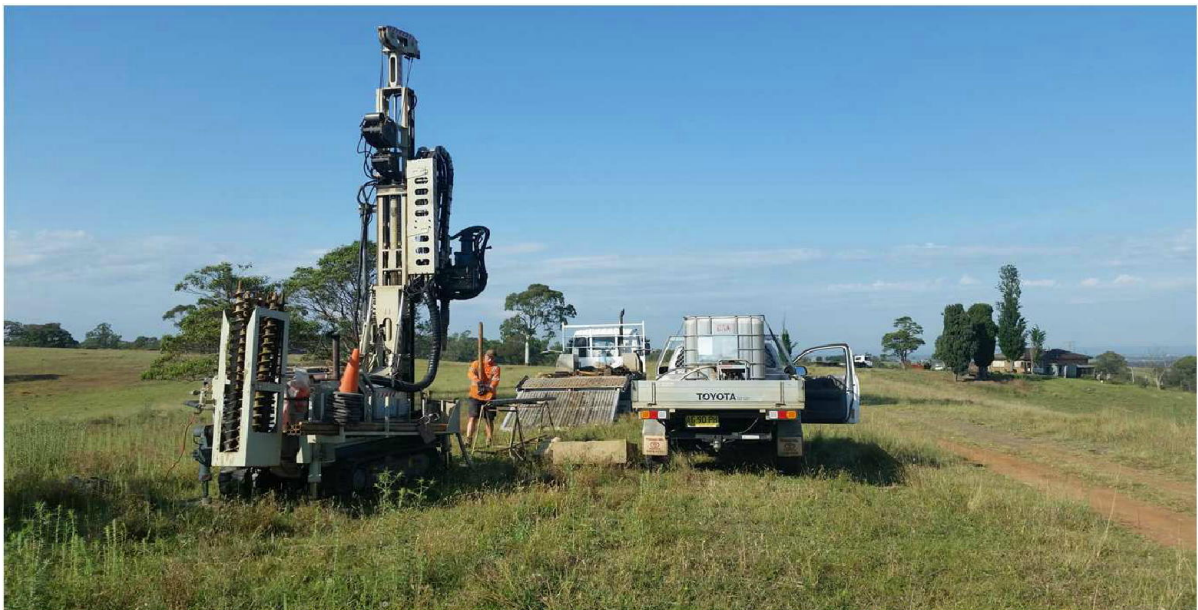
Photo 14: BH15 Drill rig set up looking south
