GEO TECHNIQUE PTY LTD

Job No: 12337/1
Our Ref: 12337/1-AB
21 October 2010

re: **United Service Station
Londonderry Road, Cranebrook
Geotechnical Investigation – Wastewater Management**

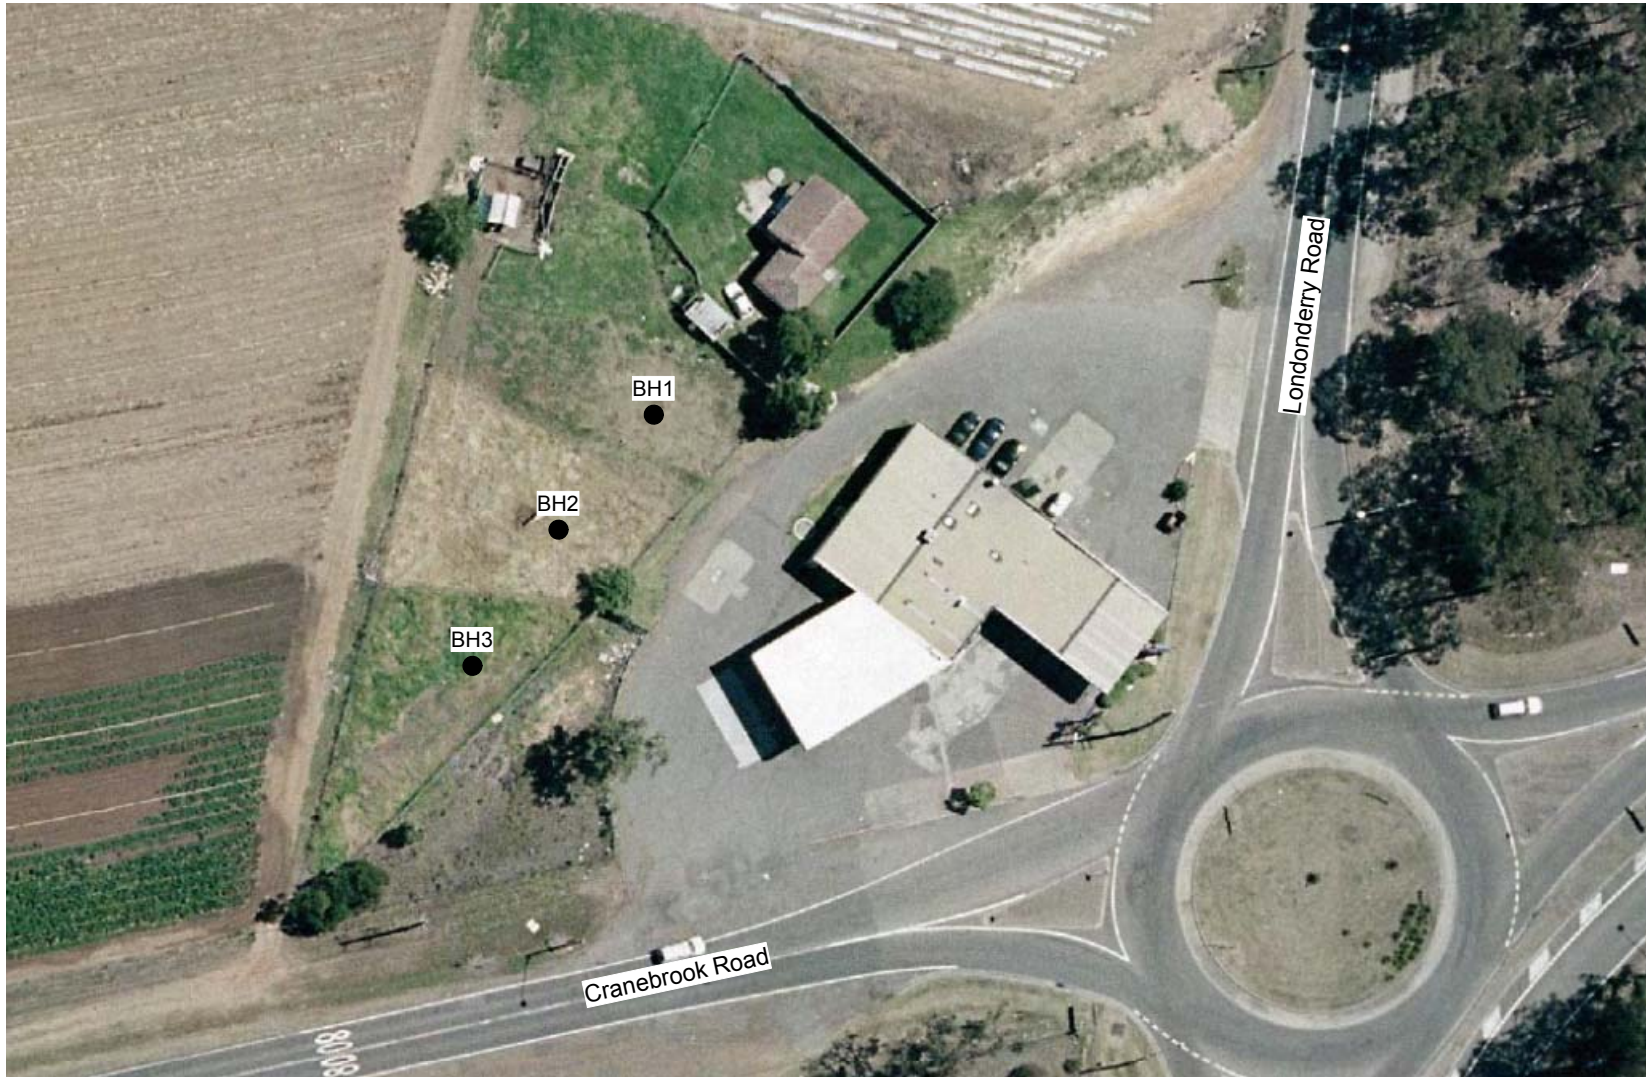
Borehole Location Plan

● Borehole

- A walk over survey of the site to assess existing surface conditions.
- Drilling three (3) boreholes using a bobcat equipped with an auger. The boreholes were terminated at about 2.5m on bedrock. The approximate borehole locations are indicated on the attached Drawing No 12337/1-1. The borehole logs are also attached.
- Three (3) Dynamic Cone Penetration (DCP) tests were conducted adjacent to drilled boreholes to assess strength characteristics of sub-surface soils. These results are shown on the borehole logs.
- Recovery of representative soil samples for visual assessment and laboratory testing.
- Measuring depths to groundwater level or seepage in test pits, where encountered.
