CONSERVATION MANAGEMENT PLAN

AUSTRALIAN ARMS HOTEL, PENRITH

Mark Bullen Architects Pty Ltd

30 June 2020

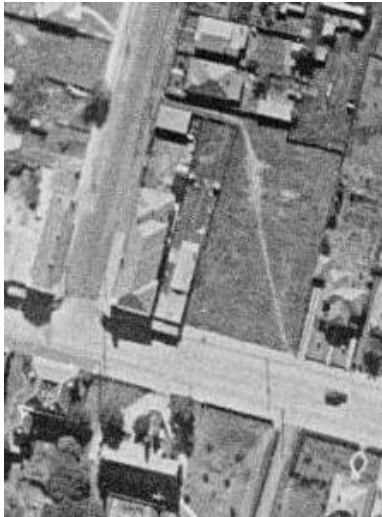
Figure 5: Aerial view of the hotel site and surrounds in 1943, showing the hotel and outbuildings, with another building and an empty lot to the east of the hotel.

An aerial view of the site in 1943 shows the hotel roof and at the rear, on the northern boundary along the laneway, another roof of an outbuilding of unknown purpose (possibly a garage). A very small structure also appears to be situated on the eastern boundary between the hotel and the larger outbuilding. The properties to the east of the hotel appear to be completely separate from the hotel site.

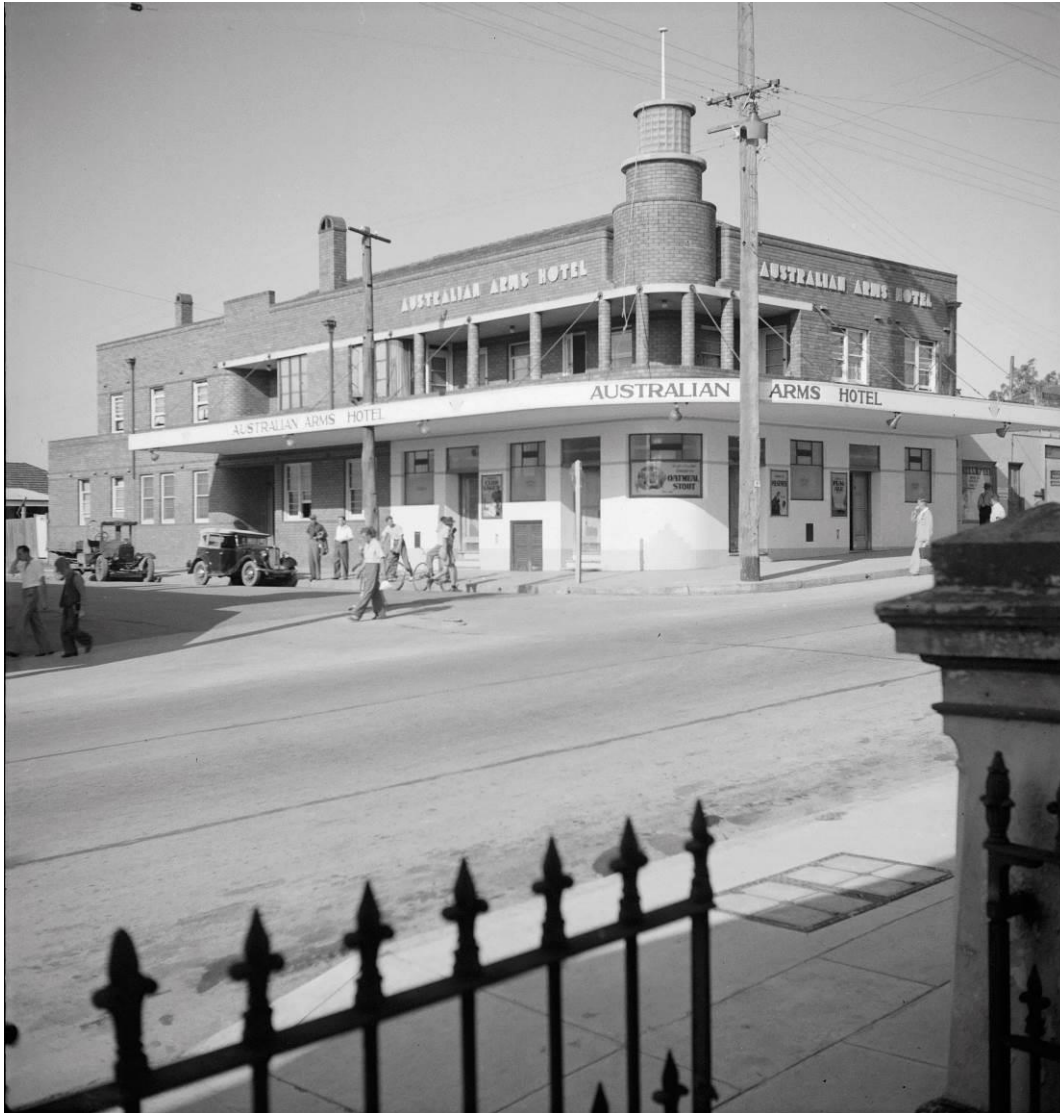
Figure 6: View of hotel taken by Max Dupain c. 1940s
Image courtesy of Mitchell Library, State Library of New South Wales, Max Dupain Exhibition
Negative Archive, File FL7649956

The photographs provide invaluable evidence of the appearance of the hotel in the first decade of its existence. They reveal that the hotel at that time had another two entrances on Lawson Street where there are now windows, and that there were two timber framed windows where there are now metal louvres. The walls around the corner are light in colour. The finish is not discernible but is likely to have been tiles, as a slightly darker band of tiles at low level stepping up to a pyramid shape on the corner can be seen. Two of the photographs also show that on Lawson Street there appears to have been no additional structures immediately to the north end of the building but a little farther away is what may have been the outbuilding whose roof appears in the 1943 aerial view. A fence (possibly paling) runs along the Lawson Street boundary where there is now a low brick wall.

The photographs confirm that, with the exception of the treatment of openings on Lawson Street, the present building appears largely as it did in the 1940s.

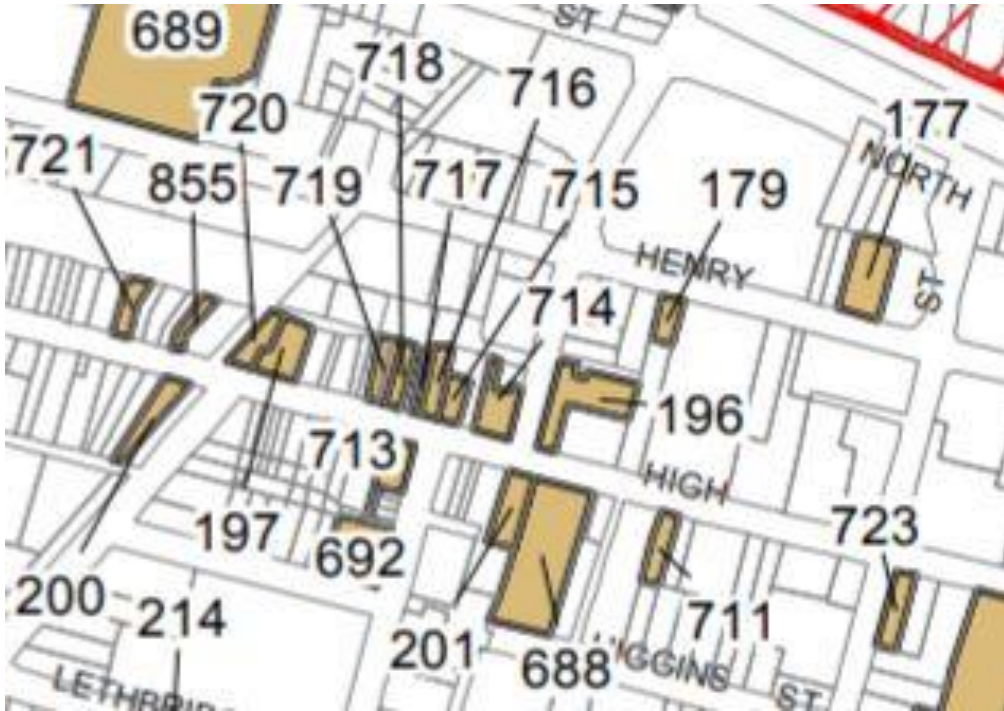
Figure 9: Heritage items in vicinity of Australian Arms Hotel (No. 196).
 Source: Penrith Local Environment Plan 2010, Heritage Map HER 013.

There are a number of local heritage items in the vicinity of the hotel, including shops, churches and banking premises. These are identified at Figure 9, which shows their item numbers in the Penrith Local Environment Plan 2010. West of the hotel, on the other corner of Lawson and High Streets, is the shop at 361-365 High Street (No. 714) which comprises a mid-Victorian structure which has had a deco inspired façade added in the 1940s. Opposite the hotel on the south side of High Street is Cram Place, as well as a coach house, well, pump and cast iron fence (No. 201). This former branch of the Commercial Banking Company was built in 1879 and “demonstrates a high quality commercial premises... and an important phase in the development of the town.”²⁰ Directly to its east is St Nicholas of Myra Catholic Church (No. 688). The church is one of the earliest extant modern buildings in this part of Penrith and there are historic items, including memorials and early electric lamp stand, on the site, which comprises land donated in the 1830s.

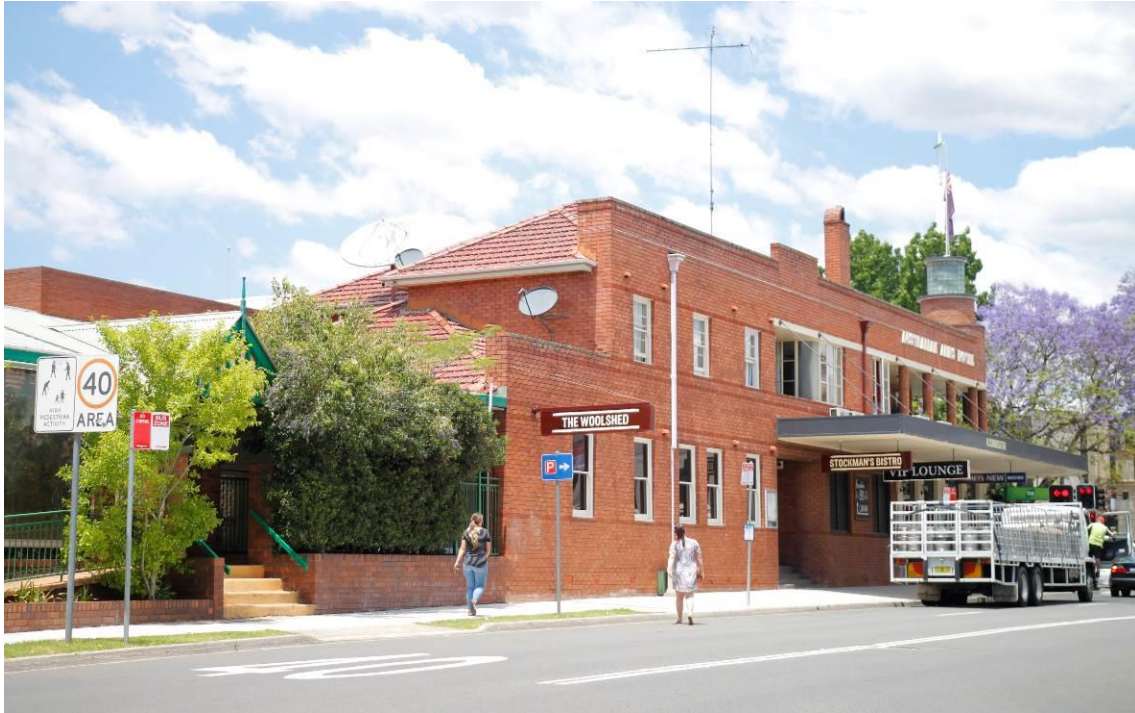
Figure 27: Lawson Street view showing roofscape and beer garden gable

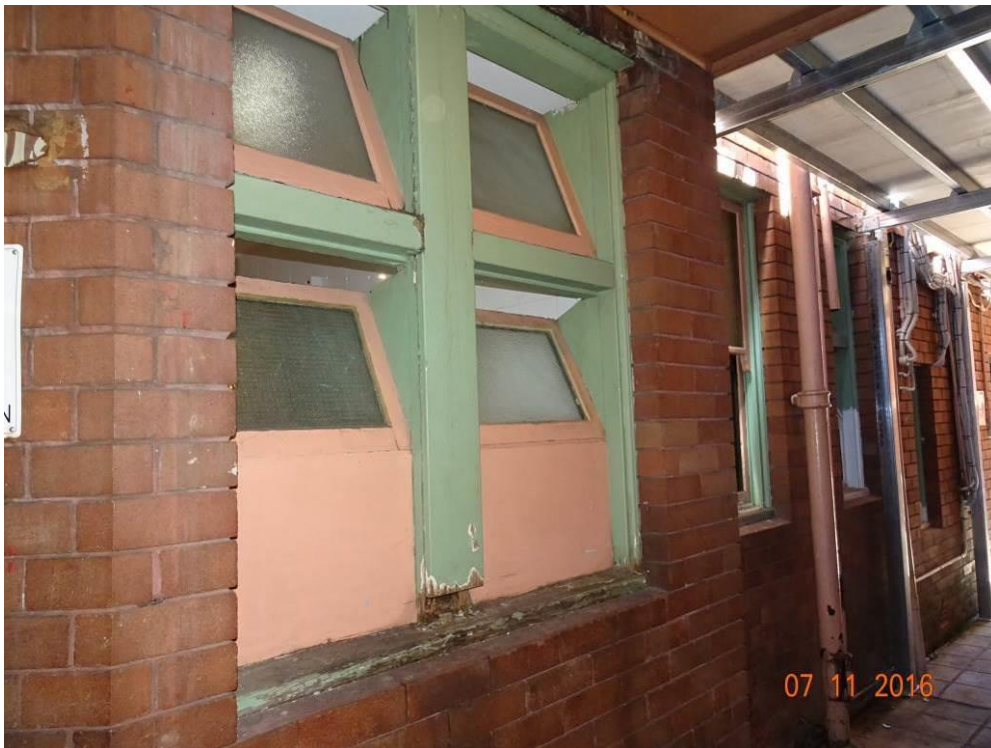
Figure 30: Ground Floor Eastern side showing windows to toilets and services pipework

There is some accretion of other modern fixtures on the façade and roof. Electrical items include cable conduits, faux coach lamps and the illuminated hotel signs. A television antenna, satellite dish and air conditioning plant on the roof are visible from the street. The eastern passageway has a vast accumulation of service pipes, conduits and the like.

Maintenance, including repointing of deteriorated mortar to match original, and painting of timber, is recommended. Removal of surface-mounted services visible from the street would be desirable. Existing garden plantings have no heritage value but, if retained, their maintenance and rejuvenation with advice from a conservation landscape architect is suggested.

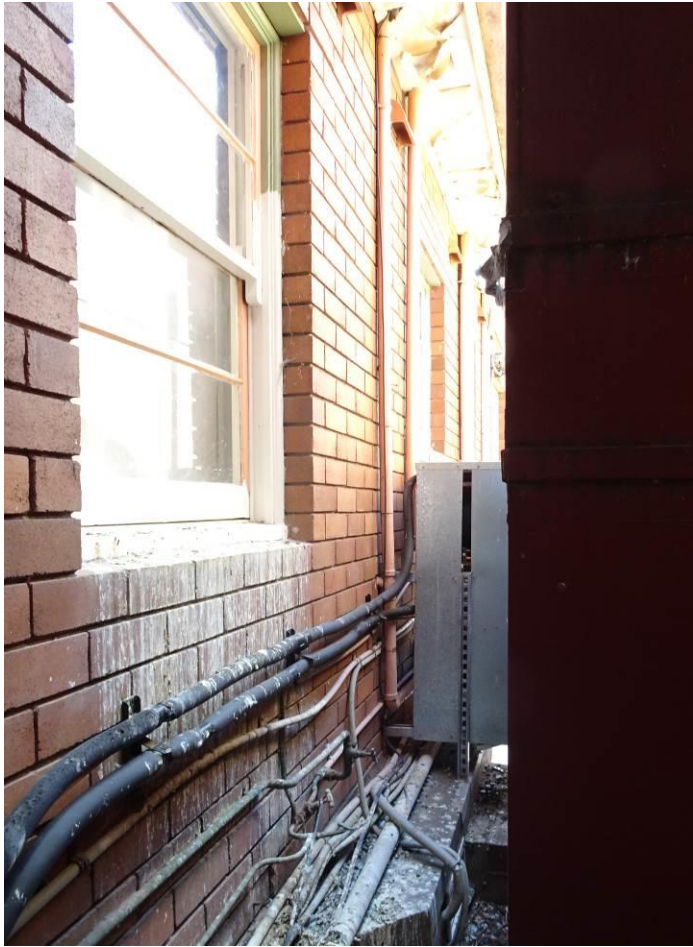
Figure 31: First Floor Eastern side showing services pipework

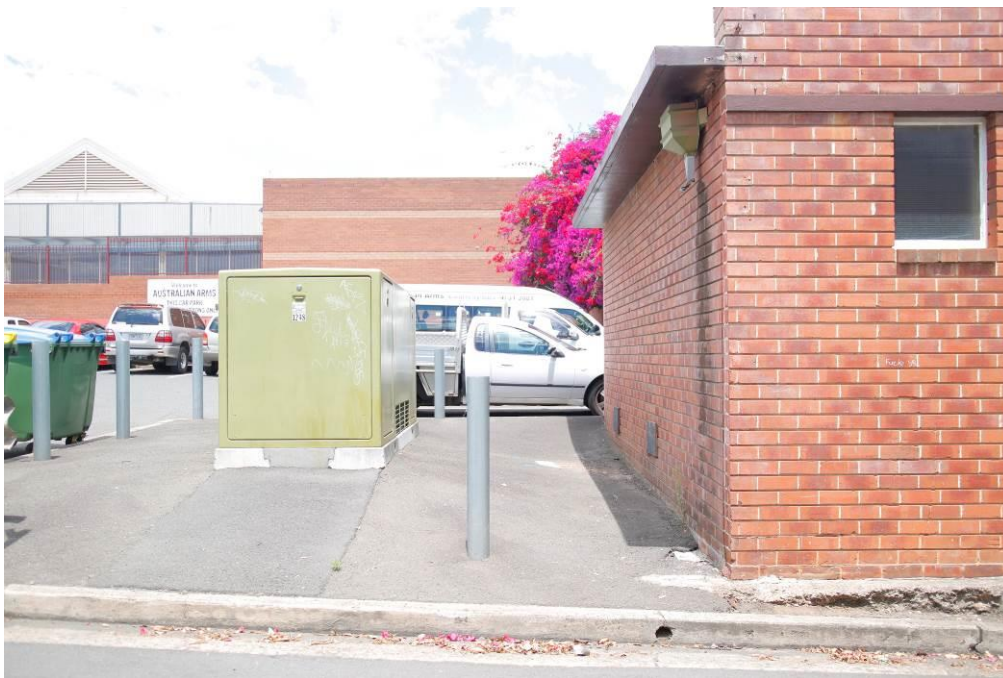
Figure 34: View of substation outbuilding and car park at rear of hotel

The remainder of the site comprises a bitumen car park accessed via the laneway. It is bounded by guard rails on the laneway and other buildings to the south and east. The beer garden can be accessed from the western side of the car park.

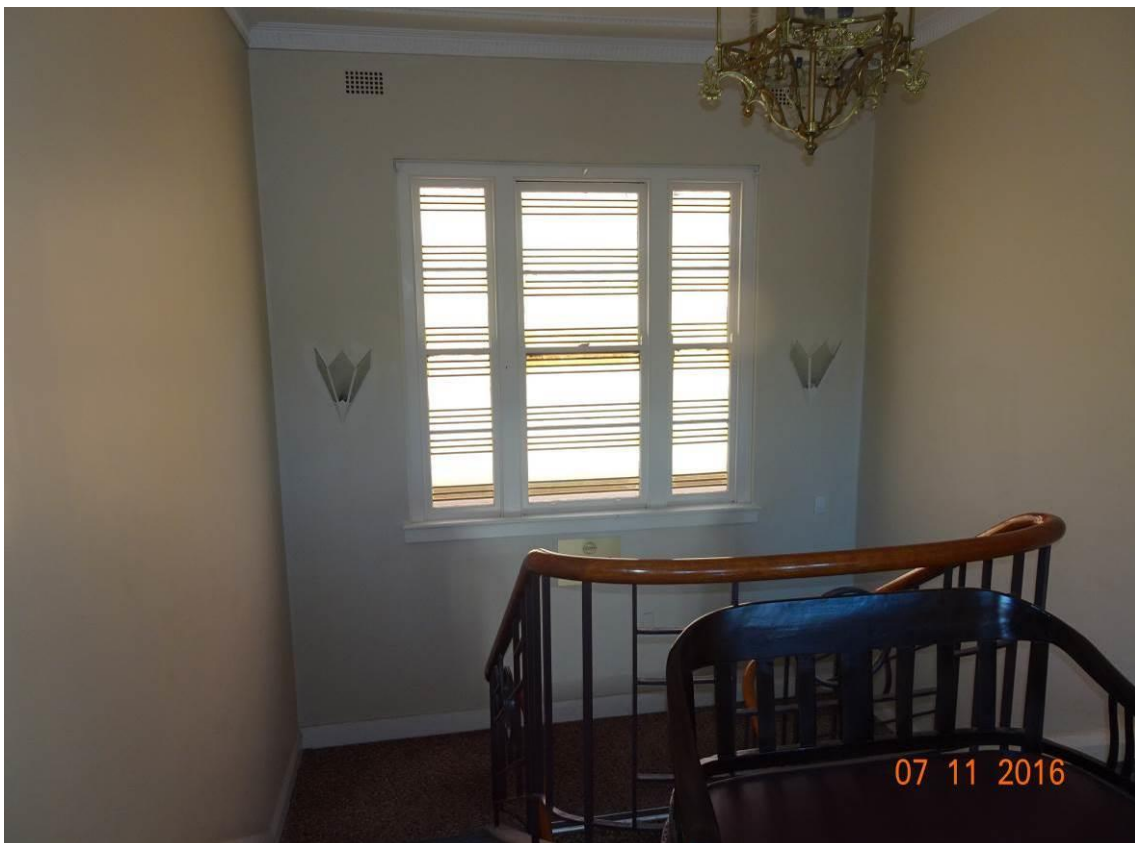
Figure 40: View of stair handrail, mid landing and window from First Floor

Most of the ground floor interiors, particularly in the bar and gaming room, have been altered since the hotel was first built. Ceilings have been replaced to accommodate services and false partitions installed. The framed and glazed doors at the northern end of the dining room have likely replaced the original brick façade. Only the curved walls and the lobby staircase remain representative of the building's Art Deco origins.

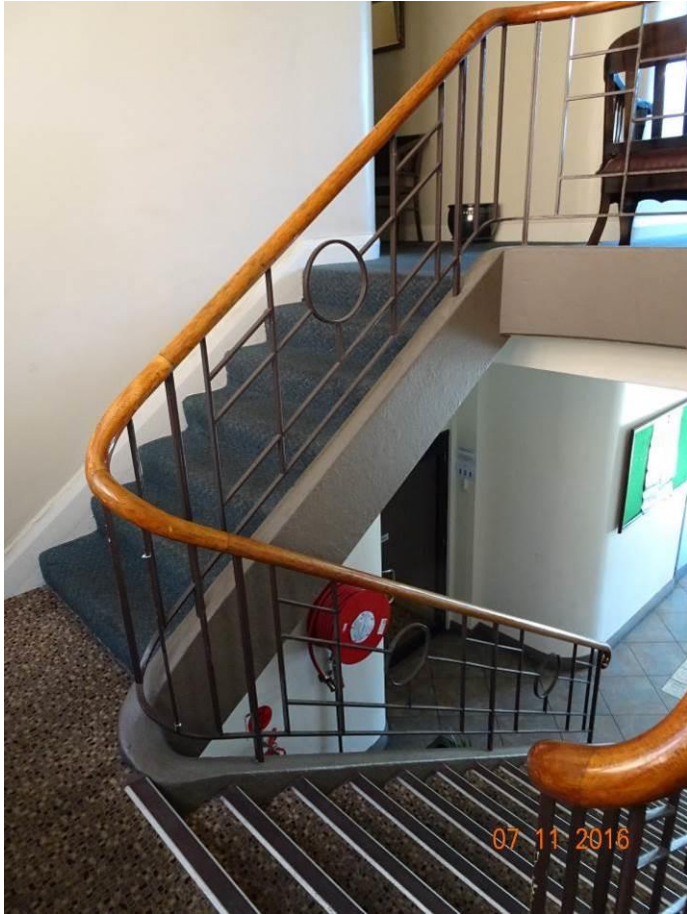
Figure 41: Stair balustrade and curved handrails

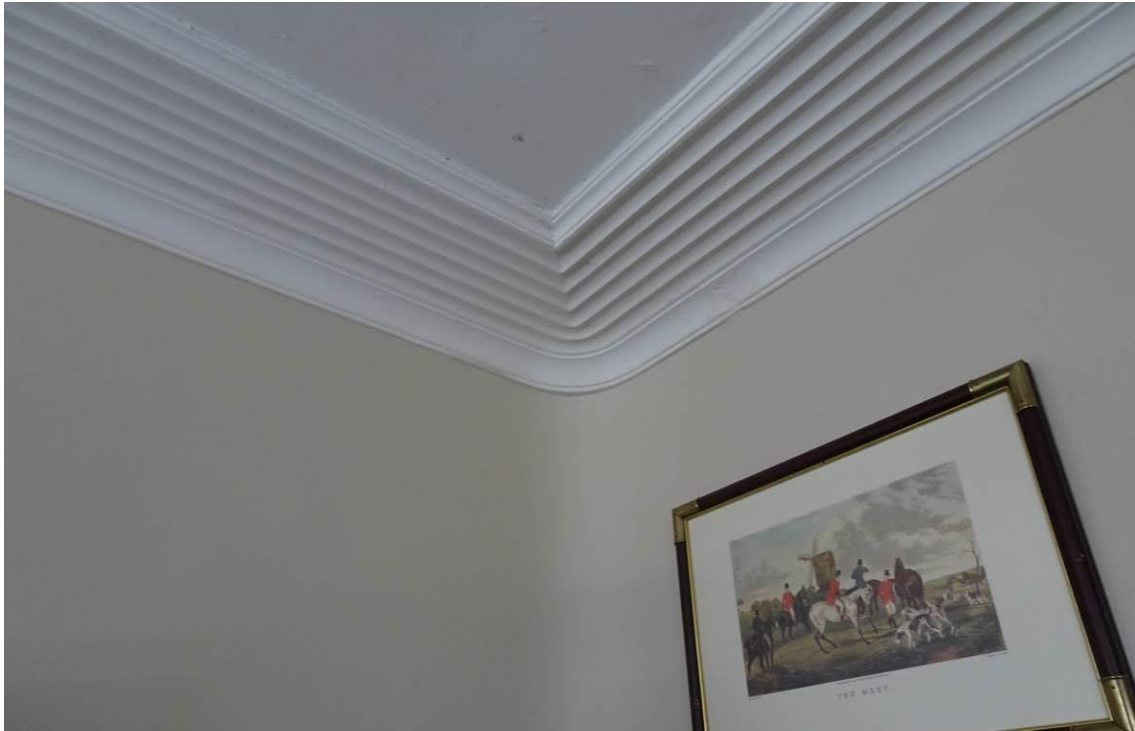
Figure 47: First Floor Lounge: Cornice detail

By comparison, the upstairs rooms, including the bathrooms, are on the whole very original. Doors have been replaced and there has been some deterioration in finishes but the fabric could be restored relatively easily.

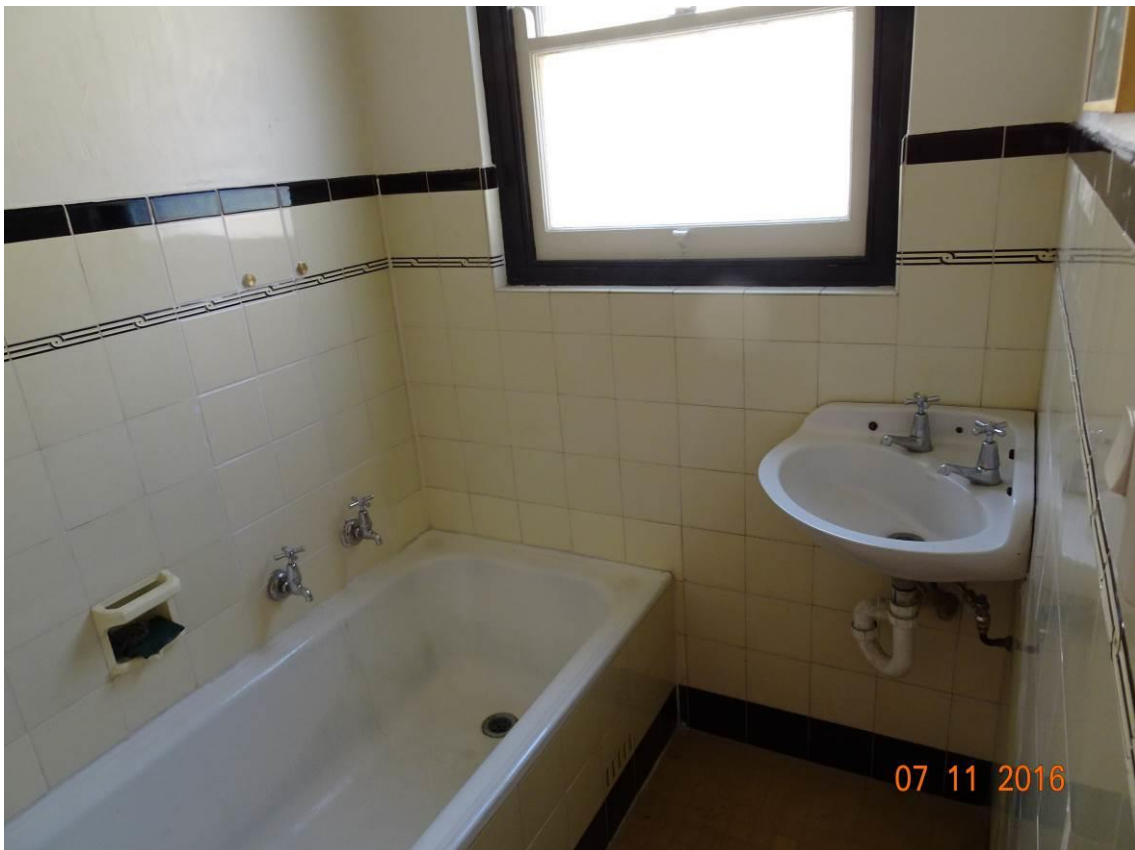
Figure 48: First Floor Ladies' Bathroom with original tiles

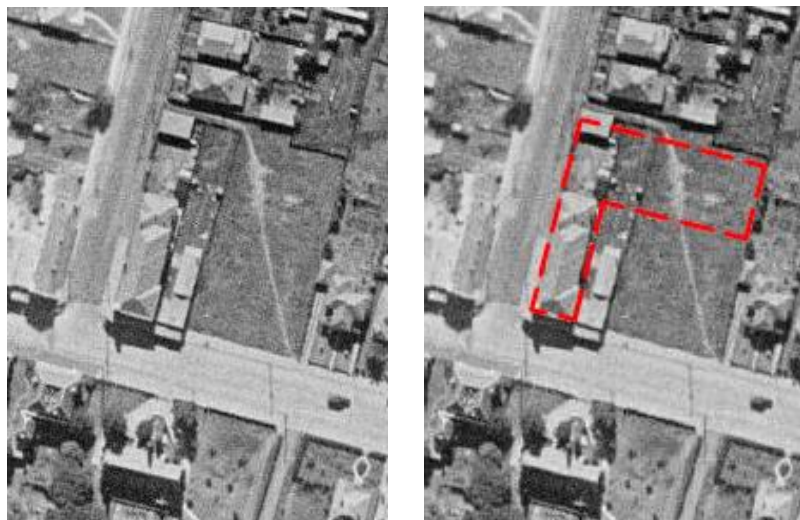
Figure 49: Aerial view of the hotel site and surrounds in 1943, showing the hotel and outbuildings, with the present day site boundaries marked in red on the image at right. Image source: LHS <https://maps.six.nsw.gov.au>, accessed 6 July 2018, RHS annotated.

The curtilage of an item provides a physical context for it and can be a buffer to surrounding development. In this case the present curtilage includes the beer garden, substation and car park. An aerial view from 1943 (see Figure 40) indicates that the hotel occupied the lot on the corner and that the adjacent lot fronting High Street was occupied by a separate building with its own back yard. East of that was an empty lot; evidence of a worn path diagonally across it suggests it was used as a shortcut to and from the main street from the rear lane. Historically it would seem that the primary curtilage of the hotel did not include the substation or car park areas.
