**RE: LANDFORM APPRAISAL - CRANEBROOK WEST LAND PARCEL
PENRITH LAKES SCHEME**

Coffey understands that Penrith Lakes Development Corporation Ltd (PLDC) may offer for sale a parcel of land known as "Cranebrook West". The Cranebrook West Parcel is shown on Drawing PLDC – 11542 (Rev C) attached. The land parcel comprises 7 proposed allotments occupying a total area of about 0.825 hectares that is a subdivision of part of Lot 102 in DP 1143931. The land parcel is bounded by residential development to the east, Castlereagh Road to the west and Farrell's Lane to the north.

This report presents a summary of landform information available to Coffey regarding the Cranebrook West Land Parcel for the purpose of informing potential purchasers.

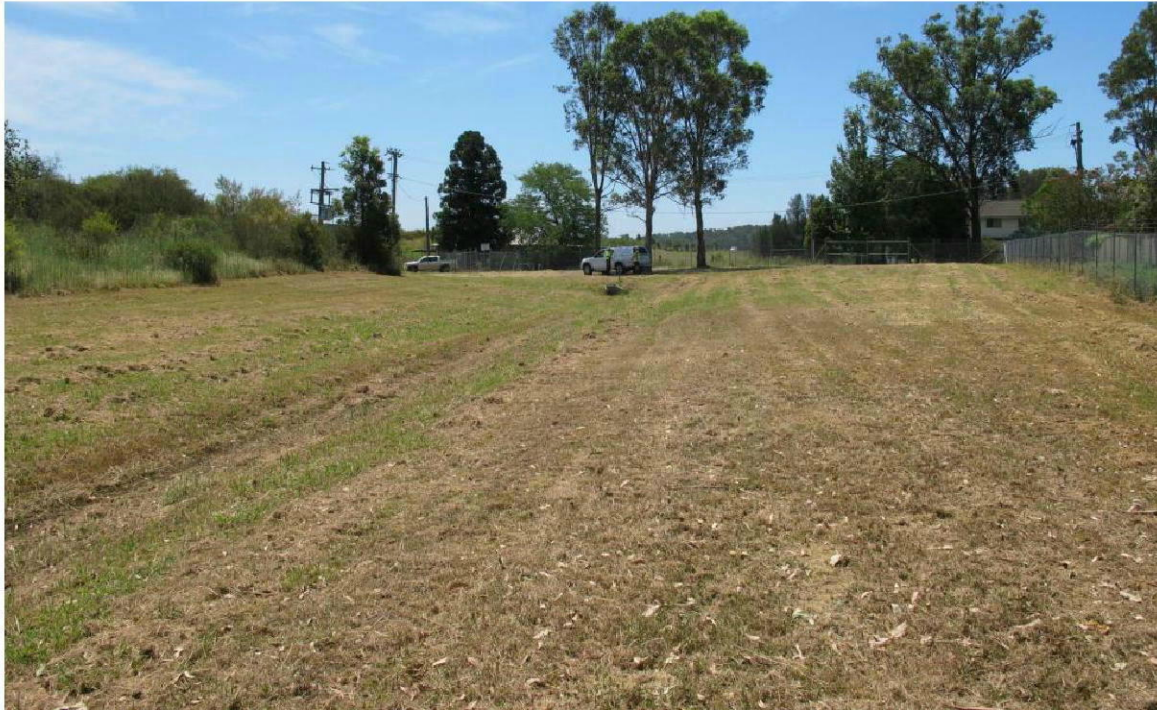
Photograph 1 – Cranebrook West land parcel (looking north)

The land parcel is located near the boundary of the Nepean River floodplain and gently undulating terrain to the east. The land parcel contains part of the Castlereagh Road embankment batter on the western sides (25m AHD to 21m AHD). The general elevation of the land surface is about 21m AHD. It has been shaped with a central "basin" with a low point below 20m AHD as shown on photograph 1. North Pond (an artificial lake) is located about 100m to the west of Castlereagh Road within the Penrith Lakes site.

Proposed Lots 1 to 7 contain substantial areas that are assessed to be located on natural ground that has not been disturbed by quarrying activities. Development of those portions of the lots would need to consider the landform characteristics described and should be based on further geotechnical advice that is specific to the proposed development.

PLDC advises that the 1:100 year flood level in this locality is about RL 21m. Parts of this land parcel are below this level, so future development may require local filling to raise building footprints above major flood levels.

Those parts of proposed Lots 1 to 7 that are located west of the marked quarry high face are interpreted to be within former quarried lands, but may not be underlain by deep fill. Nevertheless, this land comprises part of the Castlereagh Road embankment and should not be disturbed or loaded without further geotechnical advice.

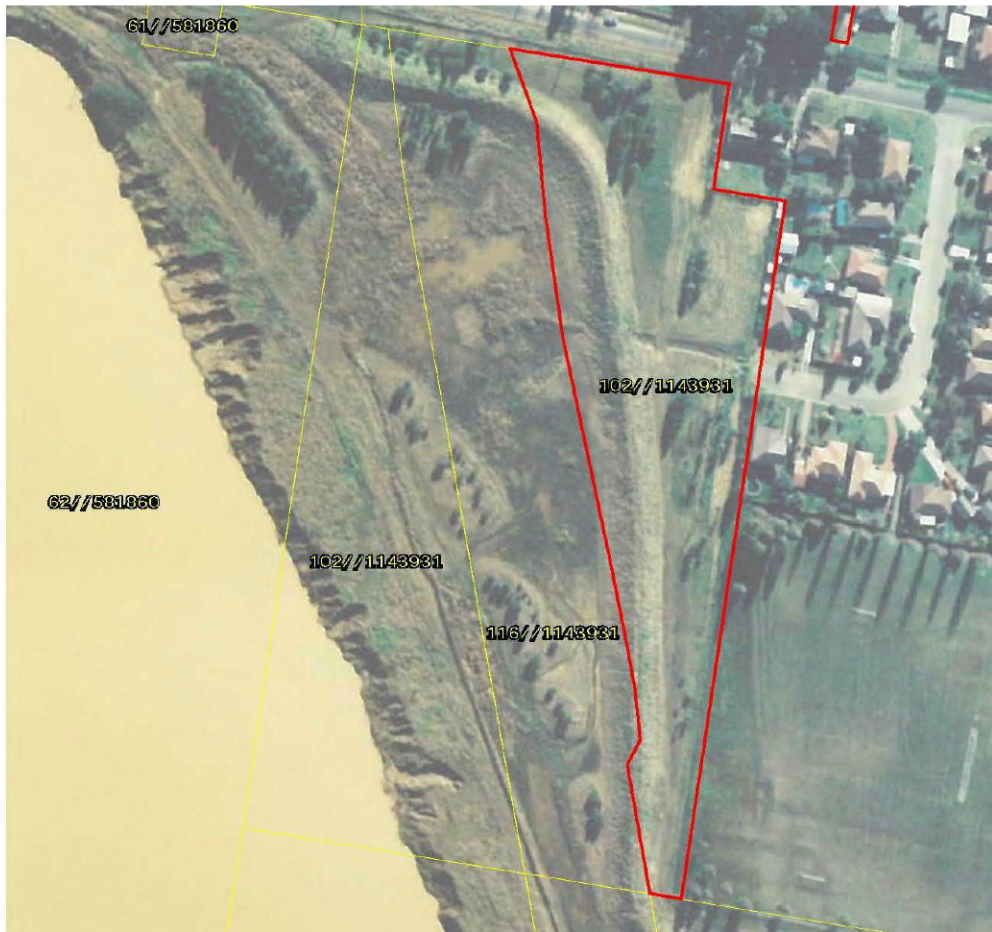
Photograph 2: Aerial photograph from c.1987.

Coffey has been provided with a series of aerial photographs taken at intervals between March 1978 and December 2010. The photographs show disturbance and local excavation within Lot 102, but not deep quarrying to extract the resource, as indicated in photograph 2.

It is possible that the resource was extracted up to the indicated position of the high face on Drawing PLDC – 11542, but this is not evident in the supplied photographs.

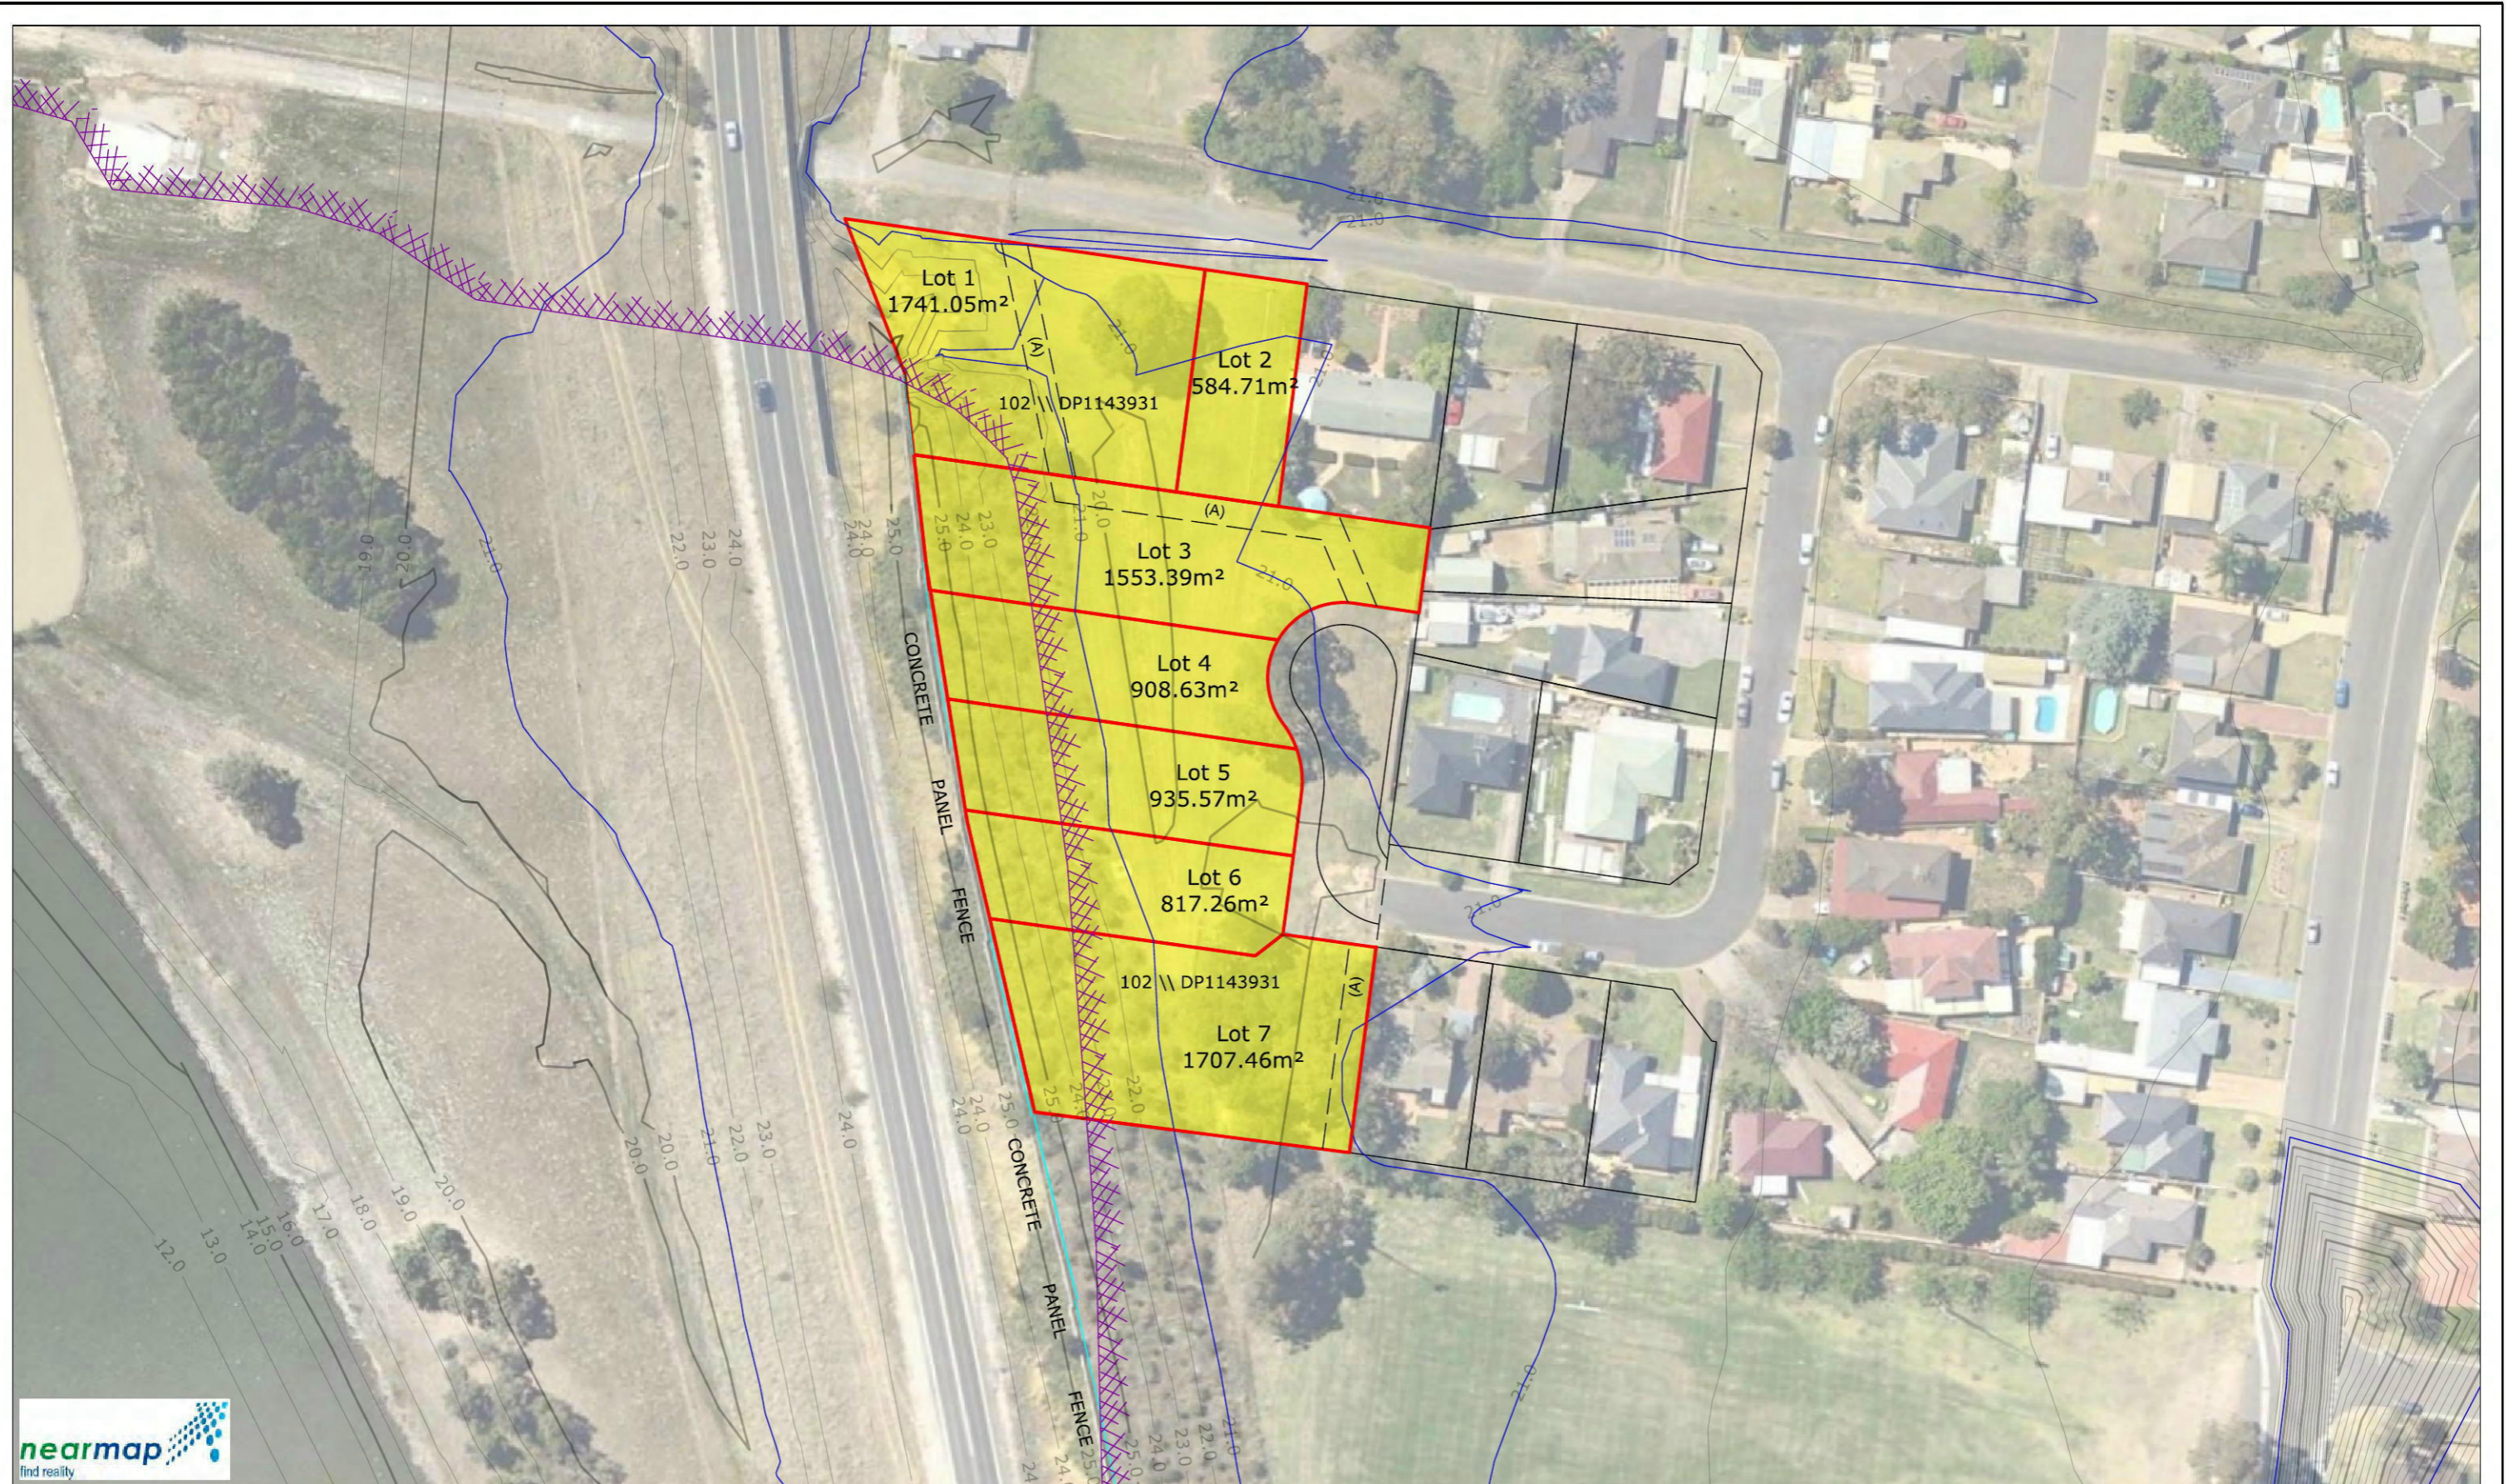
Drawing No:
PLDC - 11542

The Cranebrook West Land Parcel is located along the eastern perimeter of the quarried lands and is partially underlain by fill, and partially by natural ground. Drawing PLDC-11542 (Rev C) shows the location of the former quarry face. It is expected that the land to the east of the quarry face comprises relatively undisturbed alluvium, underlain by shale. Quarrying at the Penrith lakes site exposed shale bedrock level varying between about RL 6m and 10m AHD. This may also be indicative of the rock depth beneath the land parcel.
