Bushfire Protection Assessment: Proposed Subdivision 44-46 O'Connell St Caddens

Project Name	Bushfire Protection Assessment: Proposed Subdivision 44-46 O'Connell St Caddens
Project Number	SYD19_14769
Project Manager	David Bonjer
Prepared by	Letara Judd (minor edits by Natalie South)
Reviewed by	Mick George (v4 reviewed by Bruce Horkings - FPAAC BPAD Accredited Practitioner No. BPAD29962-L3)
Approved by	David Bonjer
Status	Final
Version Number	v4
Last saved on	3 May 2021

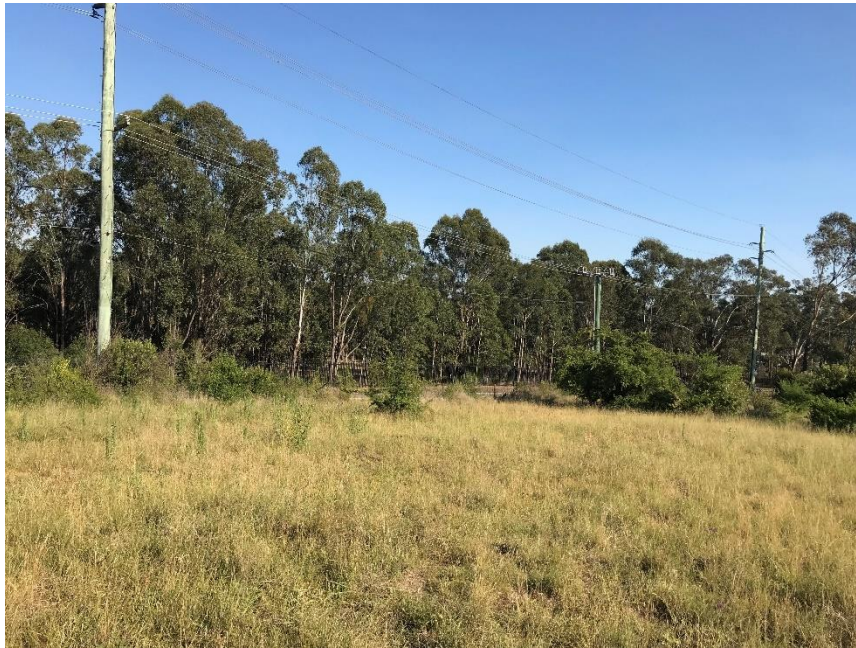
Photo 1: View of vegetation on western elevation

The vegetation to the western side of O'Connell Street forms a large reserve as part of Kingswood Campus, UWS. This vegetation covers an area of approximately 7.5 ha in size is classified by PBP as 'Forest'.

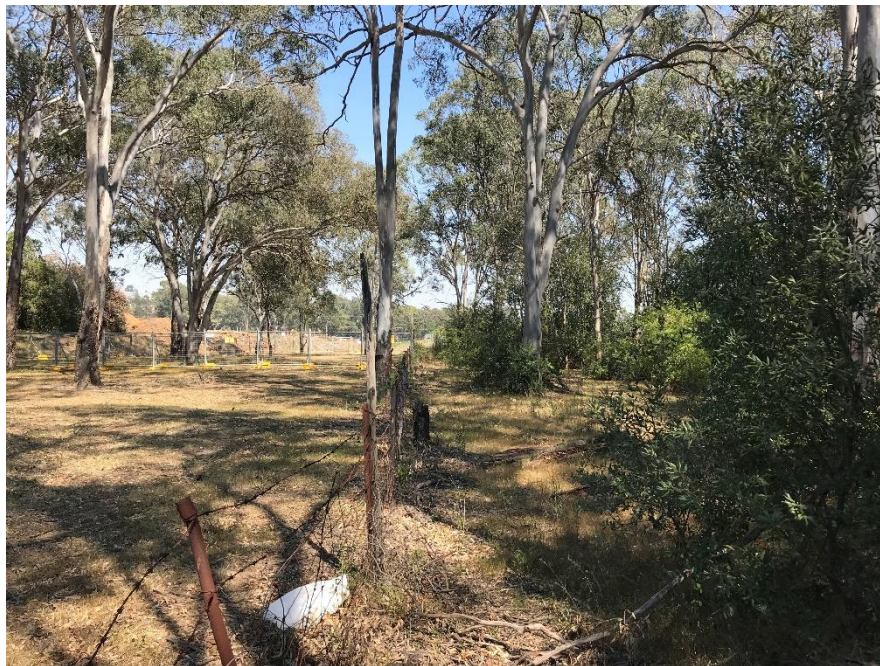
Photo 2: View of vegetation on southern elevation

Within the southern part of the subject land, existing vegetation is proposed to be retained and regenerated as Cumberland Plain Woodland within a park. The cleared area around the vegetation but still within the park will be subject to earthworks and will then be maintained as managed land. The retained vegetation has connectivity with the vegetation outside of the subject land boundary with a total combined area of 0.9 ha and there is greater than 100 m separation to any other areas of Category 1 or 2 vegetation. Therefore, this vegetation is classified as 'low threat' and has been excluded under Section A1.10(1) of PBP.
