Our ref: SYD20 16809

Regatta Park Archaeological Testing, (permit 2020/s140/015) - Summary Report

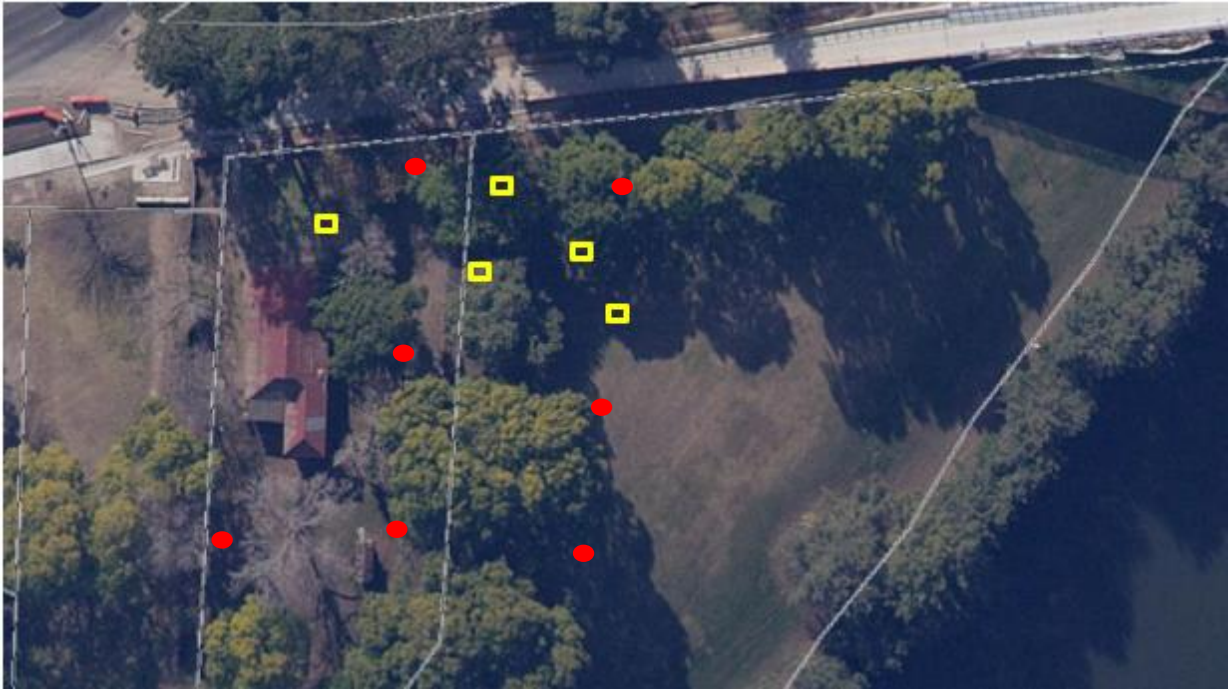
Five 1m x 1m test trenches were located in the north eastern portion of the study area to test for the Punt House. The location of trenches was based on historical overlays and landform. Four trenches were manually excavated to 1 m in depth and one trench was terminated at natural deposits under clean sandstone rubble fill at a depth of 40 cm. Three trenches contained alluvial silts with the top 40 cm containing sparse and highly fragmented archaeological material including glass and ceramics. Two trenches contained no archaeological material and only natural silt alluvium. No evidence of the Punt House, the Office or Punt Road was located, no evidence of demolition material, pits, features or artefacts dating to the Punt House phase of occupation was present in any of the trenches. The landform was observed to be highly modified in this location with at least 2 m in depth cut away from the original landform suggesting that all evidence of the Punt House has been previously removed.

Contamination testing of seven locations in the presumed vicinity of the Punt House was monitored by the Excavation Director (Figure 1). The results of the contamination testing confirmed the results of the archaeological testing and no evidence of the Punt House was located. The sandstone rubble fill was determined to be a base for the site sheds associated with the construction of the nearby Yandhai Bridge.

Figure 1 Location of test trenches (yellow) and contamination testing pits (red) associated with the location of the Punt House

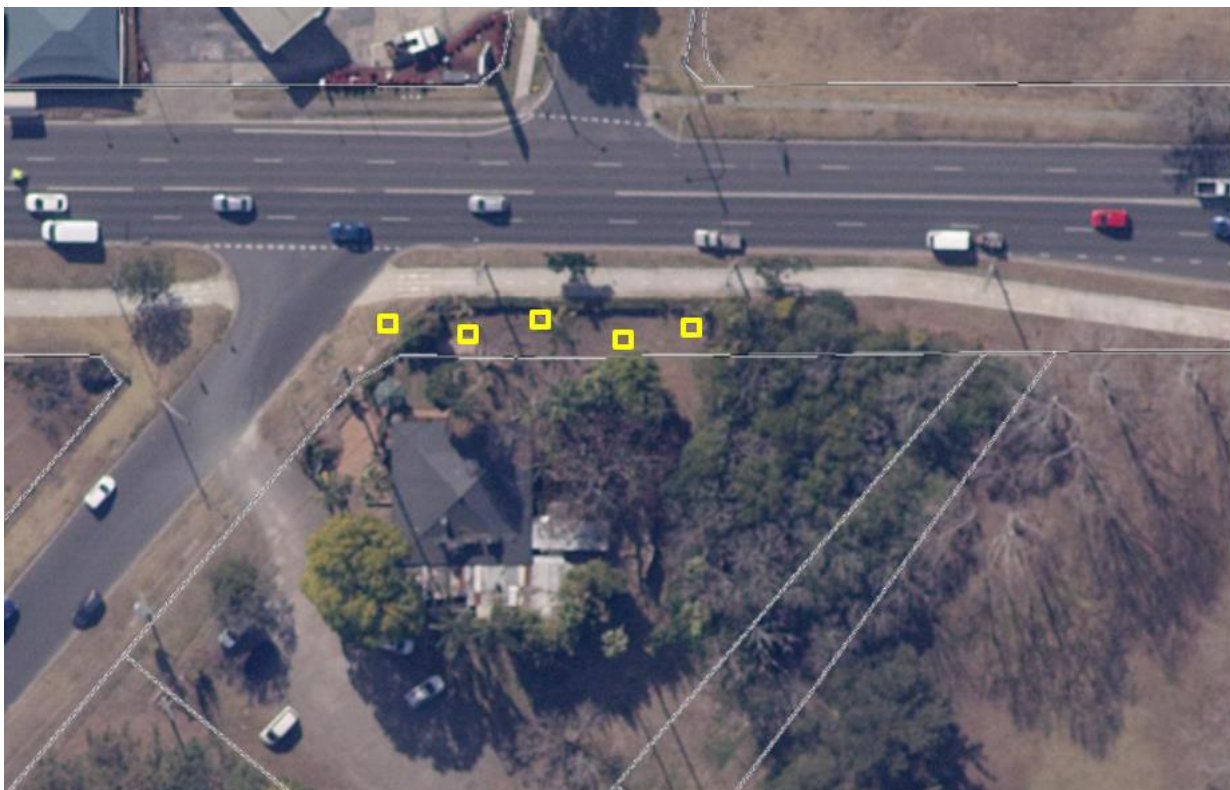
Figure 3 Location of test trenches (yellow) in the vicinity of the former Victoria Bridge Inn

Five 1m x 1m test trenches were located in the presumed location of the former Victoria Park Inn. The location of trenches was determined by the limited area available to excavate south of the existing footpath. Historical overlays indicate that the building was likely to have been located in the footpath or road to the north. Three of the trenches contained concrete slabs and/or service trenches as well as numerous layers of imported fill. The most easterly and westerly trenches contained disturbed alluvial silts. All trenches contained highly fragmented archaeological material including glass, ceramics and bone, however the deposits were mixed and/or imported and clearly not *in situ*. No evidence of the former Inn foundations, yard deposits, rubbish pits, demolition material or any other features or deposits dating to the mid-19th century phase of occupation was present in any of the trenches.

Contamination testing had not been undertaken at this stage and we are waiting on the results.

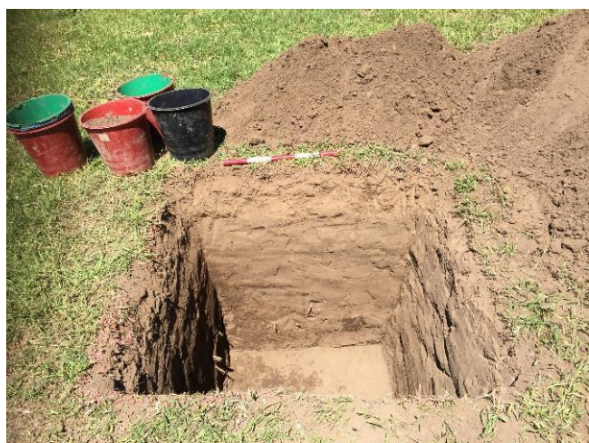
Figure 4: Typical alluvial silts

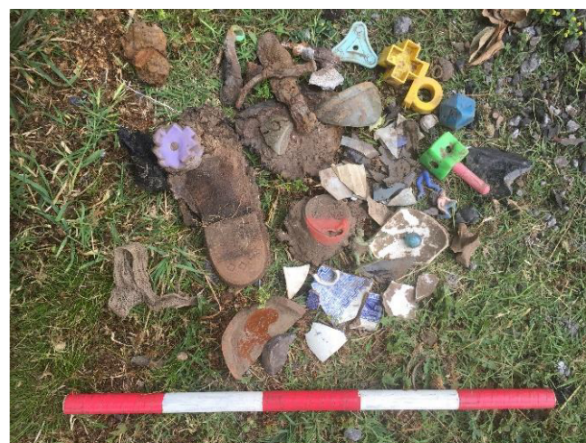
Figure 5: Range of artefacts from a test trench associated with the cottage/Police Station
