# Dilapidation Report

Proposed Works - Jordan Springs Stage 2 Retirement Living

James Sae Siew  
5<sup>th</sup> March 2019  
Revision 1

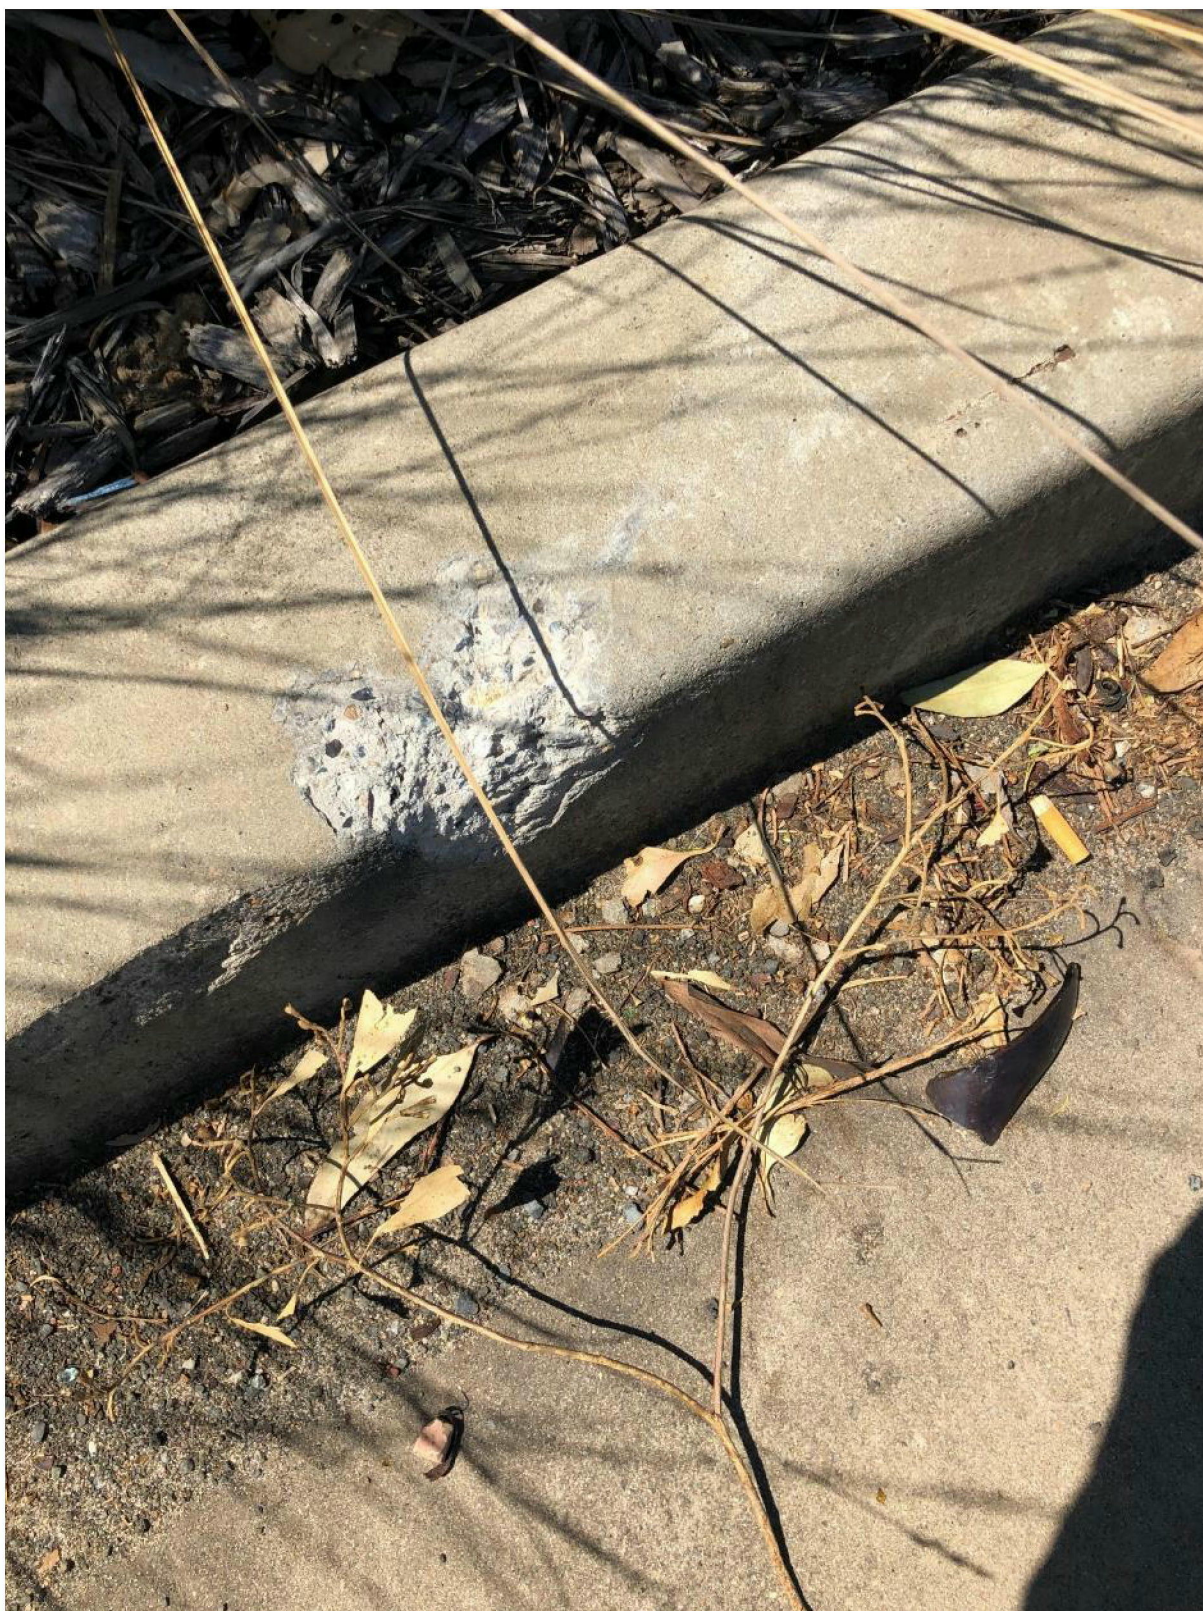
*Figure 78: chip to top of kerb.*

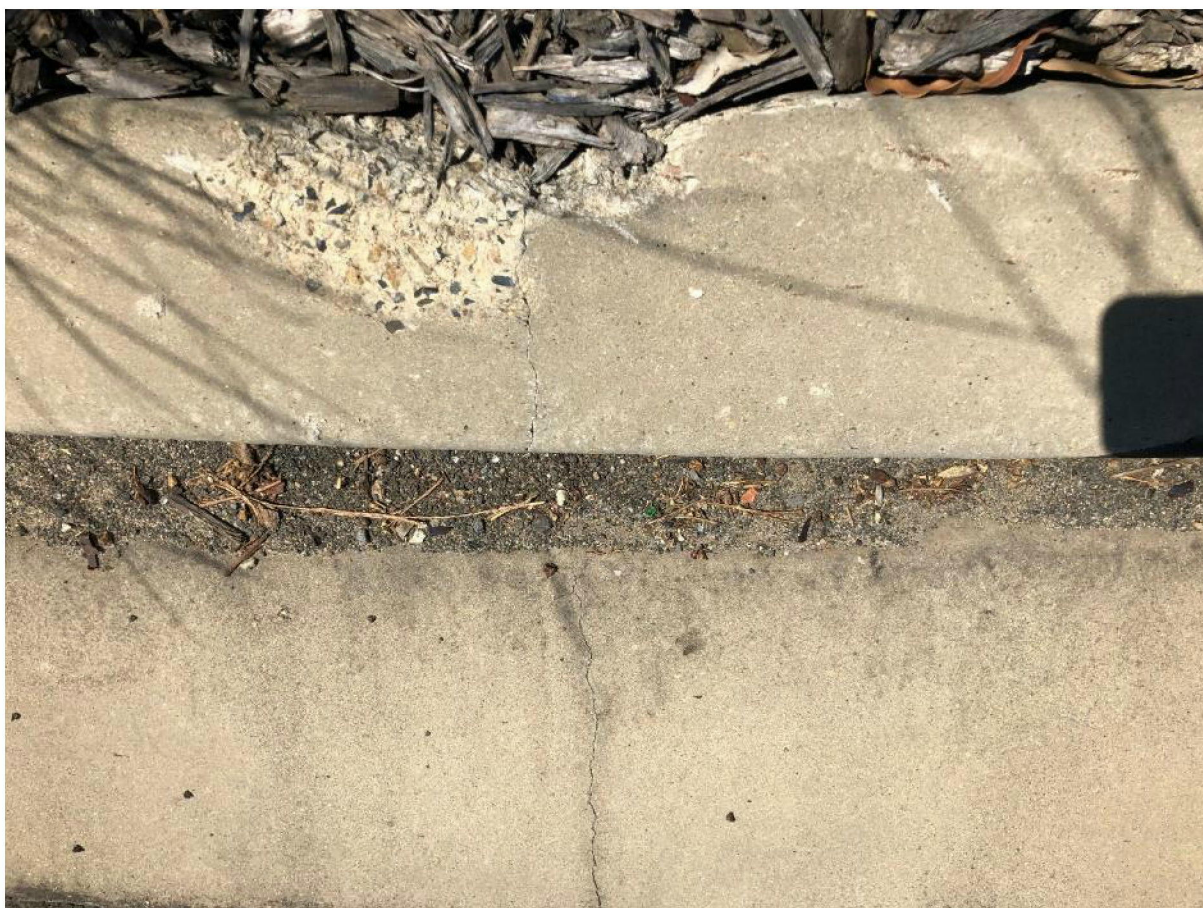
*Figure 79: chip to top of kerb.*
