QUA004 - DILAPIDATION & SITE INSPECTION REPORT

Customer/Project Name: Lendlease - Village		ase - Village O	val, Jordan S	prings.						
Customer/Project Address: Cnr Alinta Promenad					de & Greenwood Parkway, Jordan Springs					
Job No.	28	45	Contract No).	724		Date:	21/07/	2015
Prepared by: Luke Cranson					Photos en	closed:	Yes 🖂	No [
Inspection	1				Notes & Co	omments				
Water		Nearside	⊠ Fa	r-side 🖂						
Electricity	•	Aerial 🛛	Unde	erground 🛛						
Sewer		Yes 🖂	No 🗌							MIL .
Septic		Yes 🗌	No 🛛		Туре					
Kerb & Gu	itter	Yes 🖂	No 🗌		Damage	Yes 🖂	No 🗌			
Layback		Yes 🖂	No 🗌		Damage	Yes 🛛	No 🗌			
Footpath Yes		Yes 🖂	No 🗌		Damage	Yes 🖂	No 🗌			
Vehicle Ac	ccess	Good 🛛	Need	s Work 🗌						
Boundary Pegs		Yes 🗌	No 🛚				TOM:			
Existing Fe	encing	Yes 🖂	No 🗌		Туре	Builder	s Temporar	y, chain lir	nk perimet	er fence
Subsoil		Existing		1						
Excavation		Yes 🖂	No 🗌							
Trees Yes 🗵		Yes 🖂	No 🗌					DEC	EIVE	
	Stor	mwater							MGT	
Other:								2 3	JUL 2015

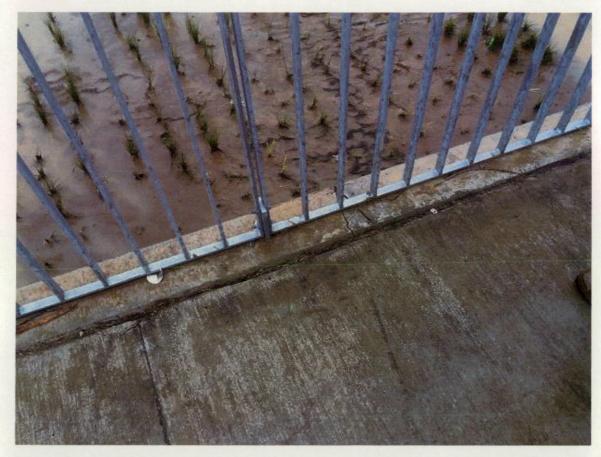
Figure 2 Pavement stains and surface cracking

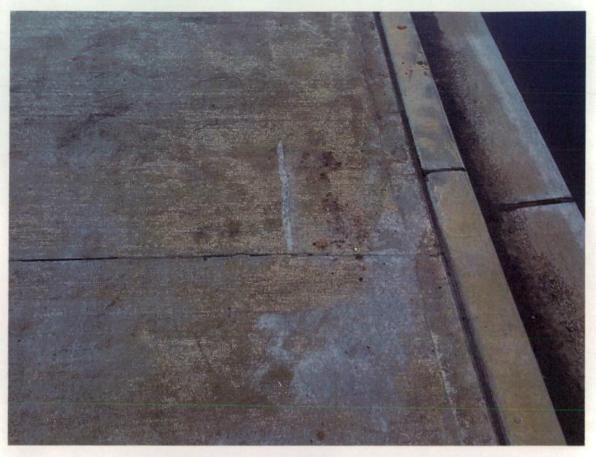
Figure 4 Pavement scratched and stained

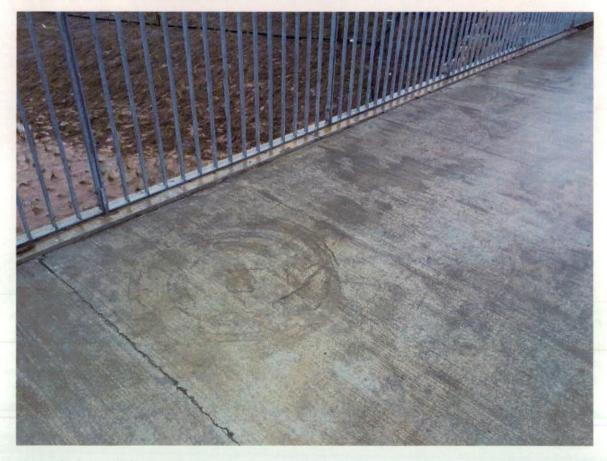
Figure 5 concrete splatter and staining present

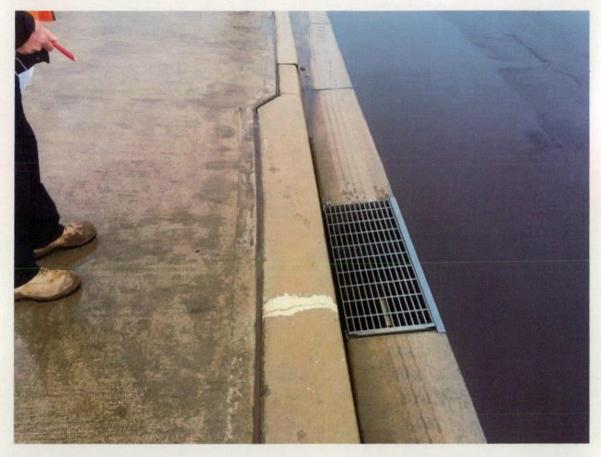
Figure 6 damage to machinery apparent

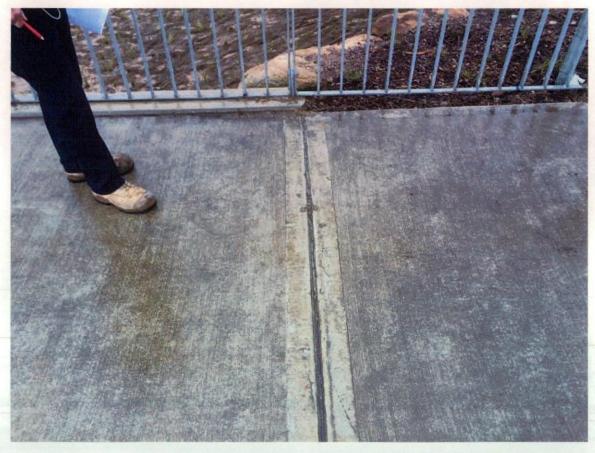
Figure 9tyre tracks and damage to stormwater grate.

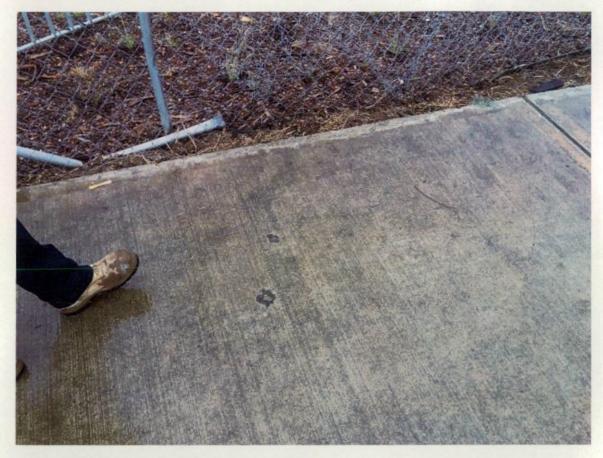
Figure 10 surface damage to concrete footpath and staining.

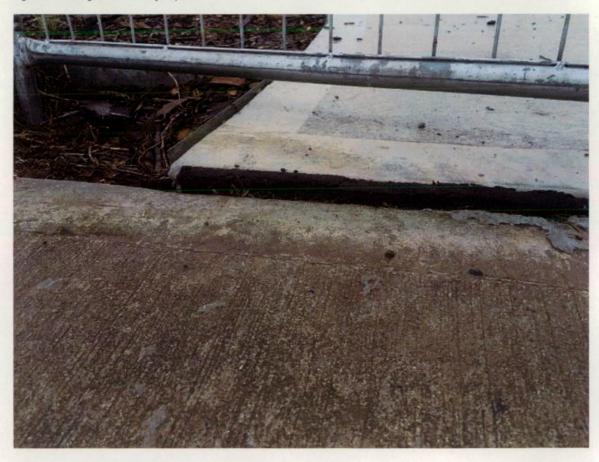
Figure 11 Damage to concrete footpath.

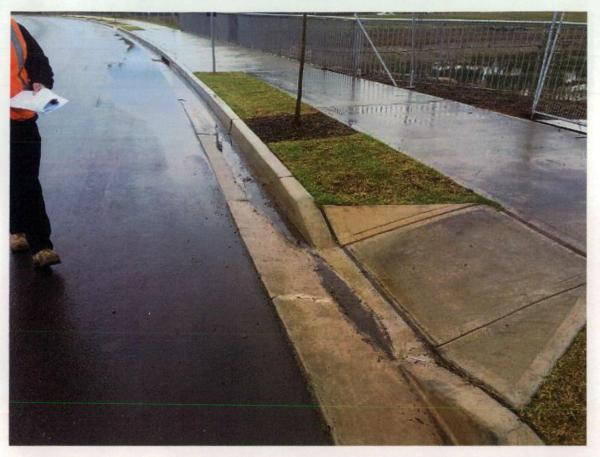
Figure 12 Poor interface between concrete footpaths.

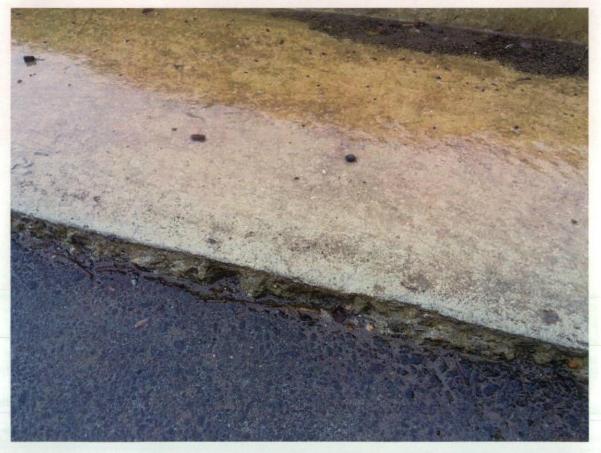
Figure 13 Kerb crack repair on pram ramp.

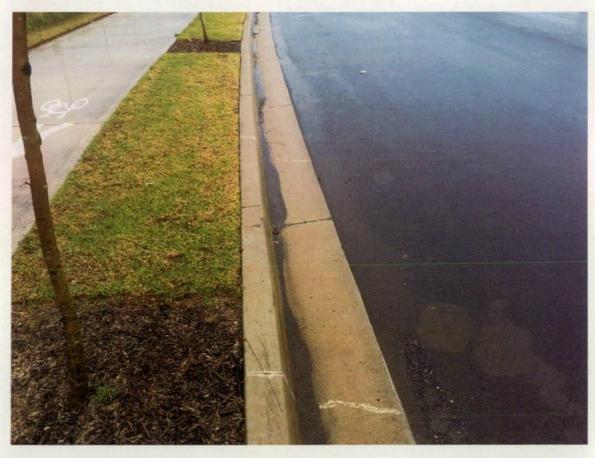
Figure 14 Damage to gutter edge.

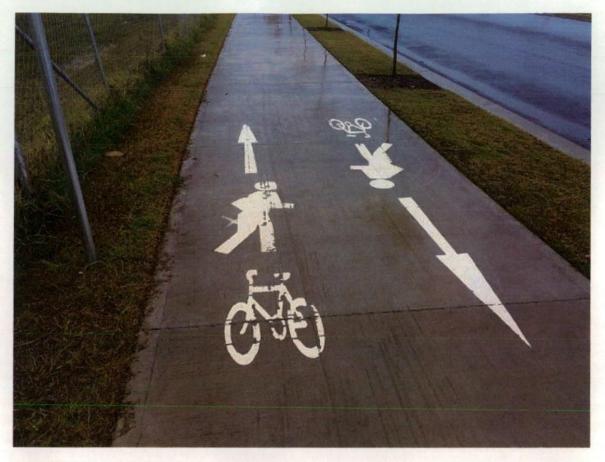
Figure 16 Marks and damage to footpath surface.

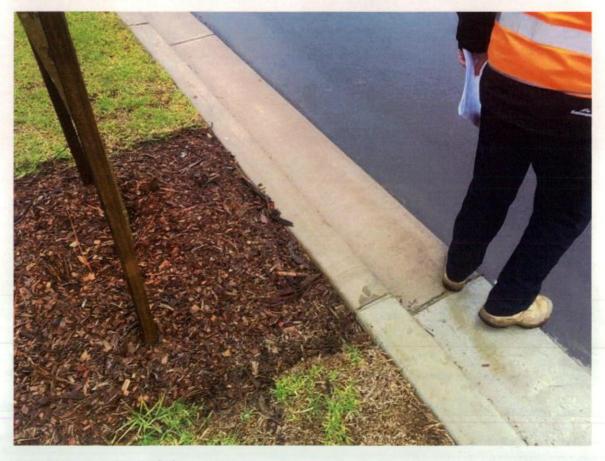
Figure 29 Concrete splatter on kerb.

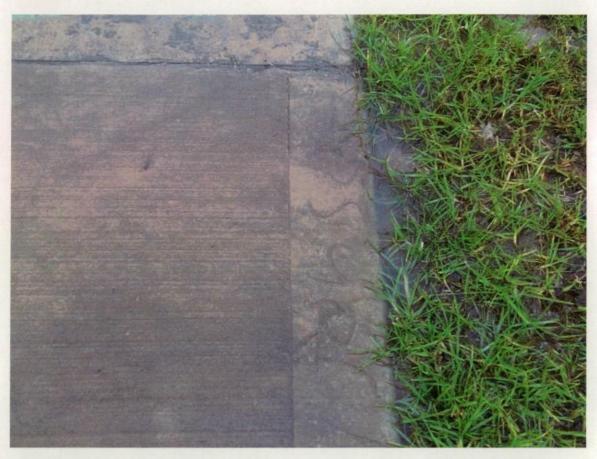
Figure 30 Concrete splatter on kerb.

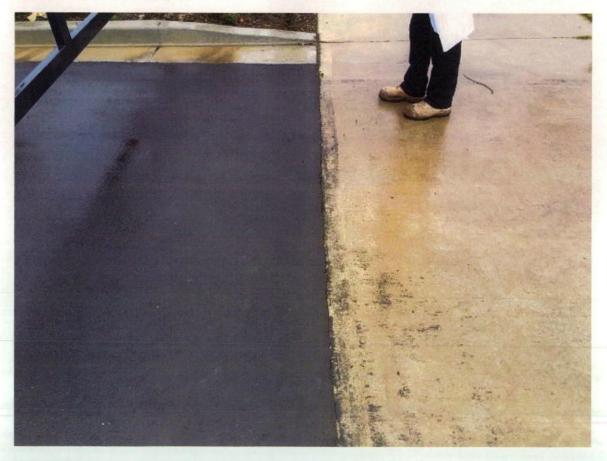
Figure 37 Staining to footpath surface.

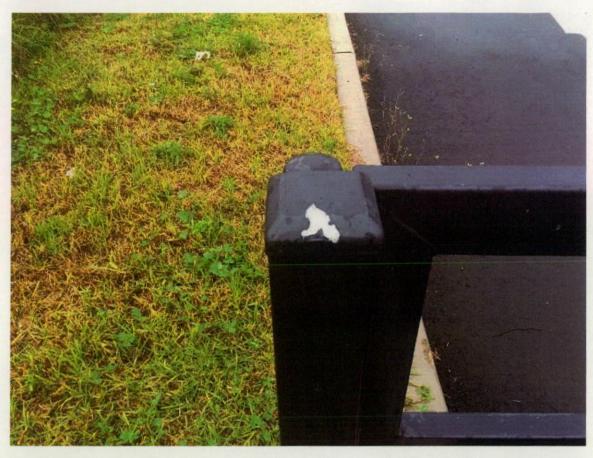
Figure 38 Bitumen staining on concrete surface.

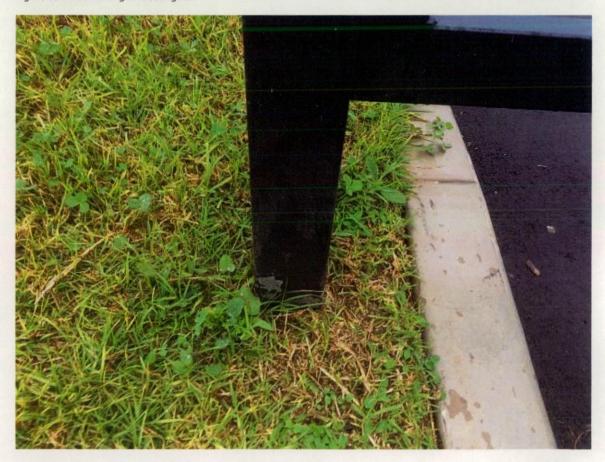
Figure 39 Paint Missing on boom gate.

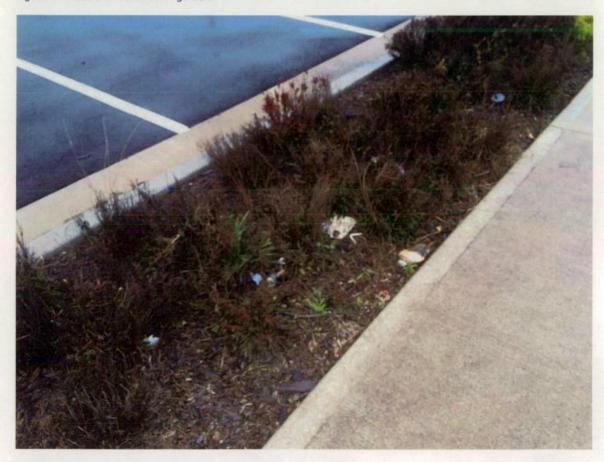
Figure 43 weeds and mulch low in garden.

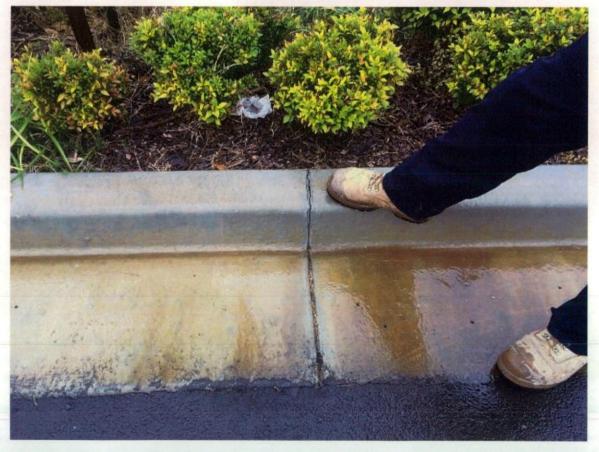
Figure 45 Damage to kerb.

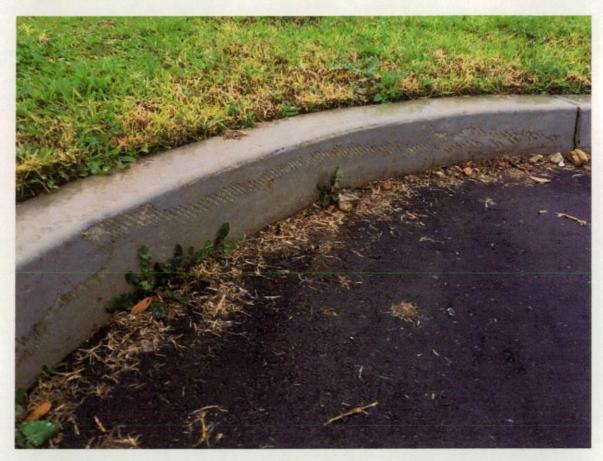
Figure 46 Cracking in kerb, wide crack in joint.

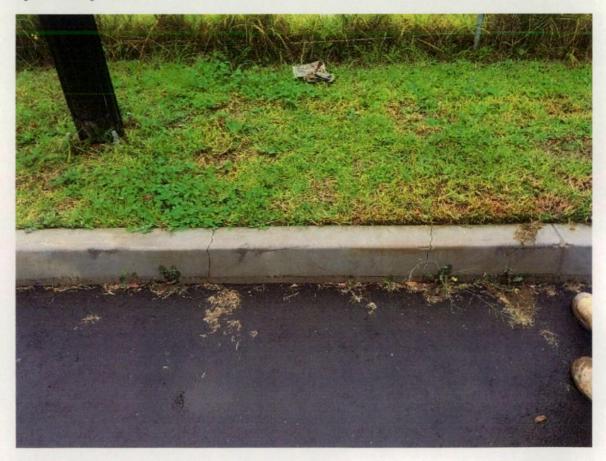
Figure 47 Damage to kerb.

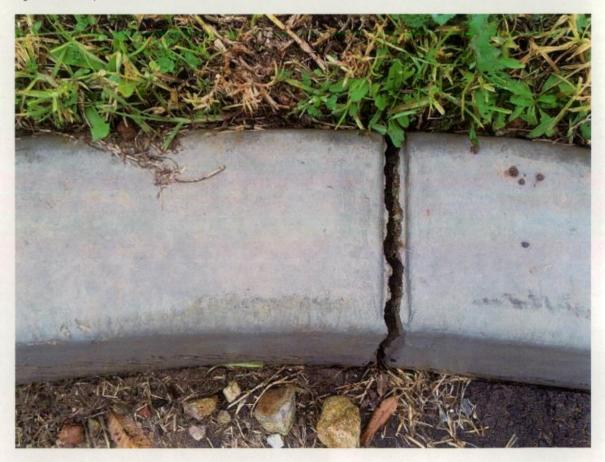
Figure 51 Cracks present in kerb.

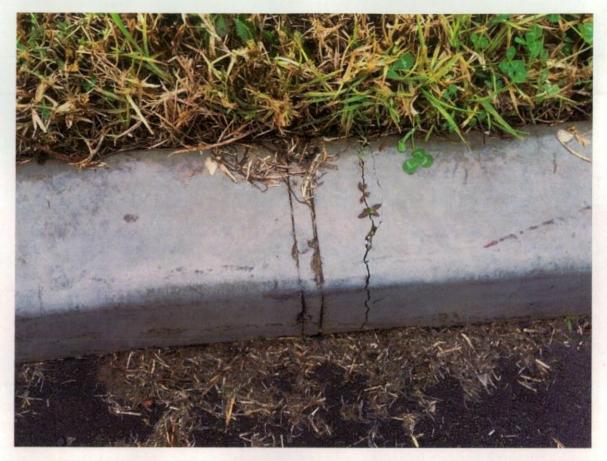
Figure 52 Wide crack present on joint.

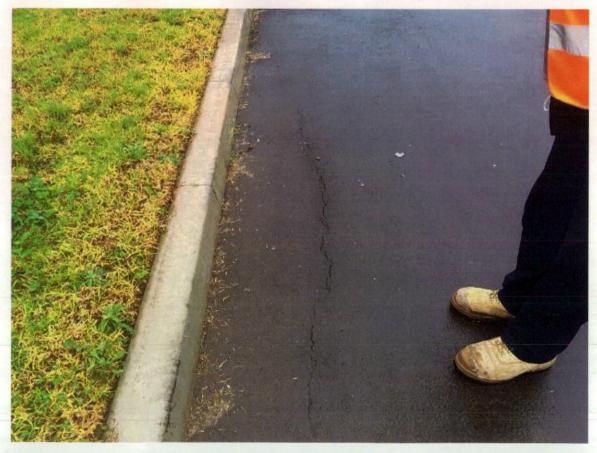
Figure 53 Cracks in kerb.

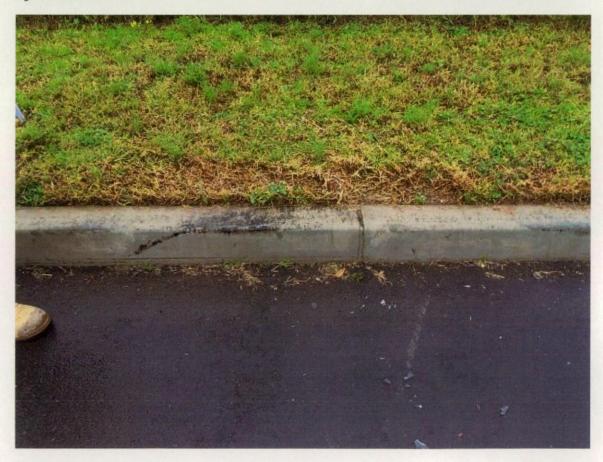
Figure 55 Crack to kerb.

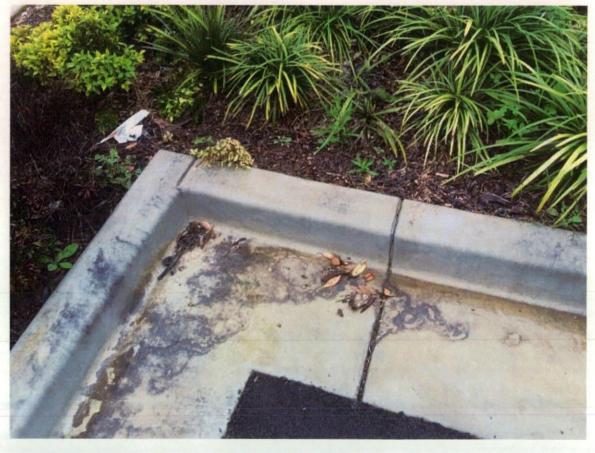
Figure 57 Concrete splatter on kerb.

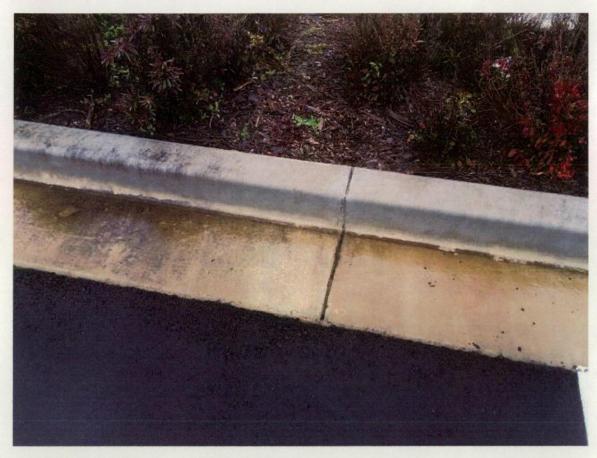
Figure 58 Bitumen stains and tyre marks on kerb.

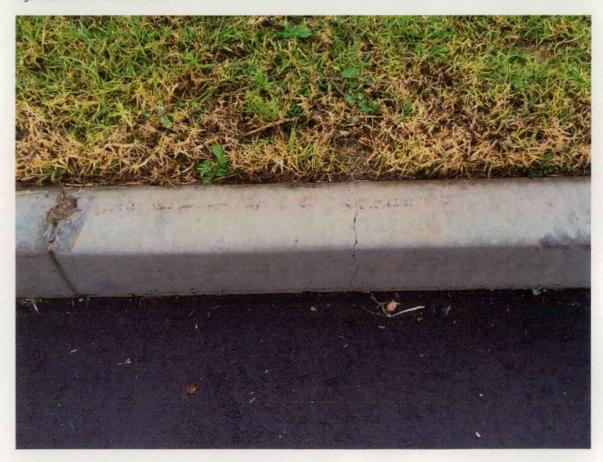
Figure 59 Bitumen stain on kerb.

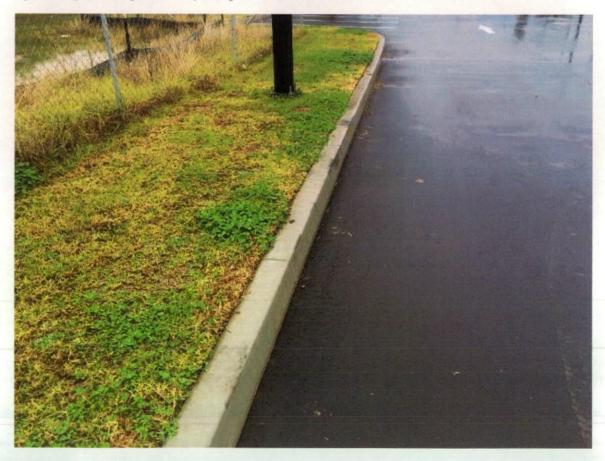
Figure 61 Surface staining to kerb and patching work on kerb.

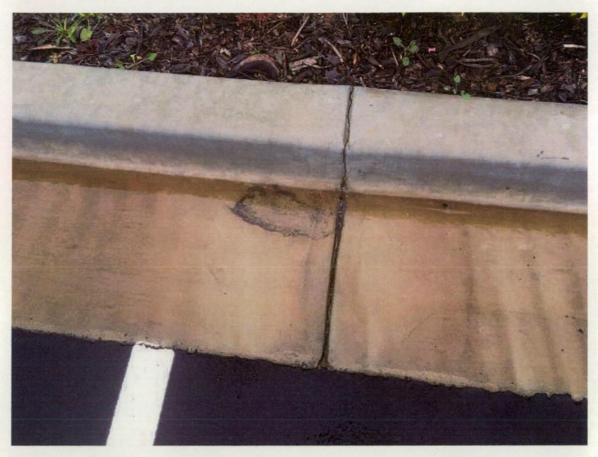
Figure 62 Marks on kerb from machinery.

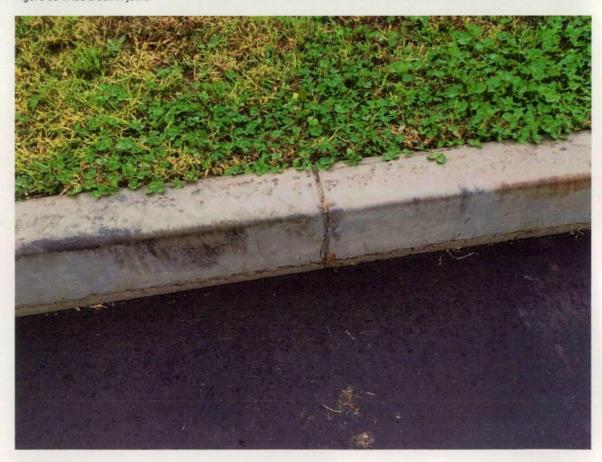
Figure 63 Wide crack in joint.

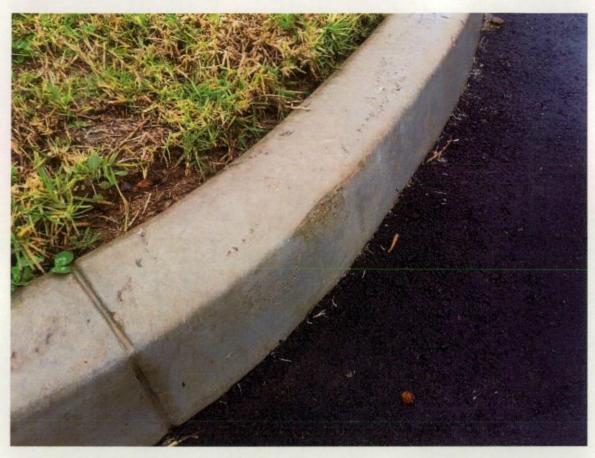
Figure 70 Marks on kerb.

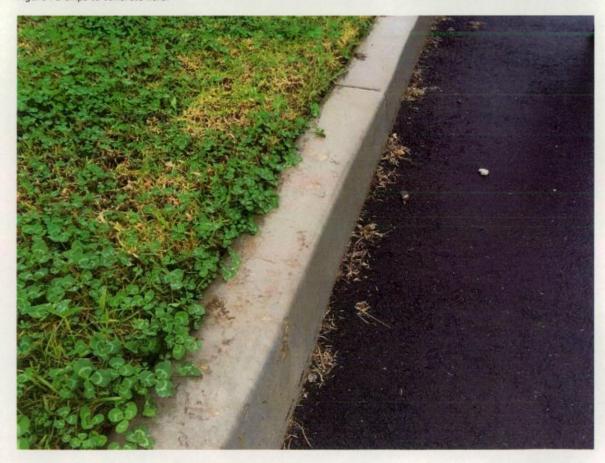
Figure 71 Chips to concrete kerb.

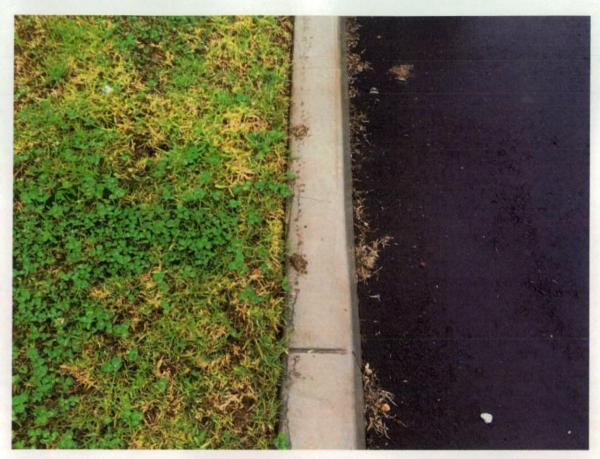
Figure 72 concrete splatter to top of kerb.

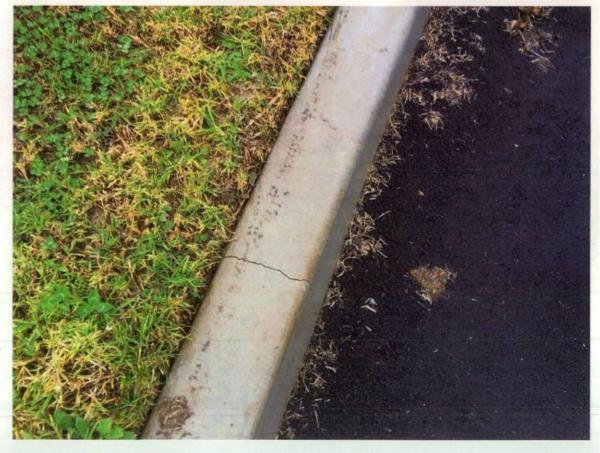
Figure 73 Staining and surface cracking to kerb.

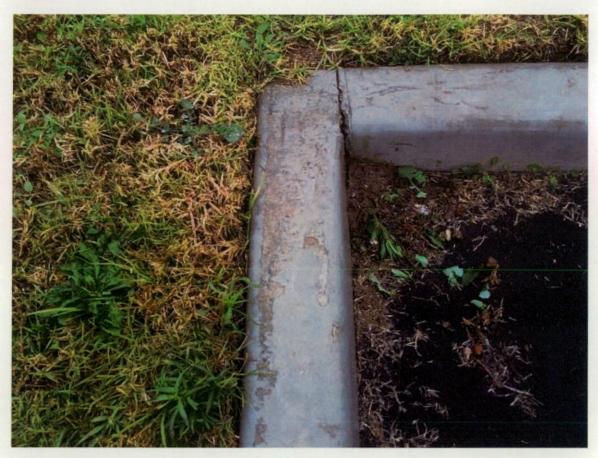
Figure 74 Surface cracks to kerb.

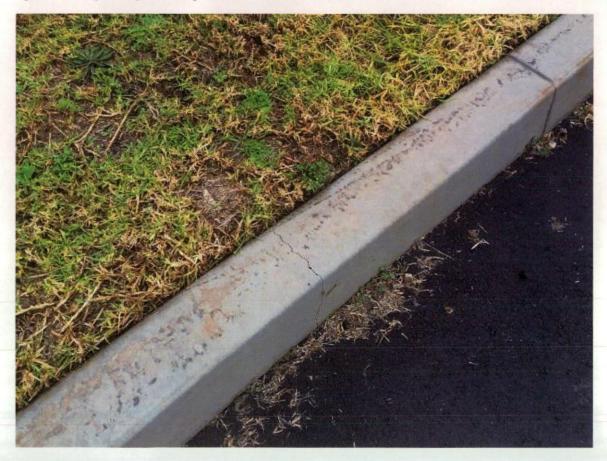
Figure 77 Staining and surface cracking to kerb.

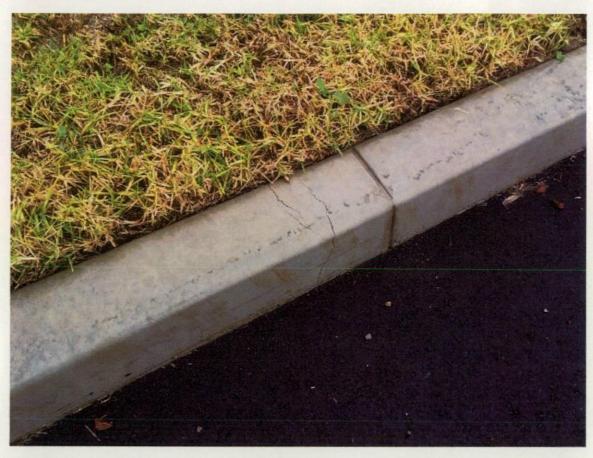
Figure 78 Cracks in concrete kerb.

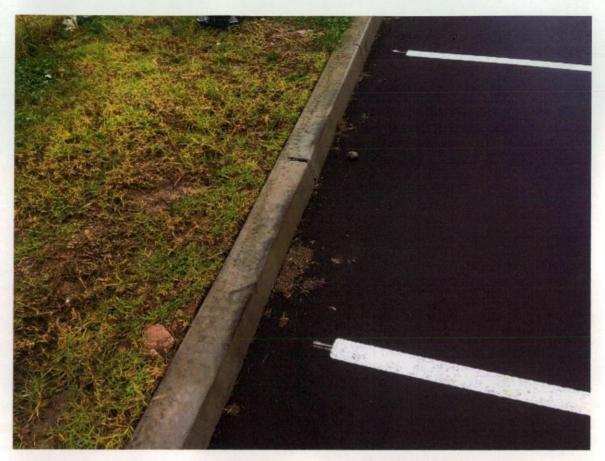
Figure 80 Damage to kerb.

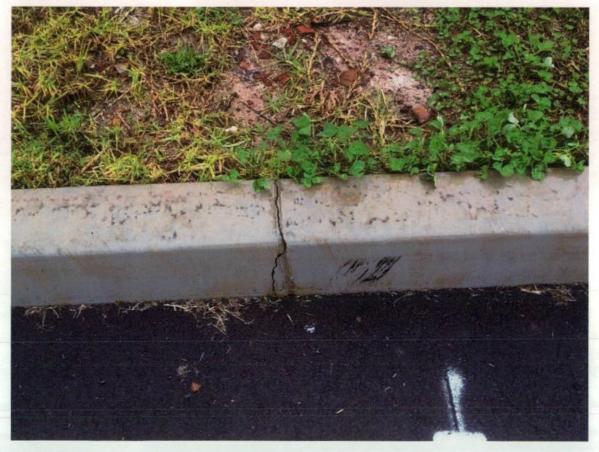
Figure 81 Staining and damage to kerb.

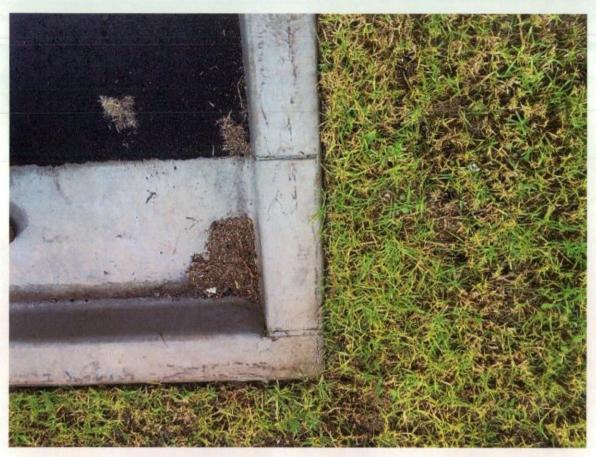
Figure 84 Damage and concrete splatter on kerb.

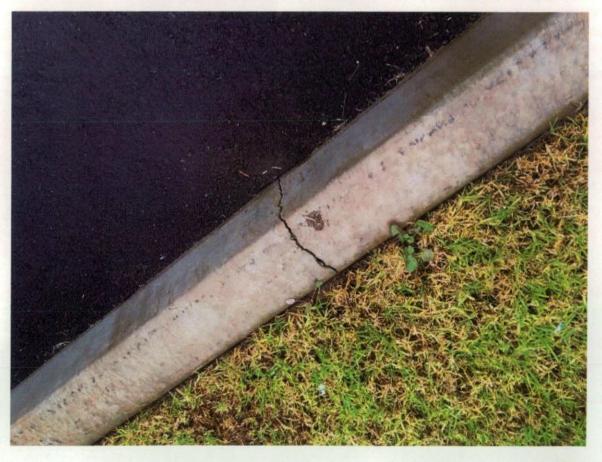
Figure 85 Crack in kerb.

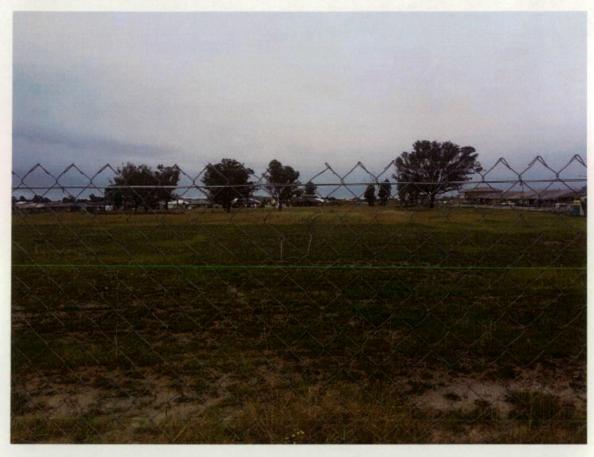
Figure 87 Damage to fence.

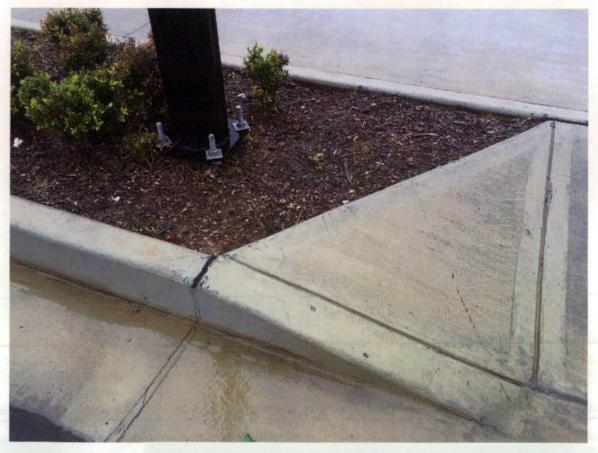
Figure 90 Damage to pram ramp.

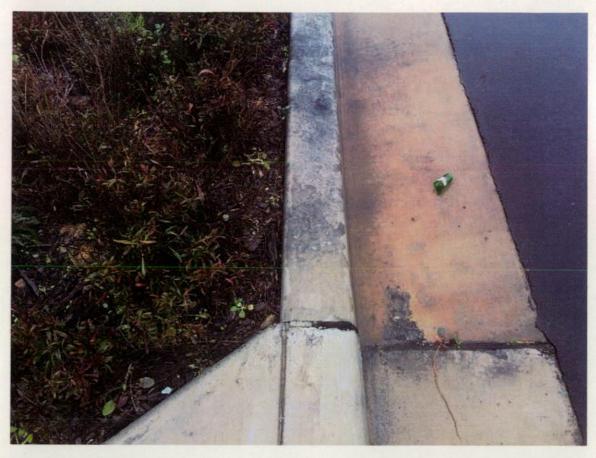
Figure 91 Damage to kerb and pram ramp.

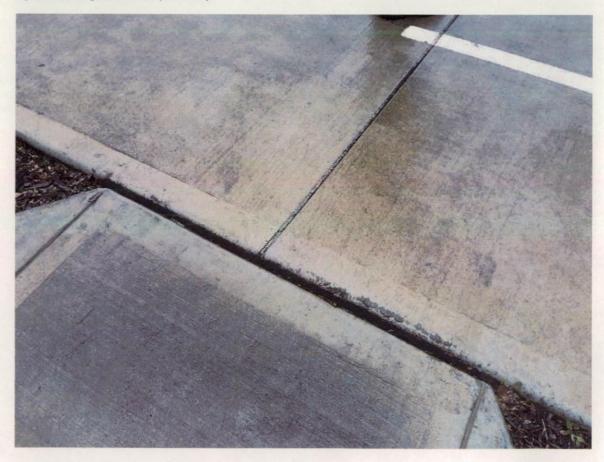
Figure 92 Concrete splatter on footpath.

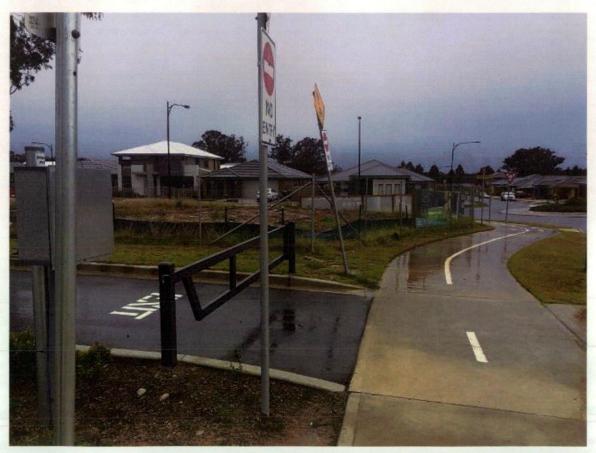
Figure 94 Street sign damaged.

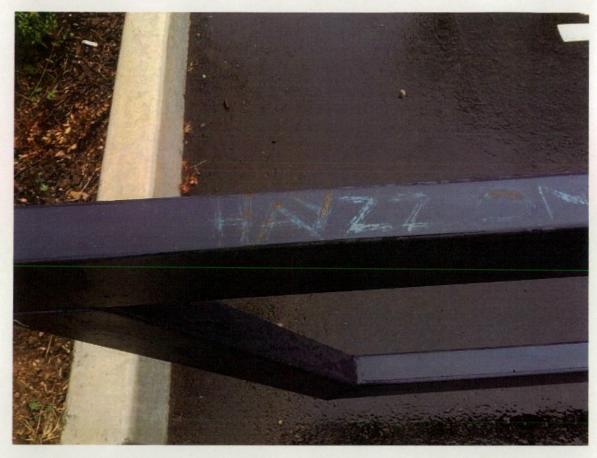
Figure 95 Vandalism to boom gate.

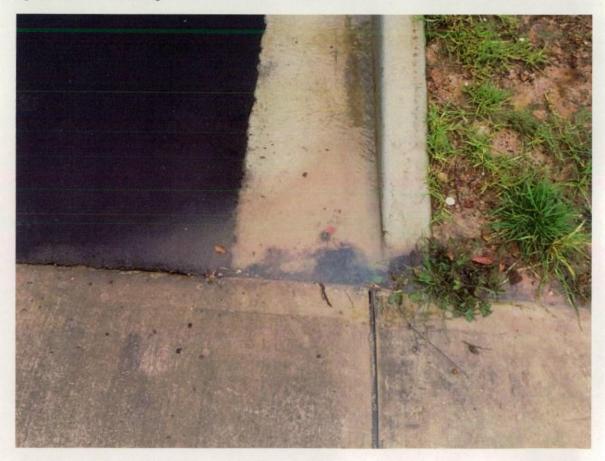
Figure 96 Gutter holding water.

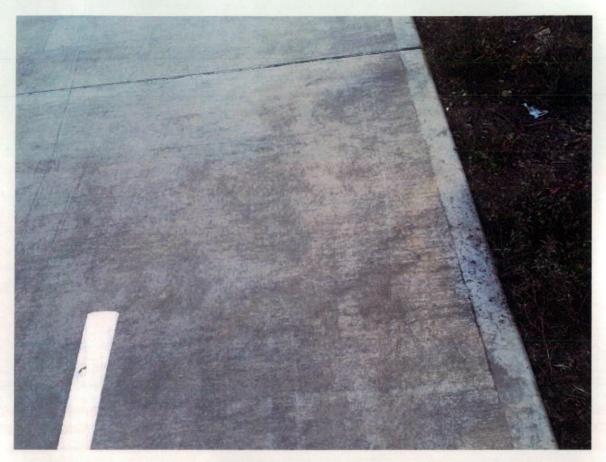
Figure 97 Stain on concrete footpath.

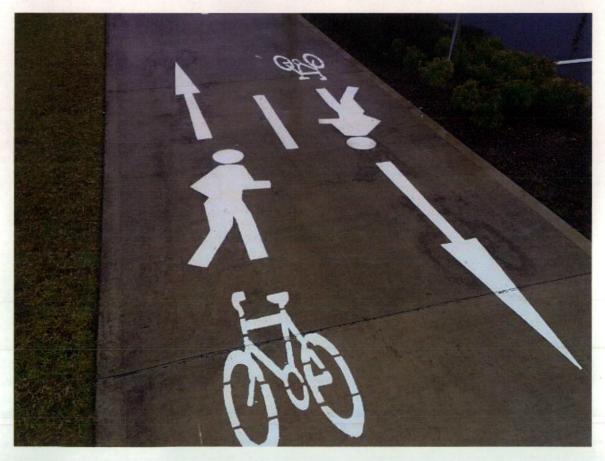
Figure 98 Damage to paint finish.

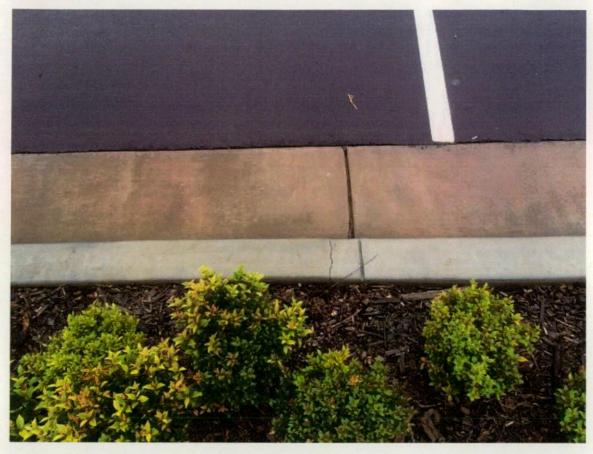
Figure 99 Crack in kerb.

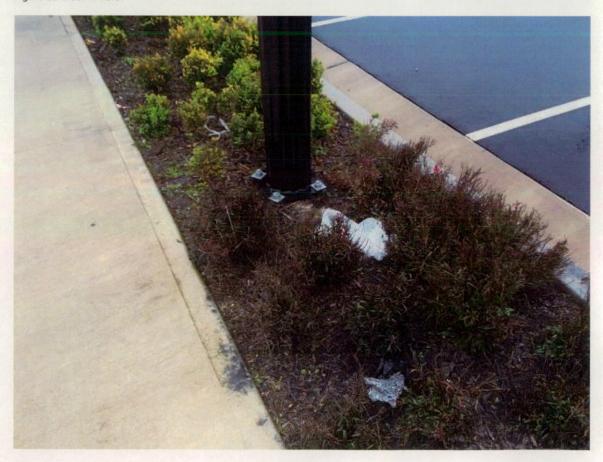
Figure 100 Rubbish in gardens.

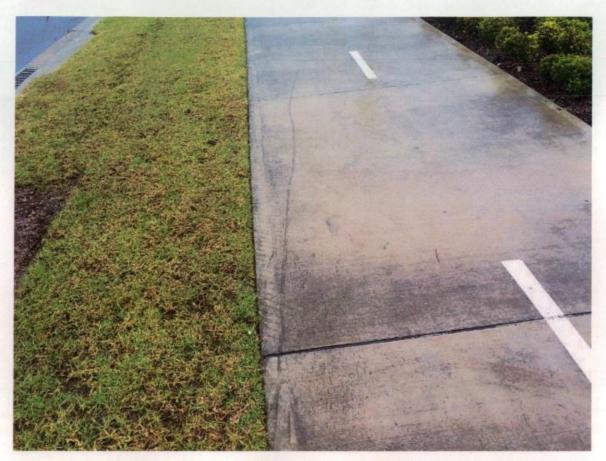
Figure 101 Marks on footpath.

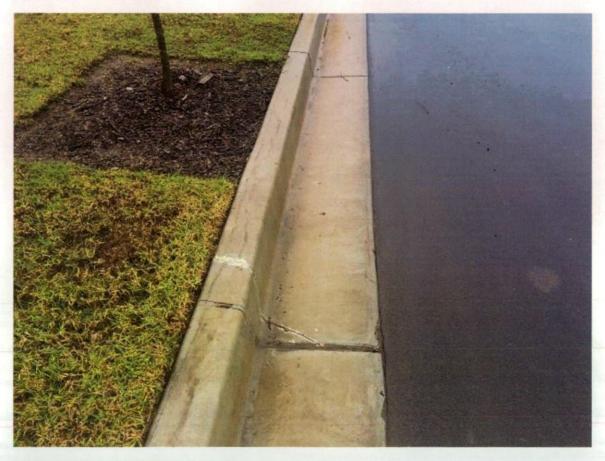
Figure 102 Crack that has been repaired in K&G.

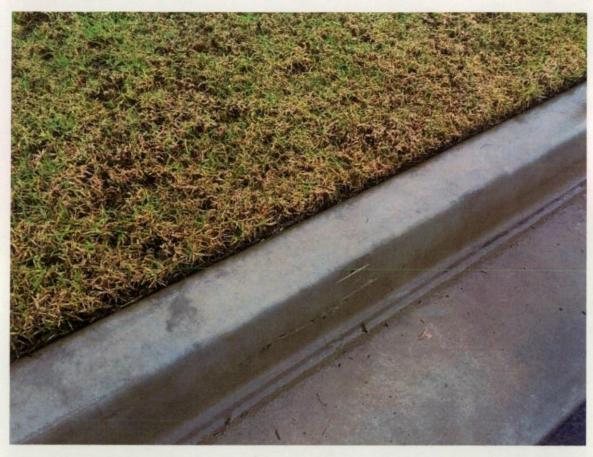
Figure 103 Damage to kerb.

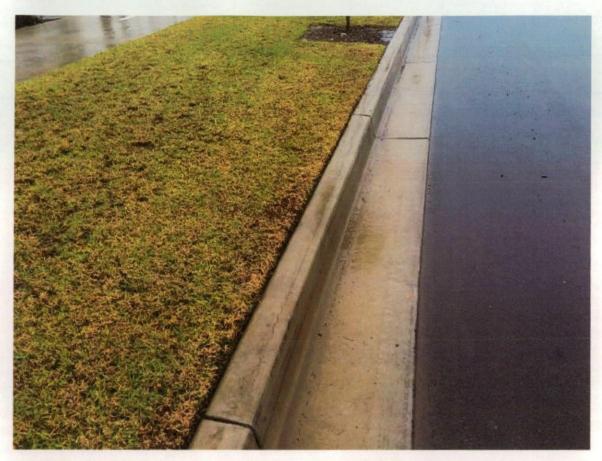
Figure 105 Marks on kerb.

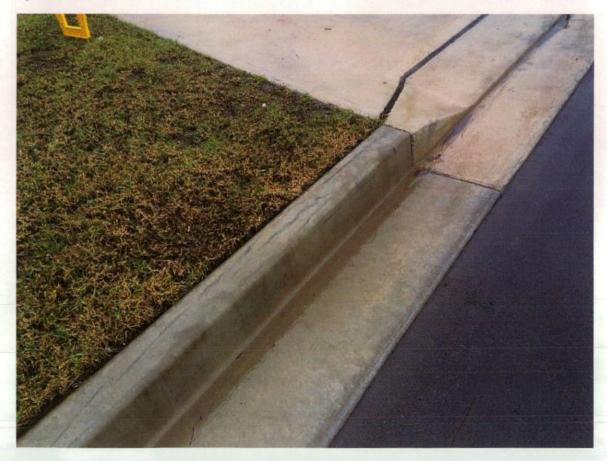
Figure 106 Marks on kerb.

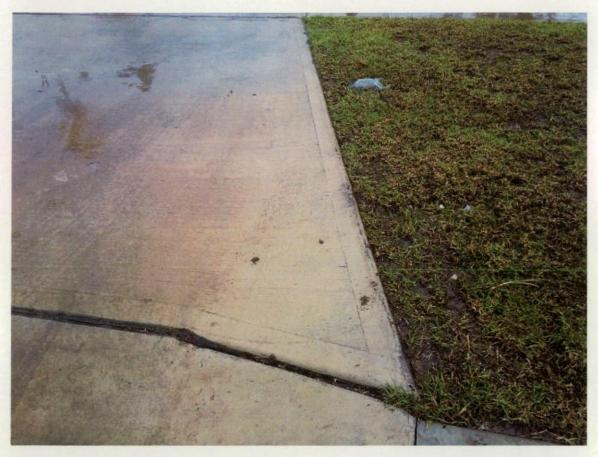
Figure 107 Surface imperfections to pram ramp wing.

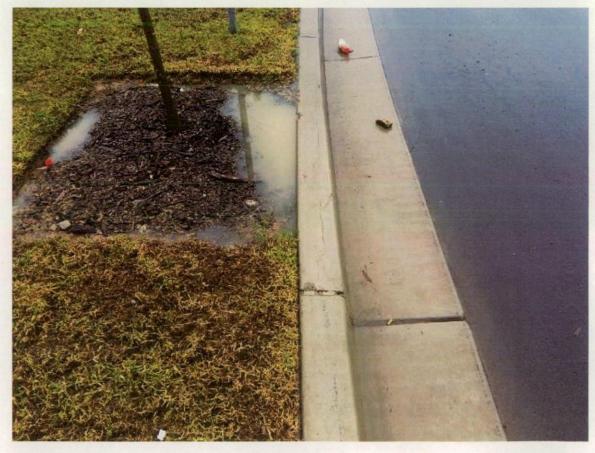
Figure 108 Holding water.

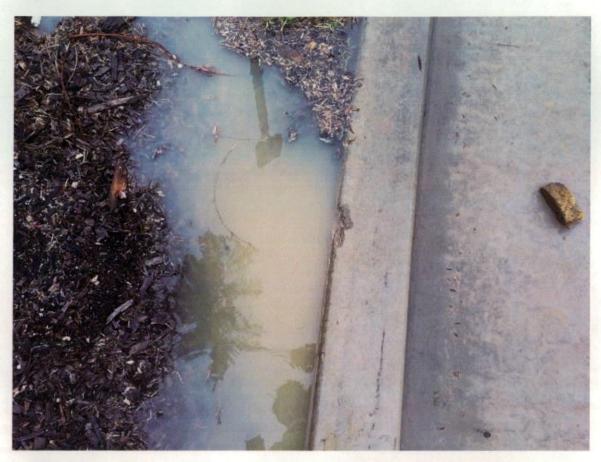
Figure 109 Holding water in footpath area.

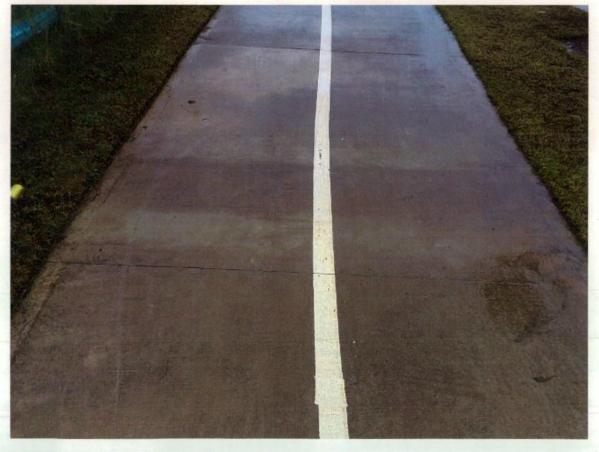
Figure 110 Surface marks on footpath and line marking.

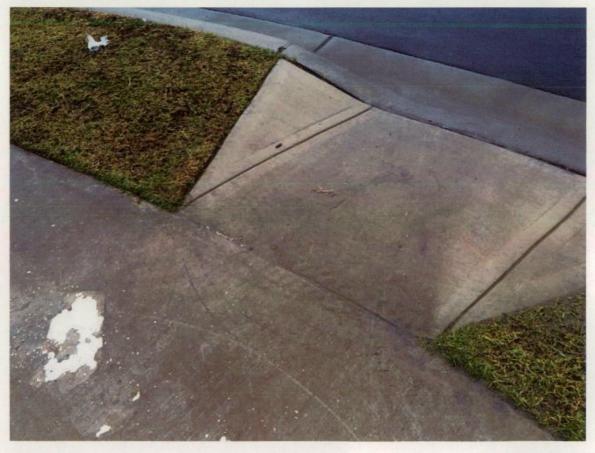
Figure 112 Stains to pram ramp.

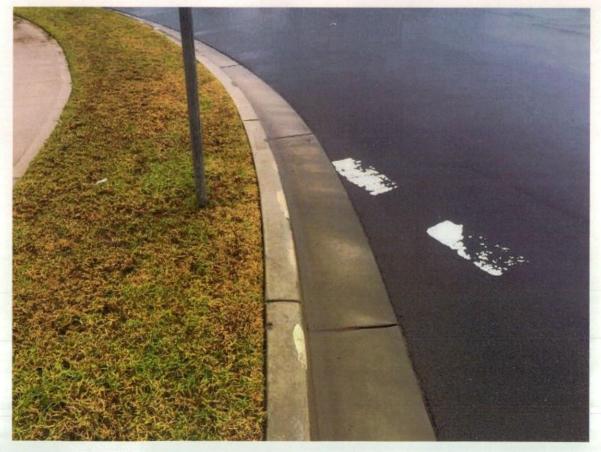
Figure 114 Repairs to K&G.

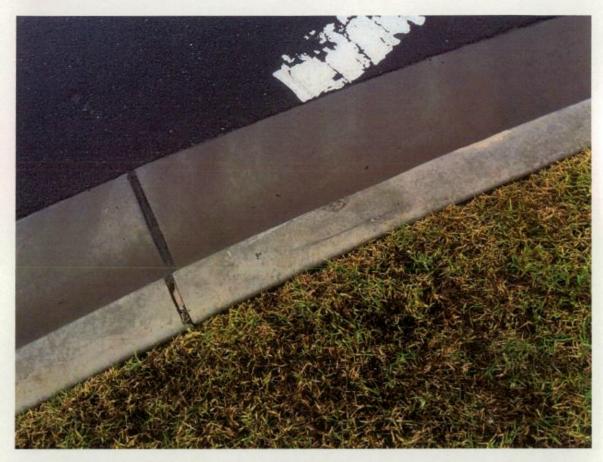
Figure 115 Chips in K&G.

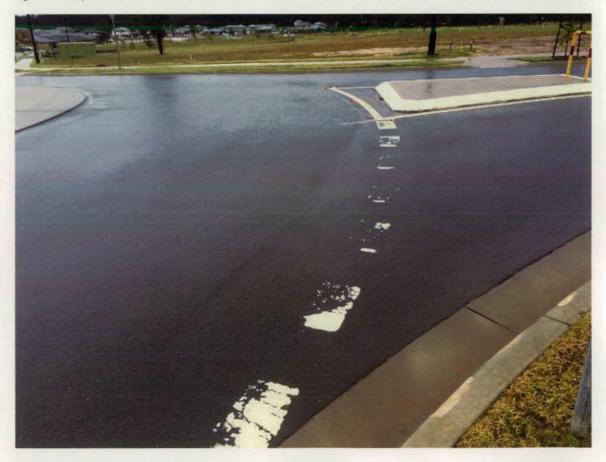
Figure 116 Line marking worn away.

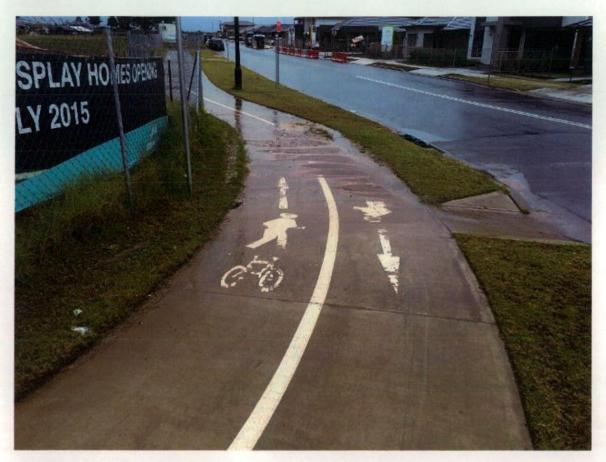
Figure 117 Damage to cycle way line marking.

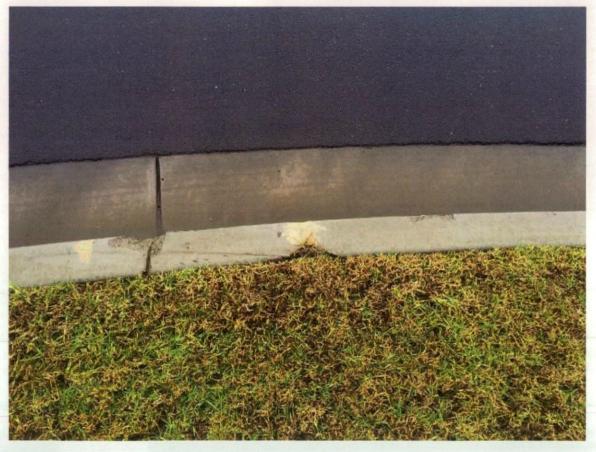
Figure 118 Damage to back of K&G.

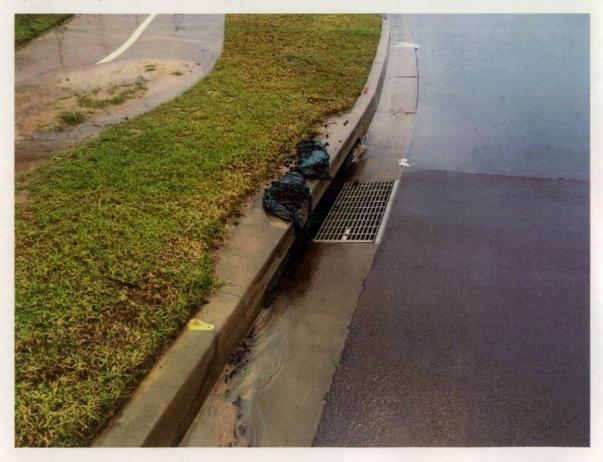
Figure 120 Existing sediment controls in disrepair.

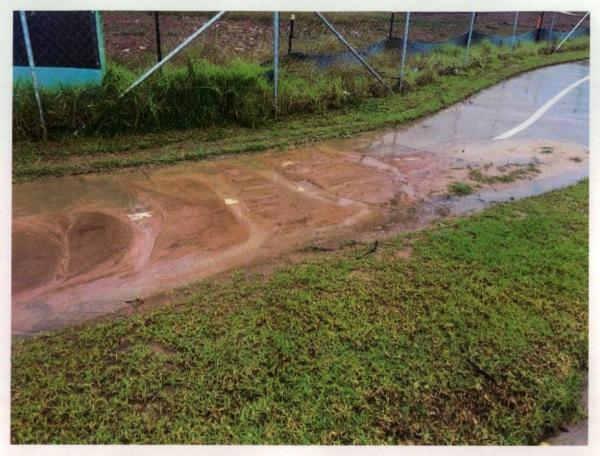
Figure 121 Footpath holding water and silt.

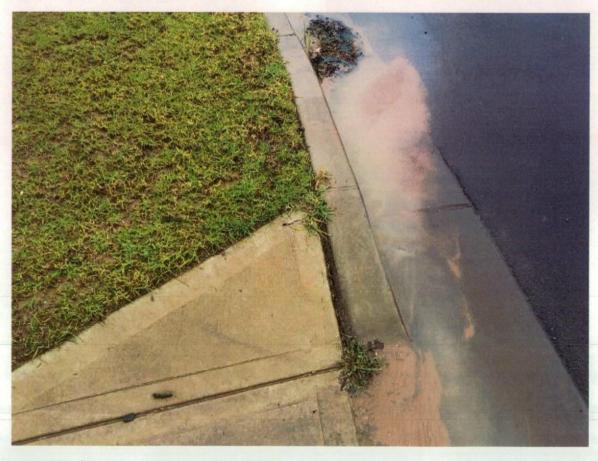
Figure 122 Surface marks to pram ramp, holding water.

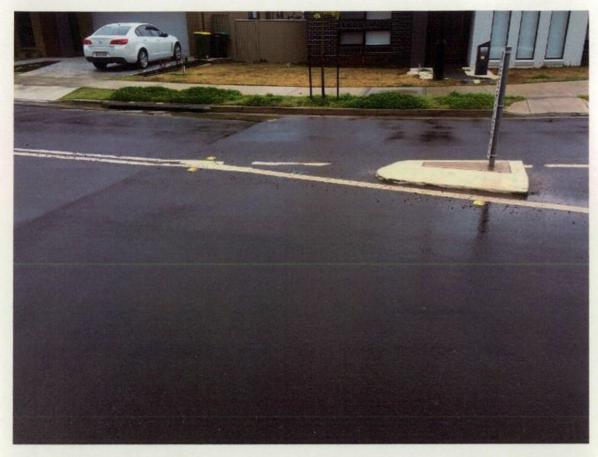
Figure 123 Line marking damaged.

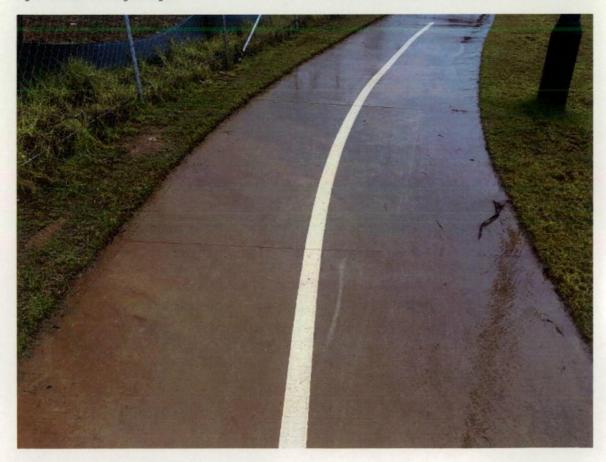
Figure 124 Line marking damaged.

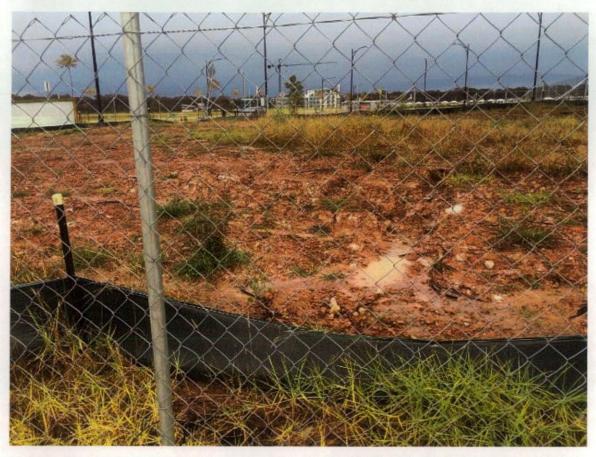
Figure 125 Subgrade holding water.

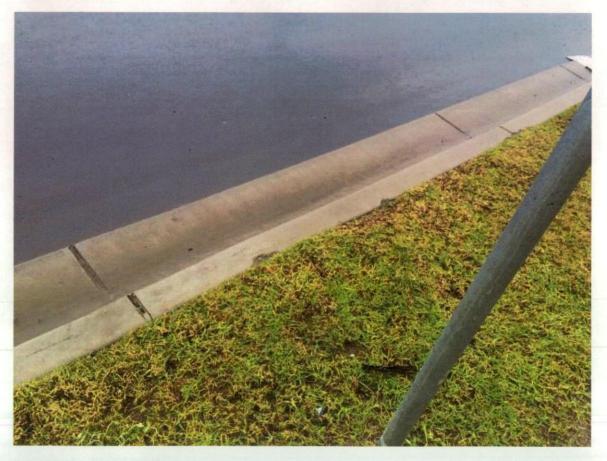
Figure 126 Chips to back of kerb.

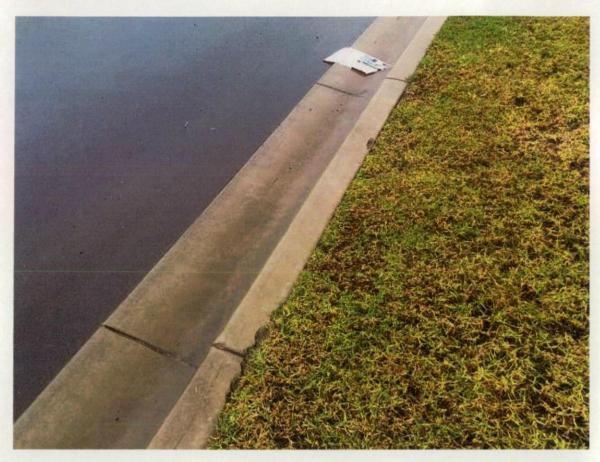
Figure 127 Chips to back of kerb.

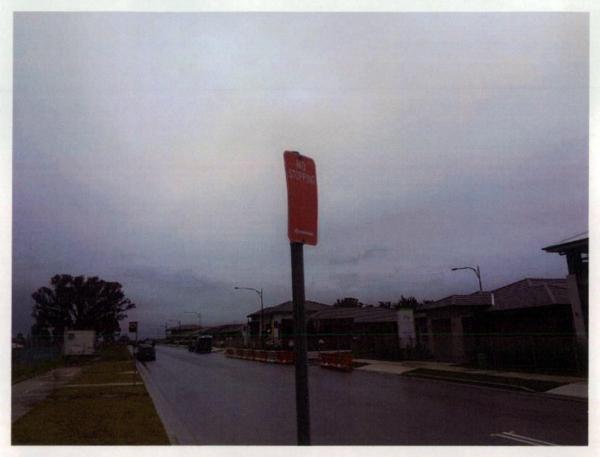
Figure 128 street sign damaged.

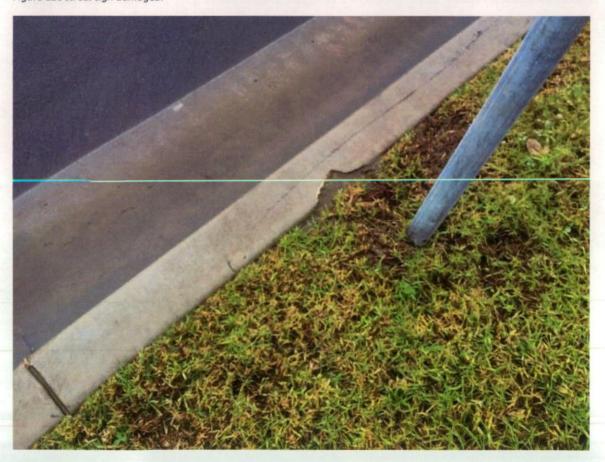
Figure 129 Chips to back of kerb.

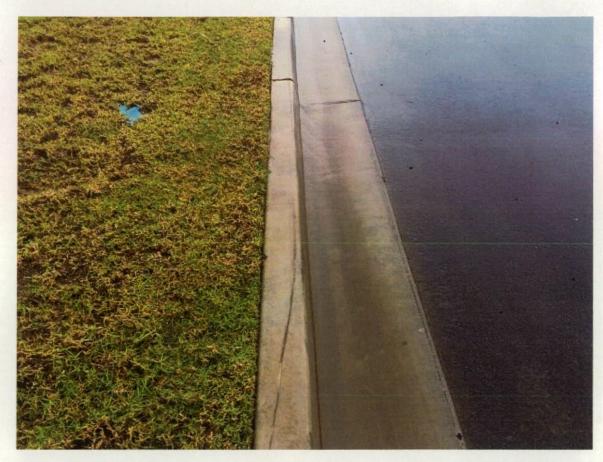
Figure 130 Marks to kerb.

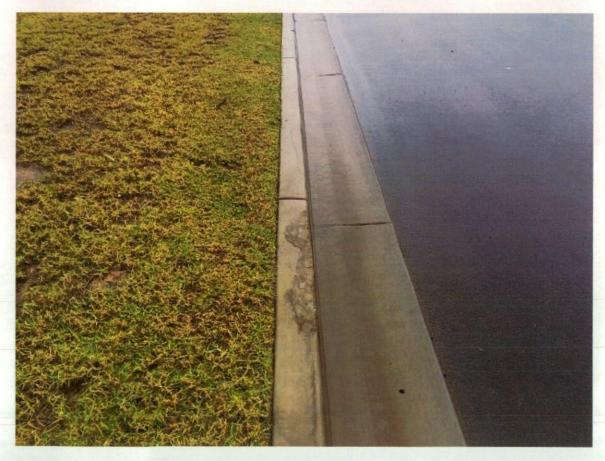
Figure 132 Patching work to kerb.

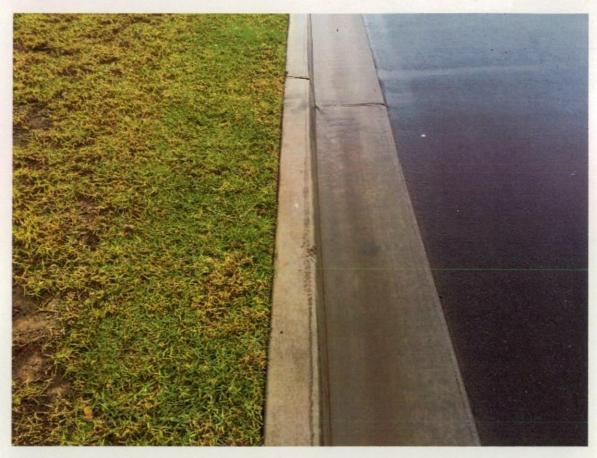
Figure 133 Damage to K&G.
