QUA004 - DILAPIDATION & SITE INSPECTION REPORT

Customer/Project Name: Lendlease - Village		ase - Village O	val, Jordan S	prings.						
Customer/Project Address: Cnr Alinta Promenad					de & Greenwood Parkway, Jordan Springs					
Job No.	28	45	Contract No).	724		Date:	21/07/	2015
Prepared by: Luke Cranson					Photos en	closed:	Yes 🖂	No [
Inspection	1				Notes & Co	omments				
Water		Nearside	⊠ Fa	r-side 🖂						
Electricity	•	Aerial 🛛	Unde	erground 🛛						
Sewer		Yes 🖂	No 🗌							MIL .
Septic		Yes 🗌	No 🛛		Туре					
Kerb & Gu	itter	Yes 🖂	No 🗌		Damage	Yes 🖂	No 🗌			
Layback		Yes 🖂	No 🗌		Damage	Yes 🛛	No 🗌			
Footpath Yes		Yes 🖂	No 🗌		Damage	Yes 🖂	No 🗌			
Vehicle Ac	ccess	Good 🛛	Need	s Work 🗌						
Boundary Pegs		Yes 🗌	No 🛚				TOM:			
Existing Fe	encing	Yes 🖂	No 🗌		Туре	Builder	s Temporar	y, chain lir	nk perimet	er fence
Subsoil		Existing		1						
Excavation		Yes 🖂	No 🗌							
Trees Yes 🗵		Yes 🖂	No 🗌					DEC	EIVE	
	Stor	mwater							MGT	
Other:								2 3	JUL 2015

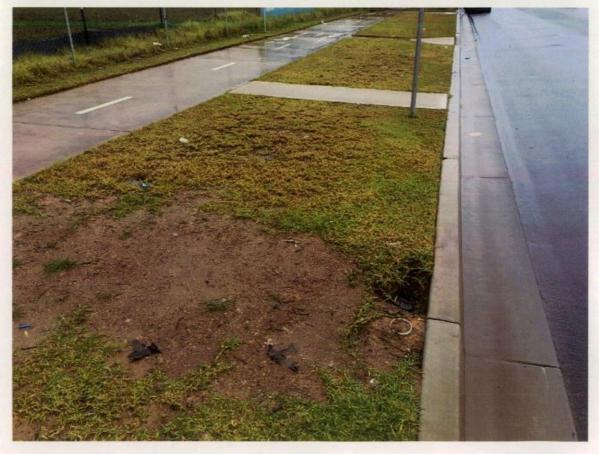
Figure 134 Grass has not grown.

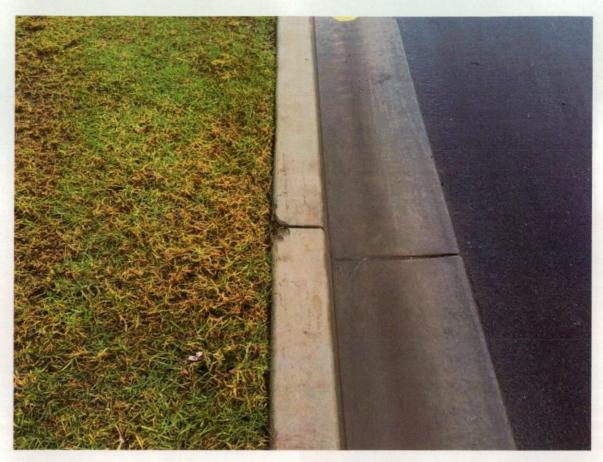
Figure 135 Chips to back of kerb.

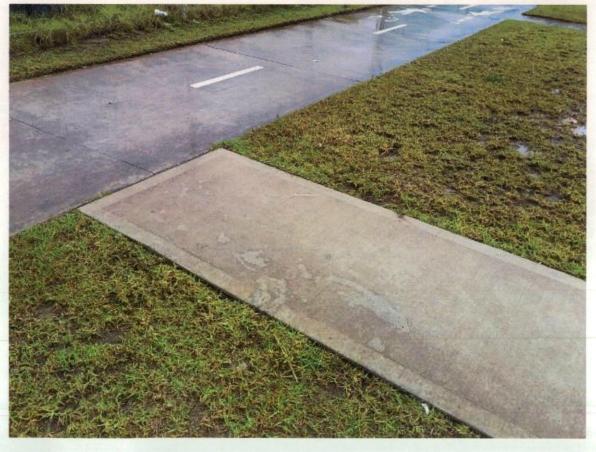
Figure 136 Concrete stains to footpath.

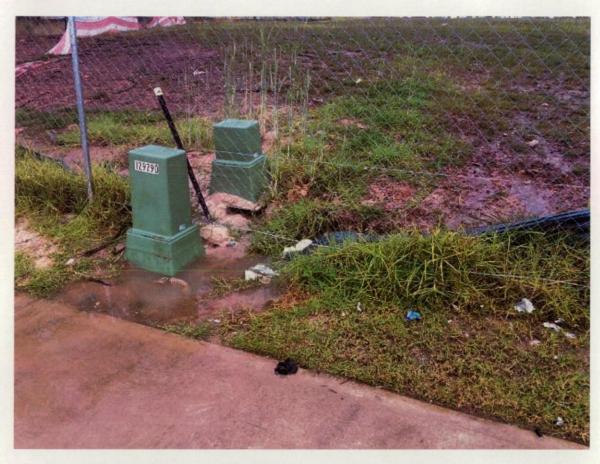
Figure 137 Subgrade and sand erosion, silt controls failing.

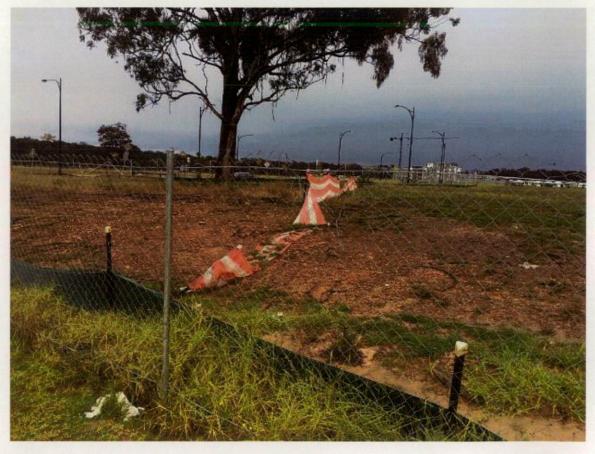
Figure 138 Damage to temp fencimg.

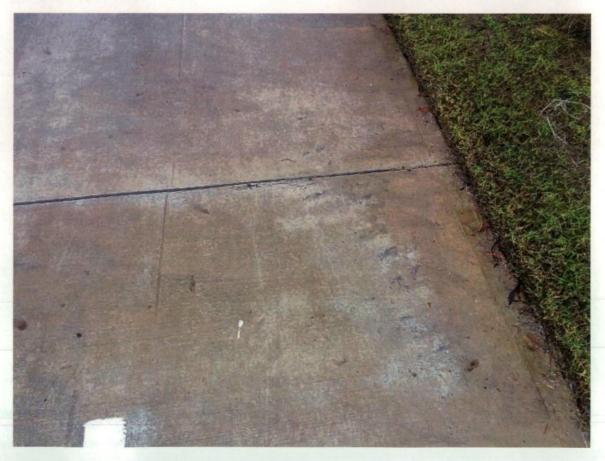
Figure 140 Scratches and damage by machinery to footpath.

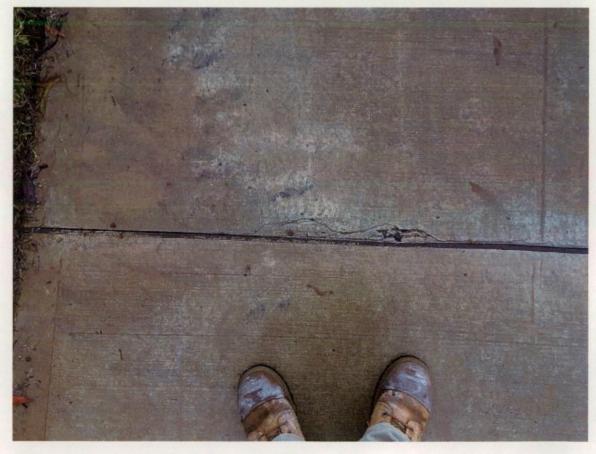
Figure 141 Damage to footpath surface.

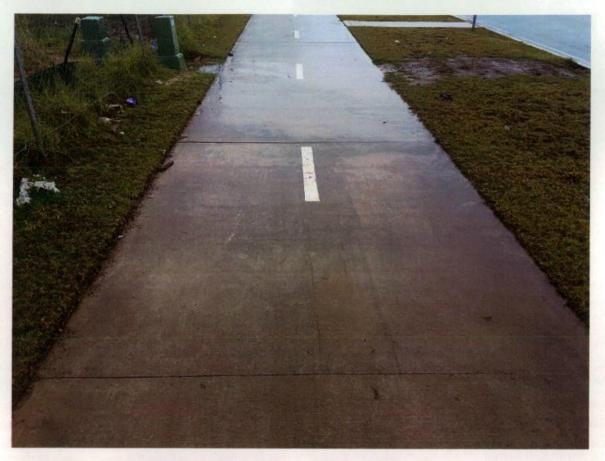
Figure 142 Machinery damage to footpath.

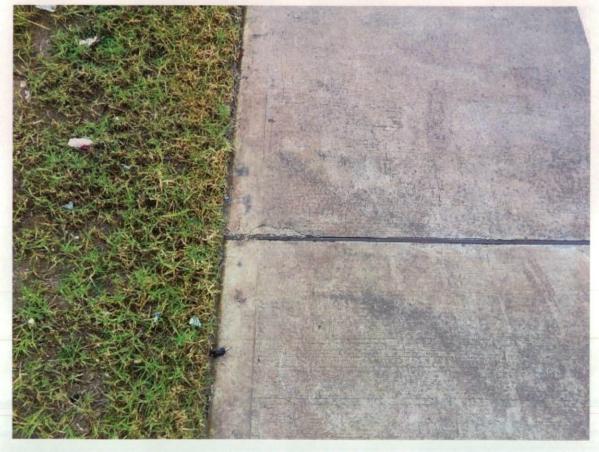
Figure 143 Surface marks on footpath.

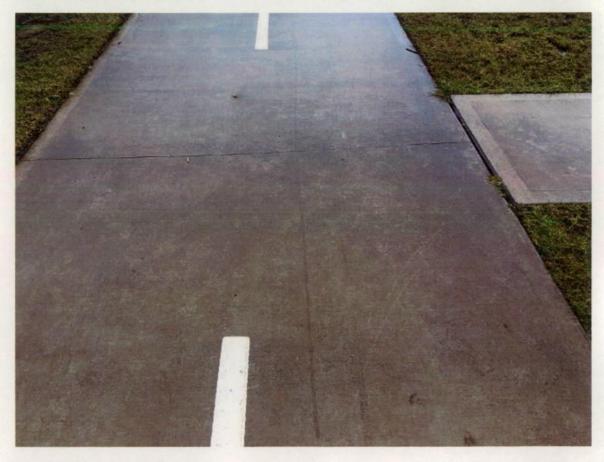
Figure 145 Surface damage to footpath.

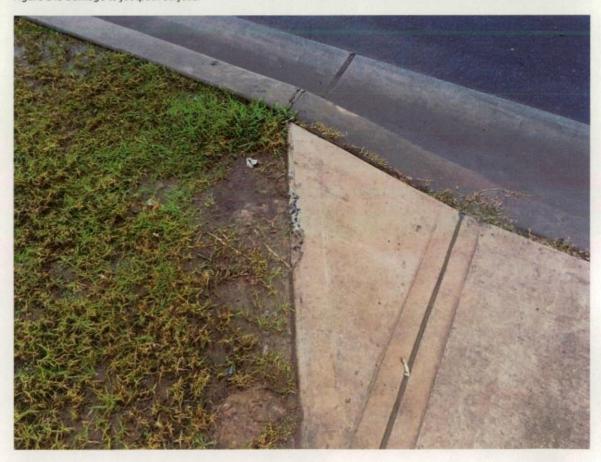
Figure 149 Damage to footpath surface.

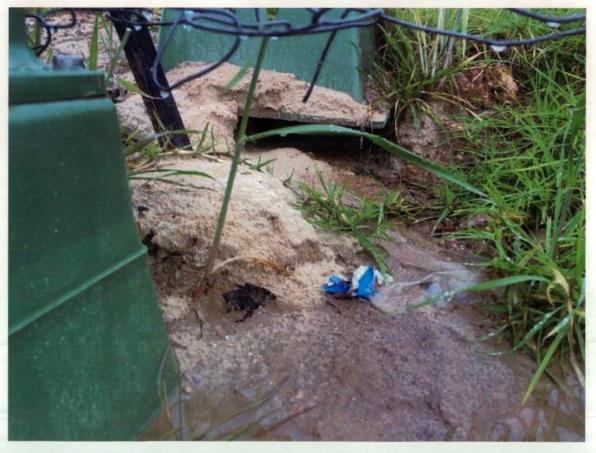
Figure 155 Damage to turf and areas where soil is low.

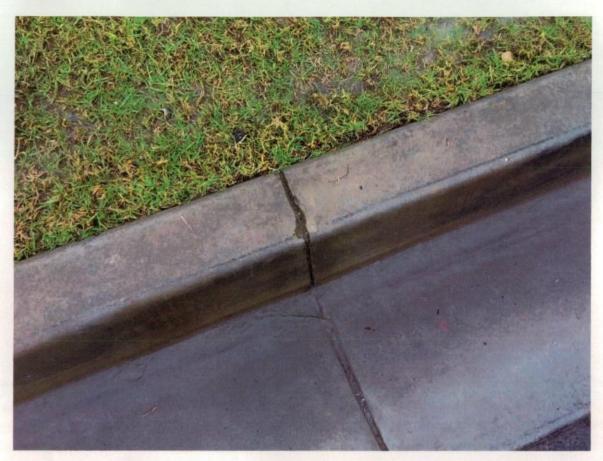
Figure 159 Damage on kerb joint.

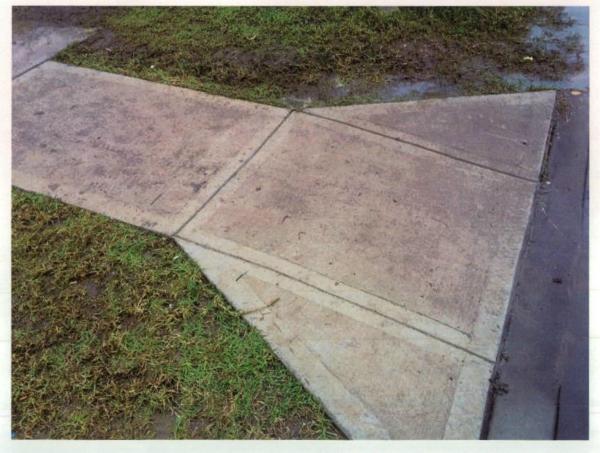
Figure 160 Stains on footpath surface.

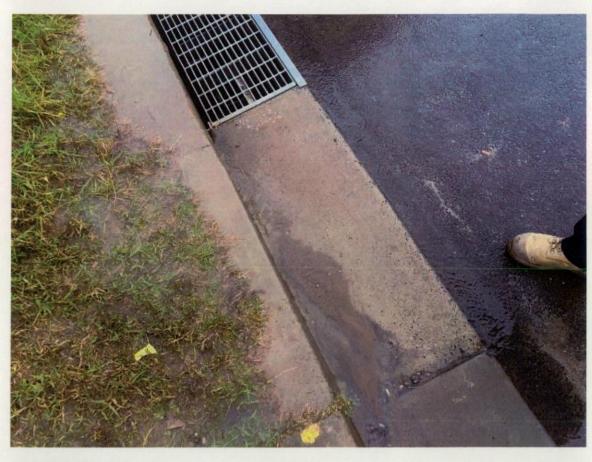
Figure 161 Lintel appears overexposed.

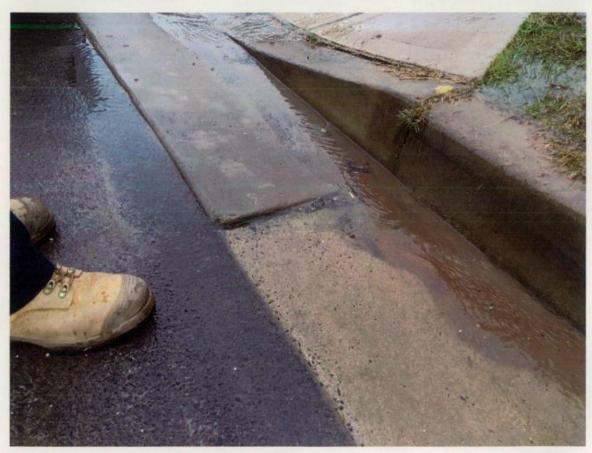
Figure 162 Lintel and pram ramp at different level.

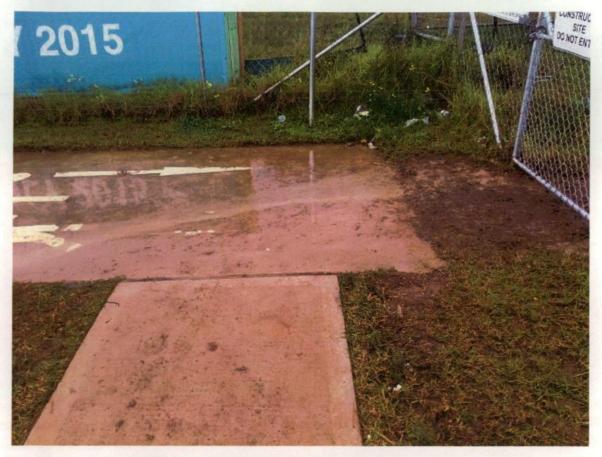
Figure 163 Erosion and soil egress from site.

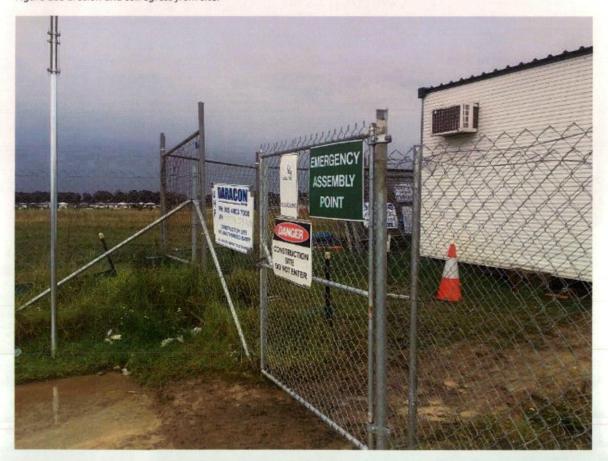
Figure 164 Existing state of Daracon site office.

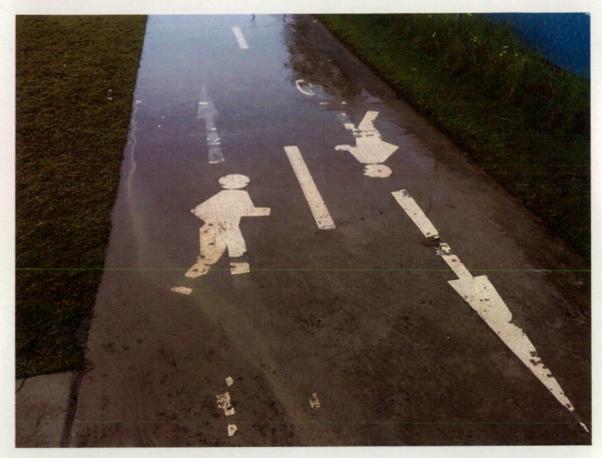
Figure 165 Damage to cycleway line marking, soil egress.

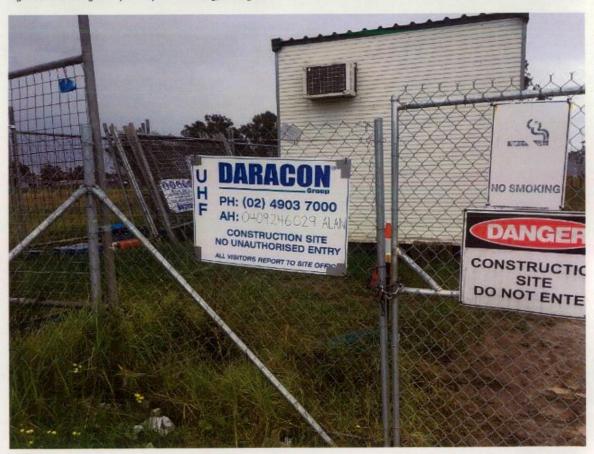
Figure 166 Existing state of Daracon site office.

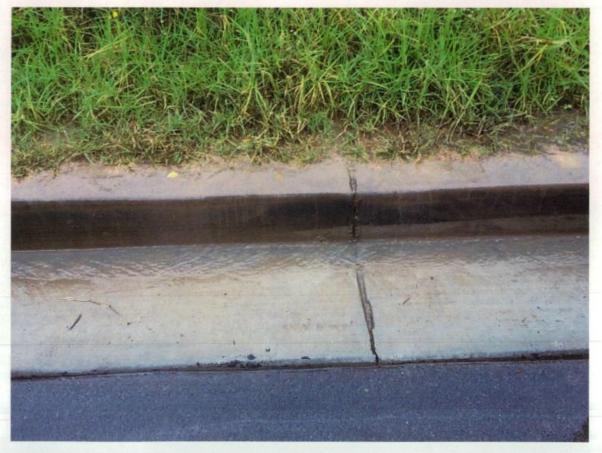
Figure 168 Staining to kerb.

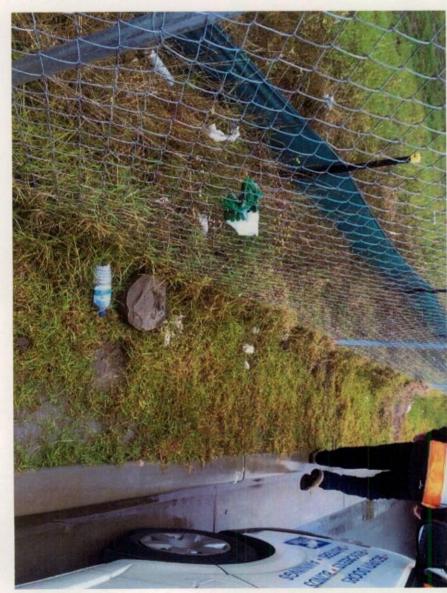
Figure 170 Existing rubbish.

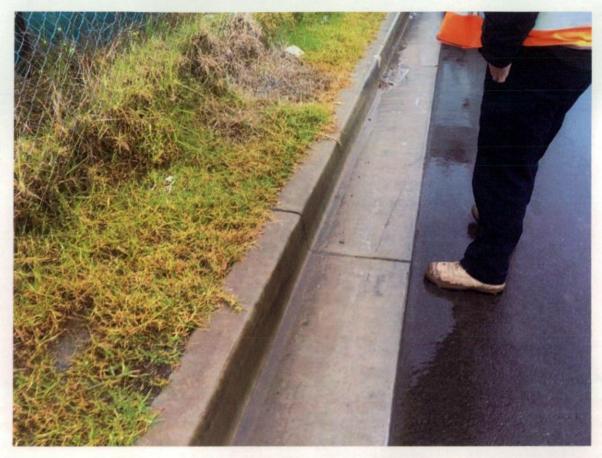
Figure 171 concrete splatter on kerb.

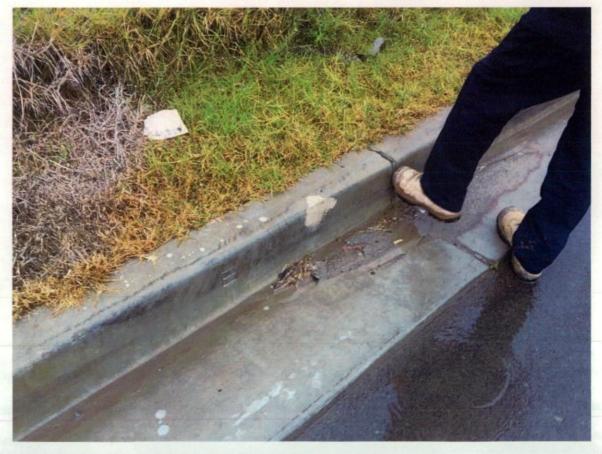
Figure 172 Patching on kerb.

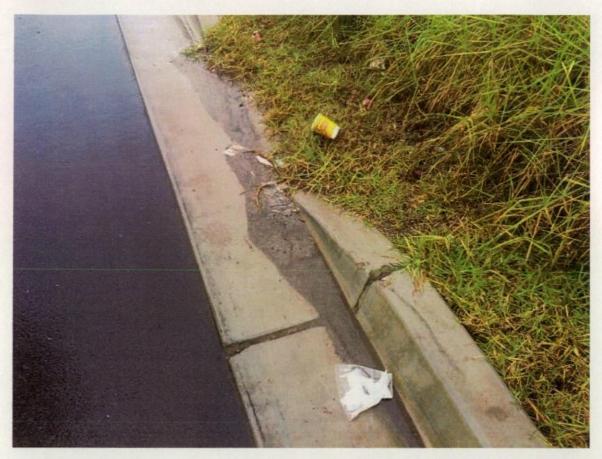
Figure 173 Silt and damage to joint.

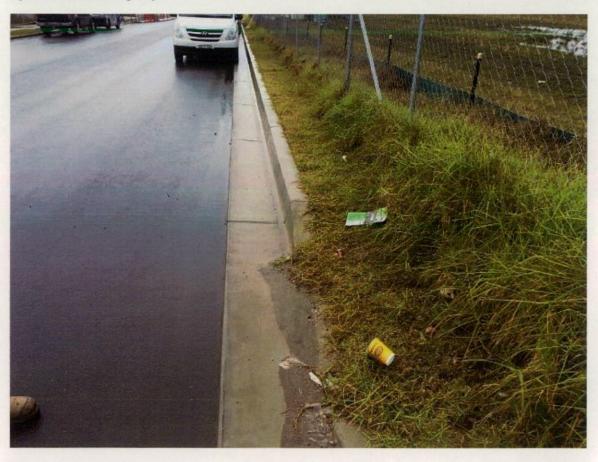
Figure 174 Existing silt in K&G.

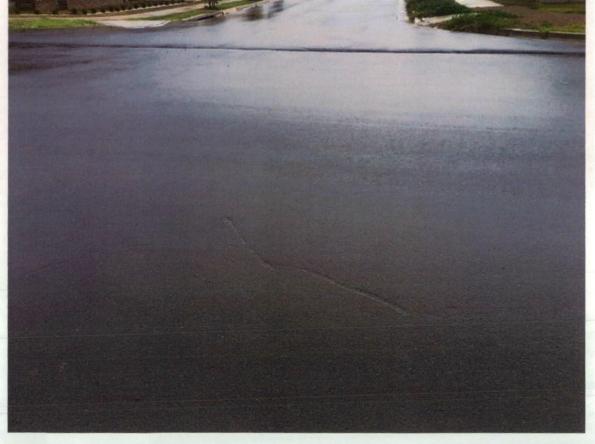
Figure 176 Gouge in existing asphalt.

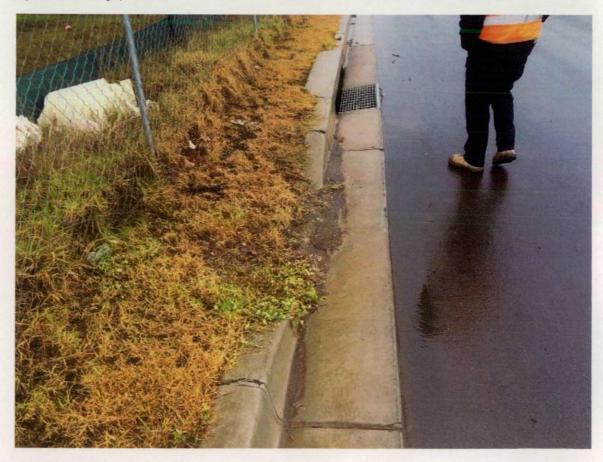
Figure 178 Silt in K&G.

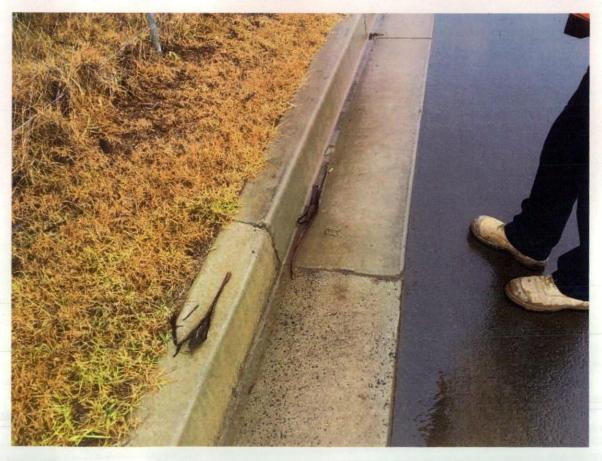
Figure 180 lintel appears overexposed.

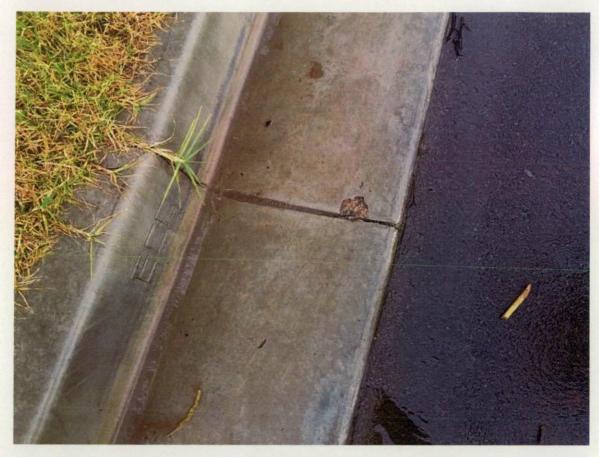
Figure 181 Damage to gutter.

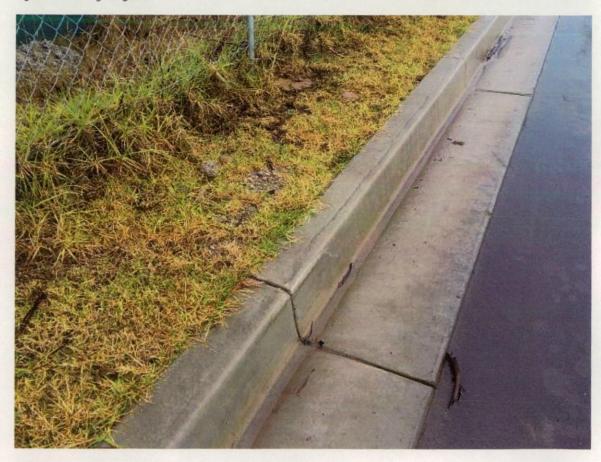
Figure 182 Surface stains on kerb.

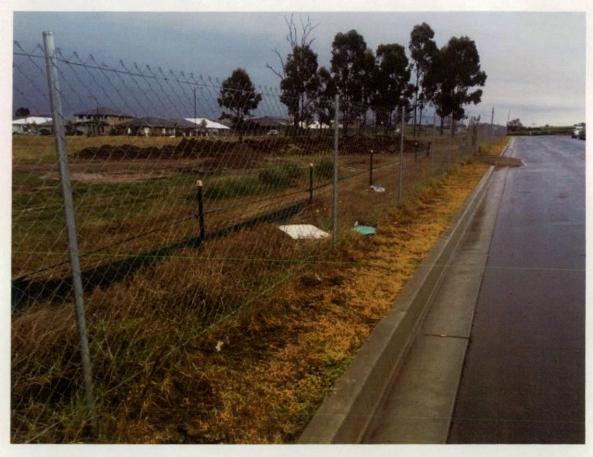
Figure 185rubbish and spoil existing on site.

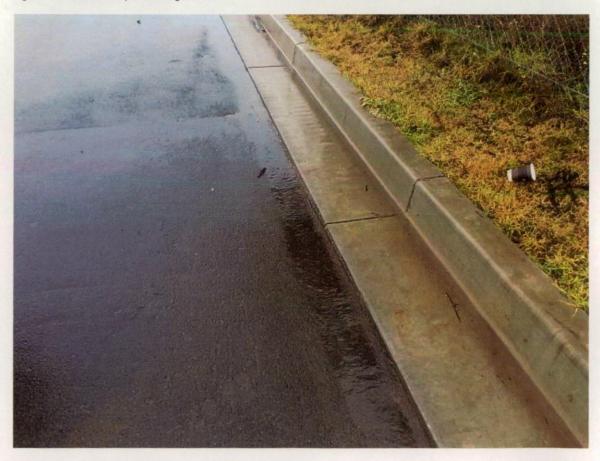
Figure 186 Asphalt surface inconsistent.

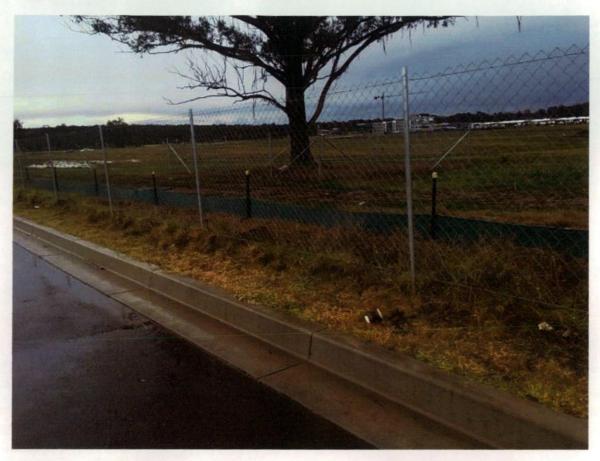
Figure 187 existing state of tree.

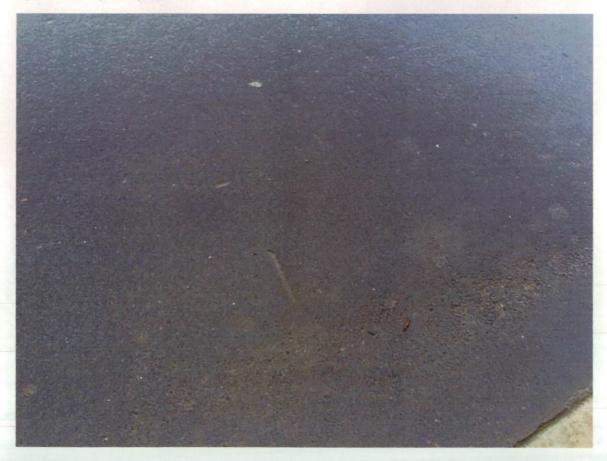
Figure 188 Damage to road surface.

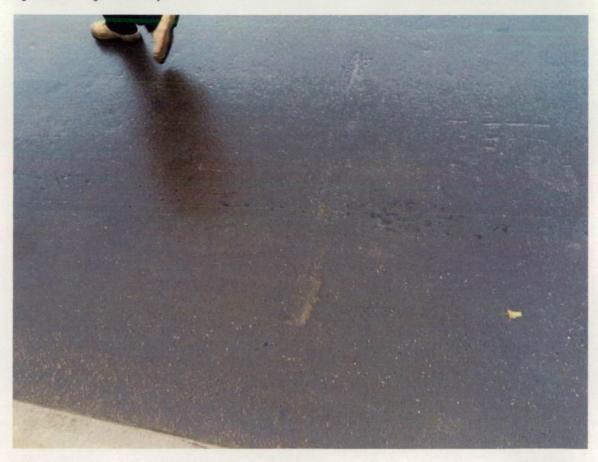
Figure 193 Damage to road surface.

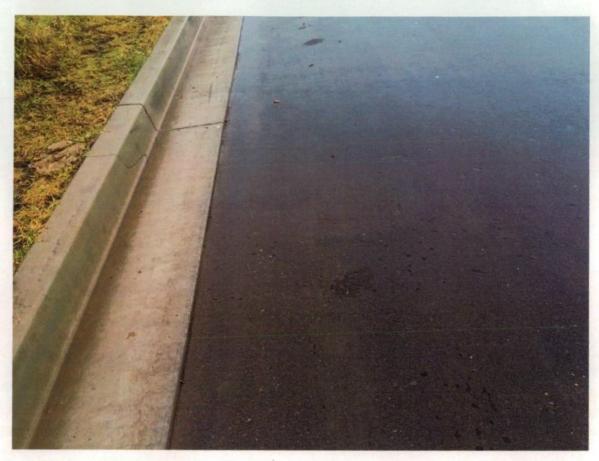
Figure 194 Damage to road surface.

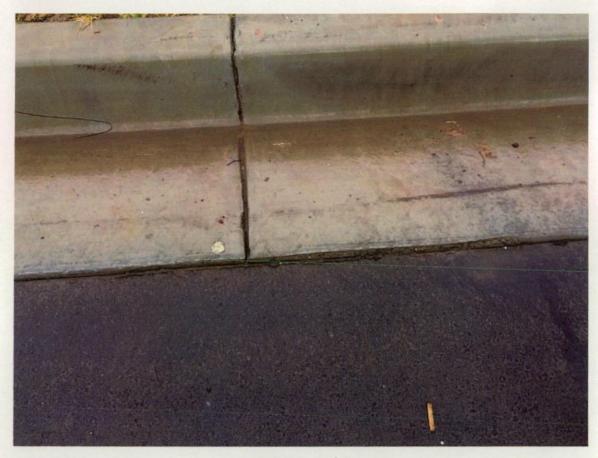
Figure 196 Damage to road surface.

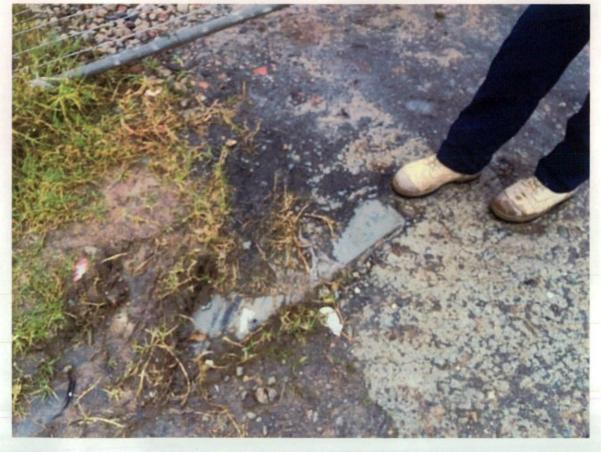
Figure 199 Site entry, ensure no damage to kerb underneath.

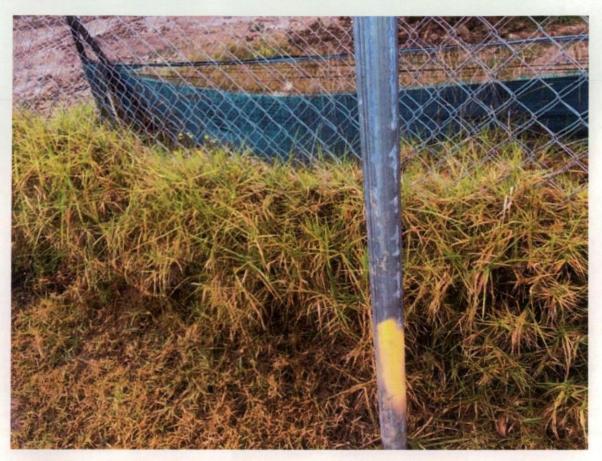
Figure 202 Kerb damage and staining from site access.

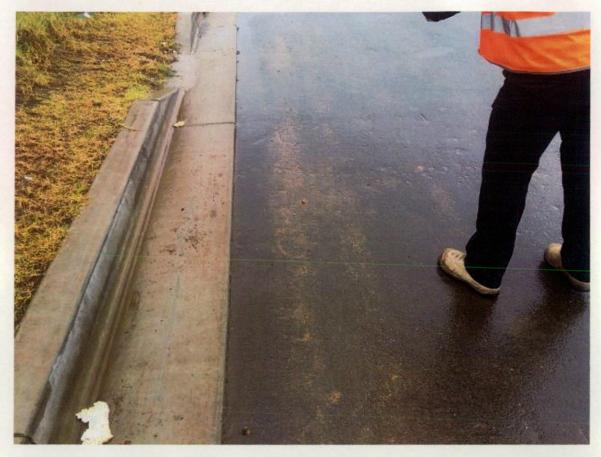
Figure 204 Stains on road surface.

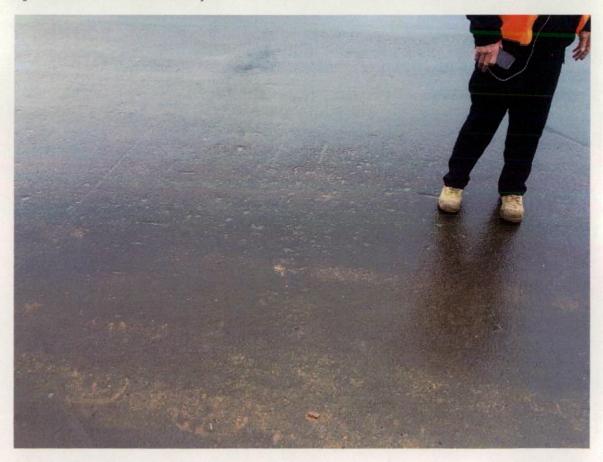
Figure 205 Stains and marks on road surface.

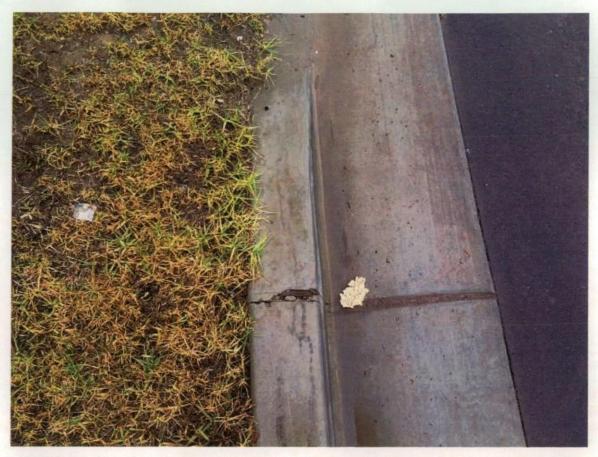
Figure 206 Pitting on asphalt surface.

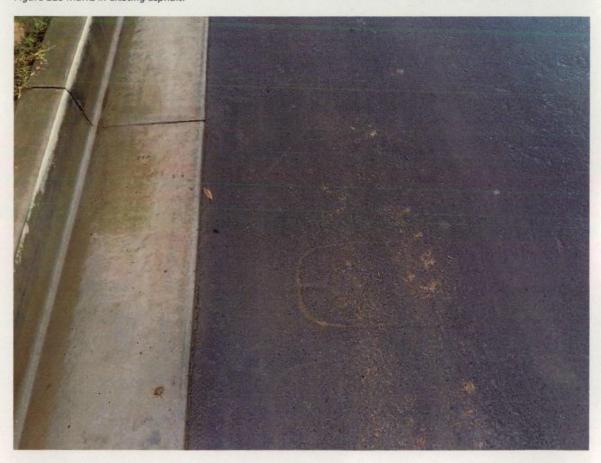
Figure 213 Marks in existing asphalt.

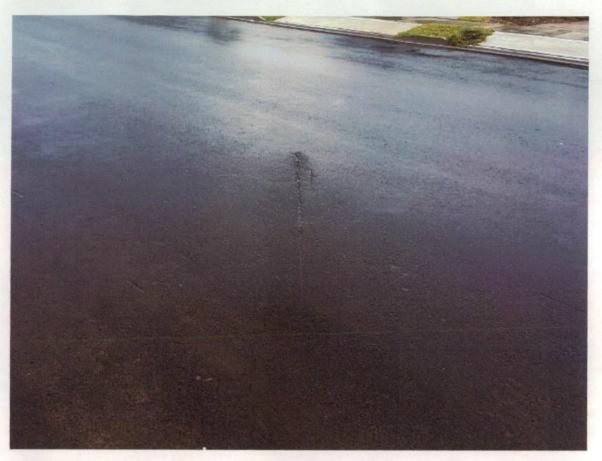
Figure 214 Marks in existing asphalt.

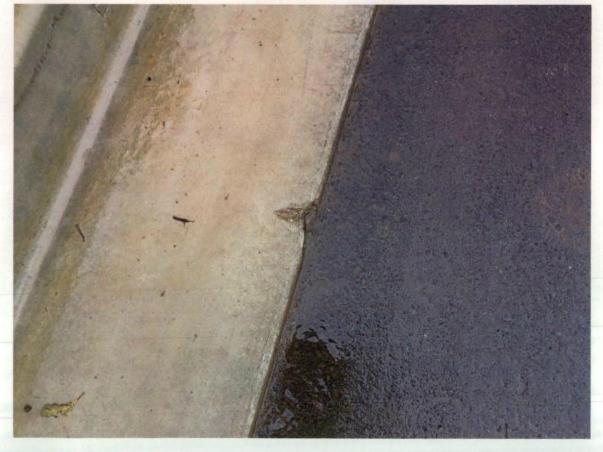
Figure 219 Damage to gutter lip.

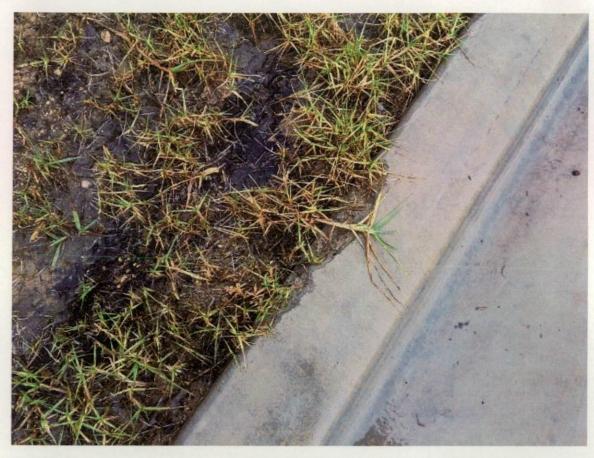
Figure 220 Damage to gutter lip.

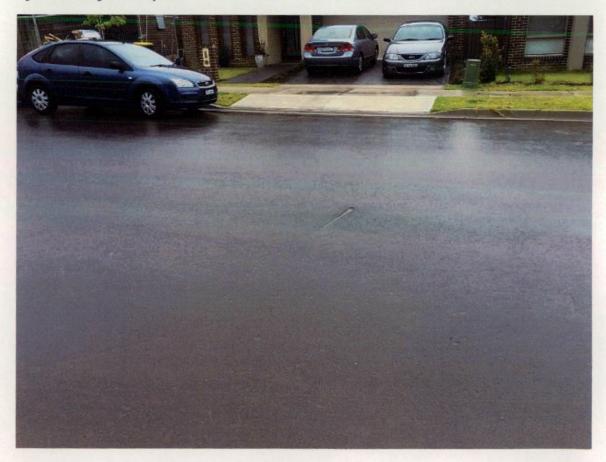
Figure 221 Damage to back of kerb.

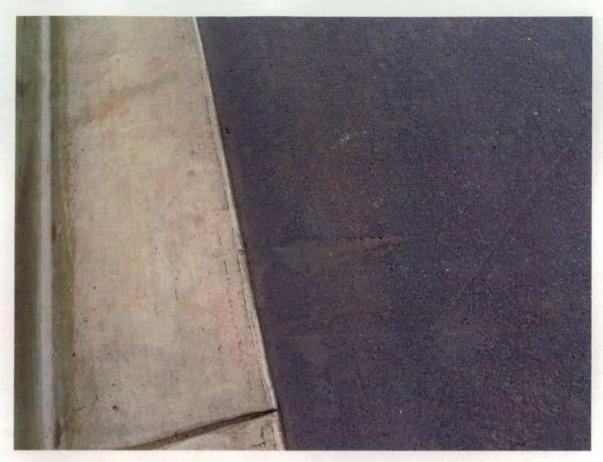
Figure 222 Gouge in asphalt surface.

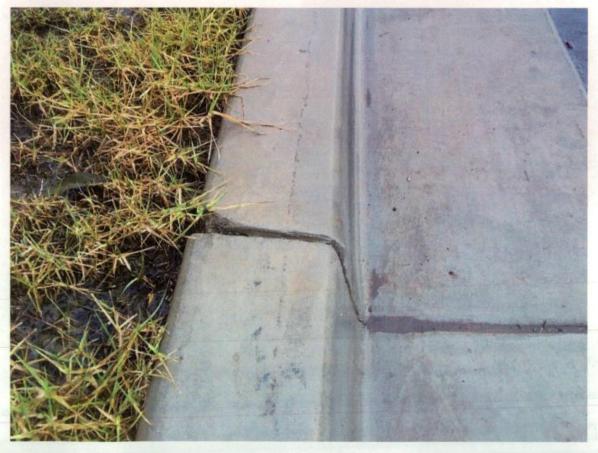
Figure 223 Damage to asphalt surface.

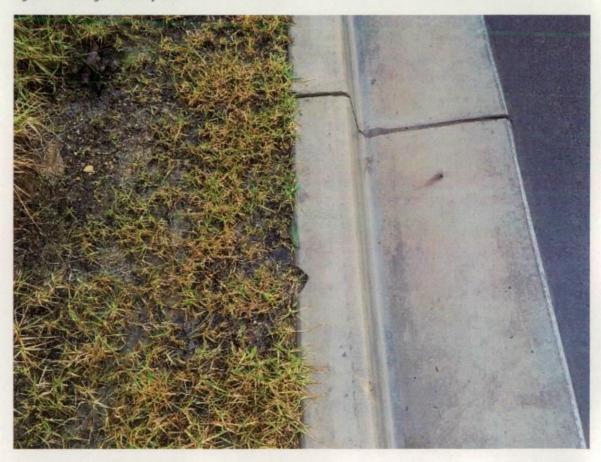
Figure 225 Damage on back of kerb.

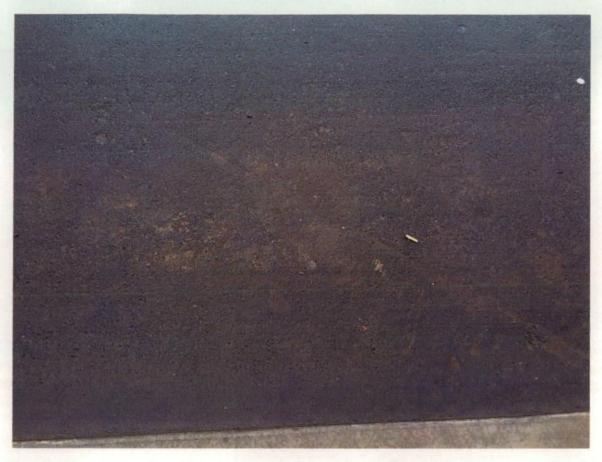
Figure 226 Damage on back of kerb.

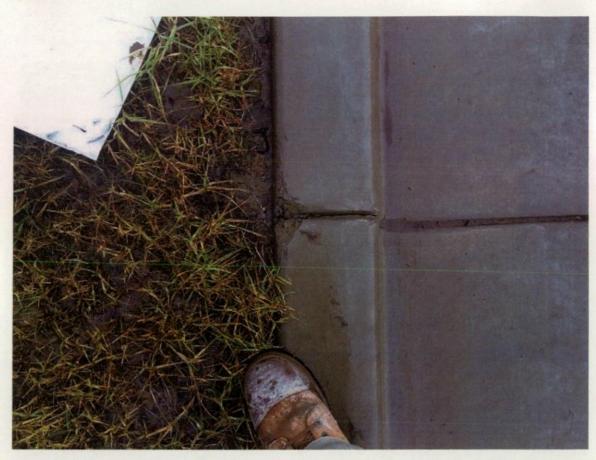
Figure 227 Damage to asphalt surface.

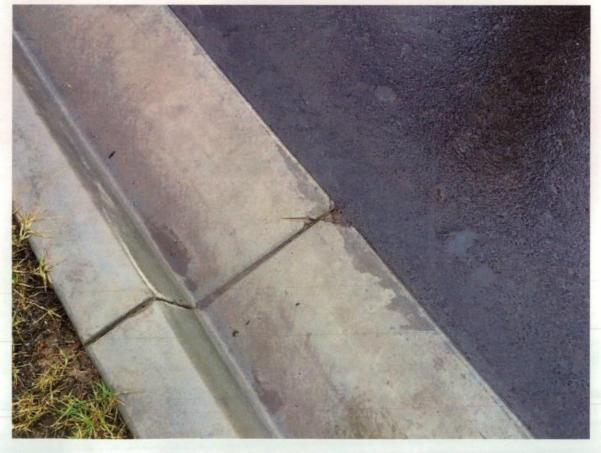
Figure 229 Damage on back of kerb.

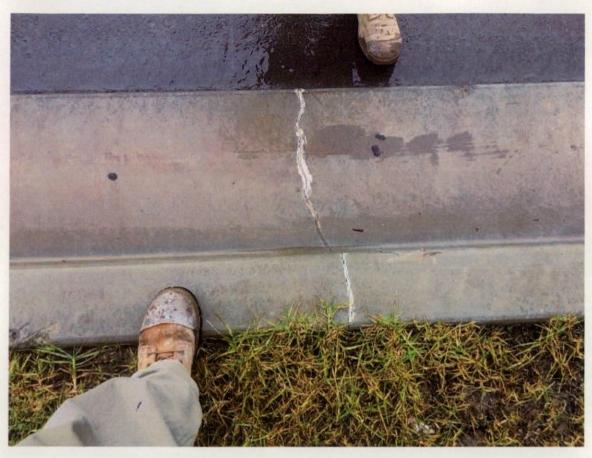
Figure 230 Damage to gutter lip.

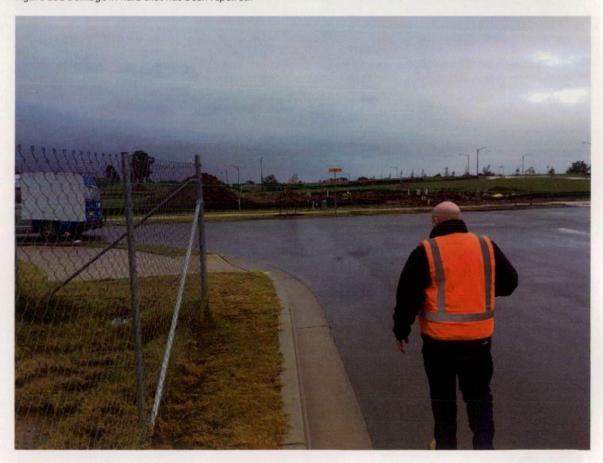
Figure 231 Damage in K&G that has been repaired.

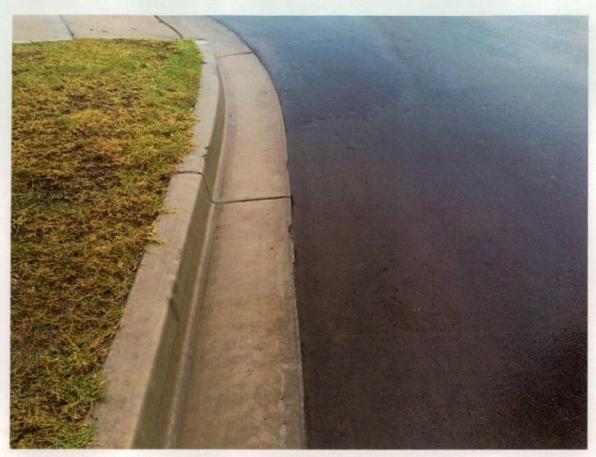
Figure 232 Existing state of asphalt on corner.

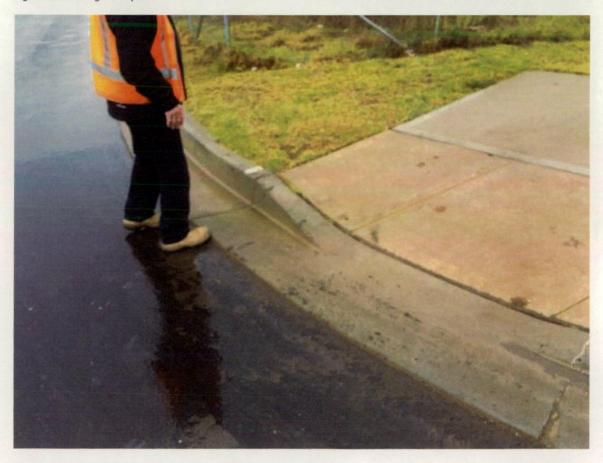
Figure 235 Damage to asphalt.

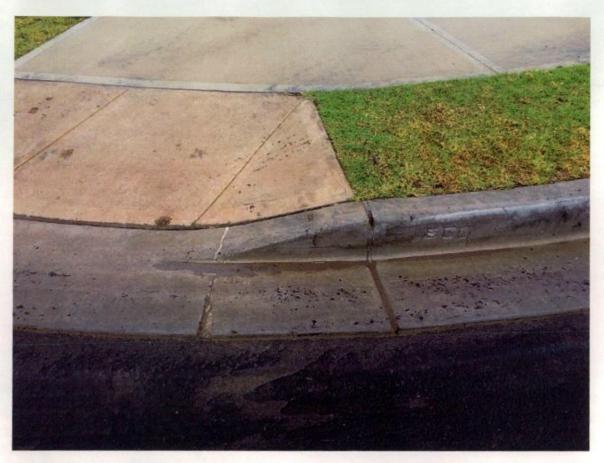
Figure 236 Bitumen stains on pram ramp and K&G.

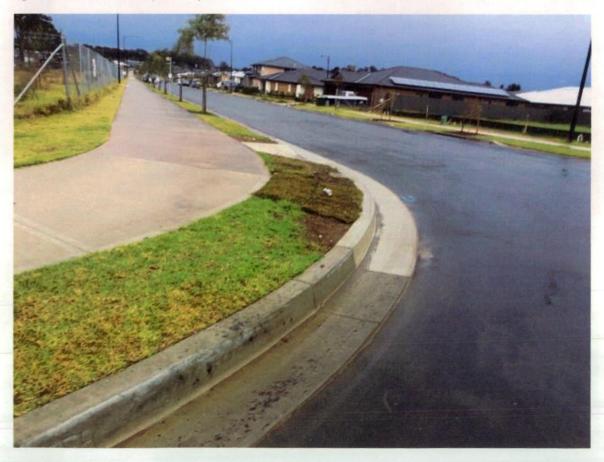
Figure 237 Bitumen stains on pram ramp and K&G.

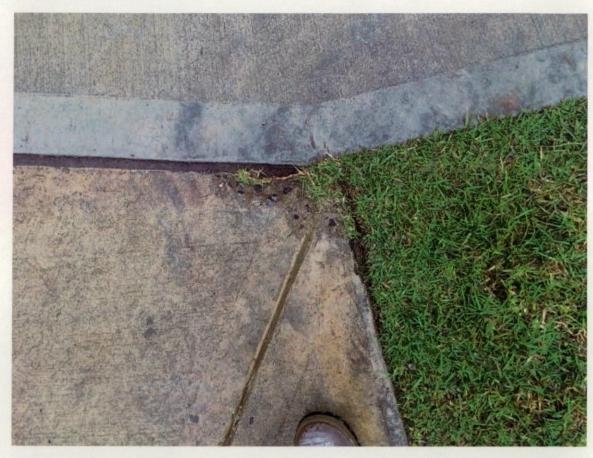
Figure 239 Damage to pram ramp.

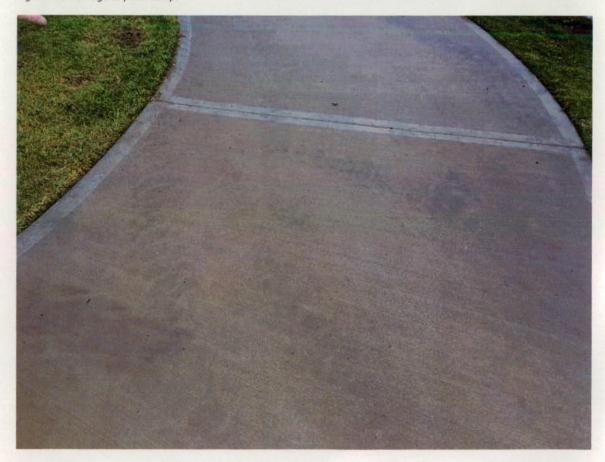
Figure 240 Tyre marks on pavement.

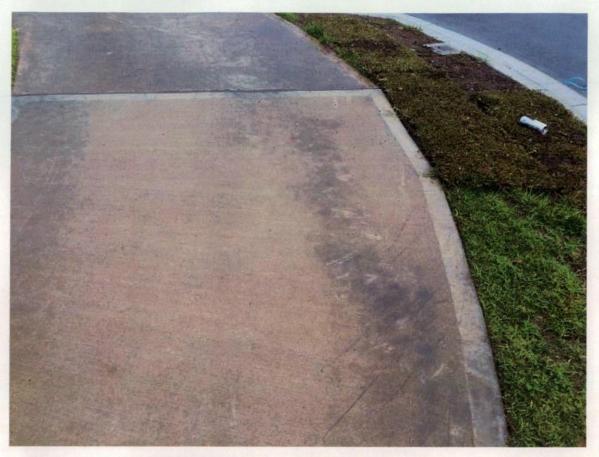
Figure 241 Tyre marks on pavement.

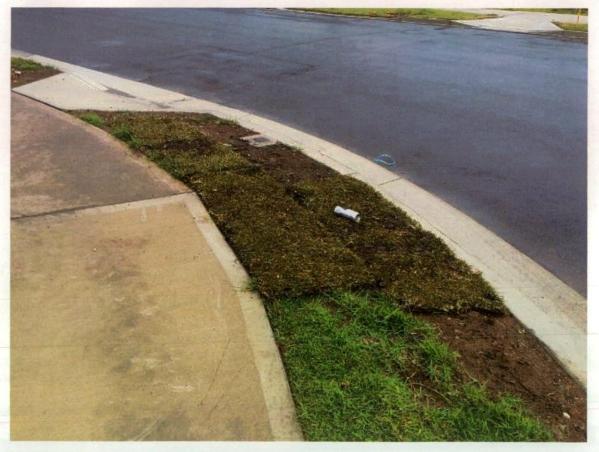
Figure 242 Turf damaged.

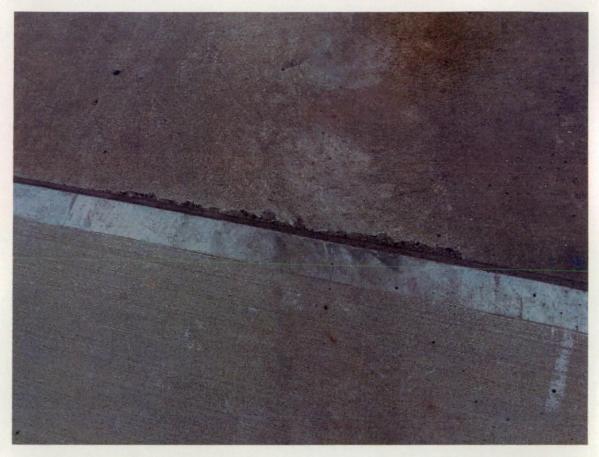
Figure 243 Concrete surface damaged.

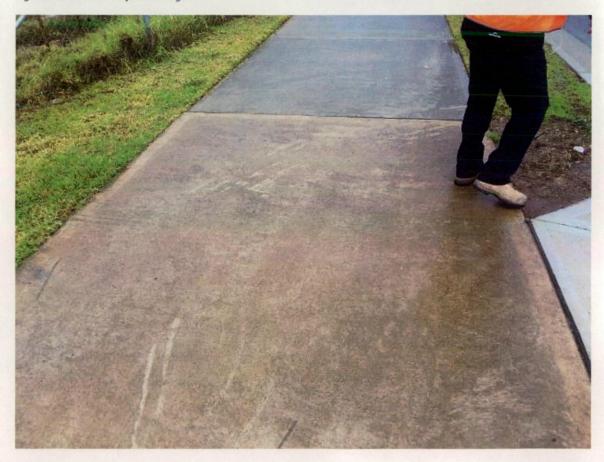
Figure 244 Concrete damage and staining.

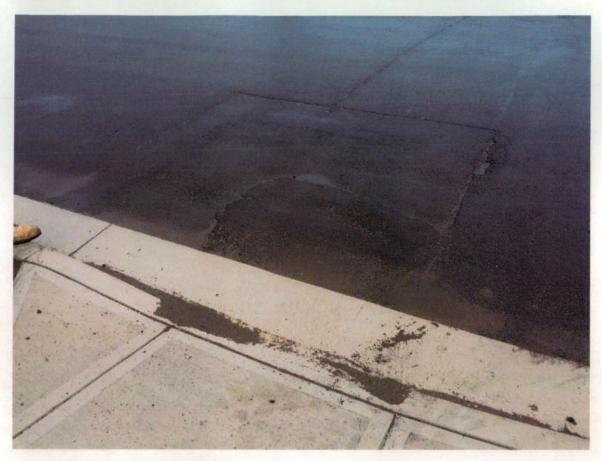
Figure 245 Asphalt has uneven finish.

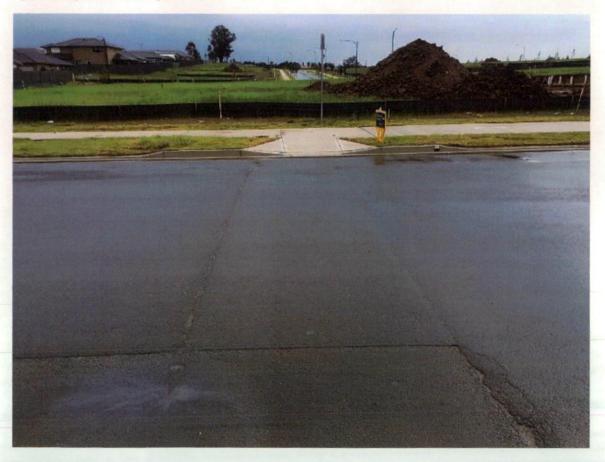
Figure 246 Asphalt has uneven finish.

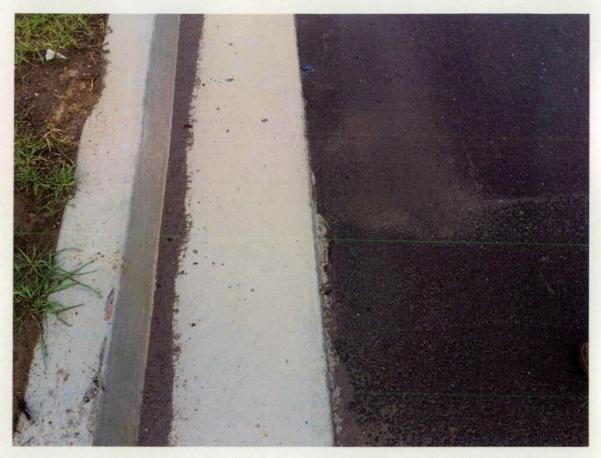
Figure 247 Concrete damage,

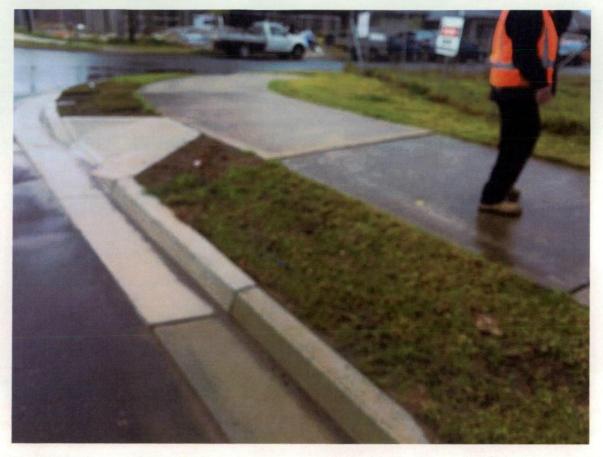
Figure 248 Exisiting state of NE pram ramp.

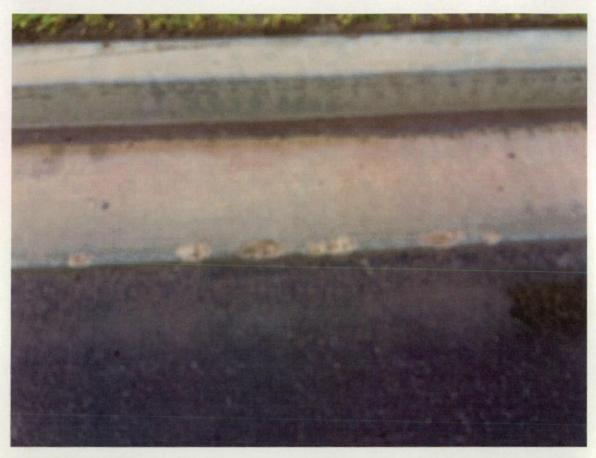
Figure 249 Damage to gutter lip.

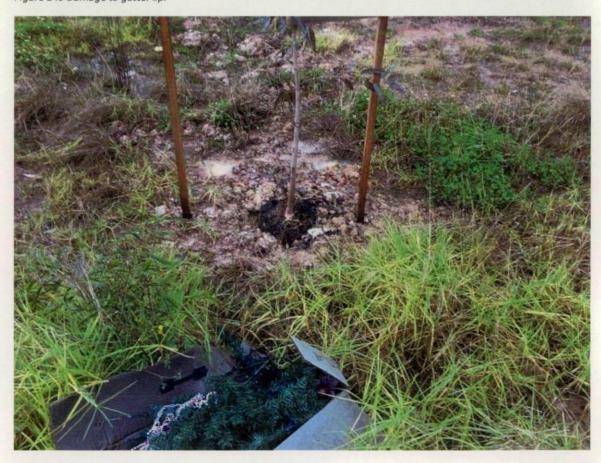
Figure 250 Rubbish, root ball of tree exposed.

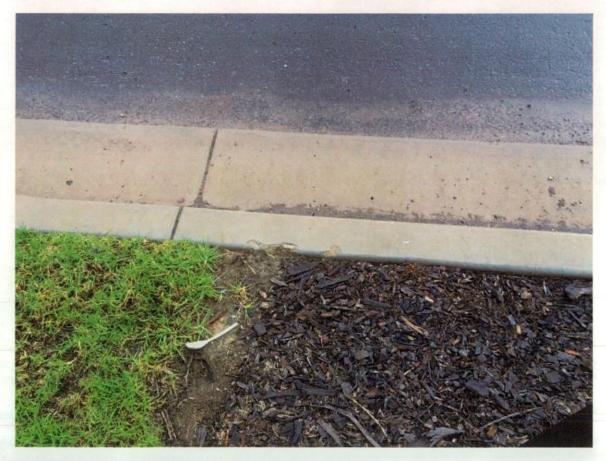
Figure 252 Damage to back of kerb.

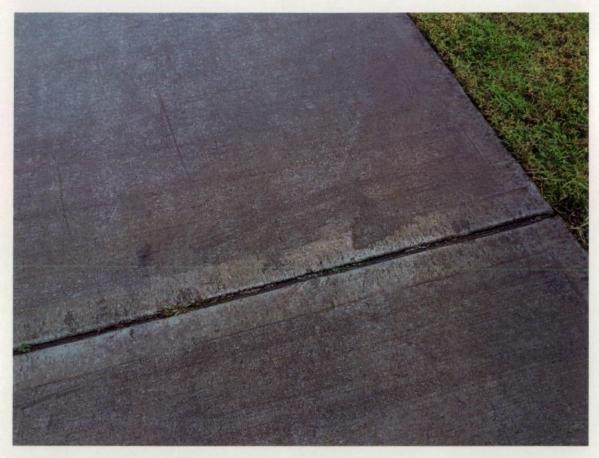
Figure 253 Damage to concrete surface.

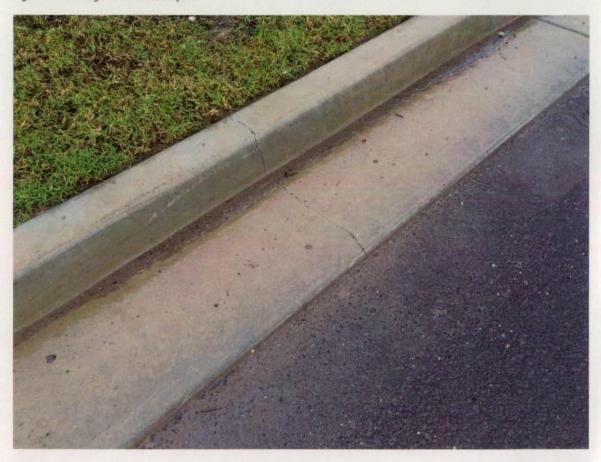
Figure 254 Crack in K&G.

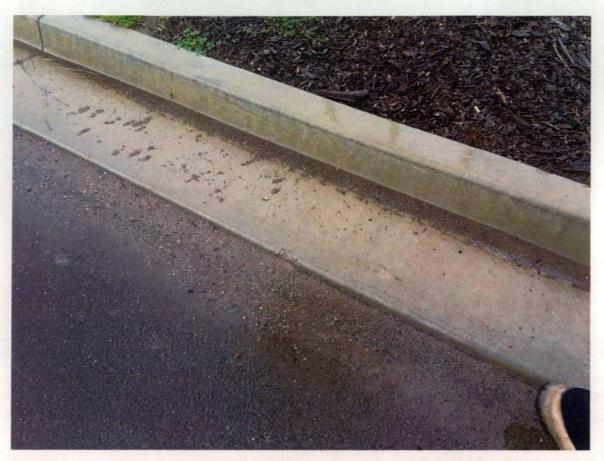
Figure 255 damage to kerb lip.

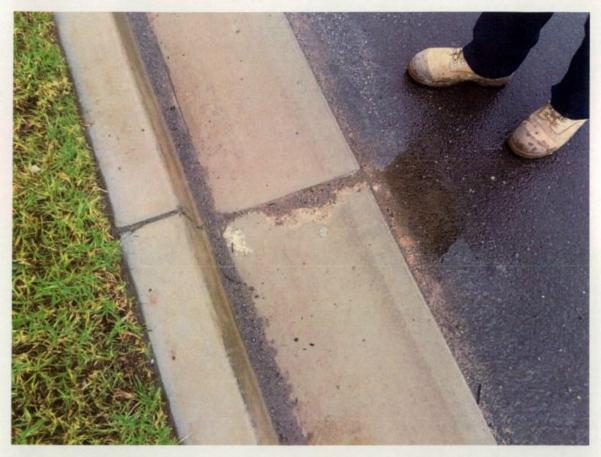
Figure 256 damage at kerb joint.

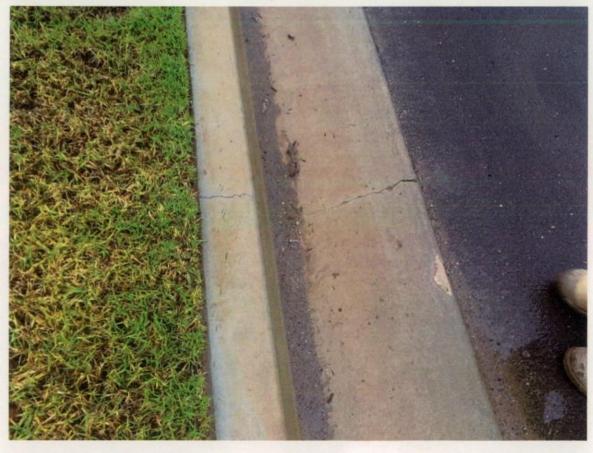
Figure 257 Crack in kerb.

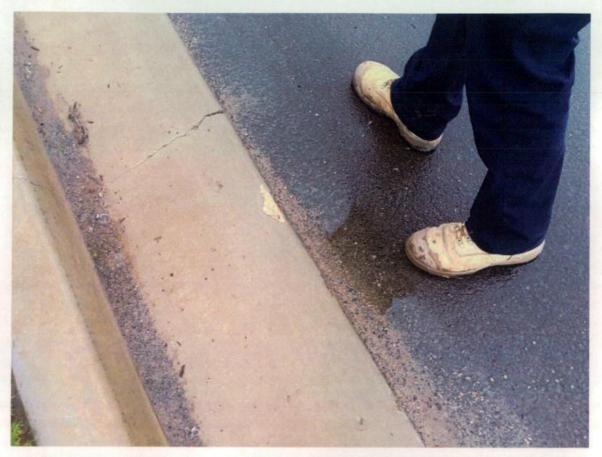
Figure 258 Patch on gutter lip.

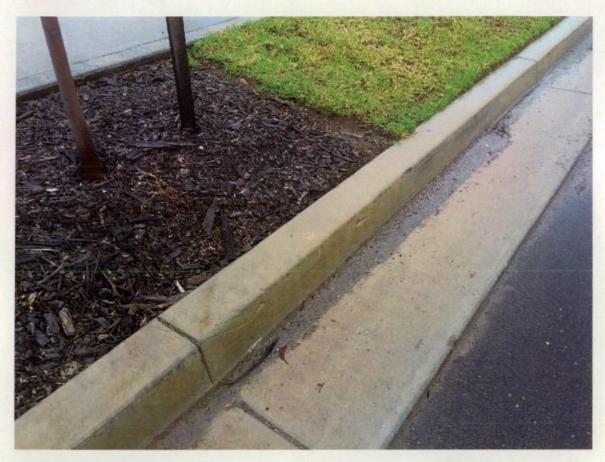
Figure 260 Marks in kerb face.
