QUA004 - DILAPIDATION & SITE INSPECTION REPORT

Customer/Project Name: Lendlease - Village		ase - Village O	val, Jordan S	prings.						
Customer/Project Address: Cnr Alinta Promenad					de & Greenwood Parkway, Jordan Springs					
Job No.	28	45	Contract No).	724		Date:	21/07/	2015
Prepared by: Luke Cranson					Photos en	closed:	Yes 🖂	No [
Inspection	1				Notes & Co	omments				
Water		Nearside	⊠ Fa	r-side 🖂						
Electricity	•	Aerial 🛛	Unde	erground 🛛						
Sewer		Yes 🖂	No 🗌							MIL .
Septic		Yes 🗌	No 🛛		Туре					
Kerb & Gu	itter	Yes 🖂	No 🗌		Damage	Yes 🖂	No 🗌			
Layback		Yes 🖂	No 🗌		Damage	Yes 🛛	No 🗌			
Footpath Yes		Yes 🖂	No 🗌		Damage	Yes 🖂	No 🗌			
Vehicle Ac	ccess	Good 🛛	Need	s Work 🗌						
Boundary Pegs		Yes 🗌	No 🛚				TOM:			
Existing Fe	encing	Yes 🖂	No 🗌		Туре	Builder	s Temporar	y, chain lir	nk perimet	er fence
Subsoil		Existing		1						
Excavation		Yes 🖂	No 🗌							
Trees Yes 🗵		Yes 🖂	No 🗌					DEC	EIVE	
	Stor	mwater							MGT	
Other:								2 3	JUL 2015

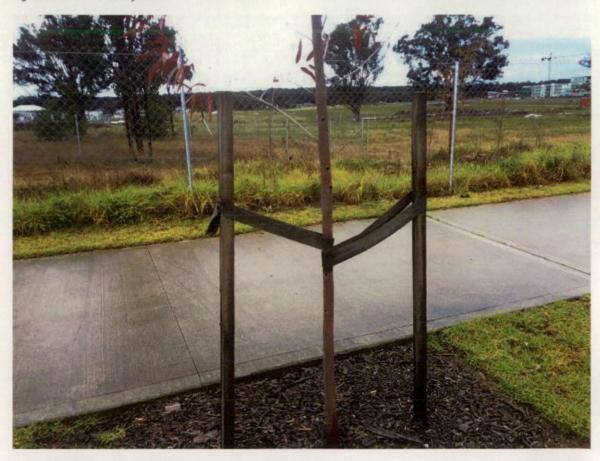
Figure 261 State of existing road trees.

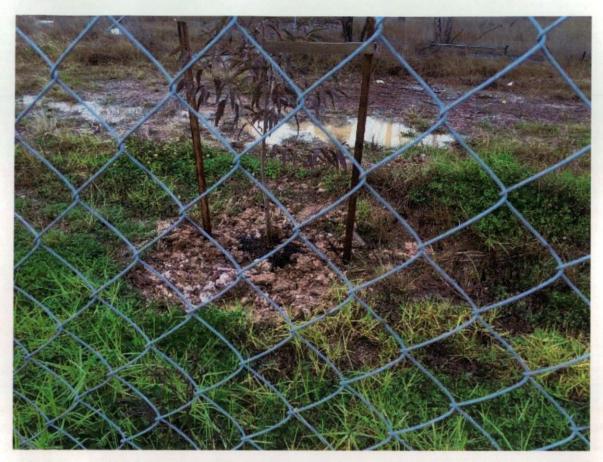
Figure 262 Exposed root ball of trees.

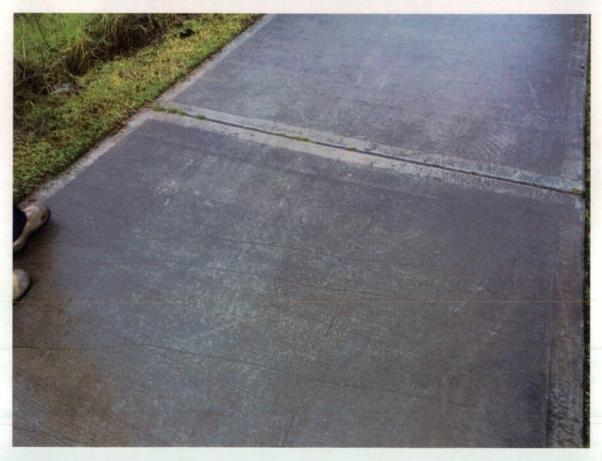
Figure 263 Scratches on concrete surface.

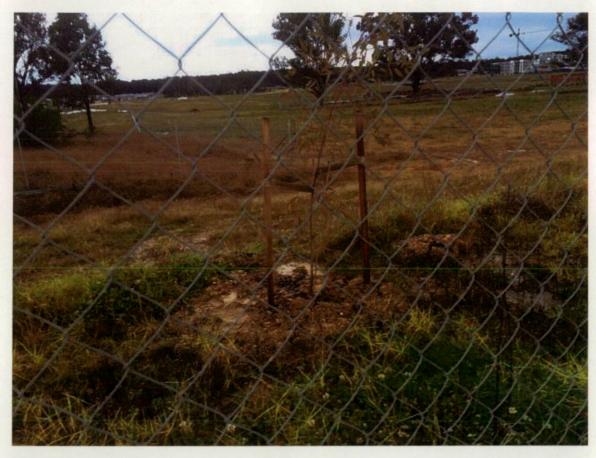
Figure 264 Exposed root ball.

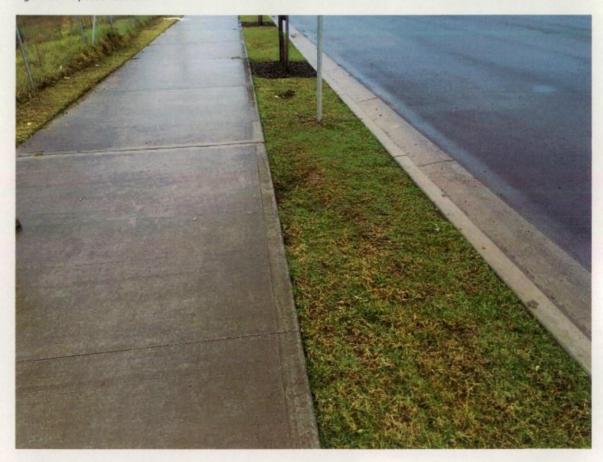
Figure 265 Tyre ruts on turf area.

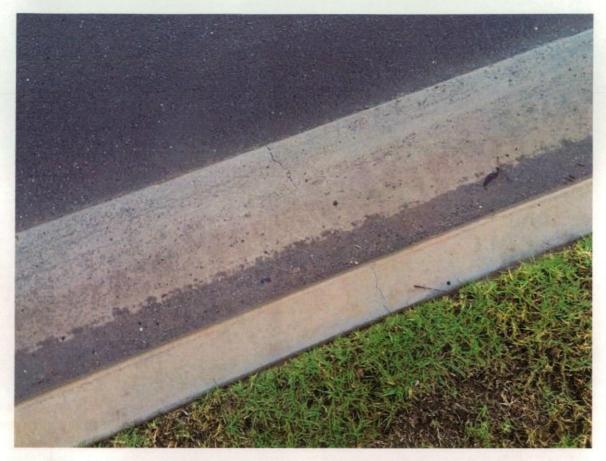
Figure 266 Crack in K&G.

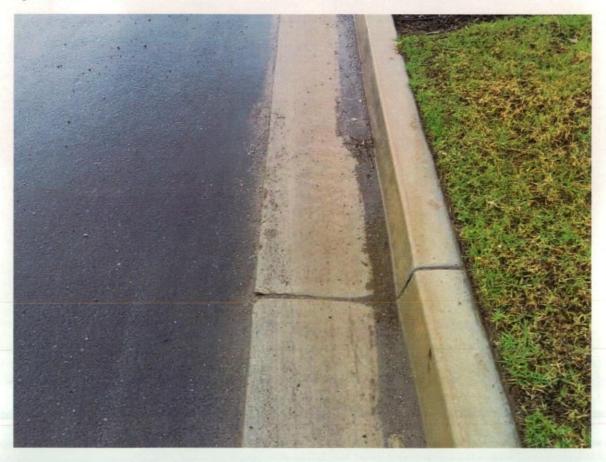
Figure 267 Surface imperfections on gutter.

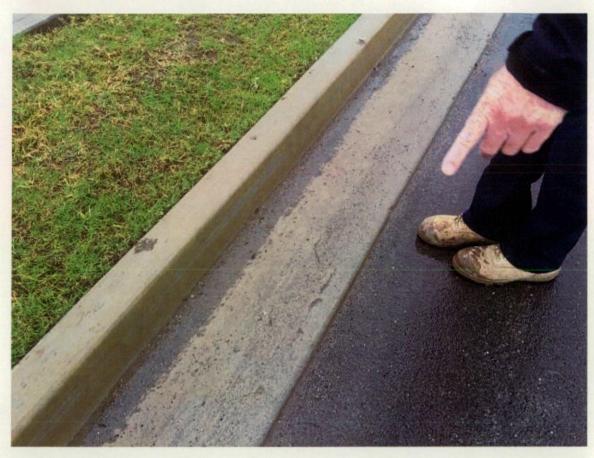
Figure 268 Surface imperfections on gutter.

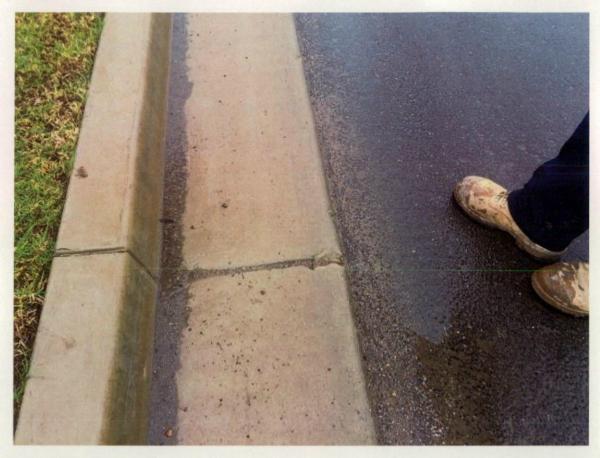
Figure 272 Damage at concrete joint.

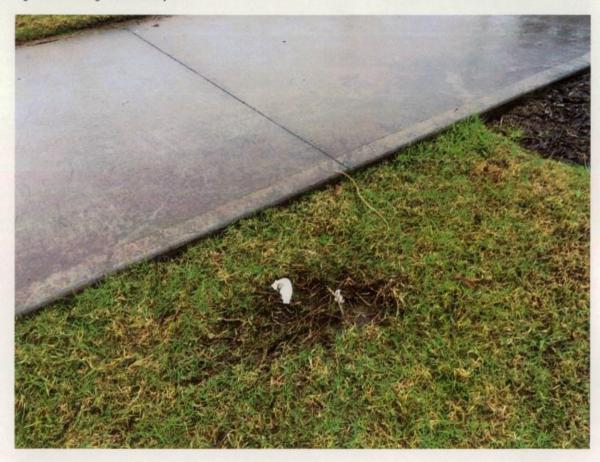
Figure 273 Damage to turf.

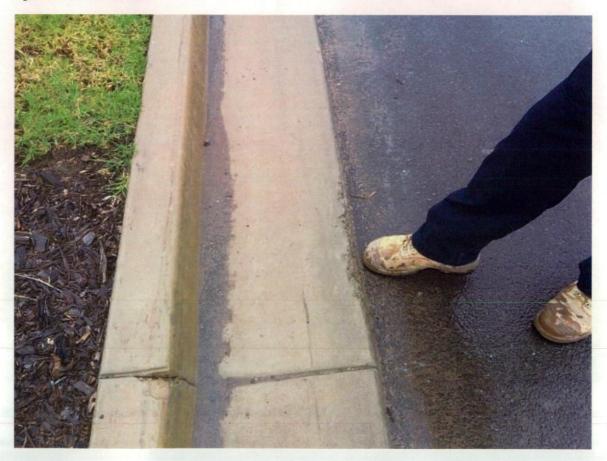
Figure 275 Damage to joint and gutter lip.

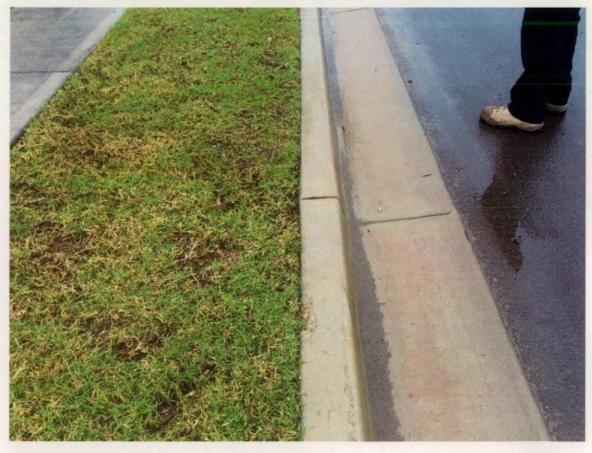
Figure 277 Damage to kerb.

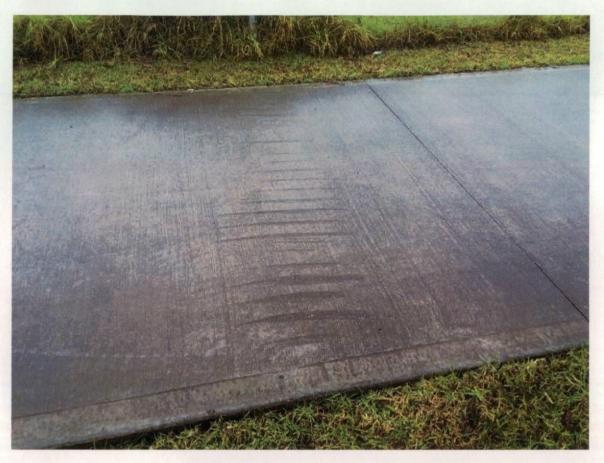
Figure 278 Machinery has damaged footpath surface.

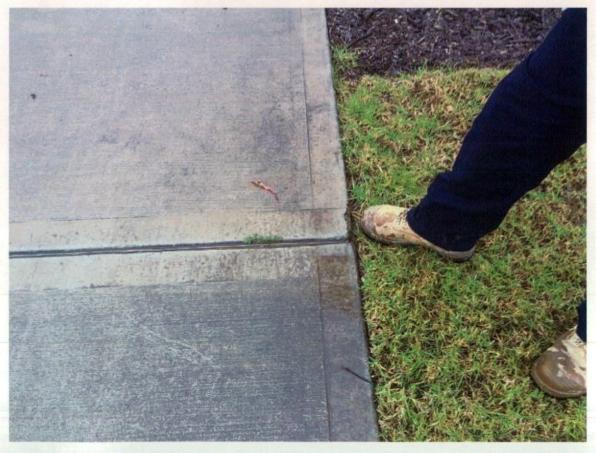
Figure 279 Damage to edge of footpath.

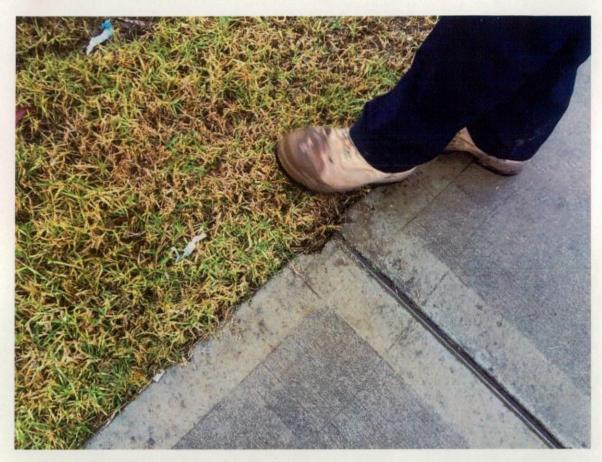
Figure 280 Damage to edge of footpath.

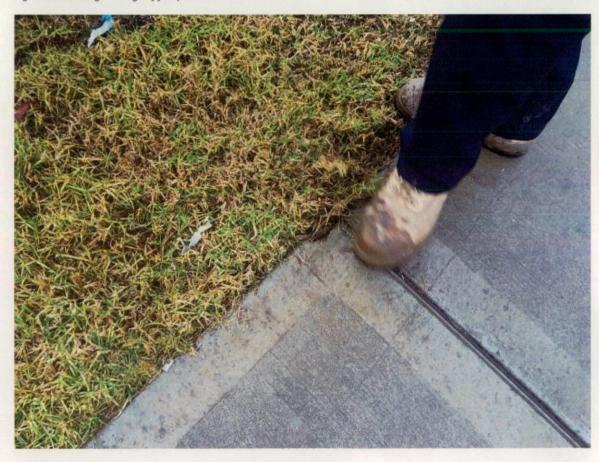
Figure 281 Damage to edge of footpath.

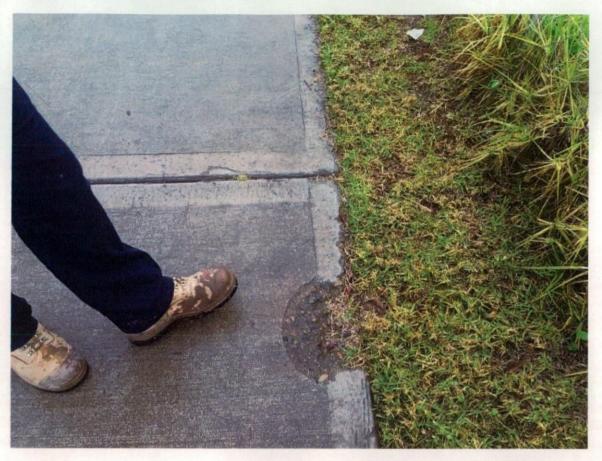
Figure 282 Damage to edge of footpath.

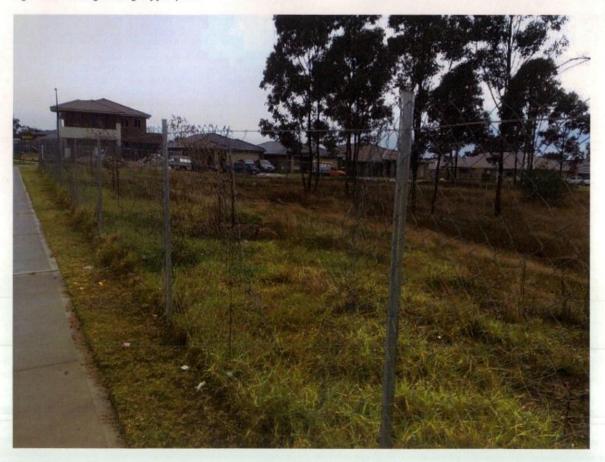
Figure 283 Fence damage.

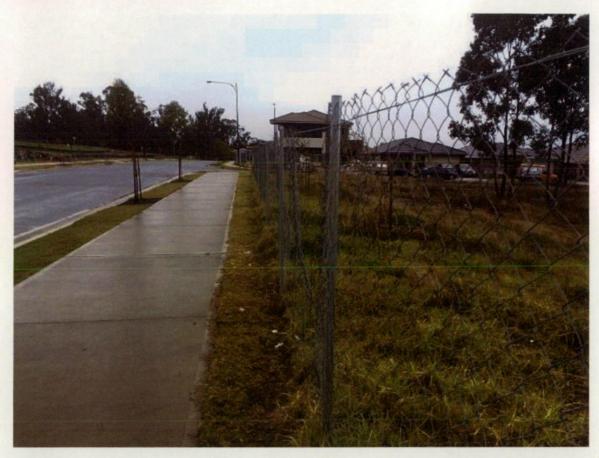
Figure 284 Fence damage.

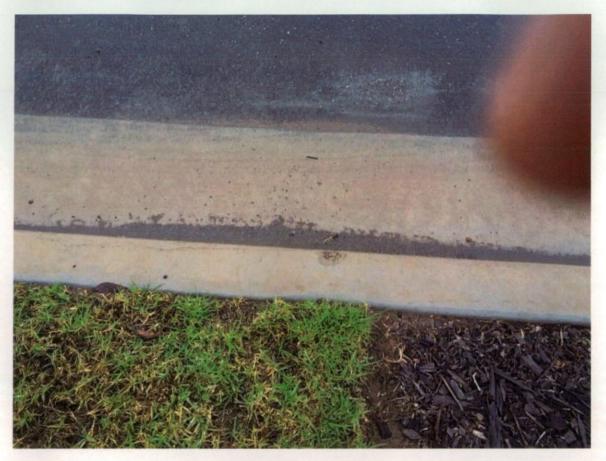
Figure 286 Damage to kerb.

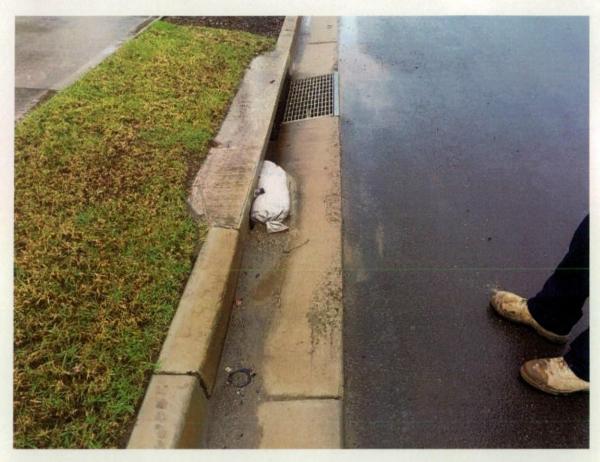
Figure 288 existing sed controls caught in drains.

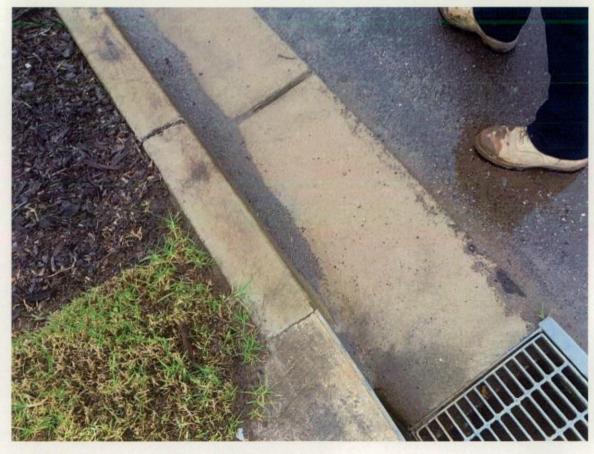
Figure 289 Edge damage to lintel.

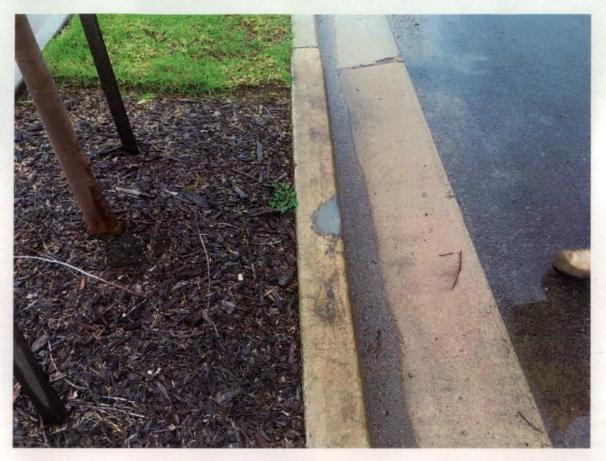
Figure 290 Concrete patching.

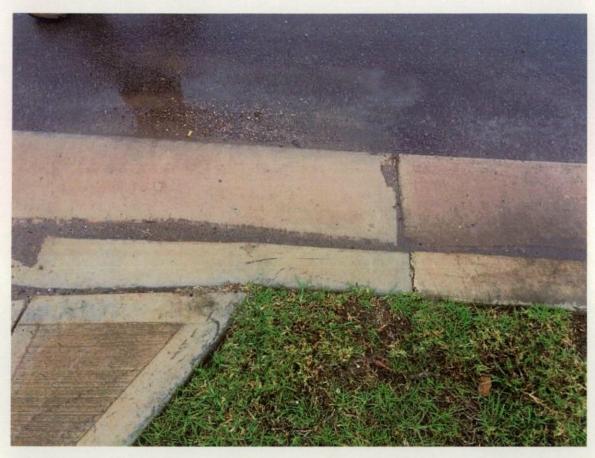
Figure 292 Damage to pram ramp and kerb.

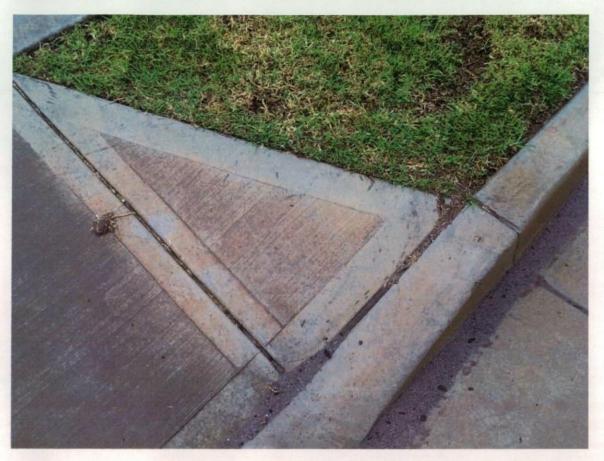
Figure 294 Stains on pram ramp.

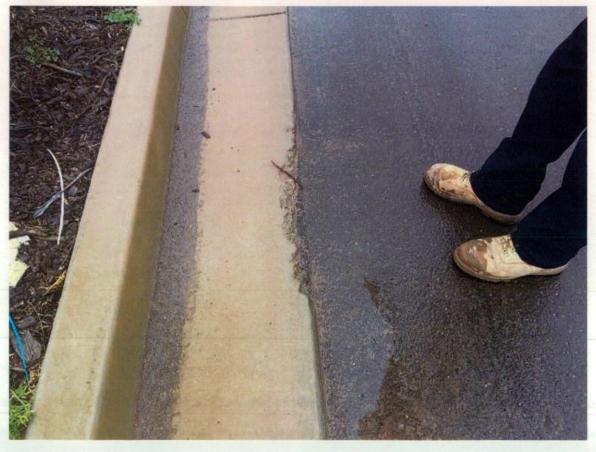
Figure 295 Damage to gutter lip.

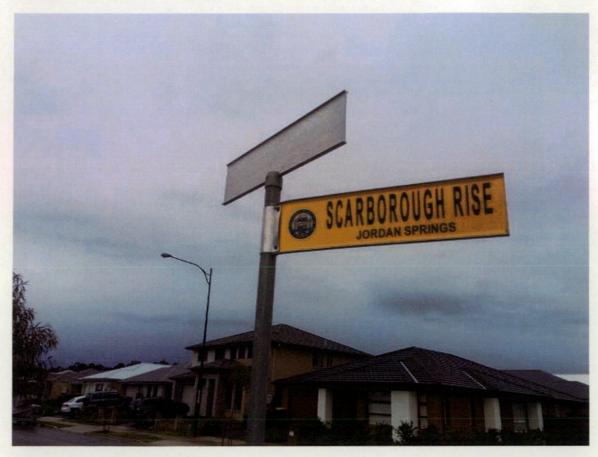
Figure 296 Street sign has been knocked.

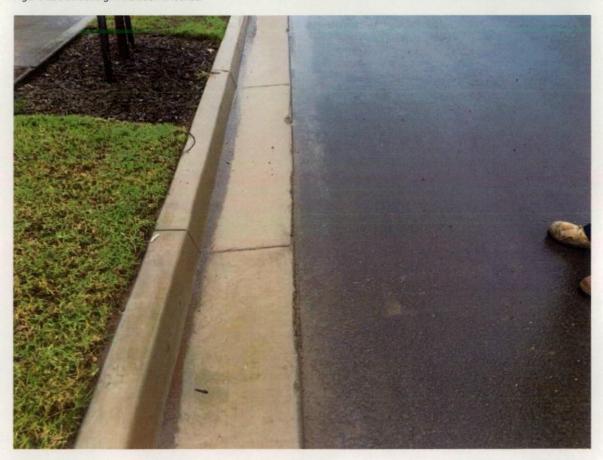
Figure 297 Damage to gutter lip.

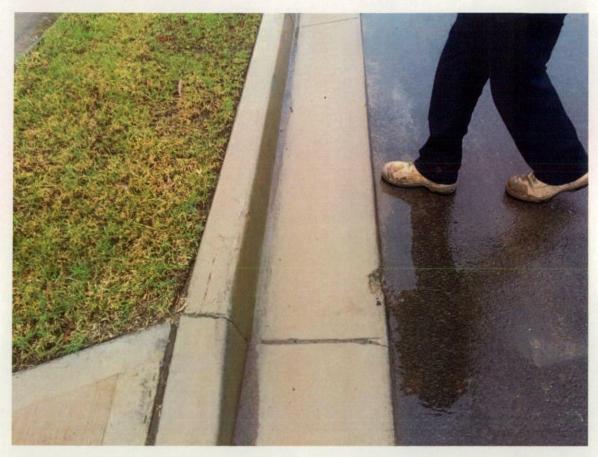
Figure 300 Damage to gutter.

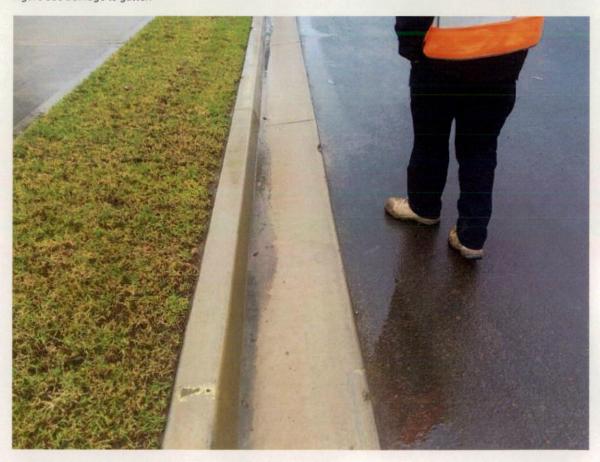
Figure 301 Damage to kerb.

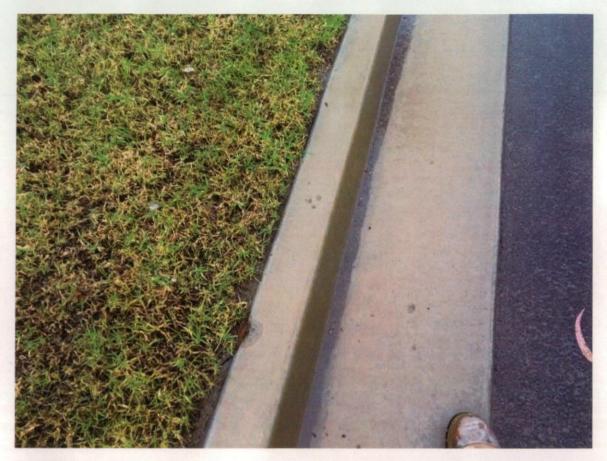
Figure 302 Damage to kerb.

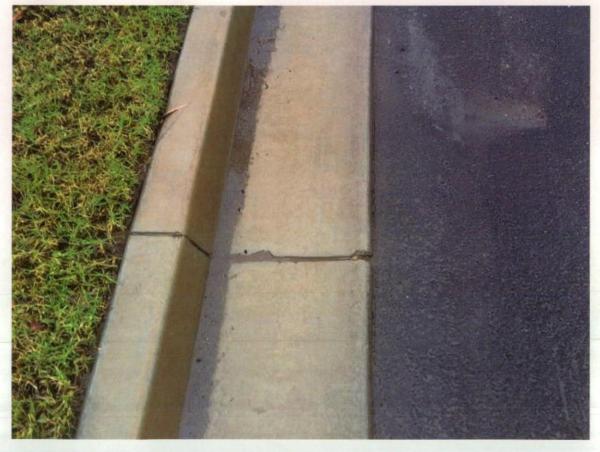
Figure 303 Damage at concrete joint.

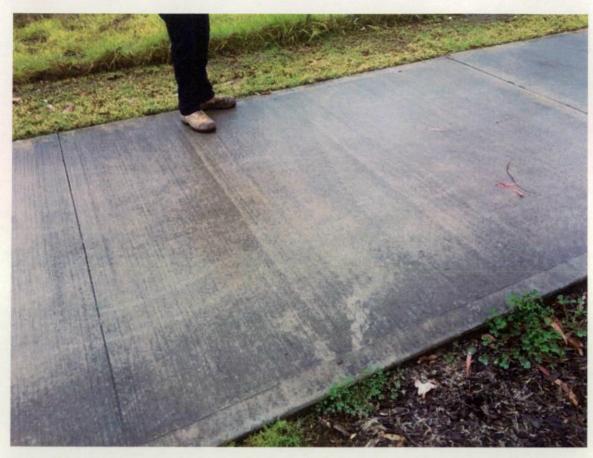
Figure 304 Damage on footpaths surface.

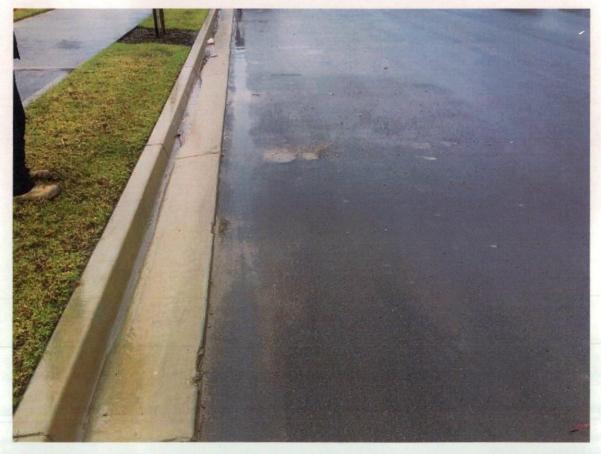
Figure 307 Marks and damage on asphalt.

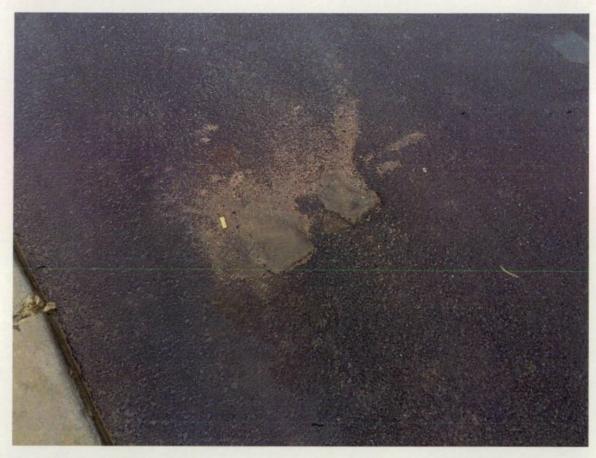
Figure 308 Marks on asphalt.

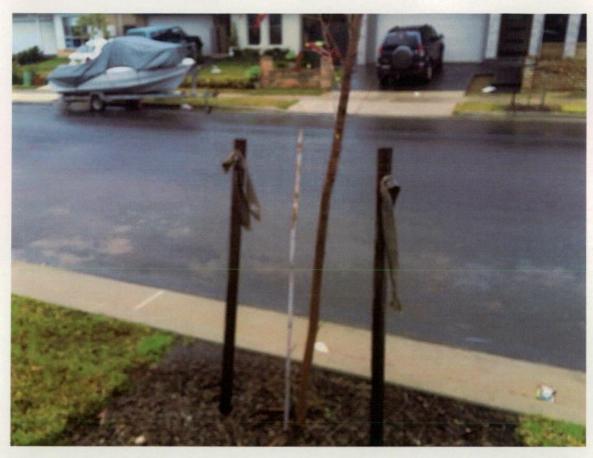
Figure 312 Damage to tree stakes.

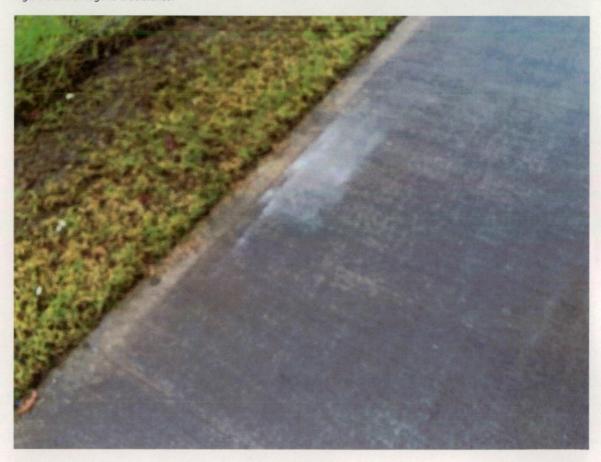
Figure 313 Surface damage to footpath.

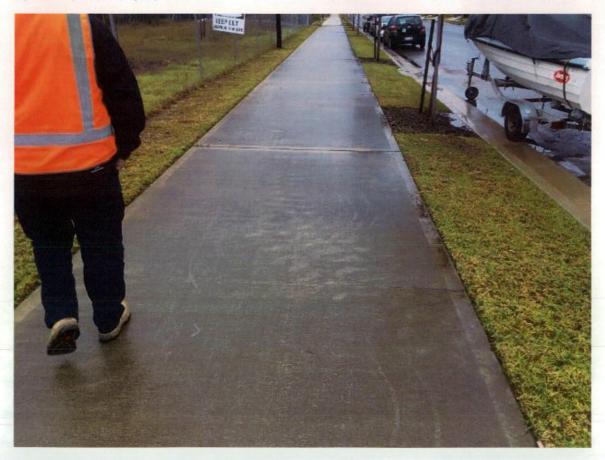
Figure 315 Tyre marks on footpath.

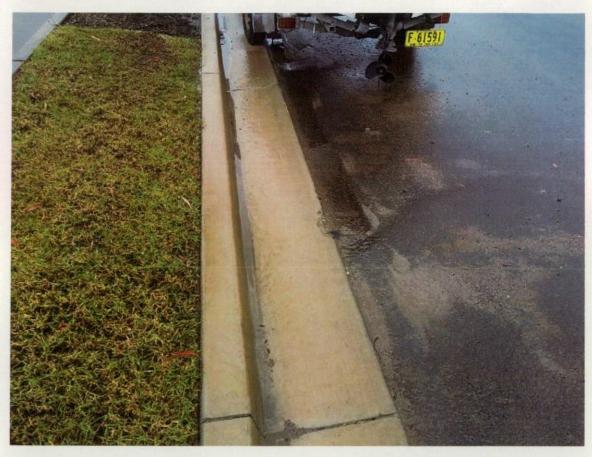
Figure 316 Damage to kerb and asphalt.

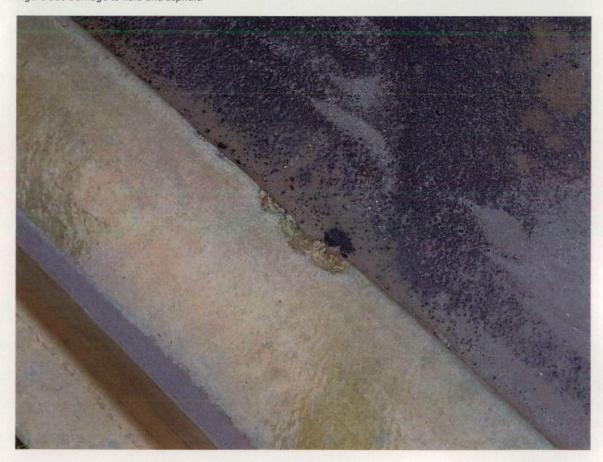
Figure 317 Gutter lip damaged.

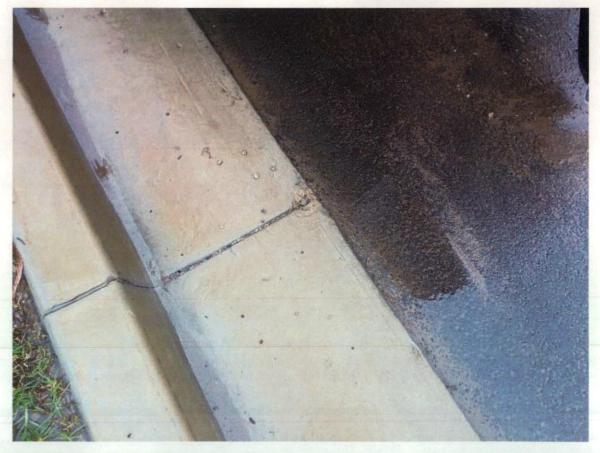
Figure 319 Damage on concrete joint.

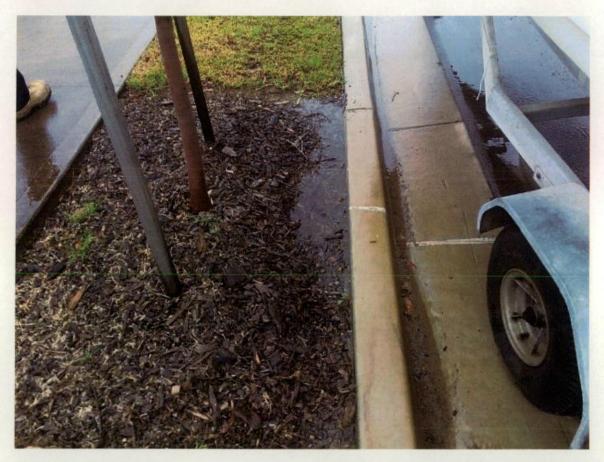
Figure 320 Holding water in low area.

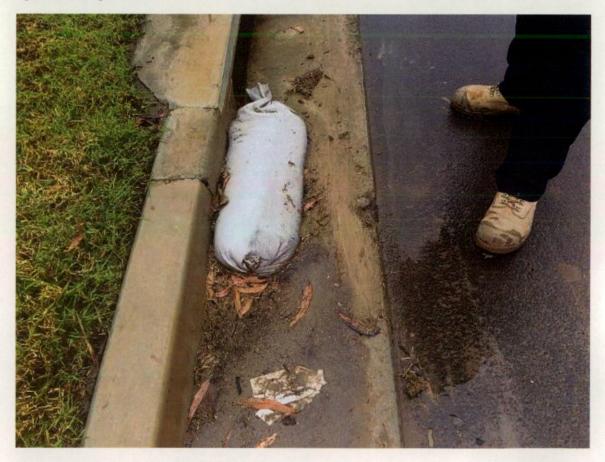
Figure 321 Existing sediment controls full of silt.

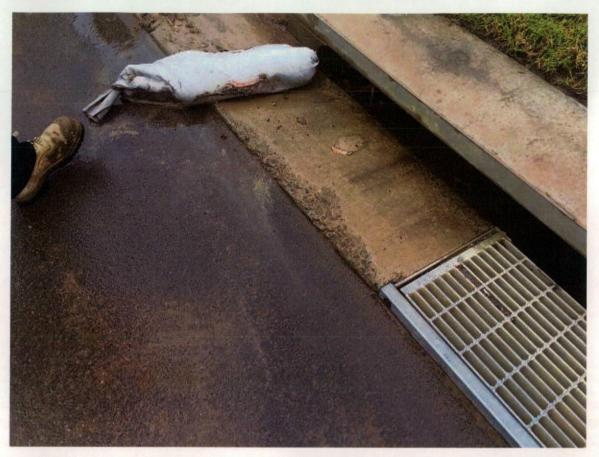
Figure 322 Damage to concrete lintel.

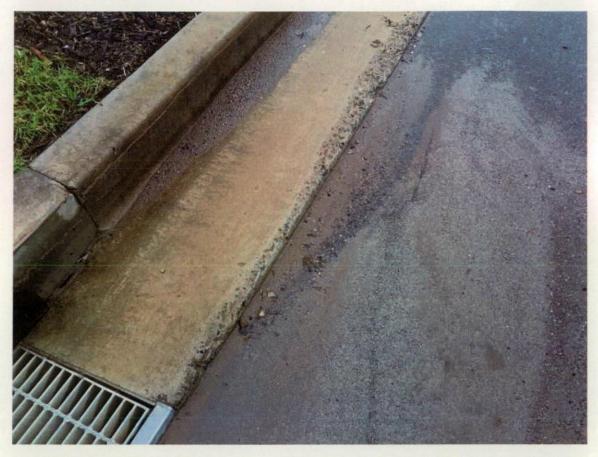
Figure 324 Damage to edge of gutter.

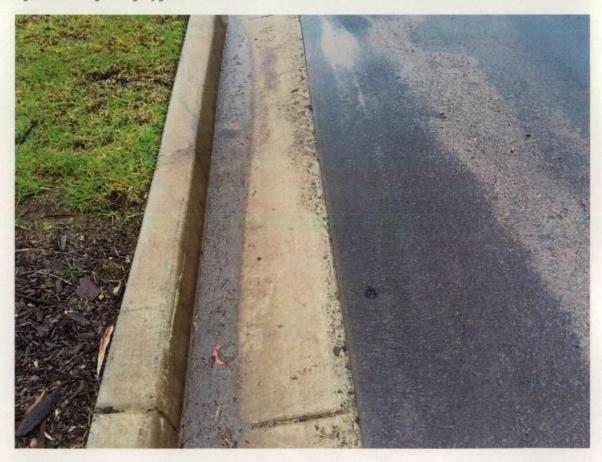
Figure 325 Damage to the lip of gutter.

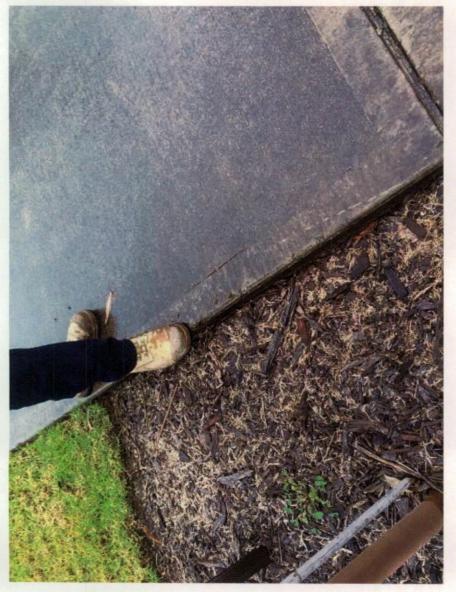
Figure 326 Low spots around footpath.

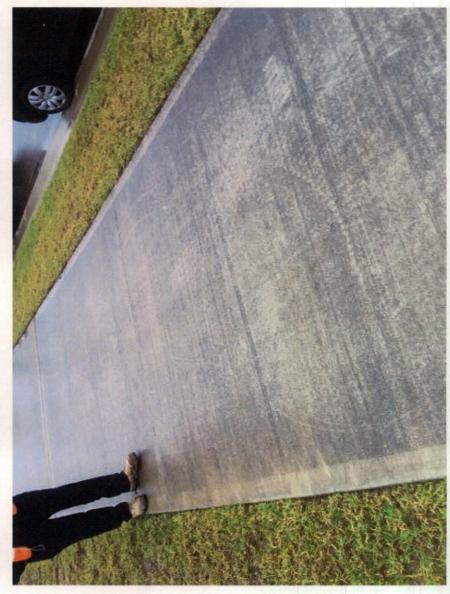
Figure 327 Tyre marks on concrete.

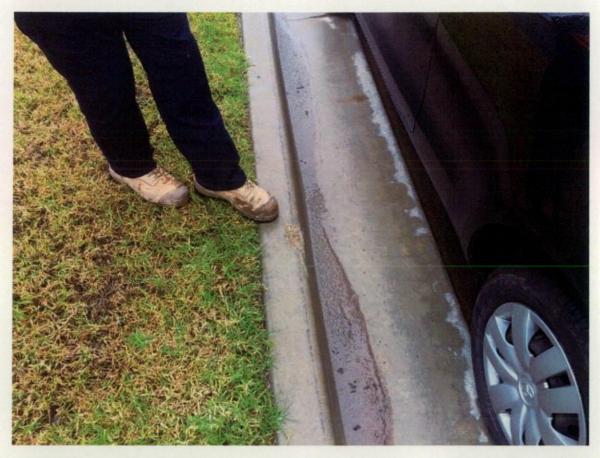
Figure 328 Damage to kerb and patching on gutter.

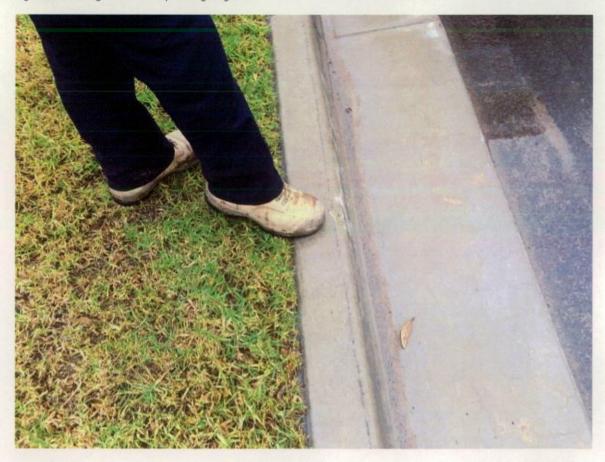
Figure 329 Damage on kerb.

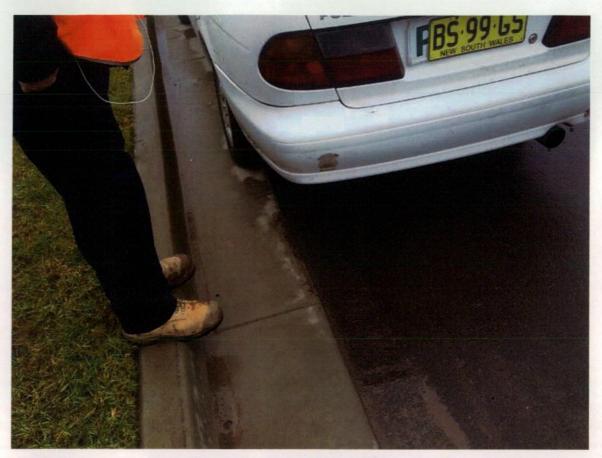
Figure 330 Patching to lip of gutter.

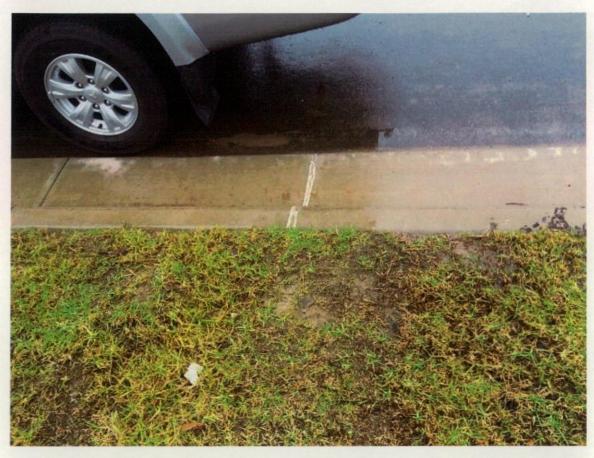
Figure 332 previously repaired concrete crack in K&G.

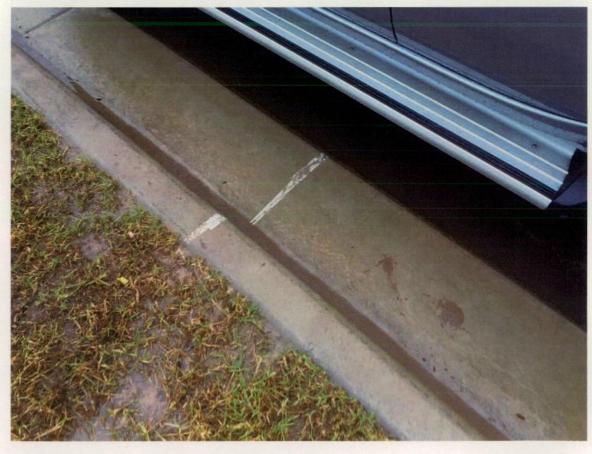
Figure 333 previously repaired concrete crack in K&G.

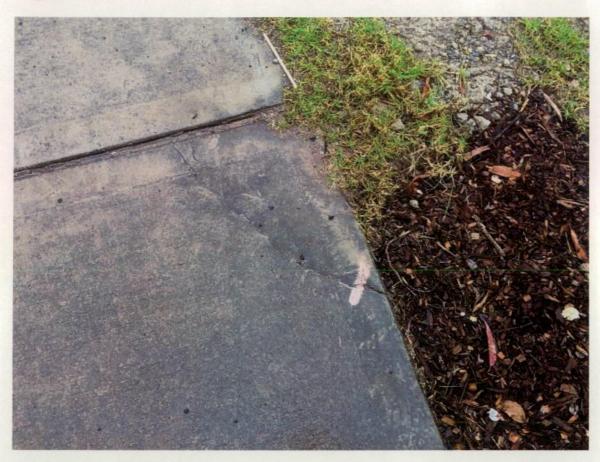
Figure 336 Crack in concrete footpath.

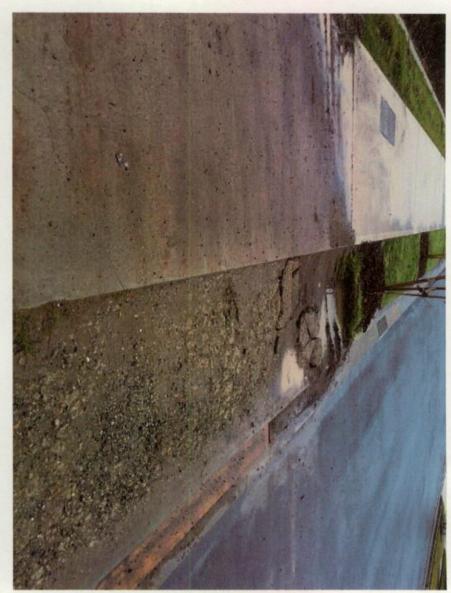
Figure 340 Crack in concrete footpath.

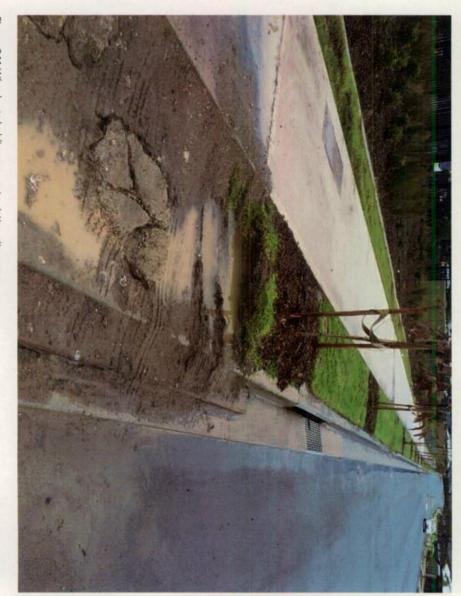
Figure 341 Wheel ruts holding waer at existing site access.

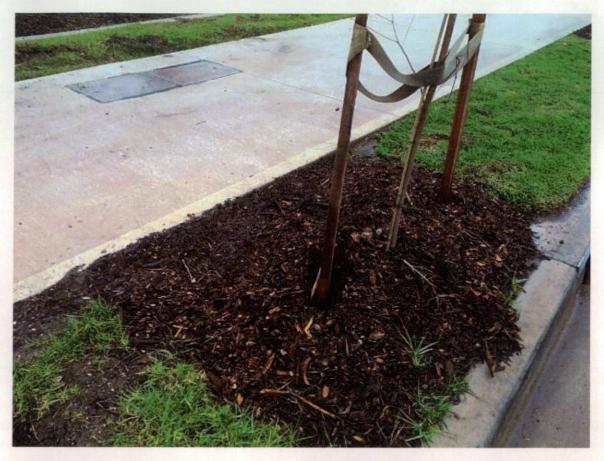
Figure 342 Wheel ruts in turf and near tree.

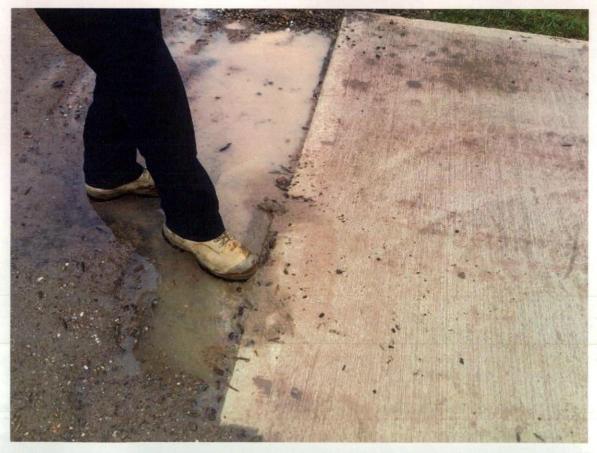
Figure 343 Damage to concrete footpath.

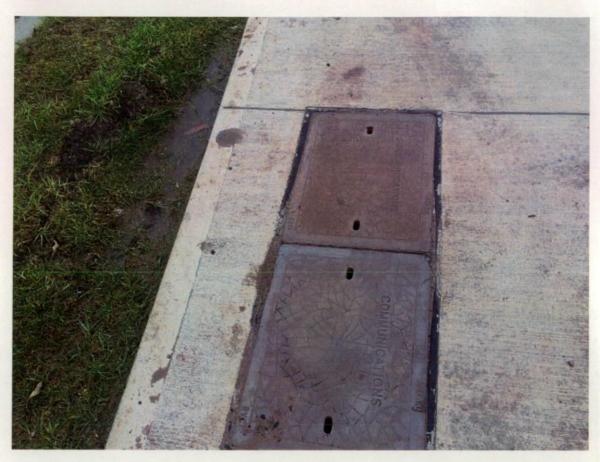
Figure 344 Damage around Telstra pits and concrete splatter.

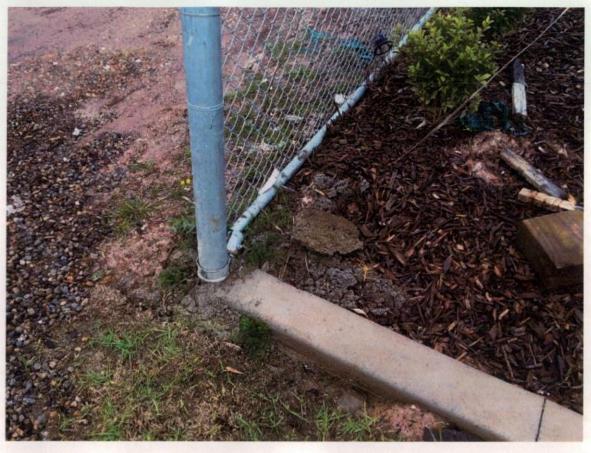
Figure 345 Concrete leftover and rubbish in garden.

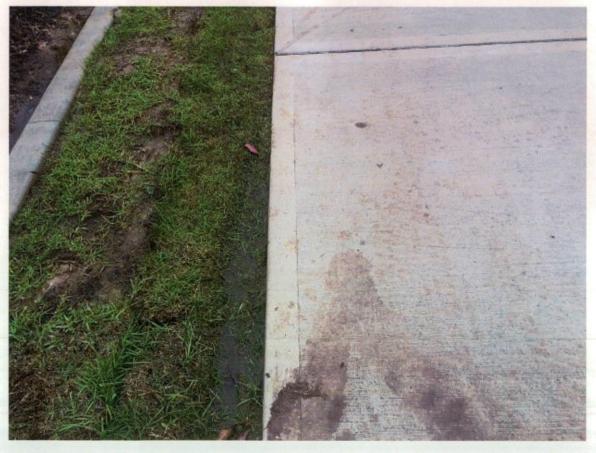
Figure 346 Tyre ruts in turf holding water.

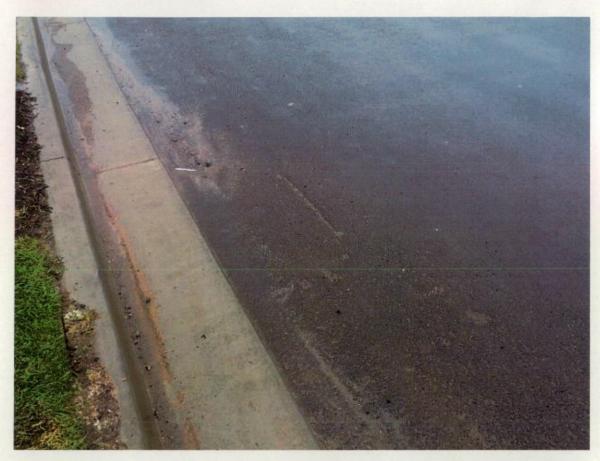
Figure 347 Asphalt damaged.

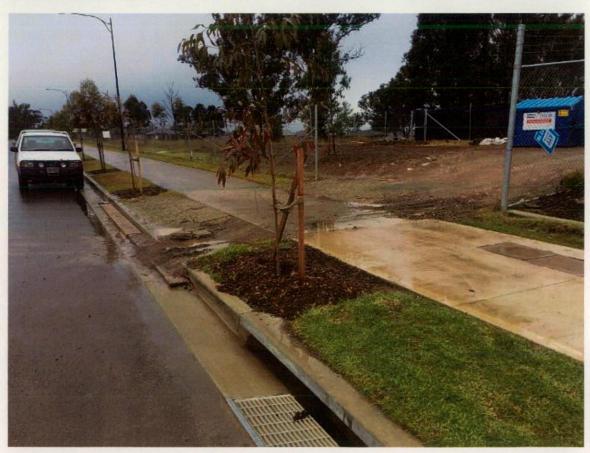
Figure 348 Tree stake knocked, general state of current LS site access and compound.

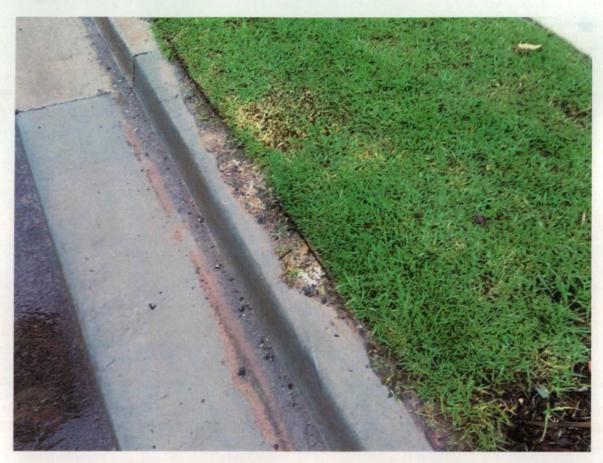
Figure 349 Clay/soil runoff into gutter.

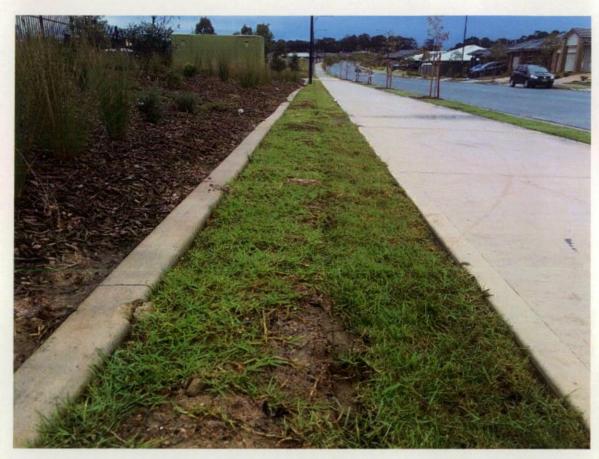
Figure 351 Wheel ruts in turf, damage to concrete garden edge.

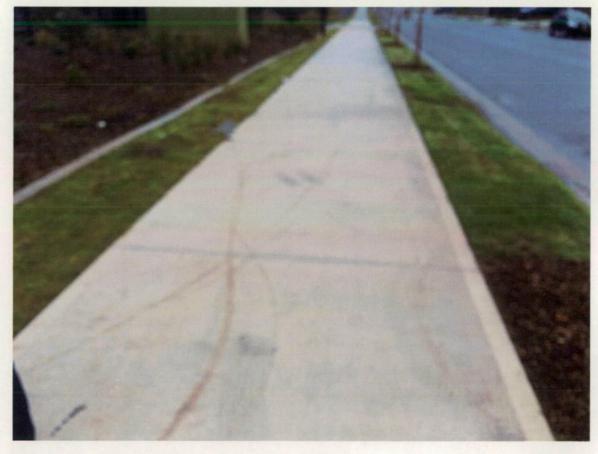
Figure 352 Marks on concrete pavement.

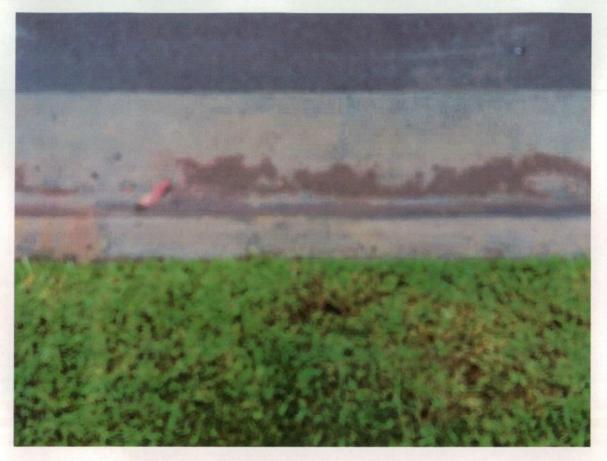
Figure 353 Damage to K&G

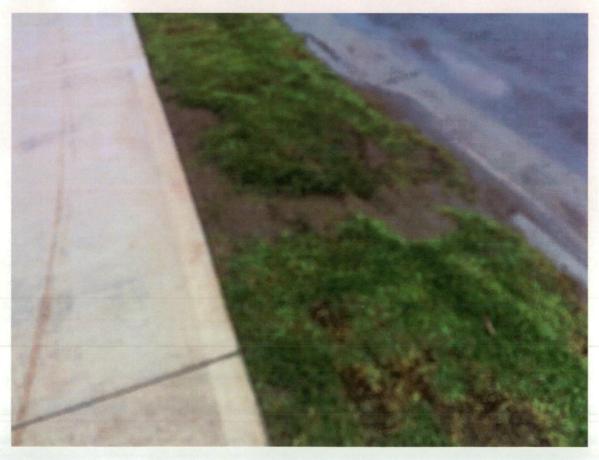
Figure 354 Damage to turf.

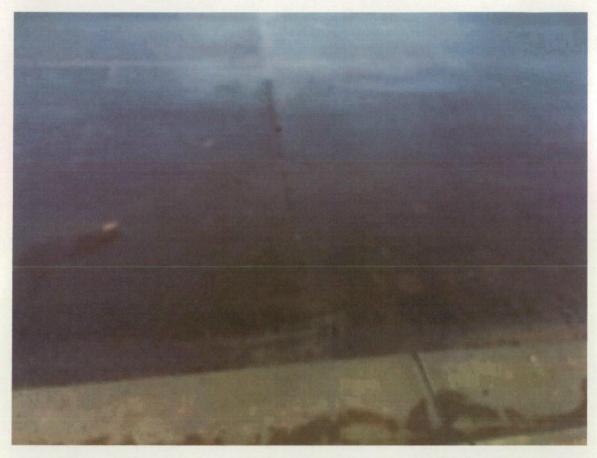
Figure 355 Marks on asphalt.

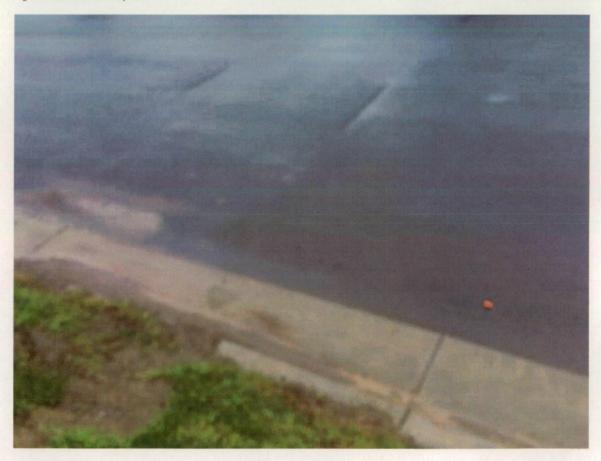
Figure 356 Marks on asphalt.

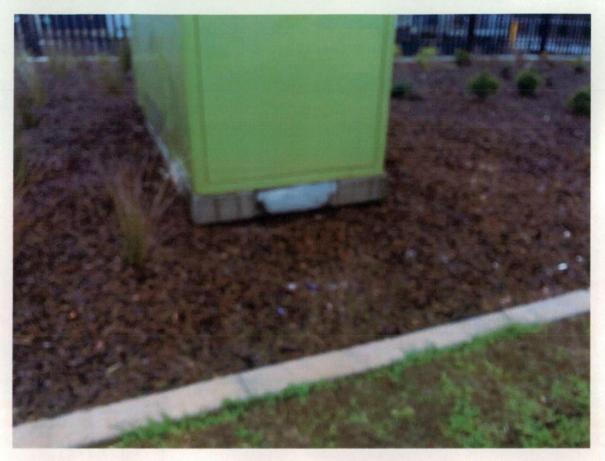
Figure 357 Mulch has been washed out from under electrical box.

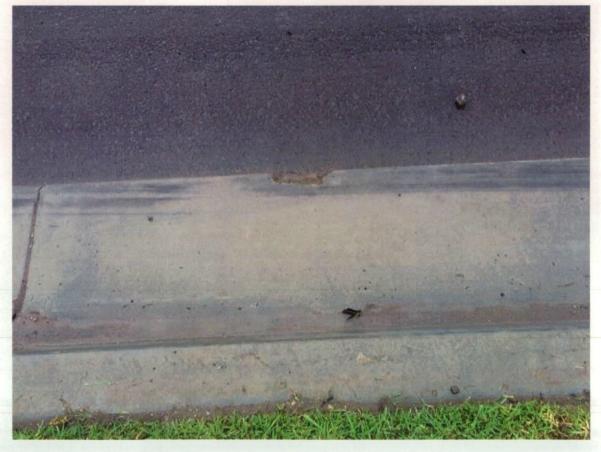
Figure 358 Damage to gutter lip.

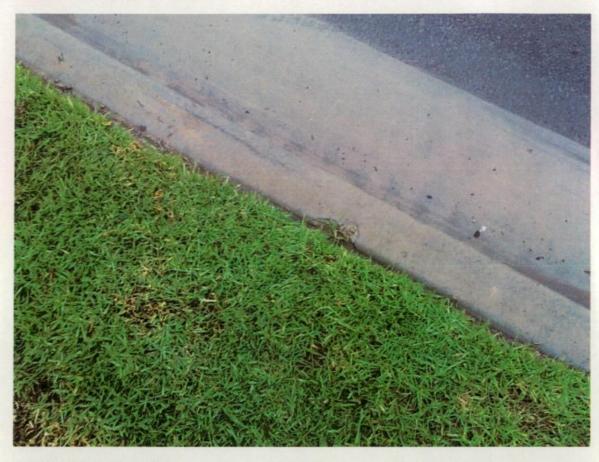
Figure 359 Damage to gutter lip.

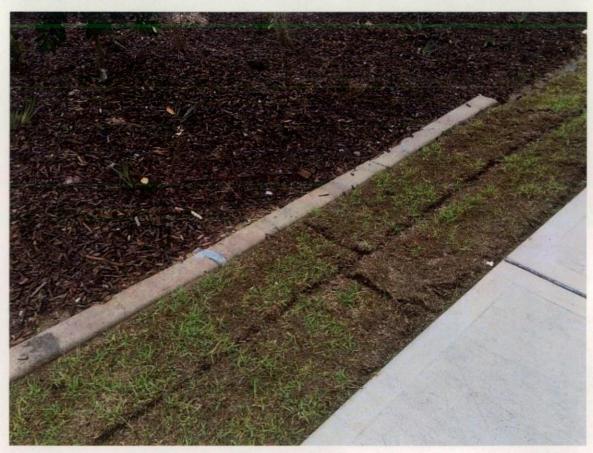
Figure 360 Damage to concrete edge.

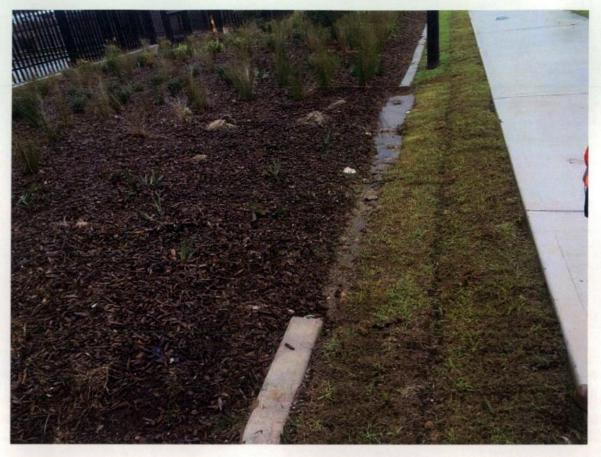
Figure 361 Concrete edge incomplete and holding water.

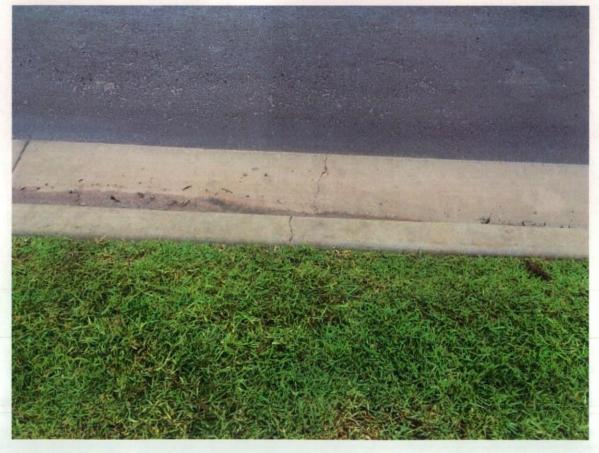
Figure 362 Crack in K&G.

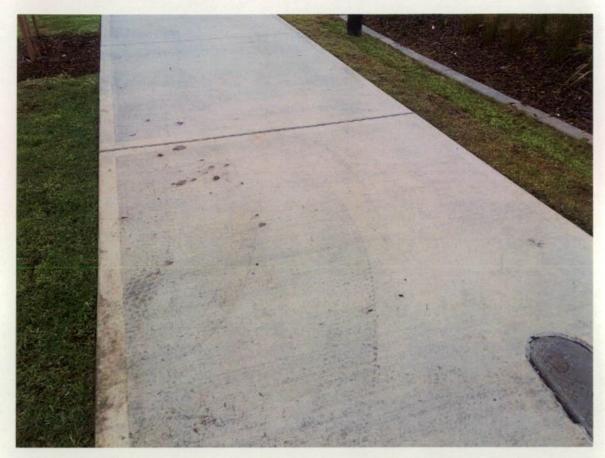
Figure 363 Marks on concrete footpath.

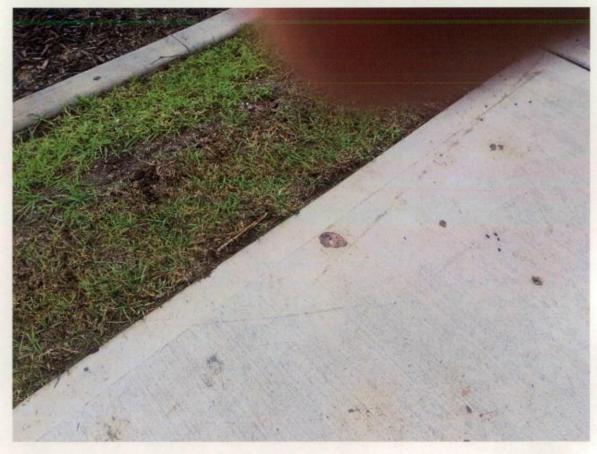
Figure 364 Marks on concrete footpath.

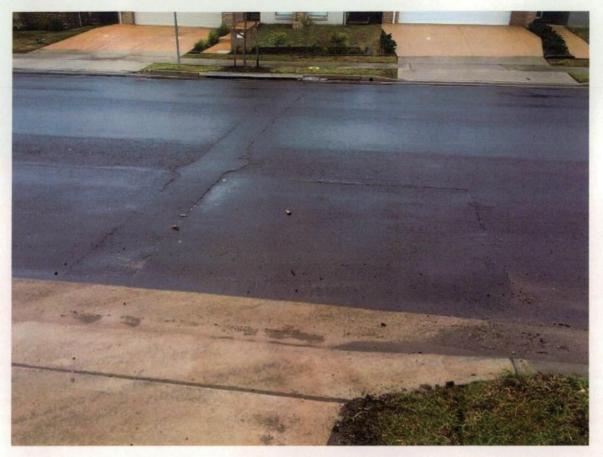
Figure 365 Current asphalt near LS compound.

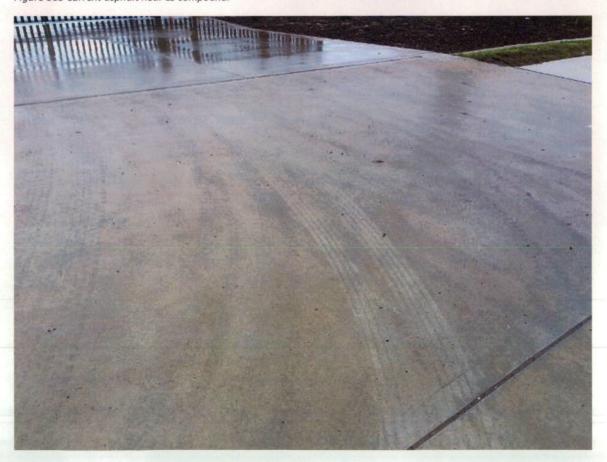
Figure 366 Tyre marks on substation driveway.
