QUA004 - DILAPIDATION & SITE INSPECTION REPORT

Customer/Project Name: Lendlease - Village		ase - Village O	val, Jordan S	prings.						
Customer/Project Address: Cnr Alinta Promenad					de & Greenwood Parkway, Jordan Springs					
Job No.	28	45	Contract No).	724		Date:	21/07/	2015
Prepared by: Luke Cranson					Photos en	closed:	Yes 🖂	No [
Inspection	1				Notes & Co	omments				
Water		Nearside	⊠ Fa	r-side 🖂						
Electricity	•	Aerial 🛛	Unde	erground 🛛						
Sewer		Yes 🖂	No 🗌							MIL .
Septic		Yes 🗌	No 🛛		Туре					
Kerb & Gu	itter	Yes 🖂	No 🗌		Damage	Yes 🖂	No 🗌			
Layback		Yes 🖂	No 🗌		Damage	Yes 🛛	No 🗌			
Footpath Yes		Yes 🖂	No 🗌		Damage	Yes 🖂	No 🗌			
Vehicle Ac	ccess	Good 🛛	Need	s Work 🗌						
Boundary Pegs		Yes 🗌	No 🛚				TOM:			
Existing Fe	encing	Yes 🖂	No 🗌		Туре	Builder	s Temporar	y, chain lir	nk perimet	er fence
Subsoil		Existing		1						
Excavation		Yes 🖂	No 🗌							
Trees Yes 🗵		Yes 🖂	No 🗌					DEC	EIVE	
	Stor	mwater							MGT	
Other:								2 3	JUL 2015

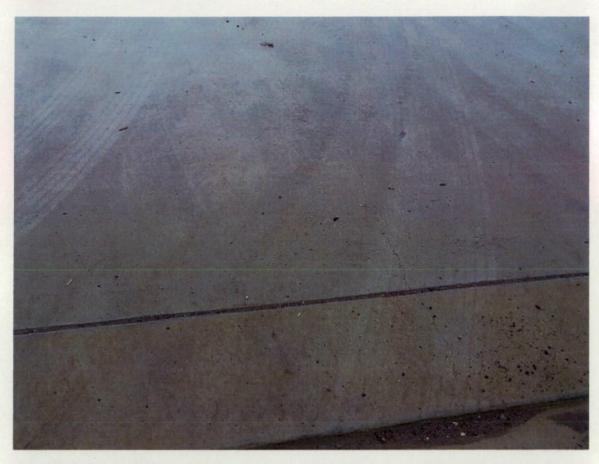
Figure 367 Tyre marks and cracks on substation driveway.

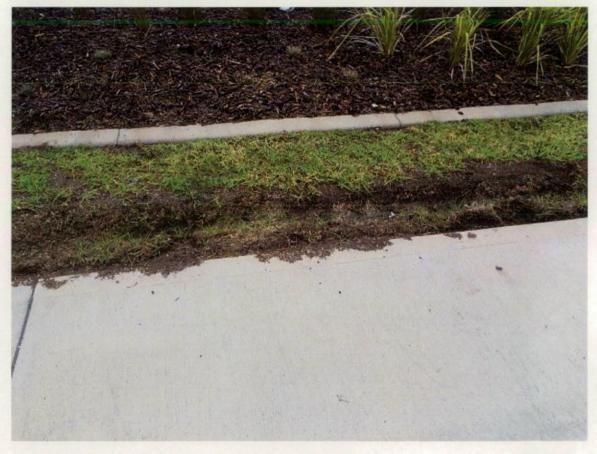
Figure 368 Wheel ruts in turf area.

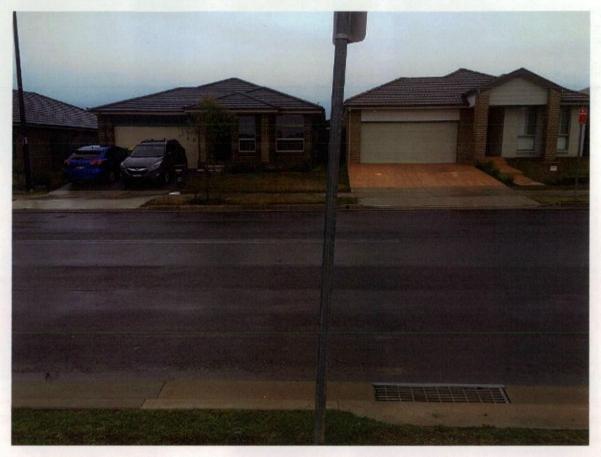
Figure 369 Pole is not straight, may have been knocked.

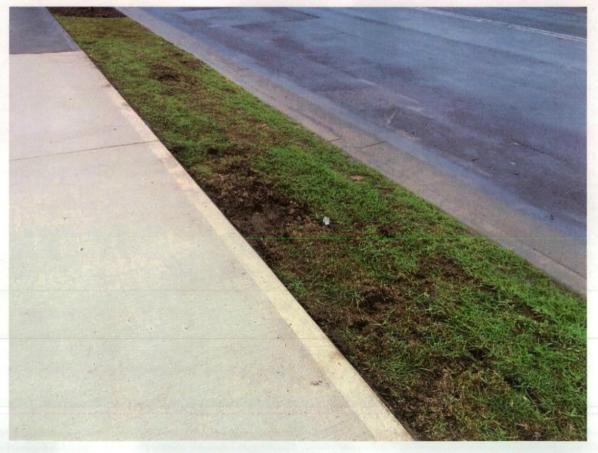
Figure 370 Damage to turf.

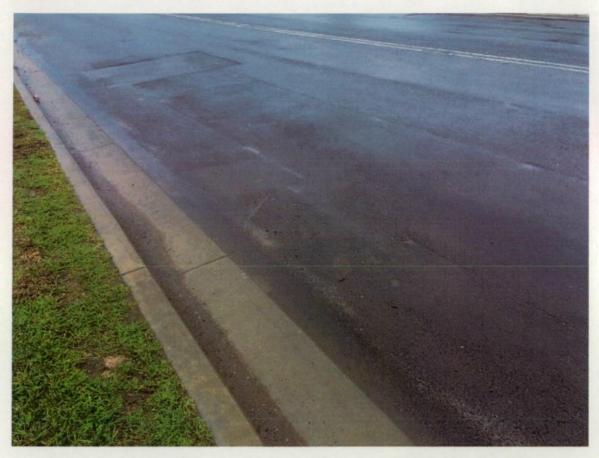
Figure 371 Damage to asphalt in road.

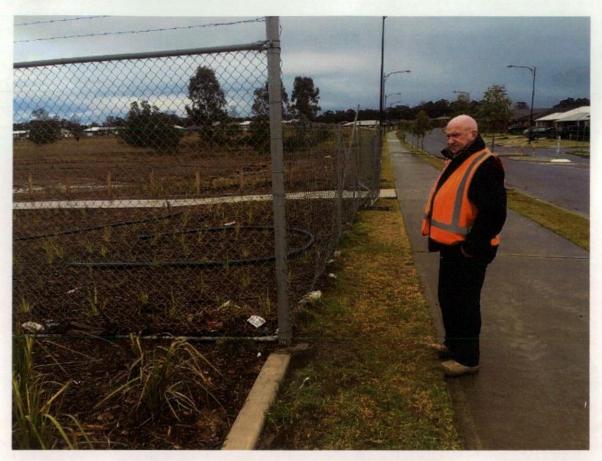
Figure 373Existing fence damaged.

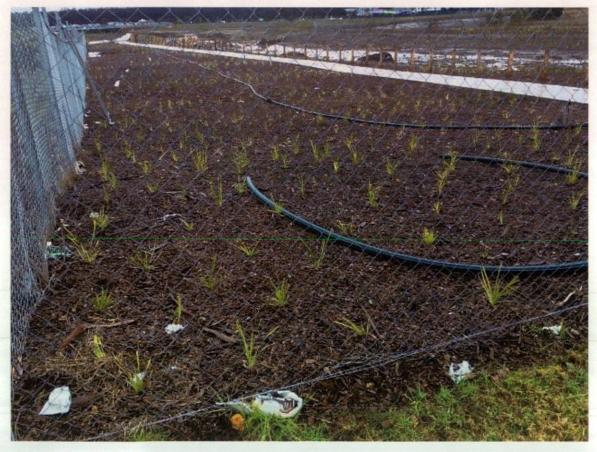
Figure 374 Rubbish and existing construction materials present on site.

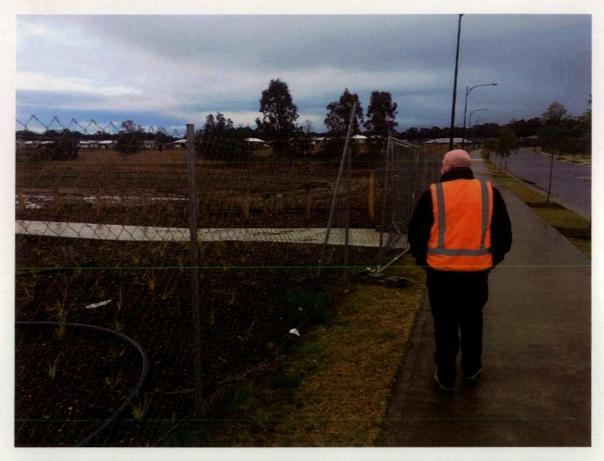
Figure 375 Damage to fence and construction materials.

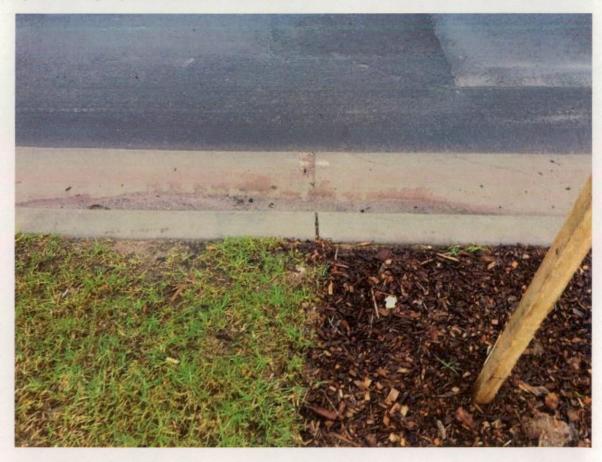
Figure 376 Silt runoff into K&G

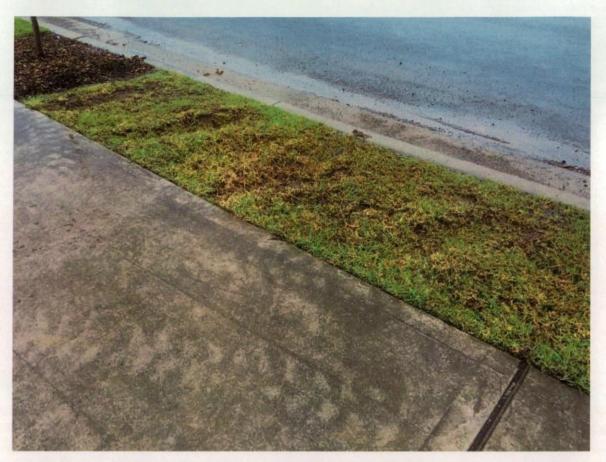
Figure 377 Wheel ruts in turf area

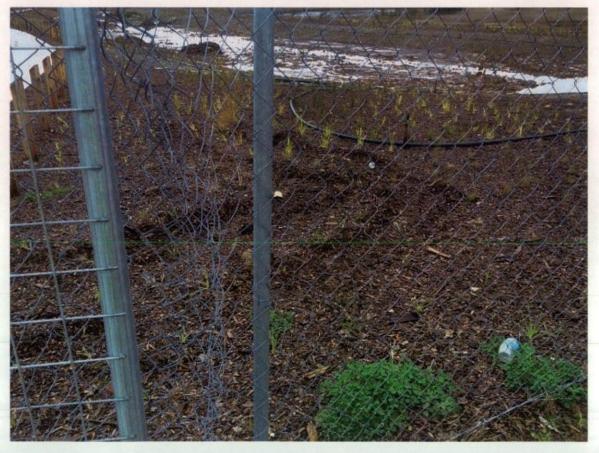
Figure 378 Wheel ruts in garden area.

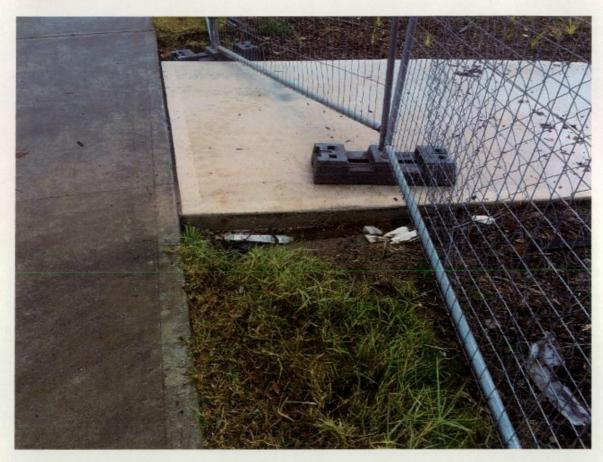
Figure 379 Soil low and holding water near to footpath.

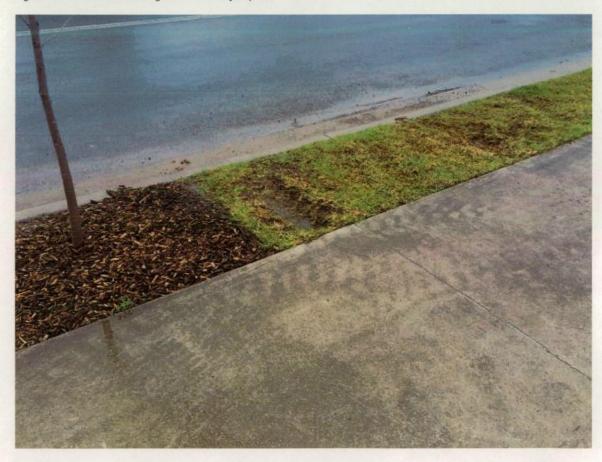
Figure 380 Wheel ruts in turf area.

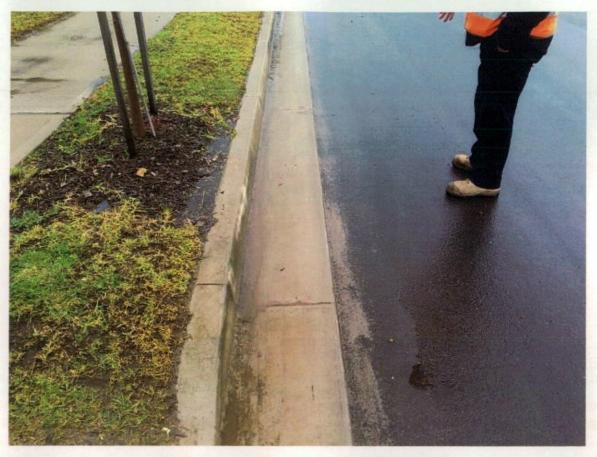
Figure 381 Concrete stains on asphalt.

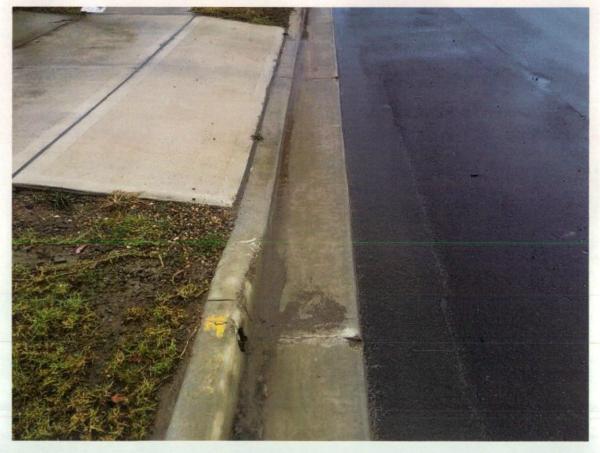
Figure 382 Cracks in K&G and egress of silt runoff.

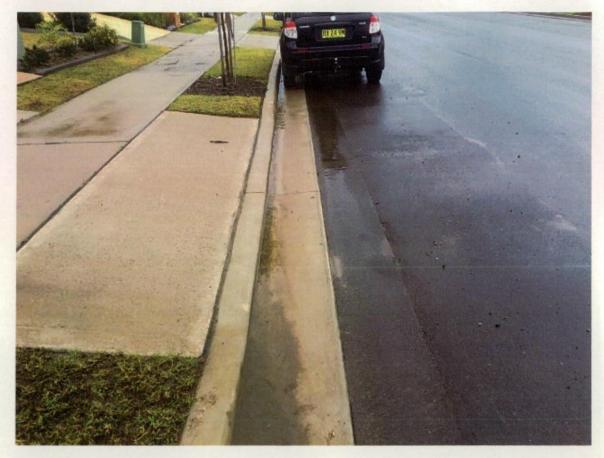
Figure 383 silt runoff in gutter.

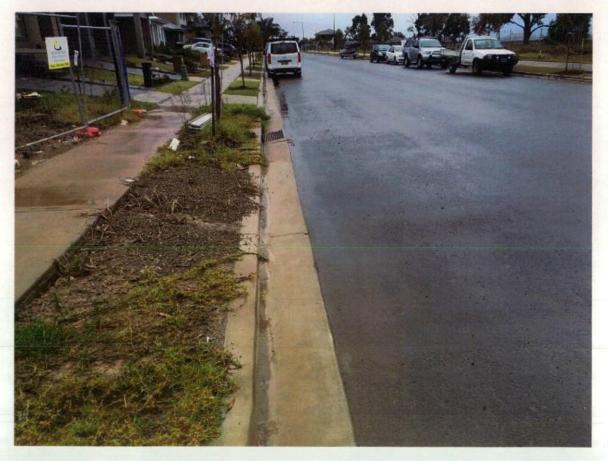
Figure 386 Existing state of driveways opp. site.

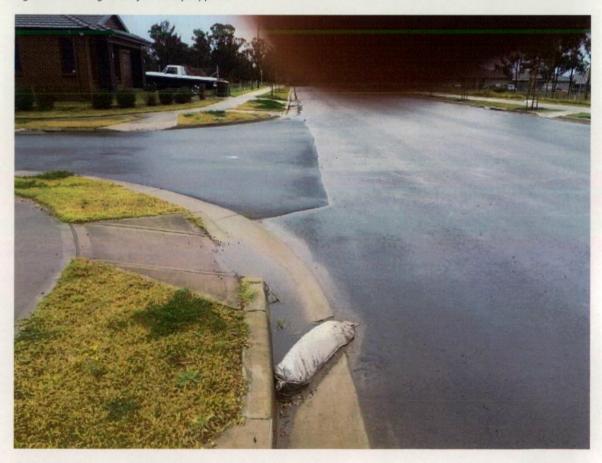
Figure 387 Existing state of driveways opp. site.

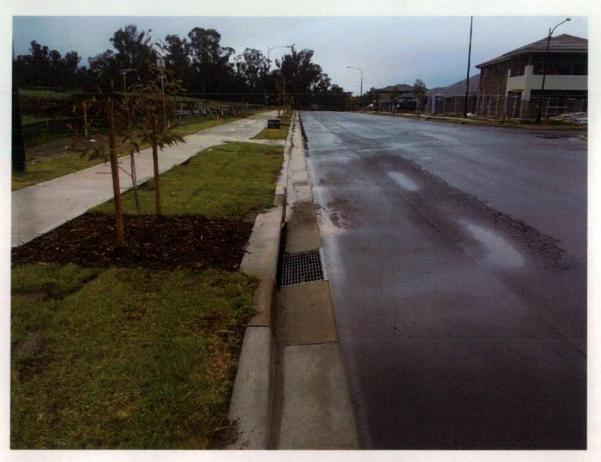
Figure 388 Existing state of driveways opp. site.

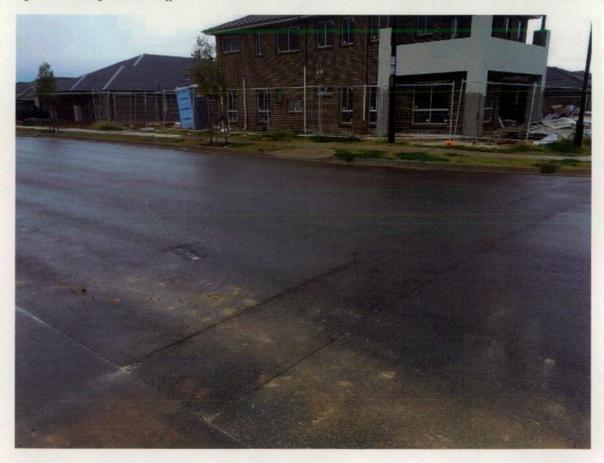
Figure 391 existing soil and runoff.

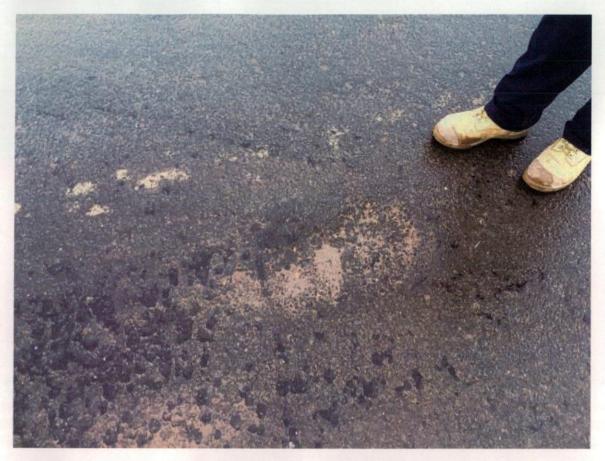
Figure 392 damage to asphalt and silt runoff from sites opp. Oval.

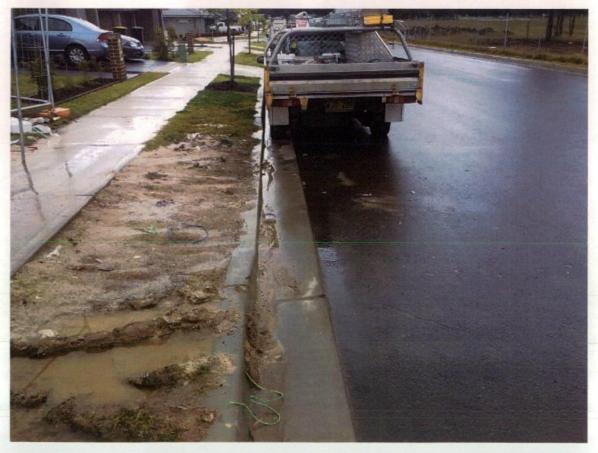
Figure 393 Surface damage to asphalt.

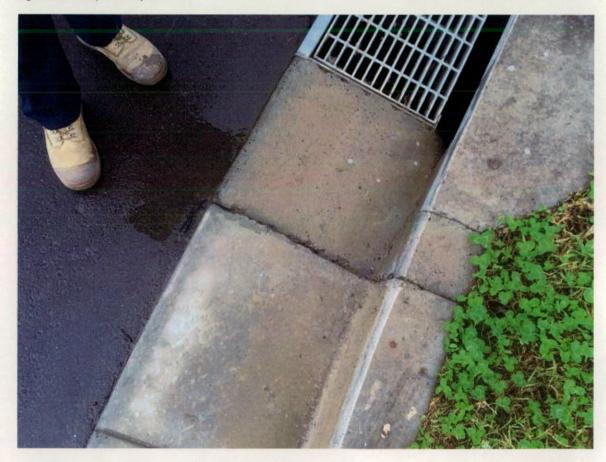
Figure 395 Low spots in asphalt.

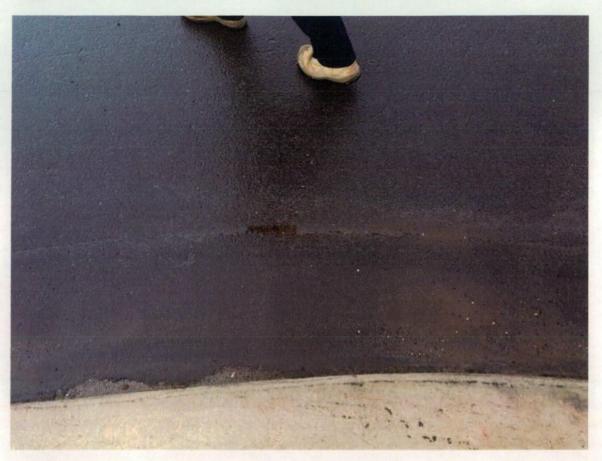
Figure 396 Large height difference between lintel and gutter.

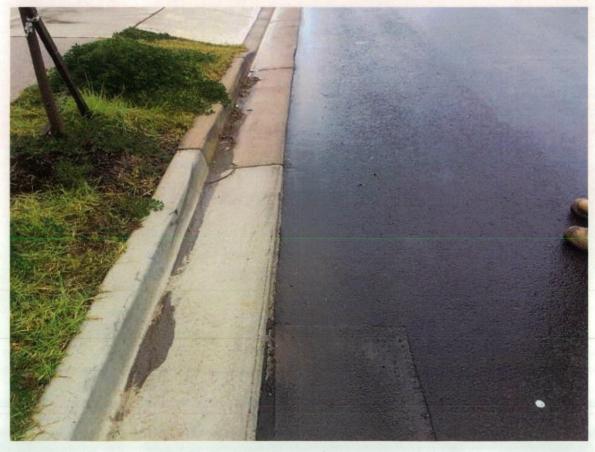
Figure 397 surface imperfections in asphalt edge.

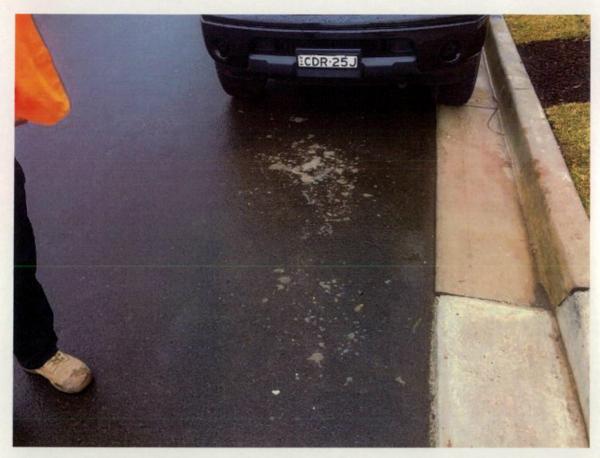
Figure 398 Existing silt and gutter damage opposite site.

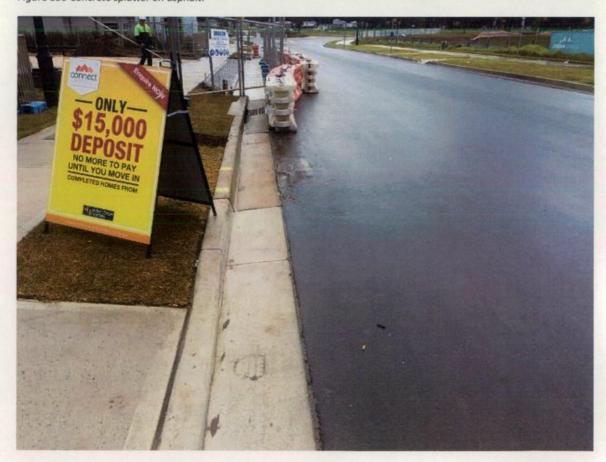
Figure 399 Concrete splatter on asphalt.

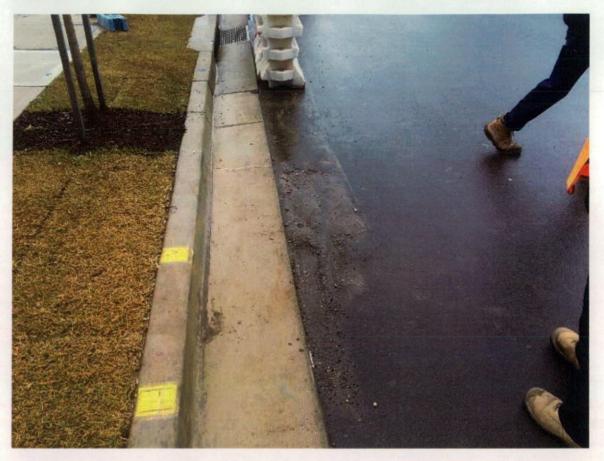
Figure 400 Edge damage and existing construction barriers.

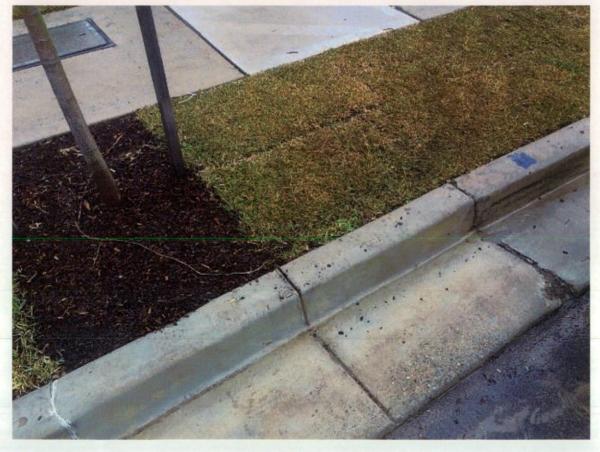
Figure 401 damage to asphalt, repaired crack in K&G.

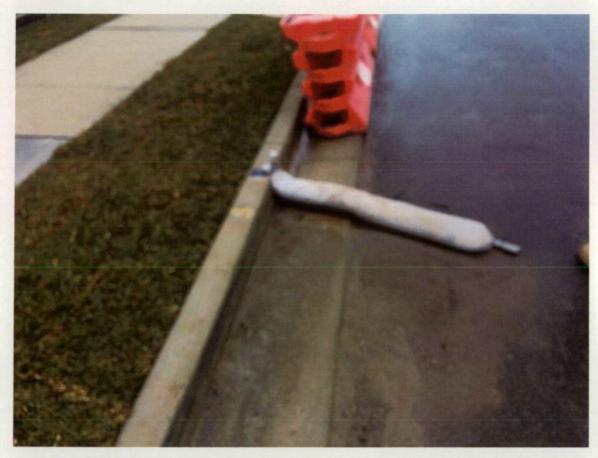
Figure 402 Damage to K&G.

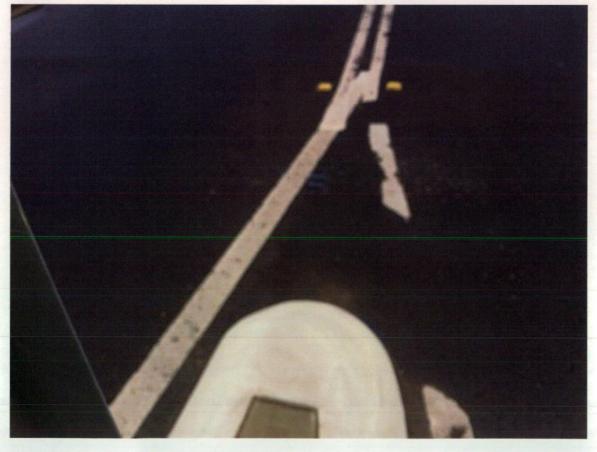
Figure 405 Damage to round about line marking.

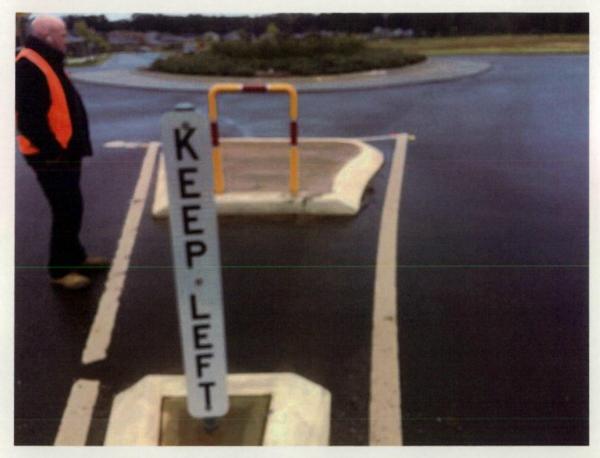
Figure 406 Damage to round about line marking.

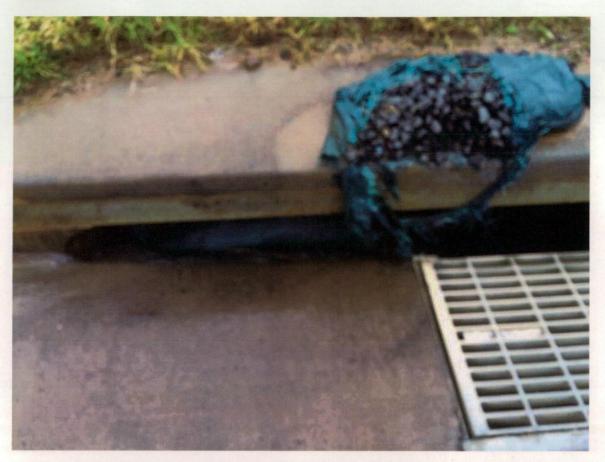
Figure 408 Existing silt control, breaking up and going down the drain.

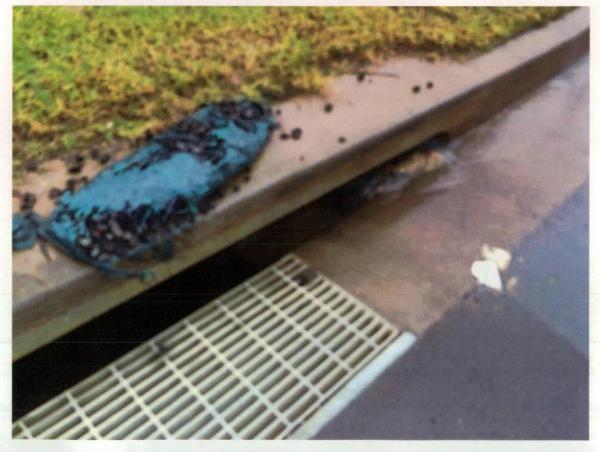
Figure 409 Existing silt control, breaking up and going down the drain.

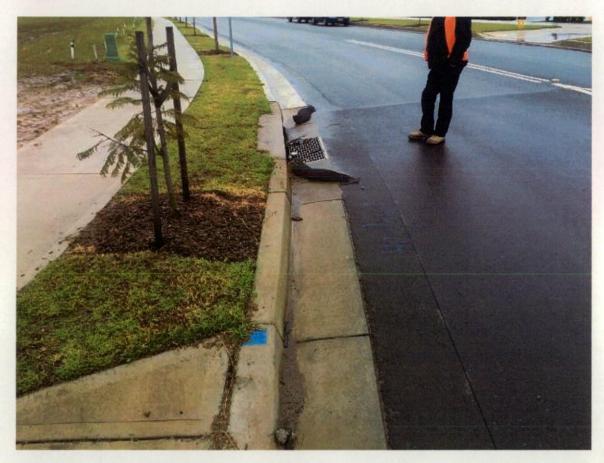
Figure 410 Existing silt control, breaking up and going down the drain.

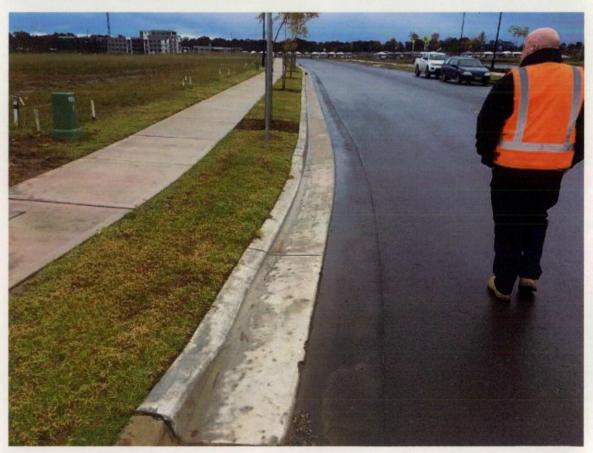
Figure 411 Existing silt and silt controls in gutter opposite site.

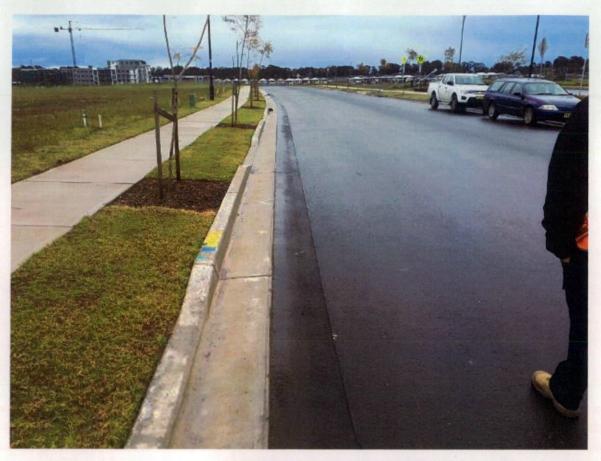
Figure 412 Surface marks on K&G.

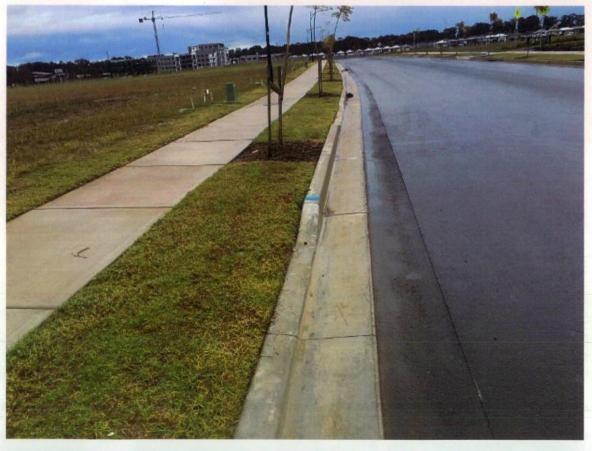
Figure 413 Surface marks on K&G and marks in asphalt.

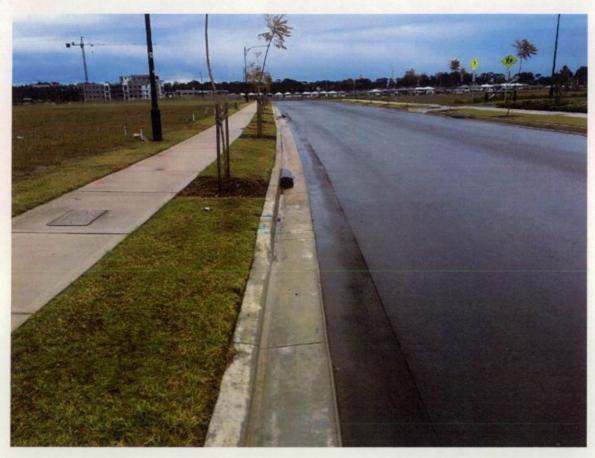
Figure 414 Marks on K&G.

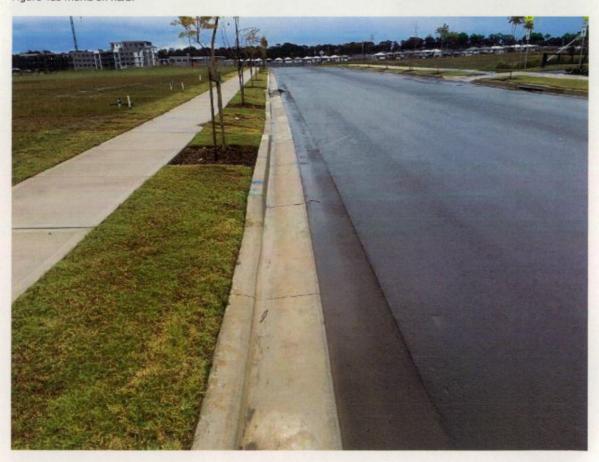
Figure 415 Marks on K&G.

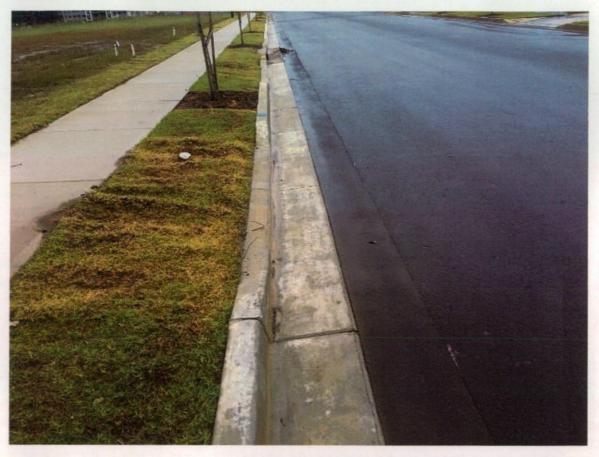
Figure 416 Marks on K&G.

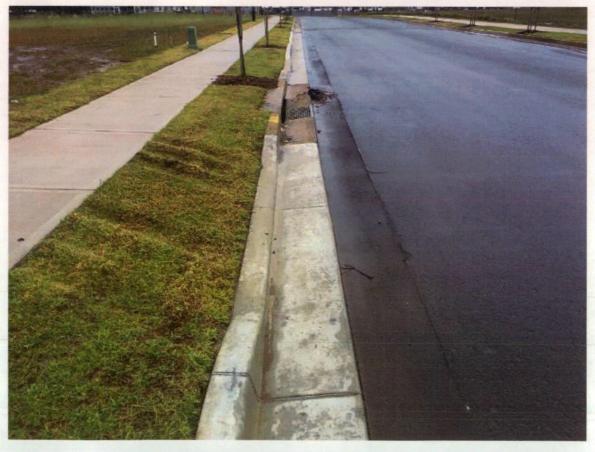
Figure 417 Marks on K&G.

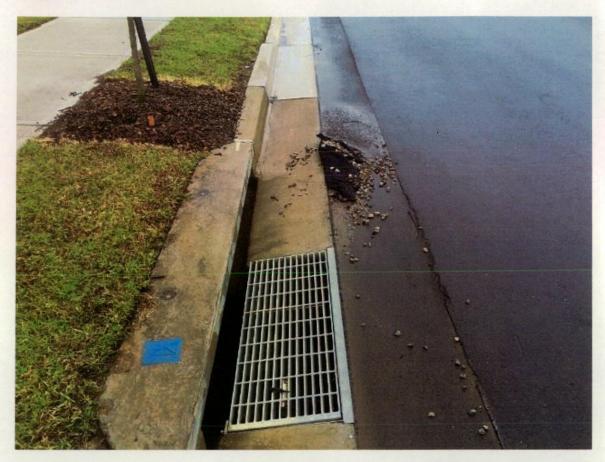
Figure 418 Marks on K&G, wheel ruts in turf area.

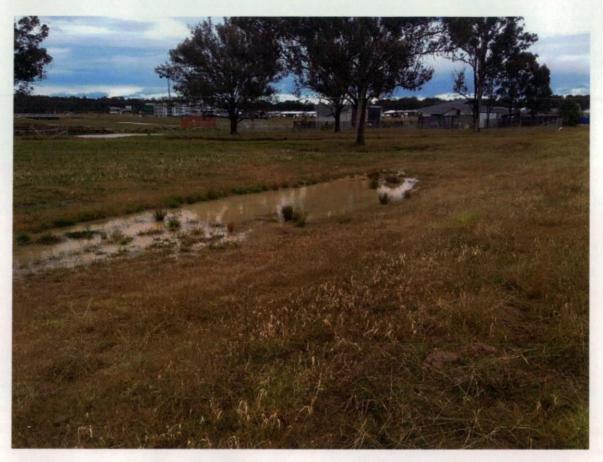
Figure 420 Interior of site holding water and wheel ruts.

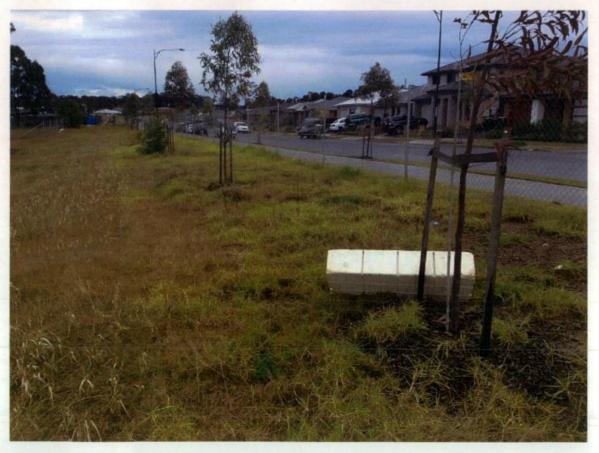
Figure 421 Site holding water in low spot.

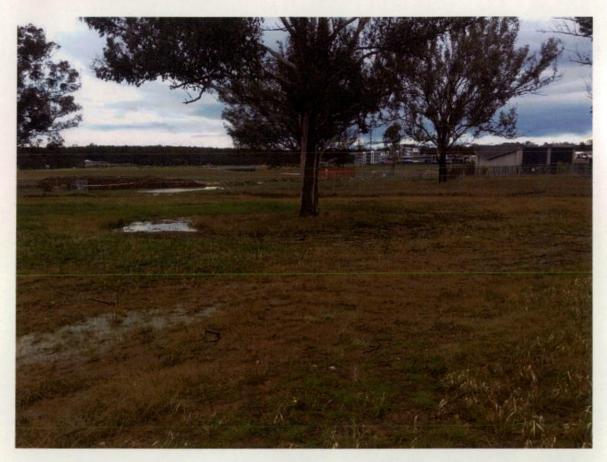
Figure 422 Rubbish left on site.

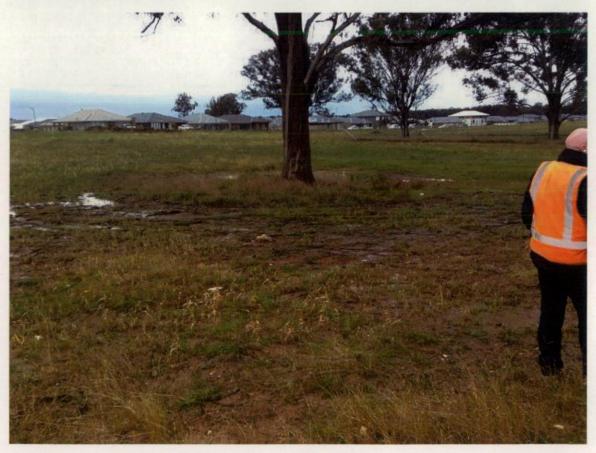
Figure 423 Holding water around tree.

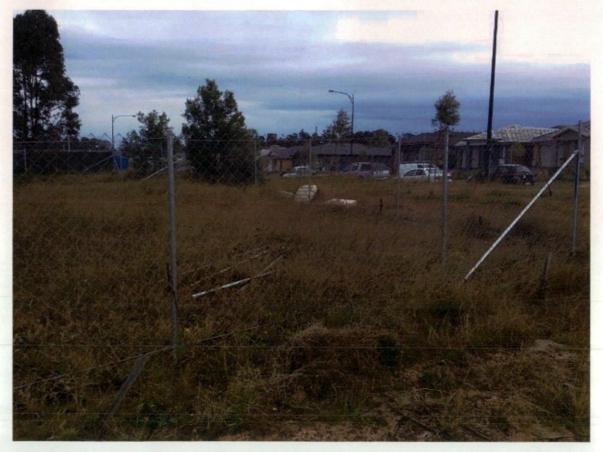
Figure 425 Holding water around tree base.

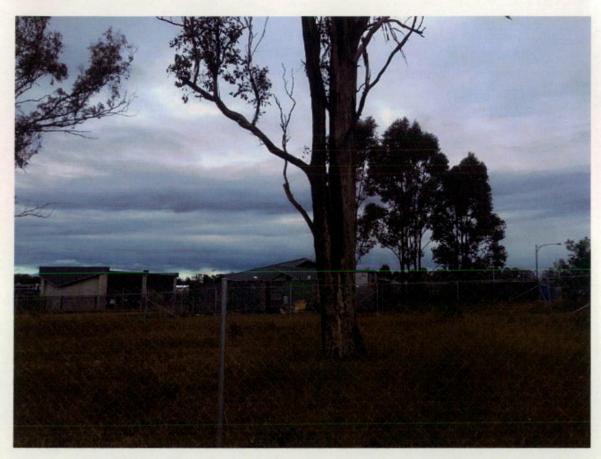
Figure 426 Left over fencing and rubbish on site.

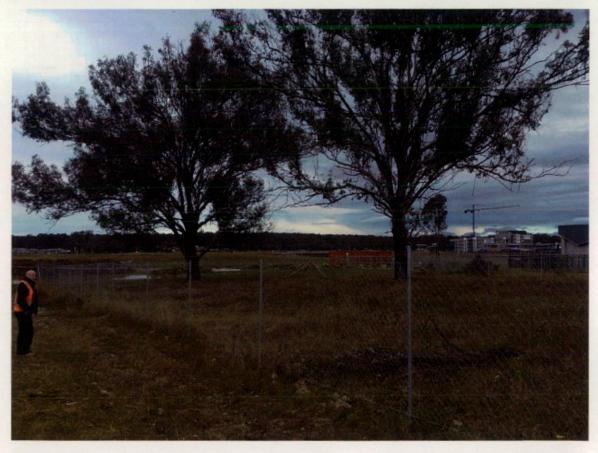
Figure 427 Existing trees on site.

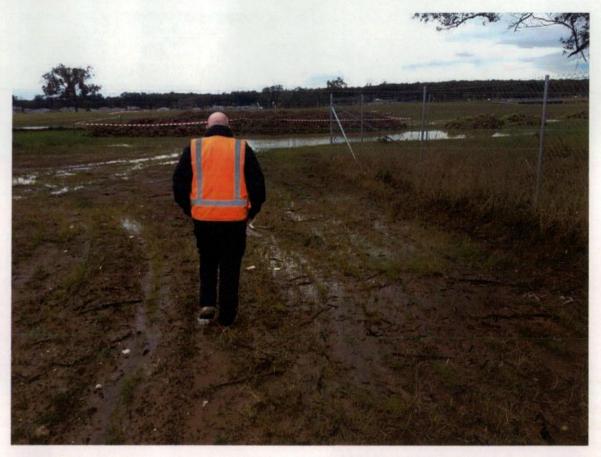
Figure 429Holding water in wheel ruts.

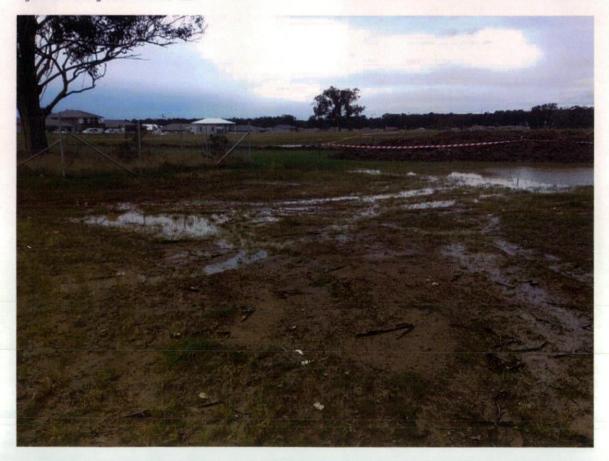
Figure 430 Site holding water in wheel ruts.

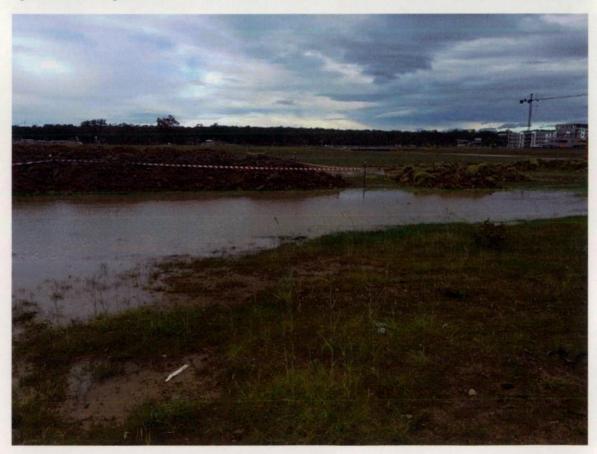
Figure 432 Site holding water, soil and turf piled in areas.

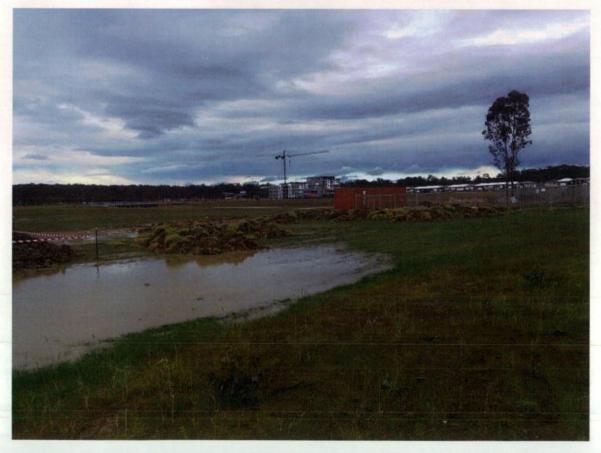
Figure 434 Turf excess piled in areas.

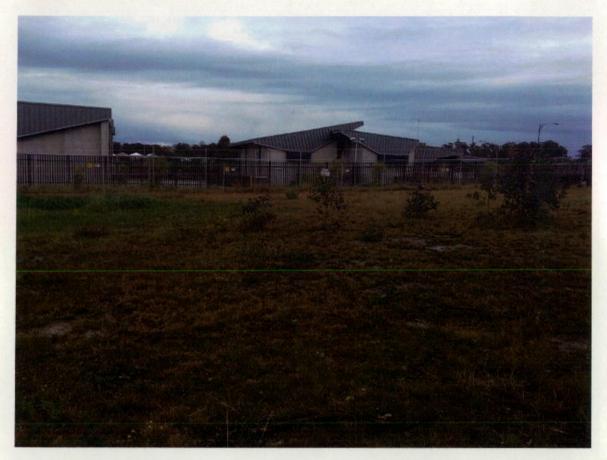
Figure 435 State of existing trees on site.

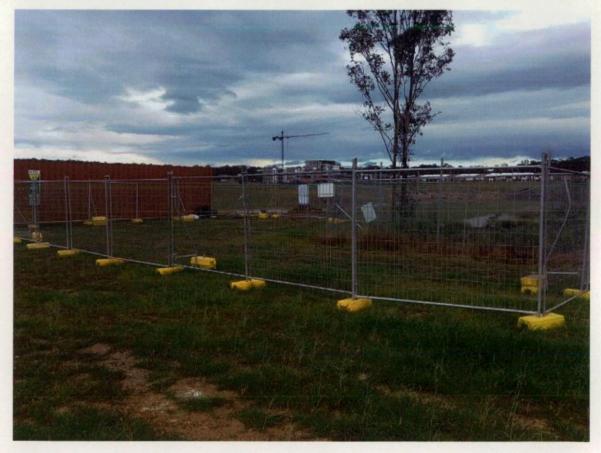
Figure 436 Existing fence and container on site.

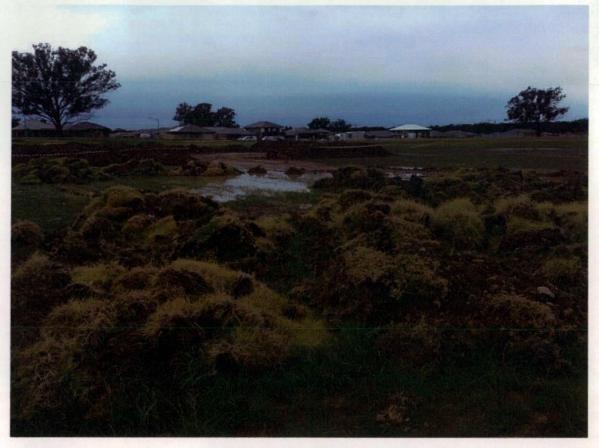
Figure 437 Existing piles of turf and soil.

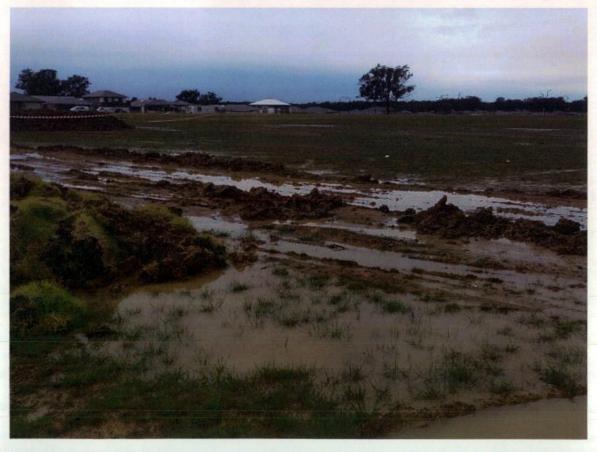
Figure 438 Wheel ruts holding water.

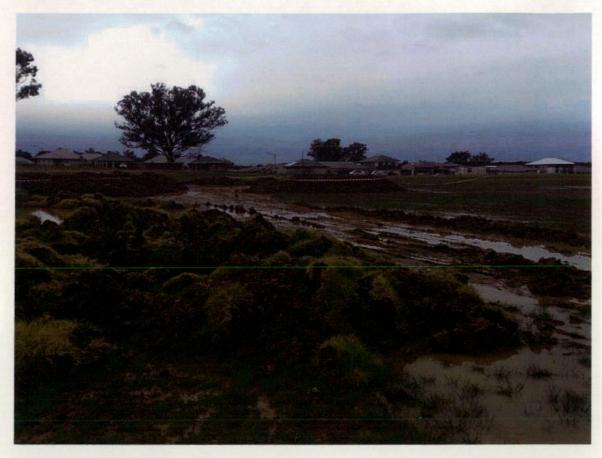
Figure 439 Soil stockpiled, wheel ruts holding water.

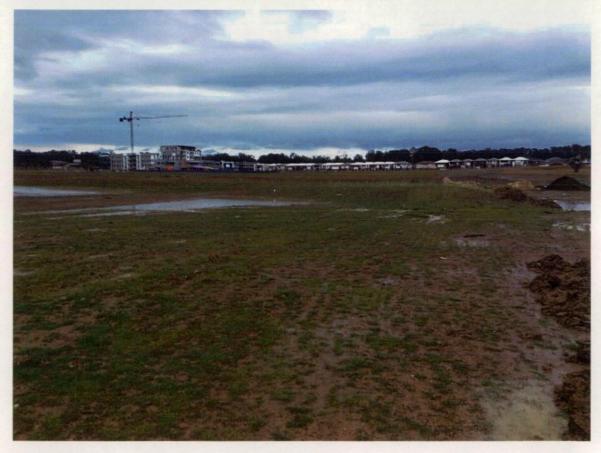
Figure 440 Holding water on site.

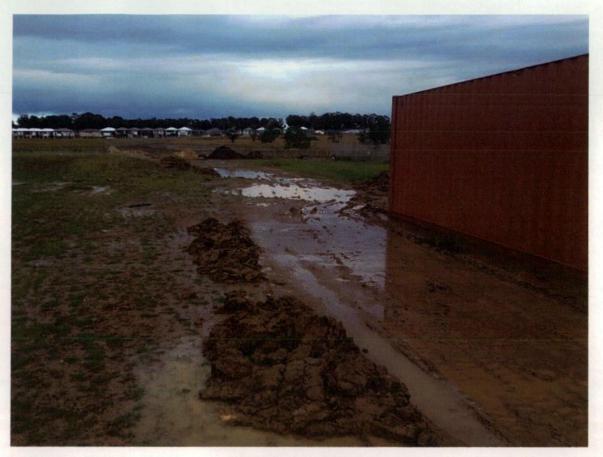
Figure 441 Holding water in wheel ruts.

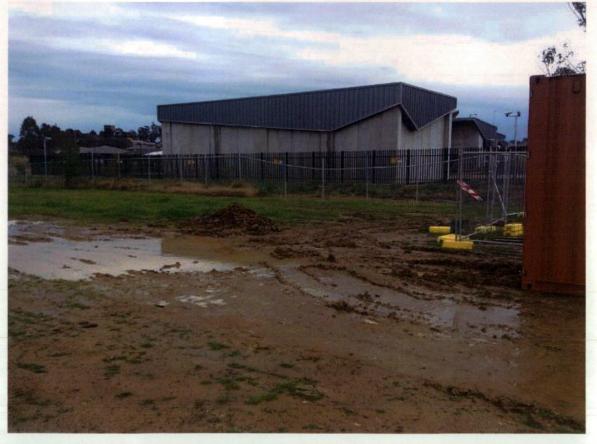
Figure 442 Wheel ruts and mud holding water.

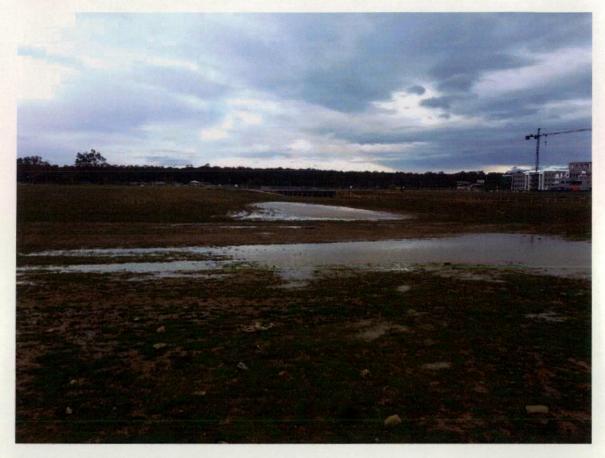
Figure 443 Holding water in low spots on site.

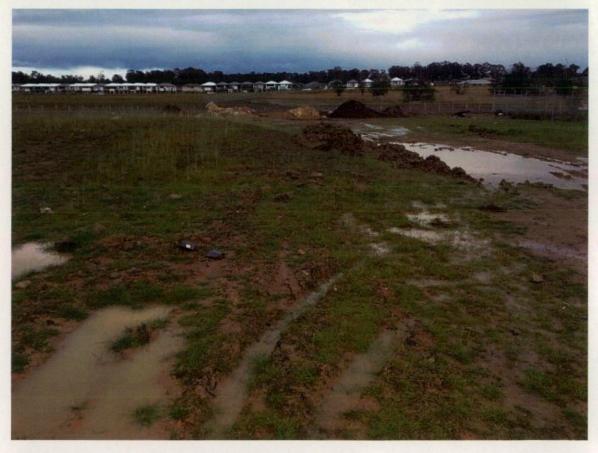
Figure 444 Wheel ruts and soil untidy in areas, holding water.

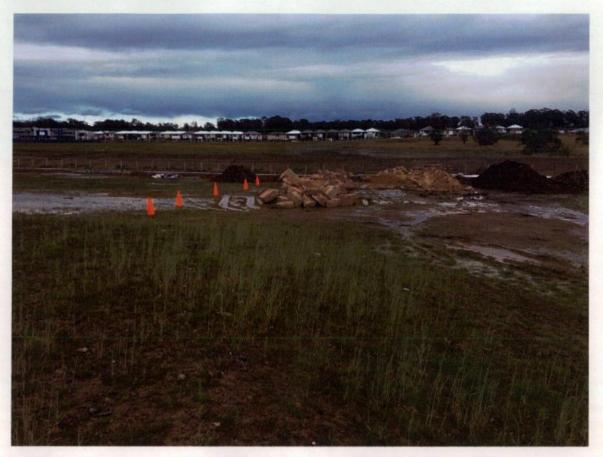
Figure 445 Sandstone and other materials stockpiled on site.

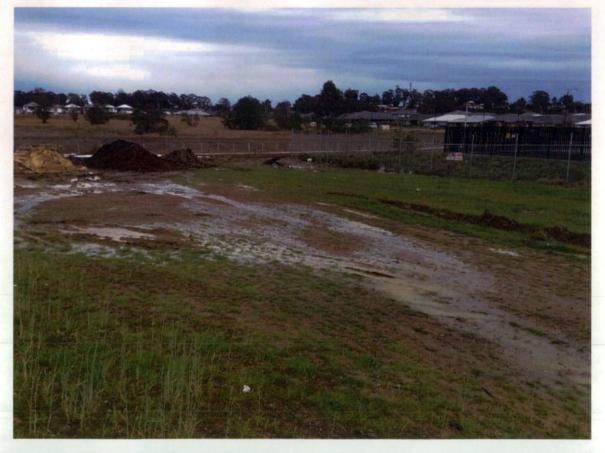
Figure 446 Wheel ruts holding water, stockpiled materials.

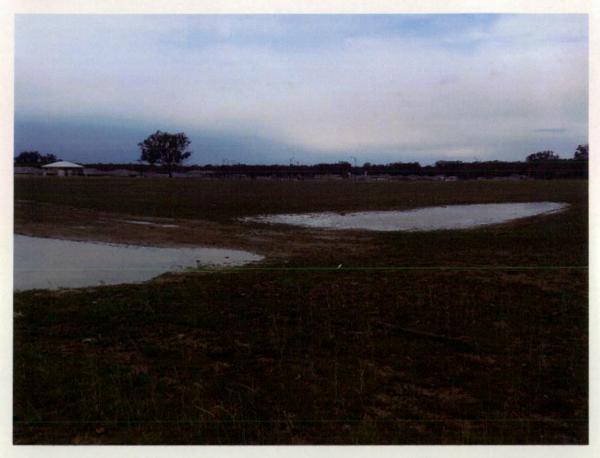
Figure 447 Holding water in low spots on site.

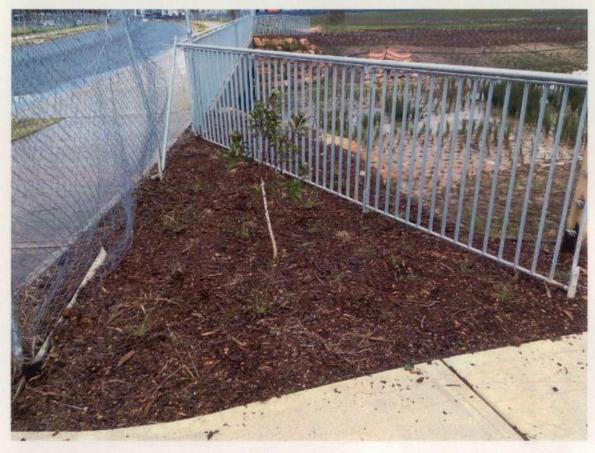
Figure 448 Fence damaged and mulch untidy in garden bed.

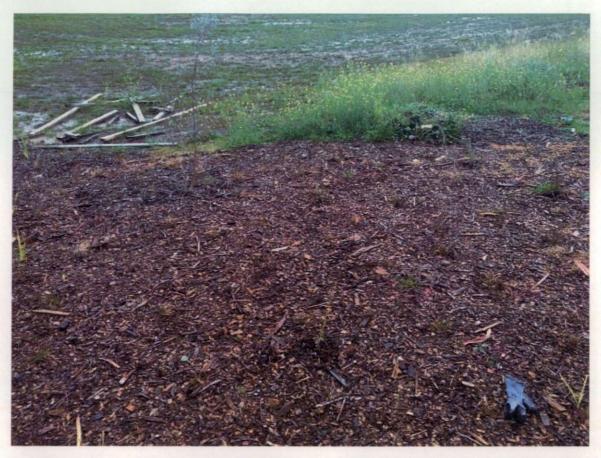
Figure 449 Dead plants in garden bed.

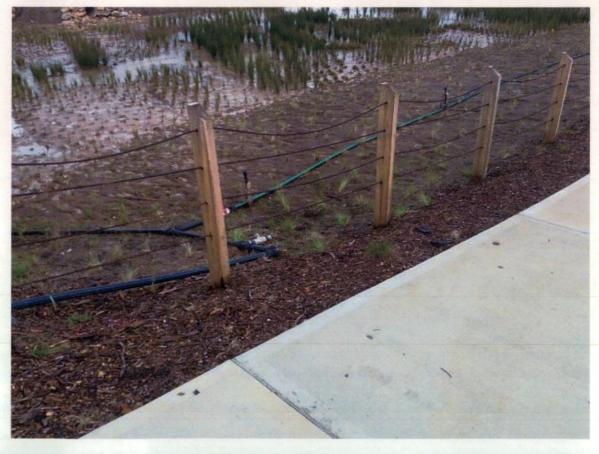
Figure 450 Loose wire on fence, existing irrigation system parts broken.

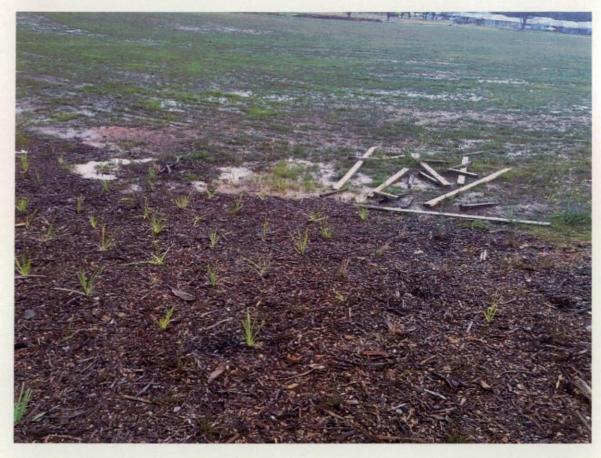
Figure 451 Holding water, building materials left on site.

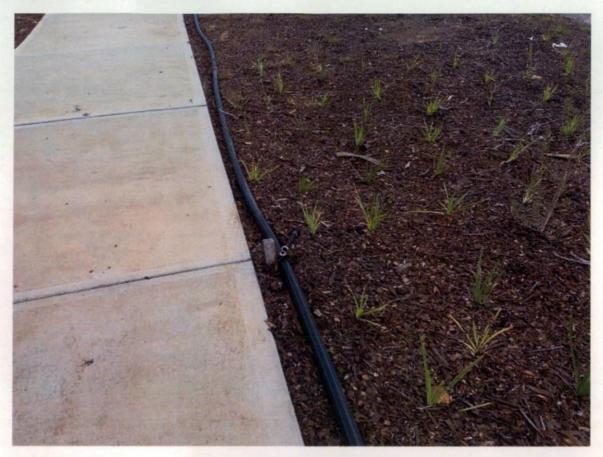
Figure 453 Broken temporary irrigation.

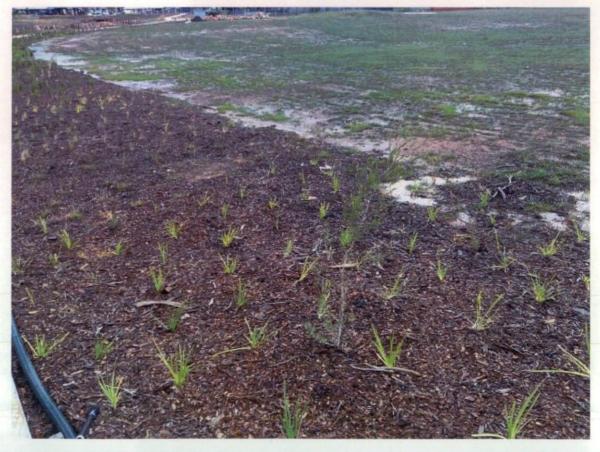
Figure 454 Holding water behind garden.

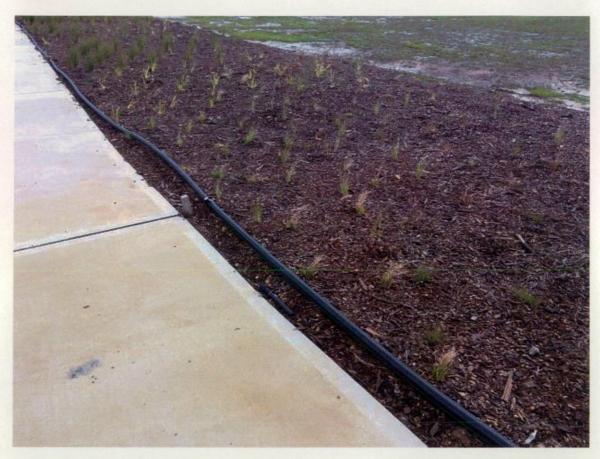
Figure 455 Broken temporary irrigation.

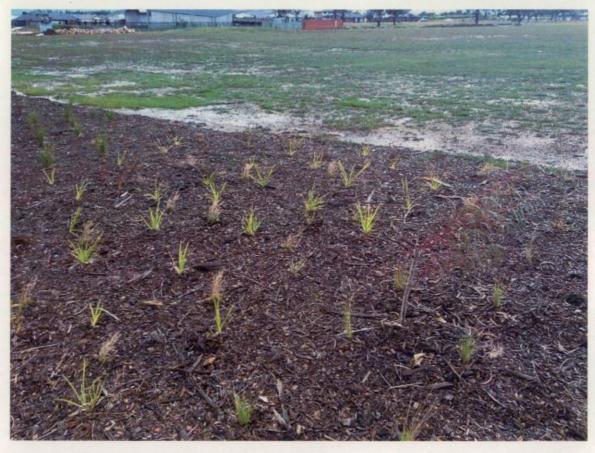
Figure 456 Dead plants in garden bed.

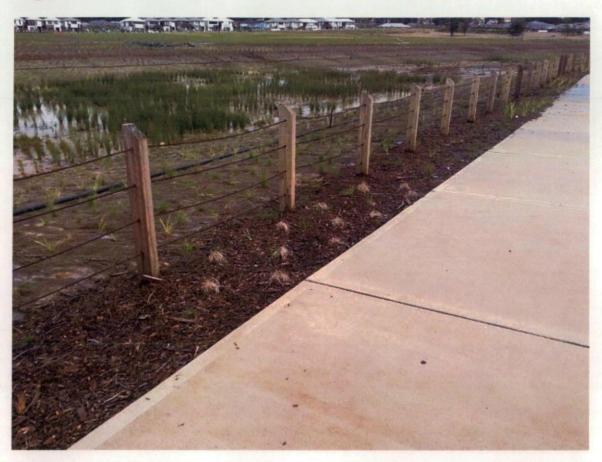
Figure 457 Dead plants in garden bed.

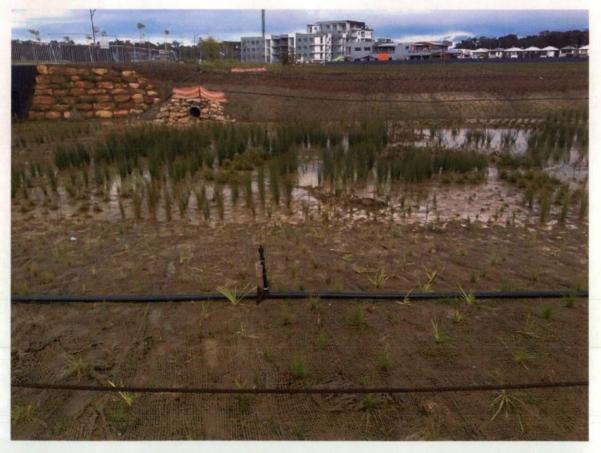
Figure 458 Existing state of riparian corridor.

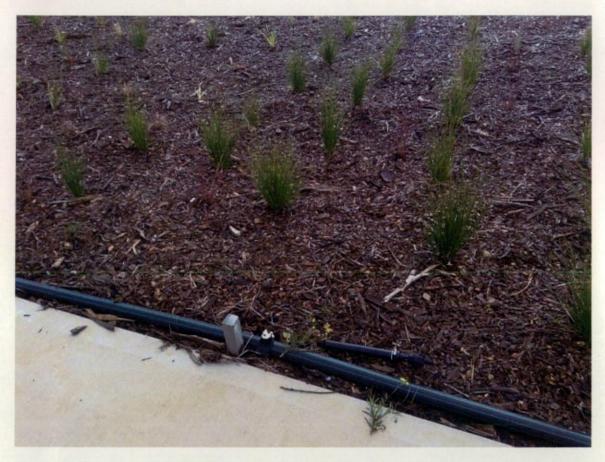
Figure 459 Broken temporary irrigation system.

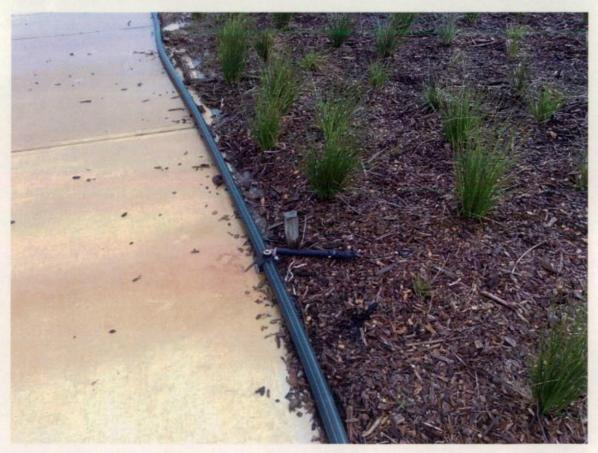
Figure 460 Broken temporary irrigation system.

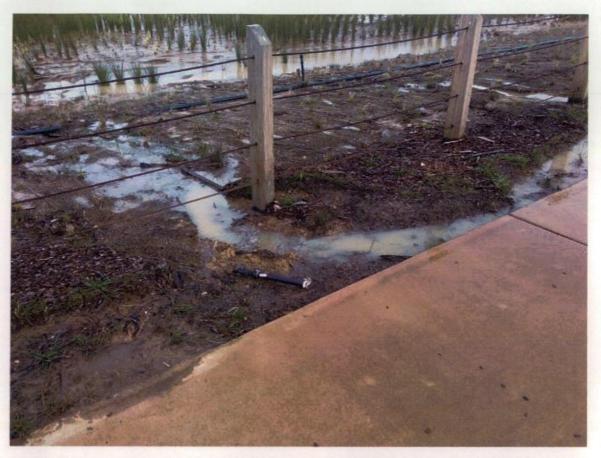
Figure 461 Broken temporary irrigation system, water runoff through garden.
