QUA004 - DILAPIDATION & SITE INSPECTION REPORT

Customer/Project Name: Lendlease - Village		ase - Village O	val, Jordan S	prings.						
Customer/Project Address: Cnr Alinta Promenad					de & Greenwood Parkway, Jordan Springs					
Job No.	28	45	Contract No).	724		Date:	21/07/	2015
Prepared by: Luke Cranson					Photos en	closed:	Yes 🖂	No [
Inspection	1				Notes & Co	omments				
Water		Nearside	⊠ Fa	r-side 🖂						
Electricity	•	Aerial 🛛	Unde	erground 🛛						
Sewer		Yes 🖂	No 🗌							MIL .
Septic		Yes 🗌	No 🛛		Туре					
Kerb & Gu	itter	Yes 🖂	No 🗌		Damage	Yes 🖂	No 🗌			
Layback		Yes 🖂	No 🗌		Damage	Yes 🛛	No 🗌			
Footpath Yes		Yes 🖂	No 🗌		Damage	Yes 🖂	No 🗌			
Vehicle Ac	ccess	Good 🛛	Need	s Work 🗌						
Boundary Pegs		Yes 🗌	No 🛚				TOM:			
Existing Fe	encing	Yes 🖂	No 🗌		Туре	Builder	s Temporar	y, chain lir	nk perimet	er fence
Subsoil		Existing		1						
Excavation		Yes 🖂	No 🗌							
Trees Yes 🗵		Yes 🖂	No 🗌					DEC	EIVE	
	Stor	mwater							MGT	
Other:								2 3	JUL 2015

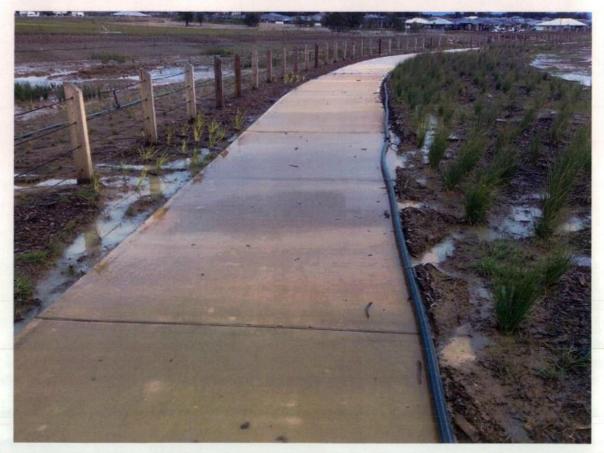
Figure 462 Holding water in wheel ruts.

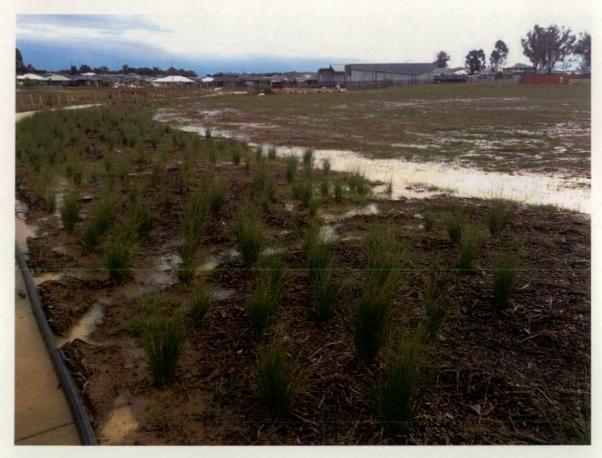
Figure 463 Water runoff through garden, holding water.

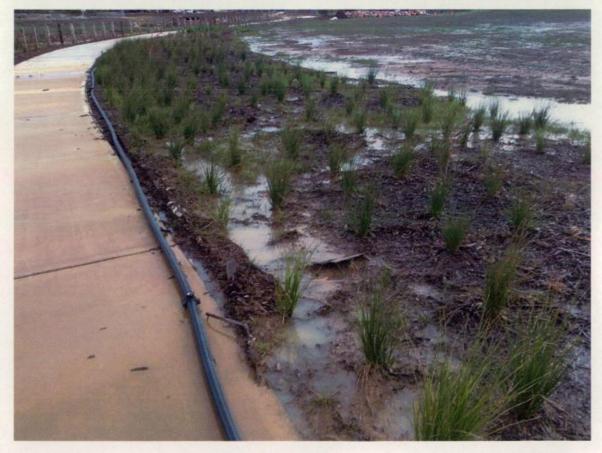
Figure 464 Water runoff through garden, holding water.

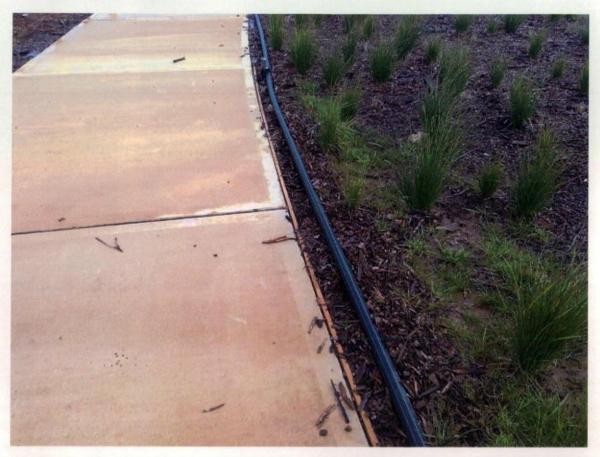
Figure 465 Marks on concrete footpath.

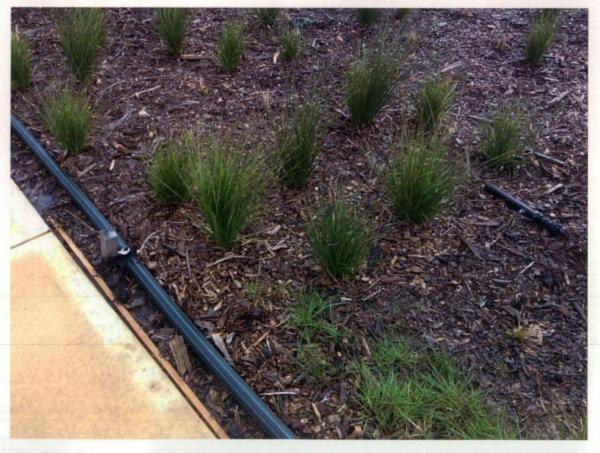
Figure 466 Broken temp irrigation system.

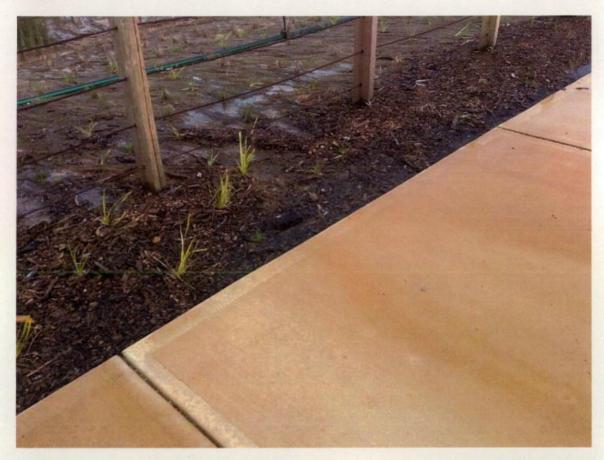
Figure 467 Water runoff through garden from site.

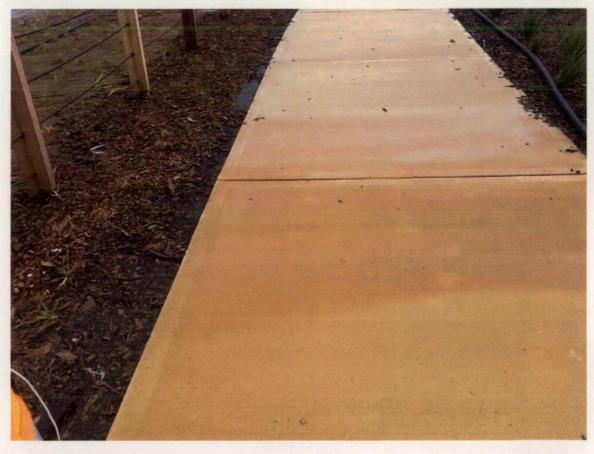
Figure 468 Marks on existing pavement.

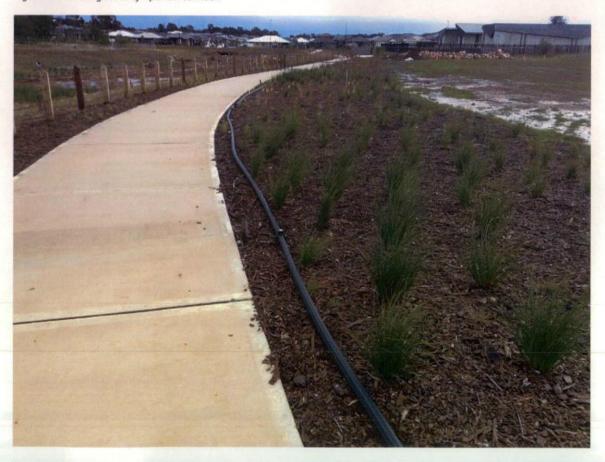
Figure 469 Existing state of riparian corridor.

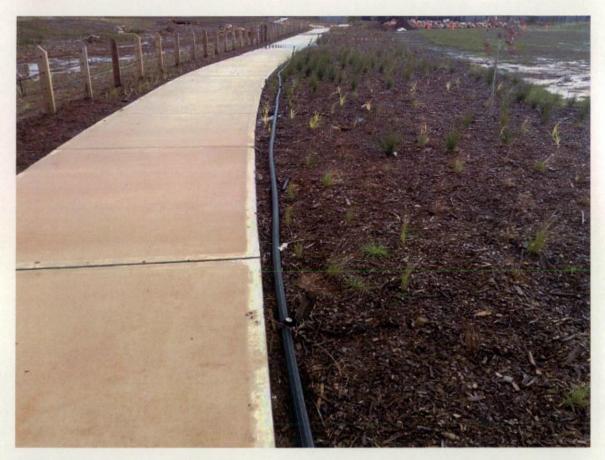
Figure 470 Broken temporary irrigation.

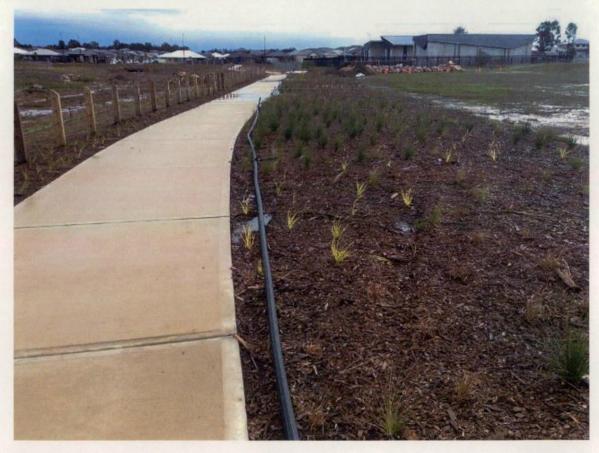
Figure 471 Broken temporary irrigation system.

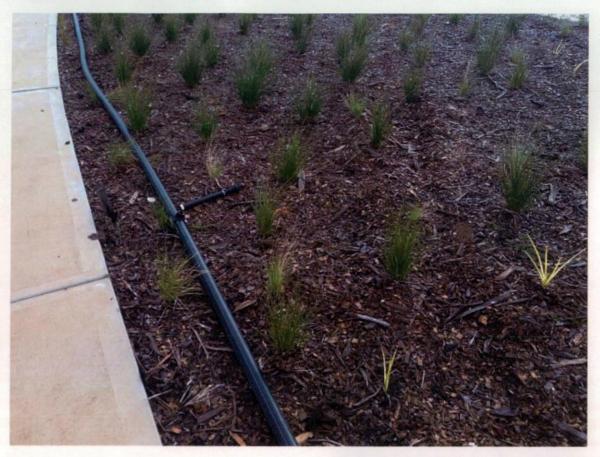
Figure 472 Ruts in garden bed, dead plants.

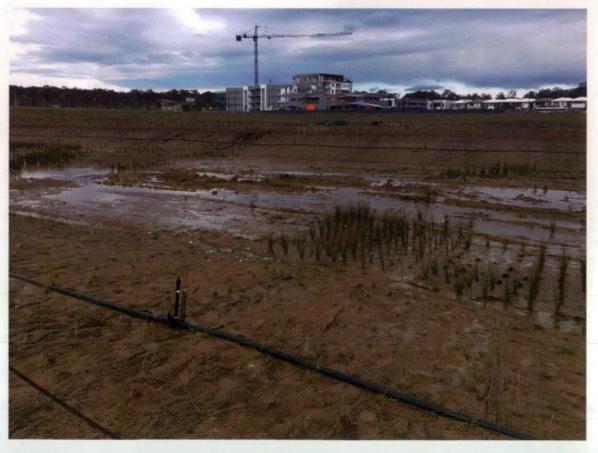
Figure 473 Broken irrigation, wheel ruts in garden.

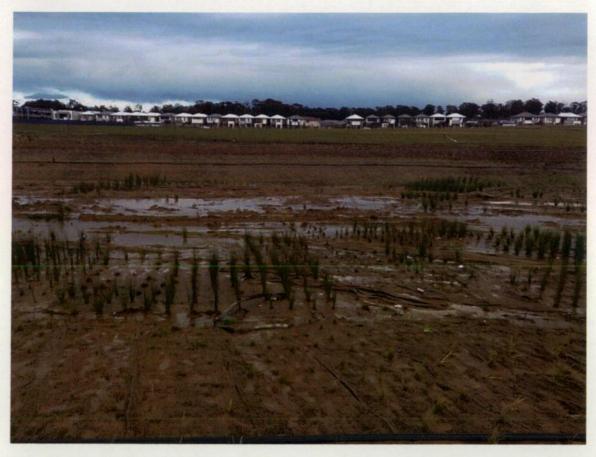
Figure 474 Existing state of riparian corridor.

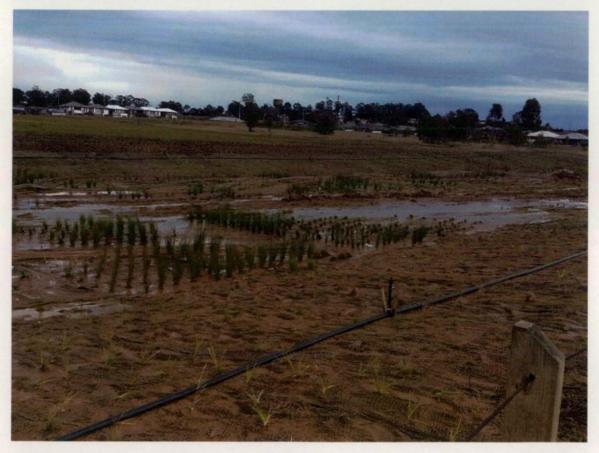
Figure 475 Existing state of riparian corridor.

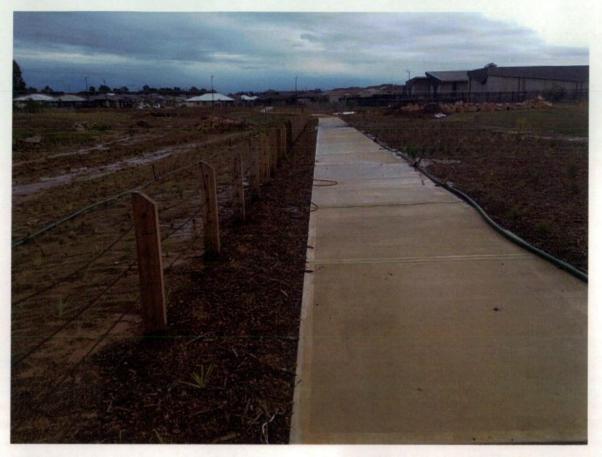
Figure 476 Existing state of riparian corridor.

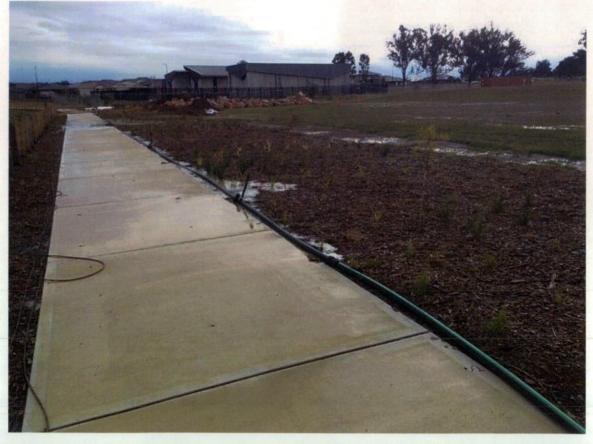
Figure 477Steel cables from handrail cut and on footpath.

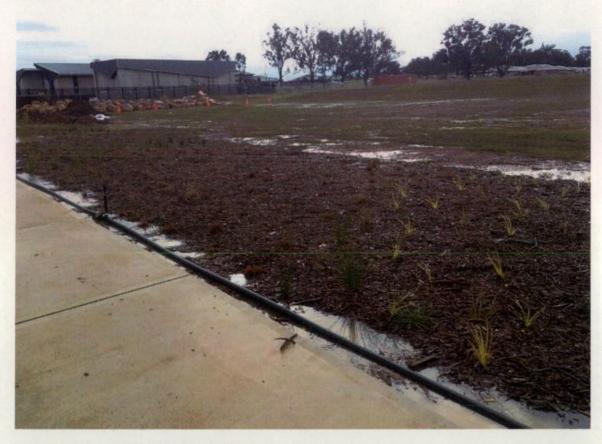
Figure 478 Holding water in garden bed.

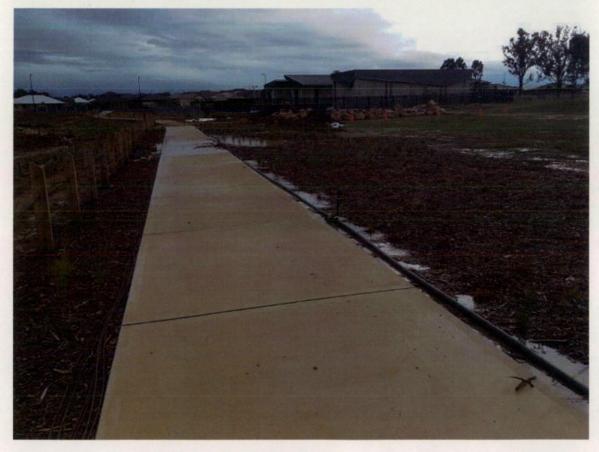
Figure 479 Holding water in garden bed, dead plants in garden area.

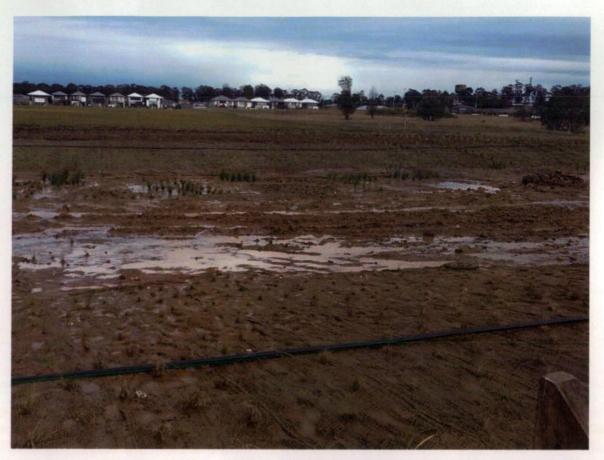
Figure 480 Holding water in garden bed.

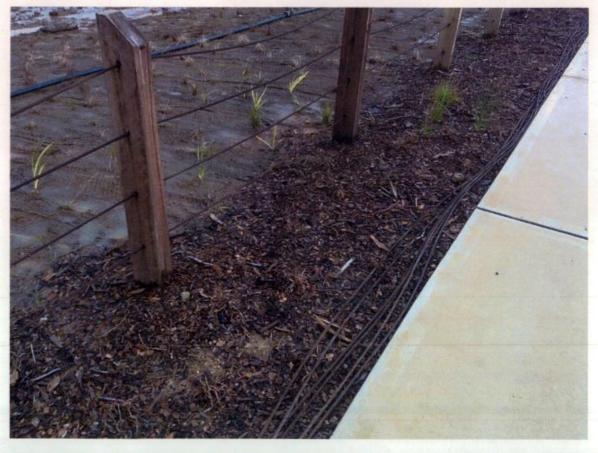
Figure 481 Existing state of riparian corridor.

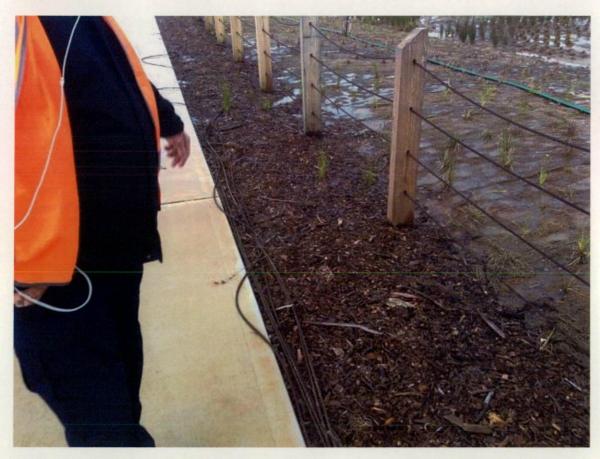
Figure 482 Cables cut from handrail near riparian

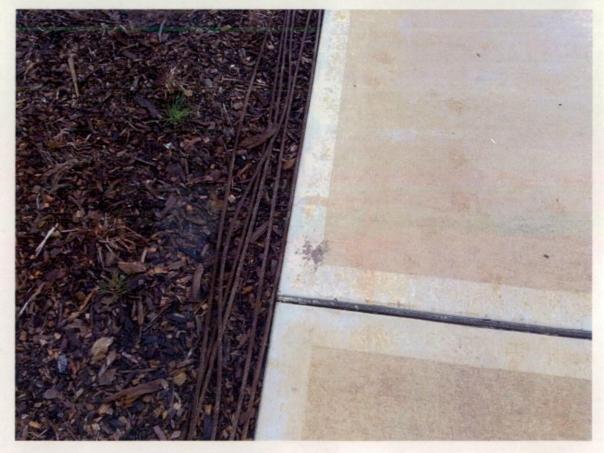
Figure 483 Cables cut from handrail near riparian

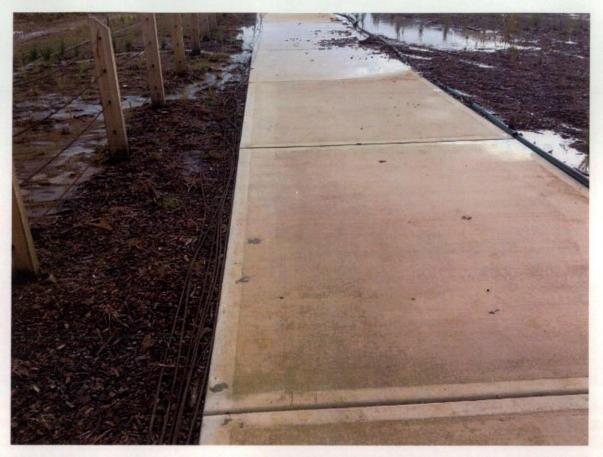
Figure 484 Cables cut from handrail near riparian

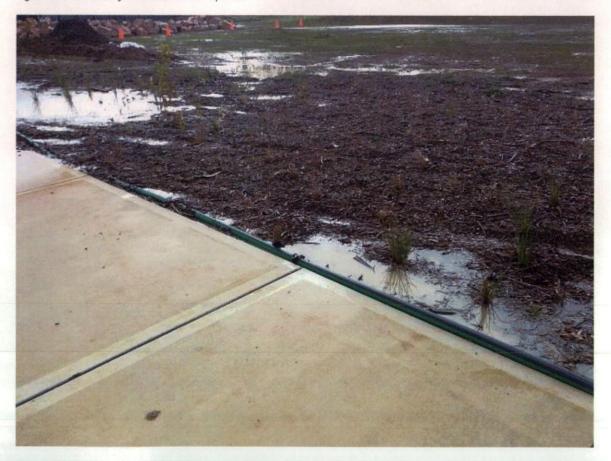
Figure 485 Cables cut from handrail near riparian

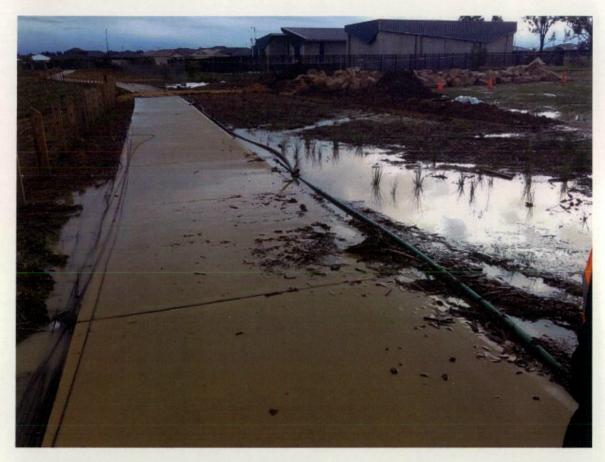
Figure 486 Holding water and dead plants in garden zone.

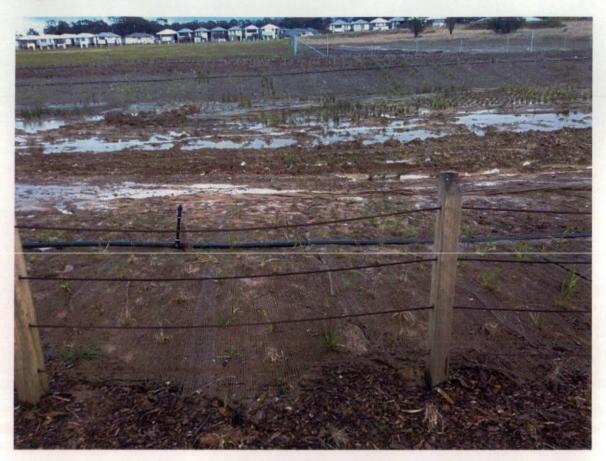
Figure 488 Holding water in garden beds.

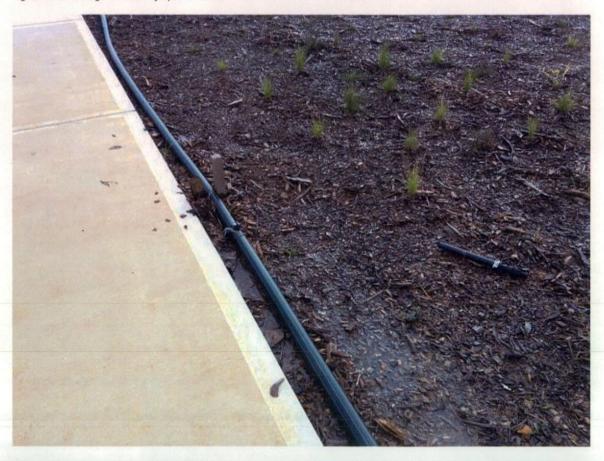
Figure 489 Existing condition of riparian zone.

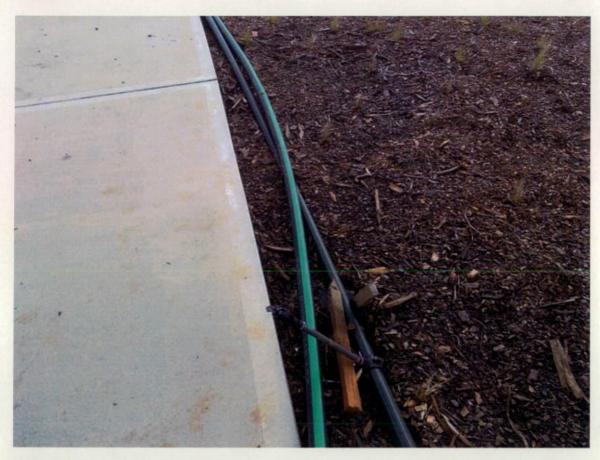
Figure 490 Broken existing irrigation main.

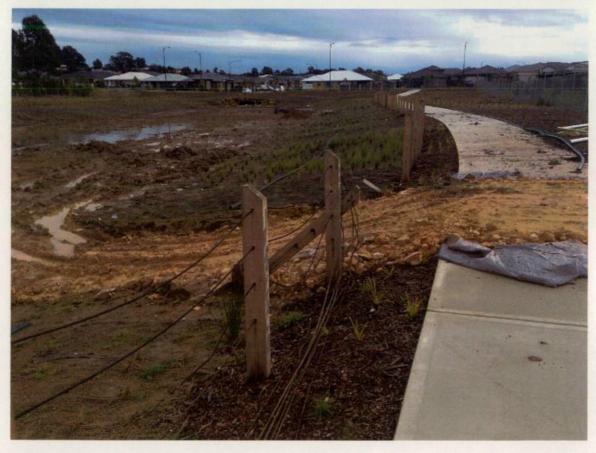
Figure 491 Broken existing temporary irrigation.

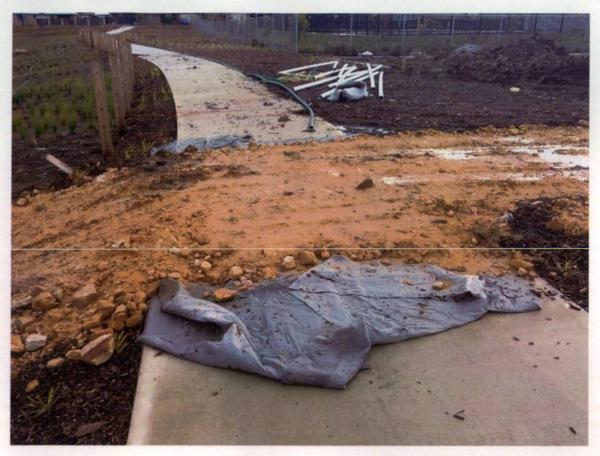
Figure 492 Existing access to riparian corridor.

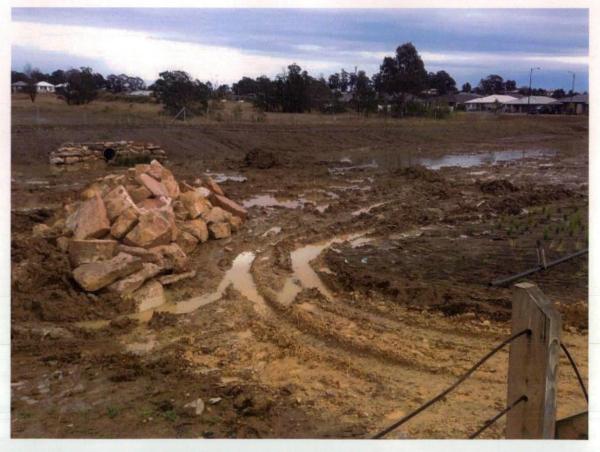
Figure 493 Existing access to riparian corridor, possible damage to concrete footpath underneath.

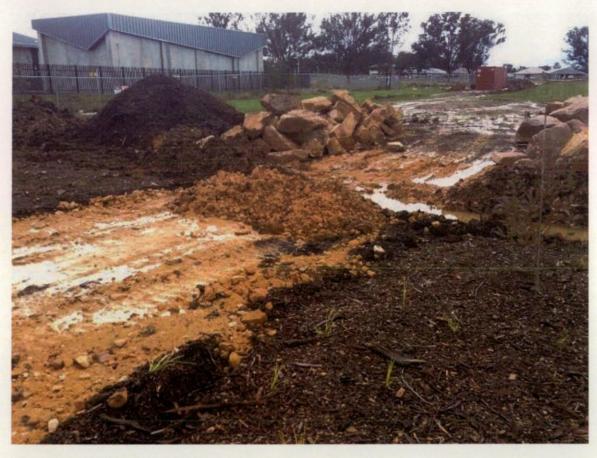
Figure 494 Existing state of Riparian Corridor, construction materials stockpiled.

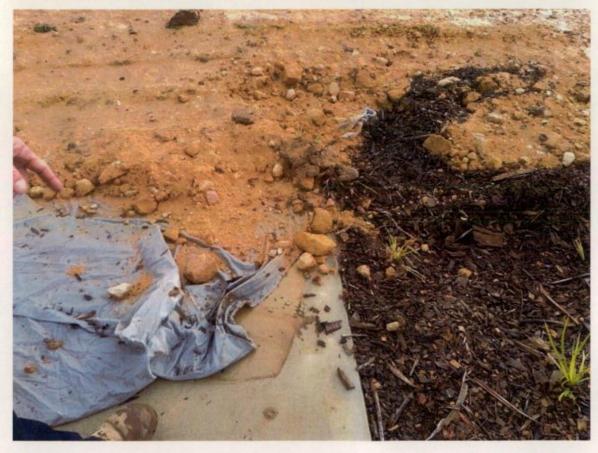
Figure 495 Construction materials stockpiled on site.

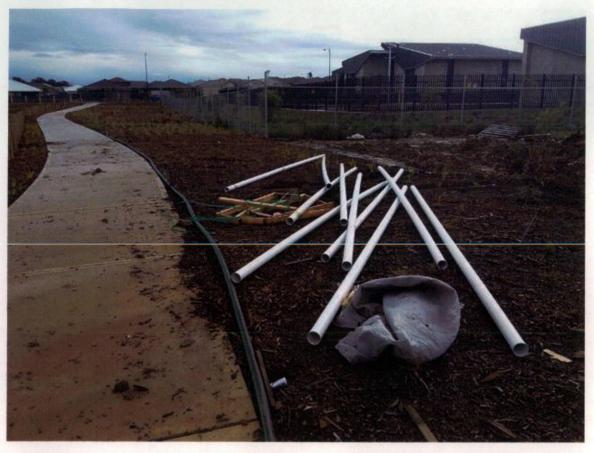
Figure 496 Possible damage to footpath beneath crushed sandstone.

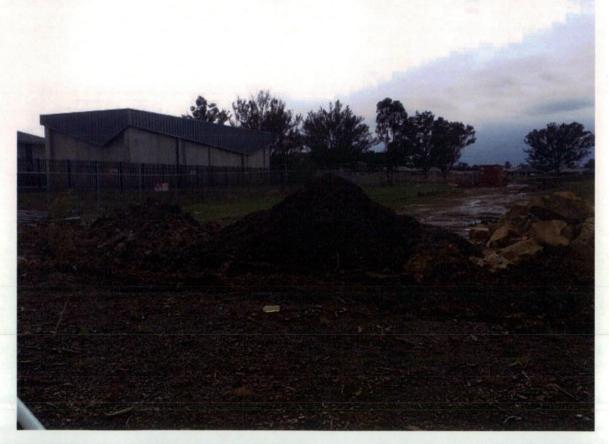
Figure 497 Excess building materials.

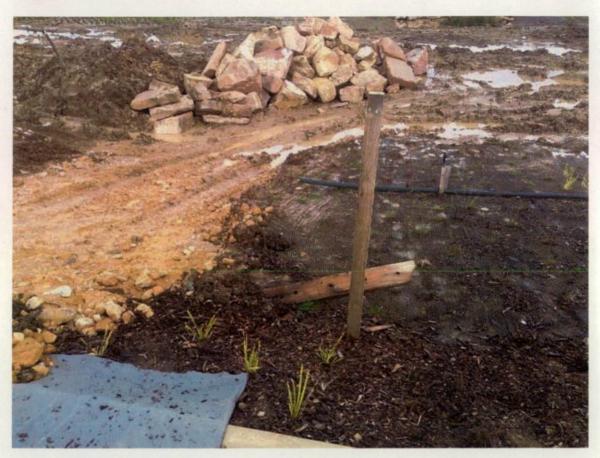
Figure 498 Excess building materials.

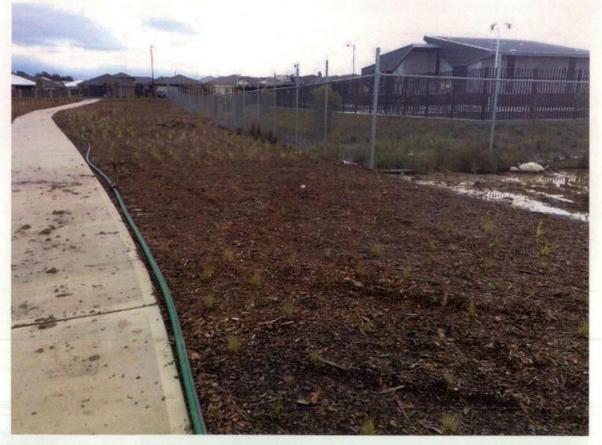
Figure 501 Building materials and wheel ruts in garden.

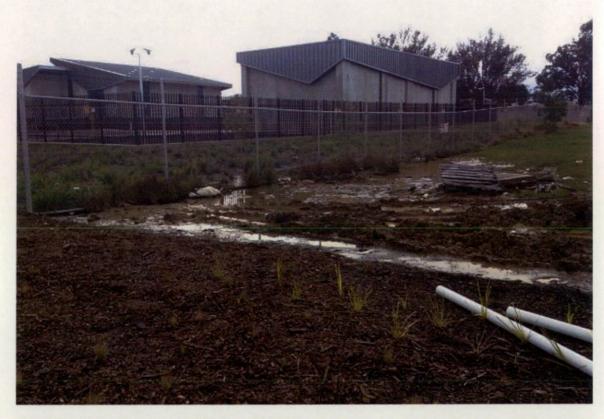
Figure 502 Wheel ruts and dead plants present in garden bed.

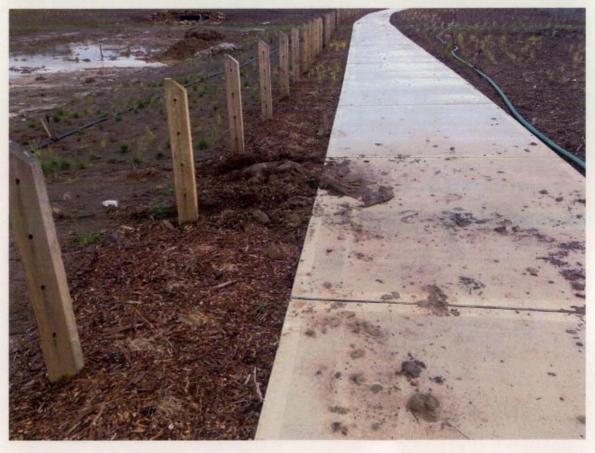
Figure 503 holding water at low point behind electrical substation.

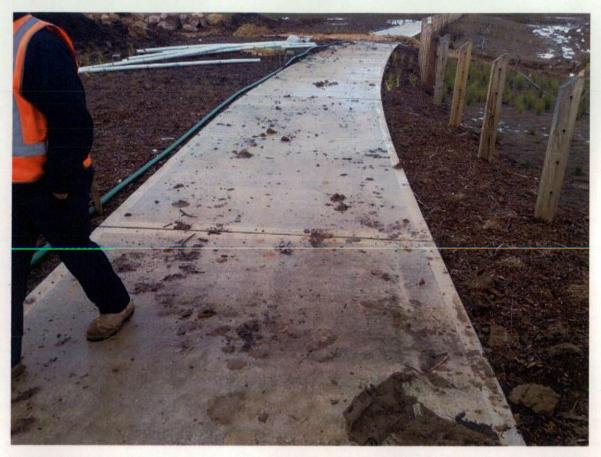
Figure 504 Wheel ruts and excess soil on concrete footpath.

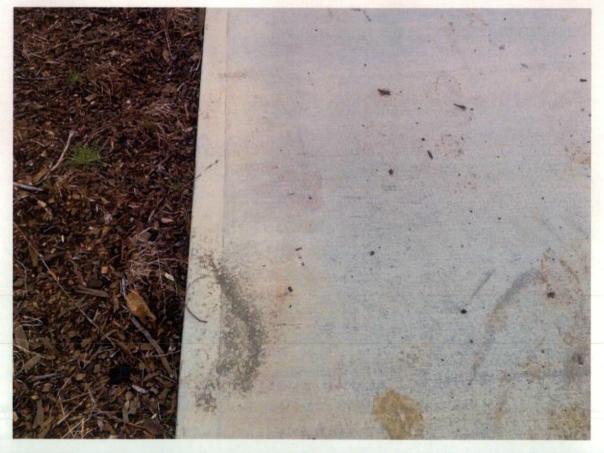
Figure 505 Excess soil on concrete footpath.

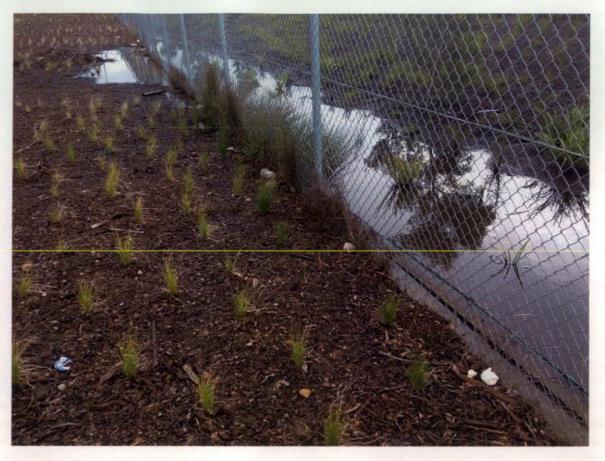
Figure 508Holding water near garden bed.

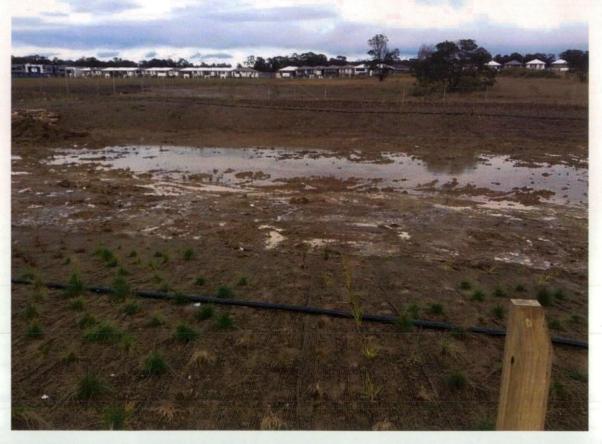
Figure 509 Holding water at low point.

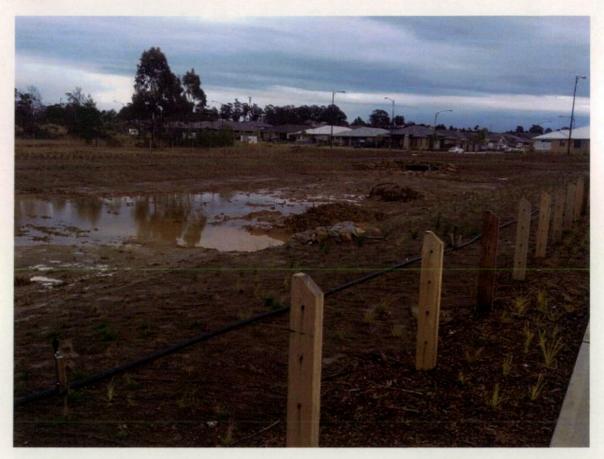
Figure 510 Existing condition of riparian corridor.

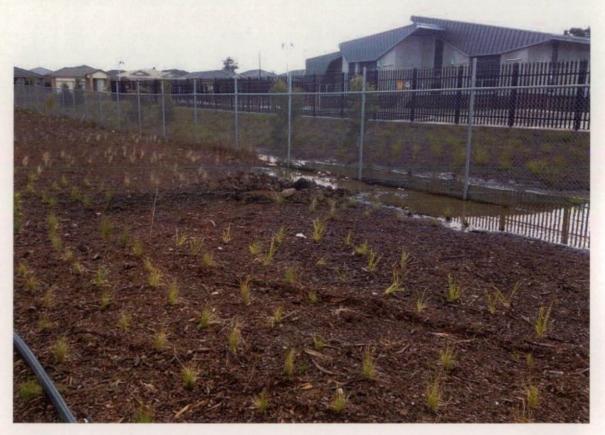
Figure 511 Existing condition of riparian corridor.

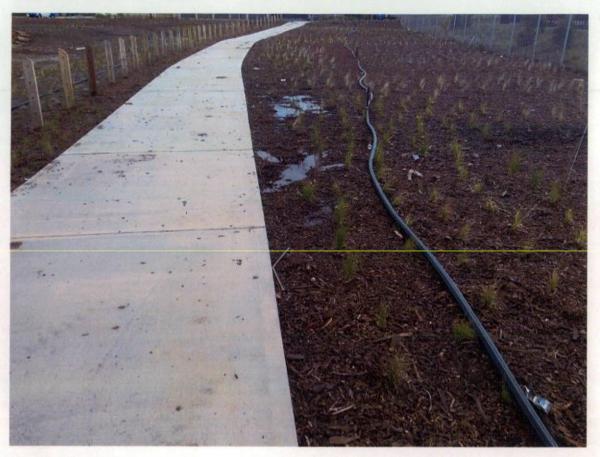
Figure 512 Wheel ruts and disturbance in garden bed.

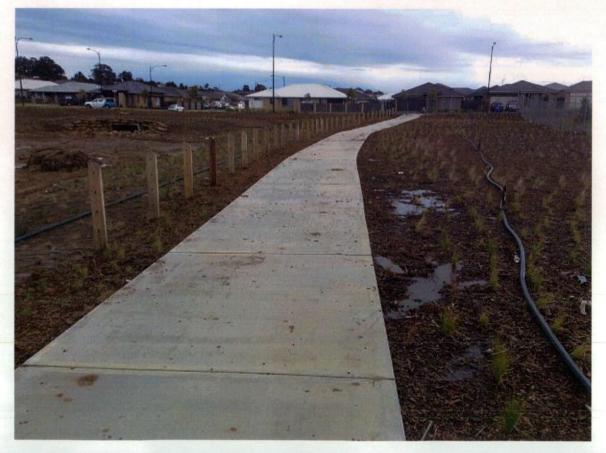
Figure 513 Wheel ruts in garden bed.

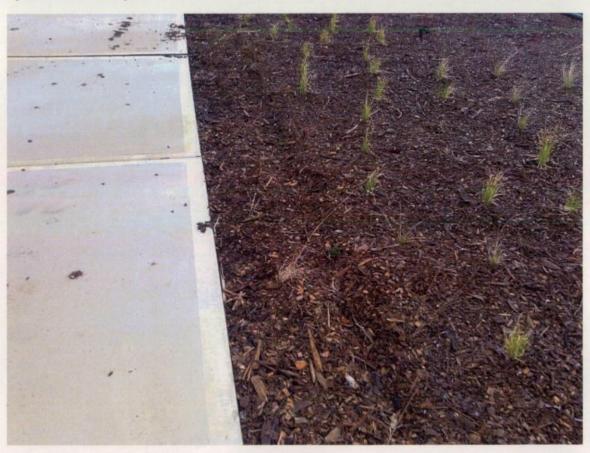
Figure 515 Wheel ruts in garden bed.

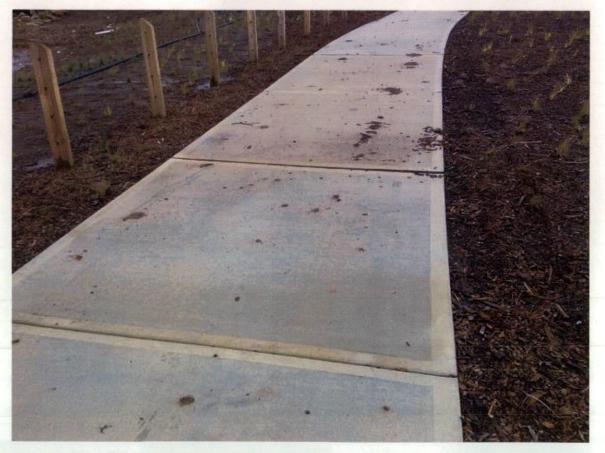
Figure 517 marks on footpath surface.

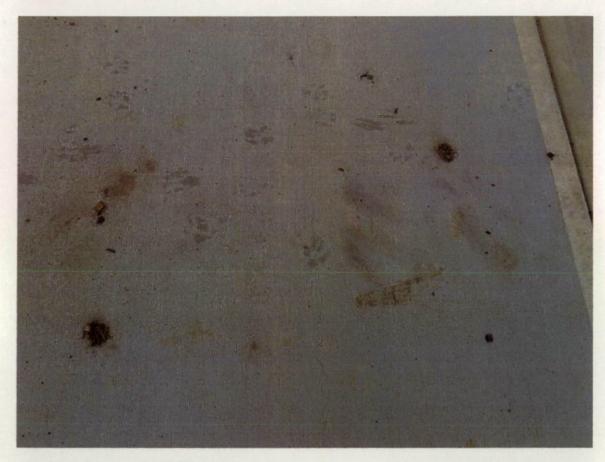
Figure 518 Scratches and excess soil on footpath surface.

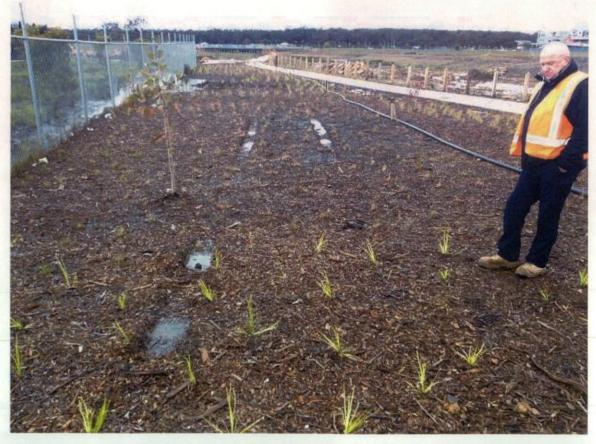
Figure 521 Wheel ruts in garden bed.

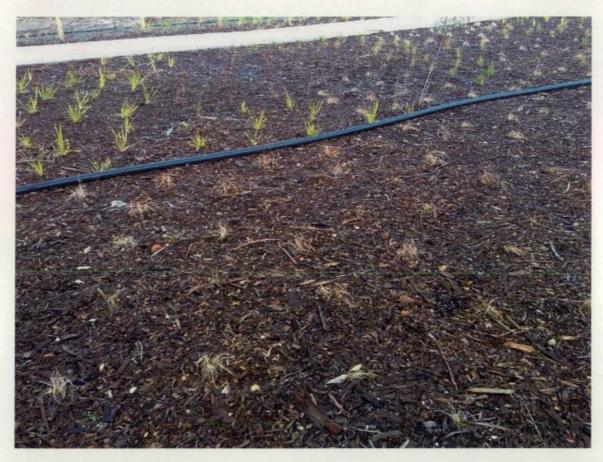
Figure 522 Wheel ruts in garden bed.

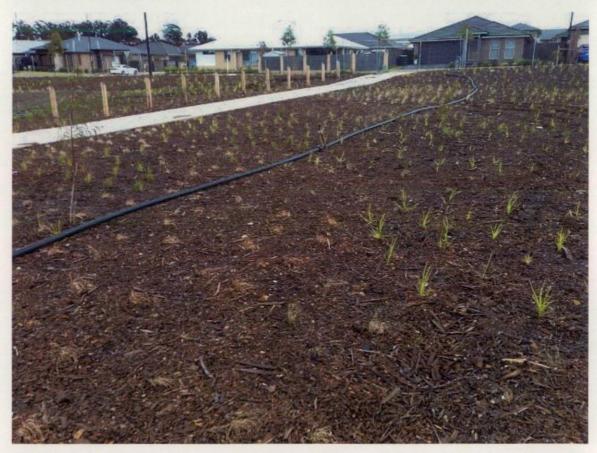
Figure 523 Dead plants in garden bed.

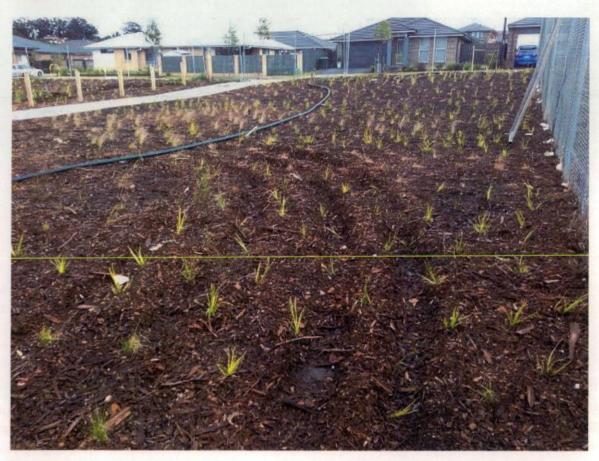
Figure 524 Dead plants in garden bed.

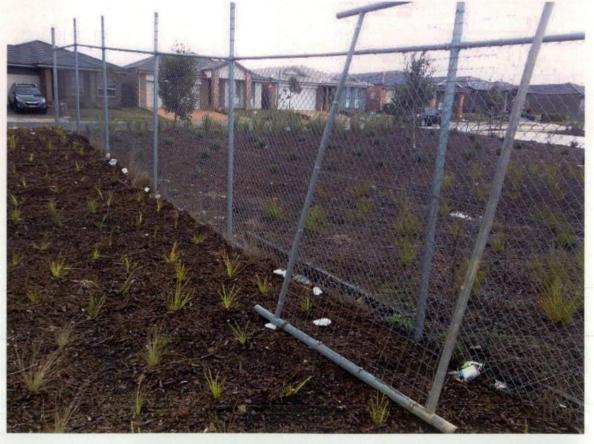
Figure 525 Wheel ruts in garden bed.

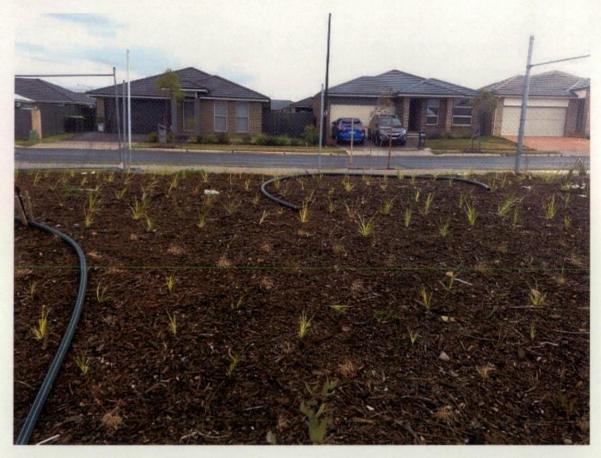
Figure 526 temp fencing left over.

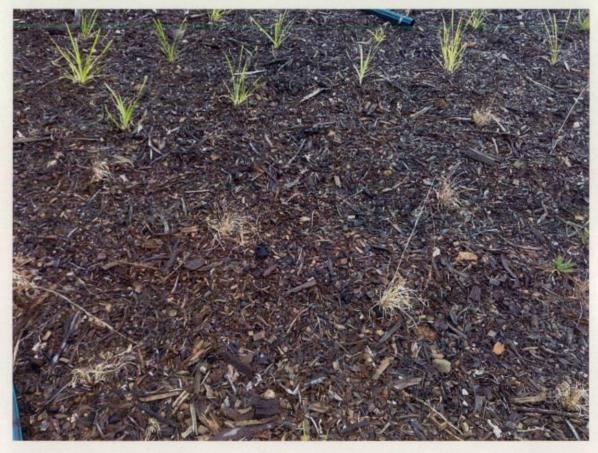
Figure 527 Excess irrigation material left on site.

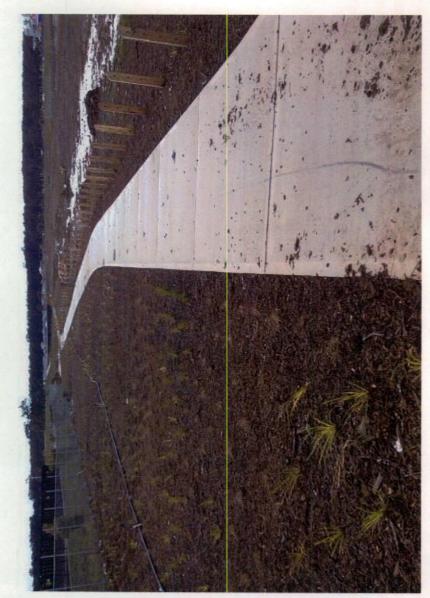
Figure 528 dead plants in garden area.

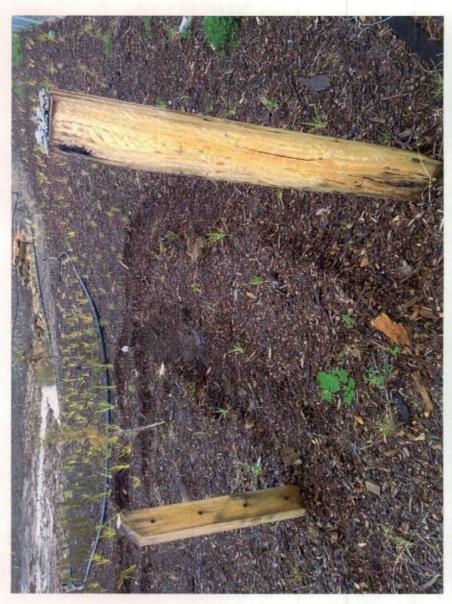
Figure 529 dead plants in garden area.

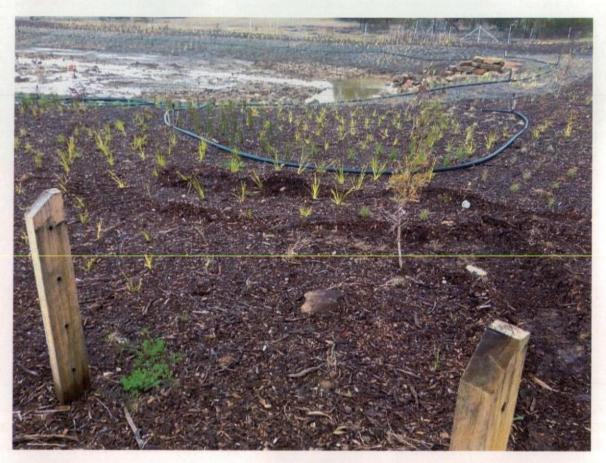
Figure 532 Dead plants in garden.

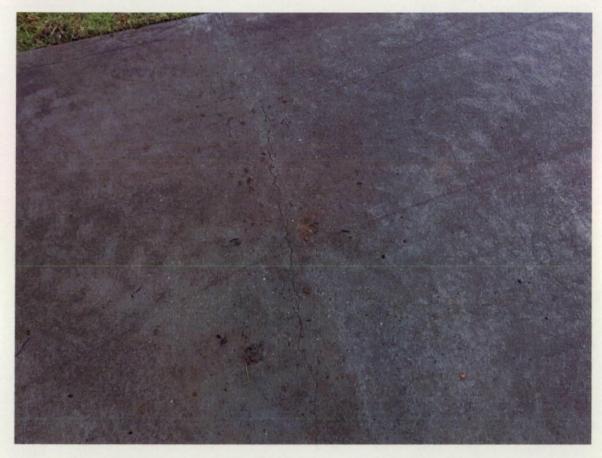
Figure 534 Scratches on footpath surface.
