J K Williams Contracting Pty Ltd

Dilapidation Report

Proposed Works - Jordan Springs Stage 2 Retirement Living

James Sae Siew
5th March 2019
Revision 1

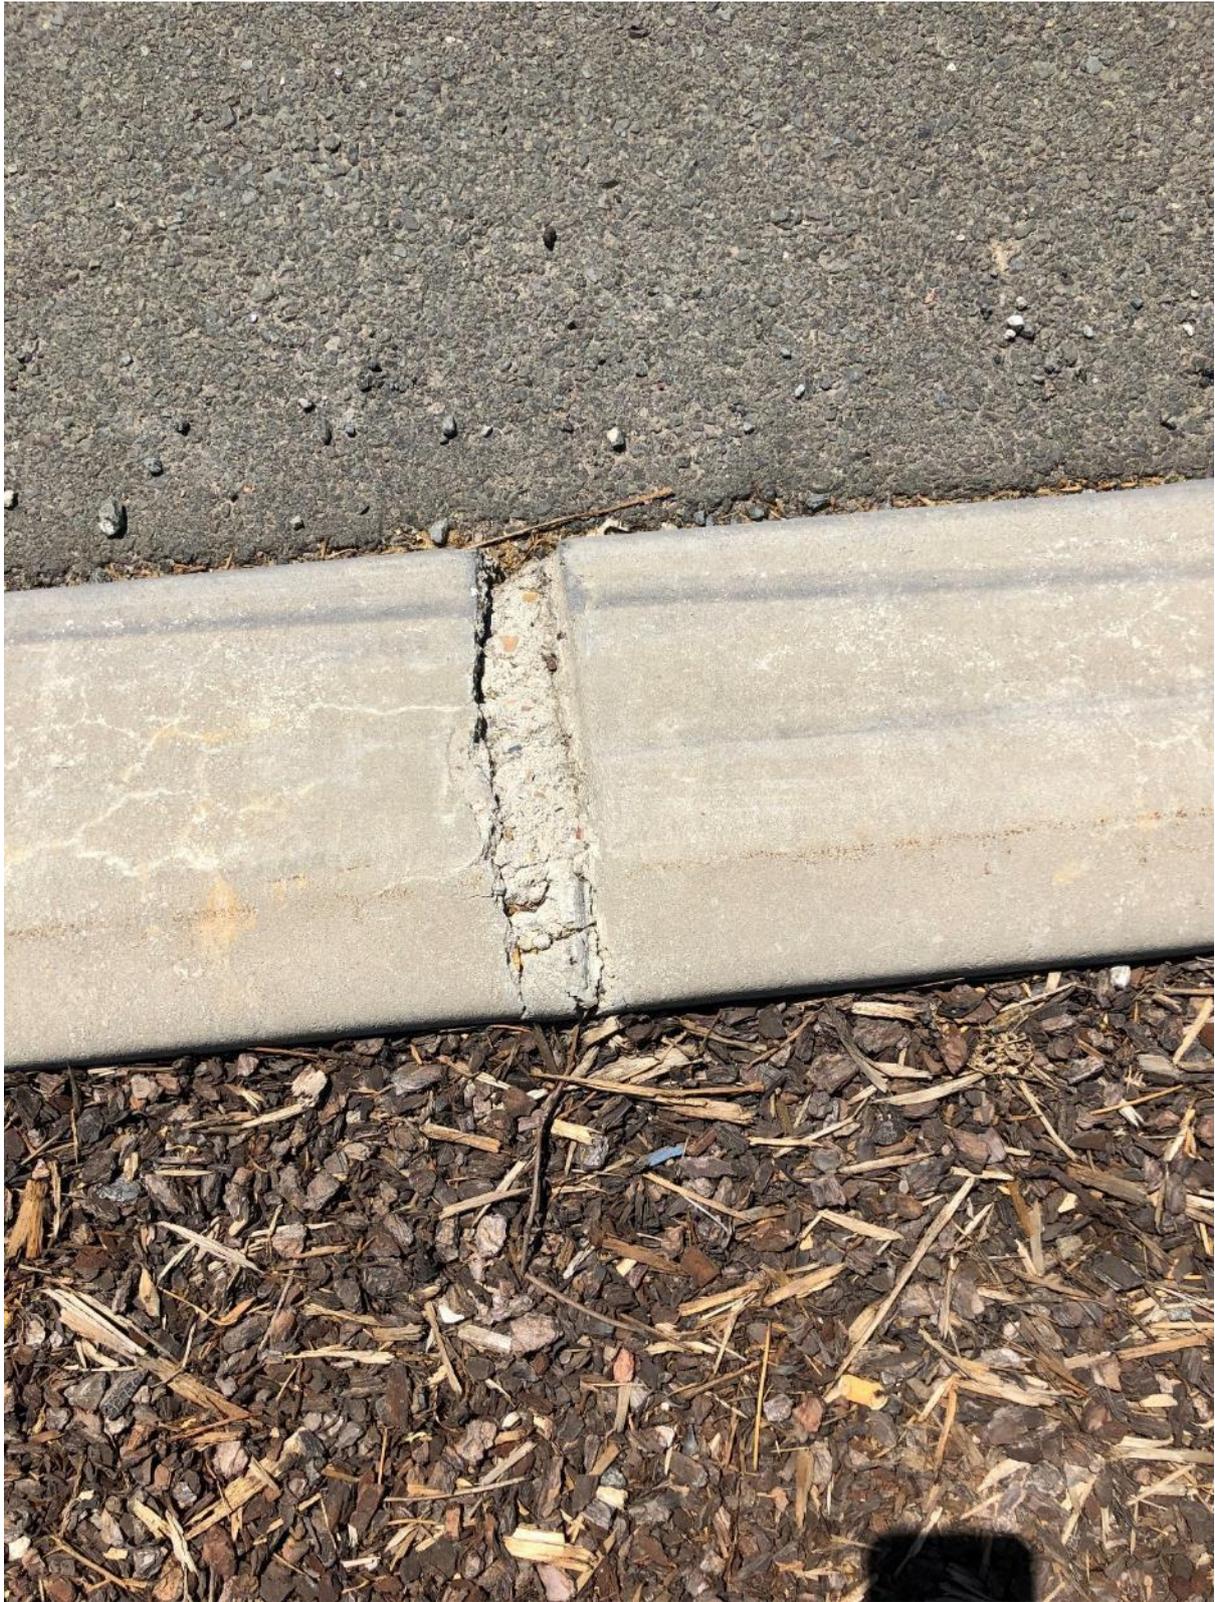
Figure 17: separation of kerb at construction joint interface.

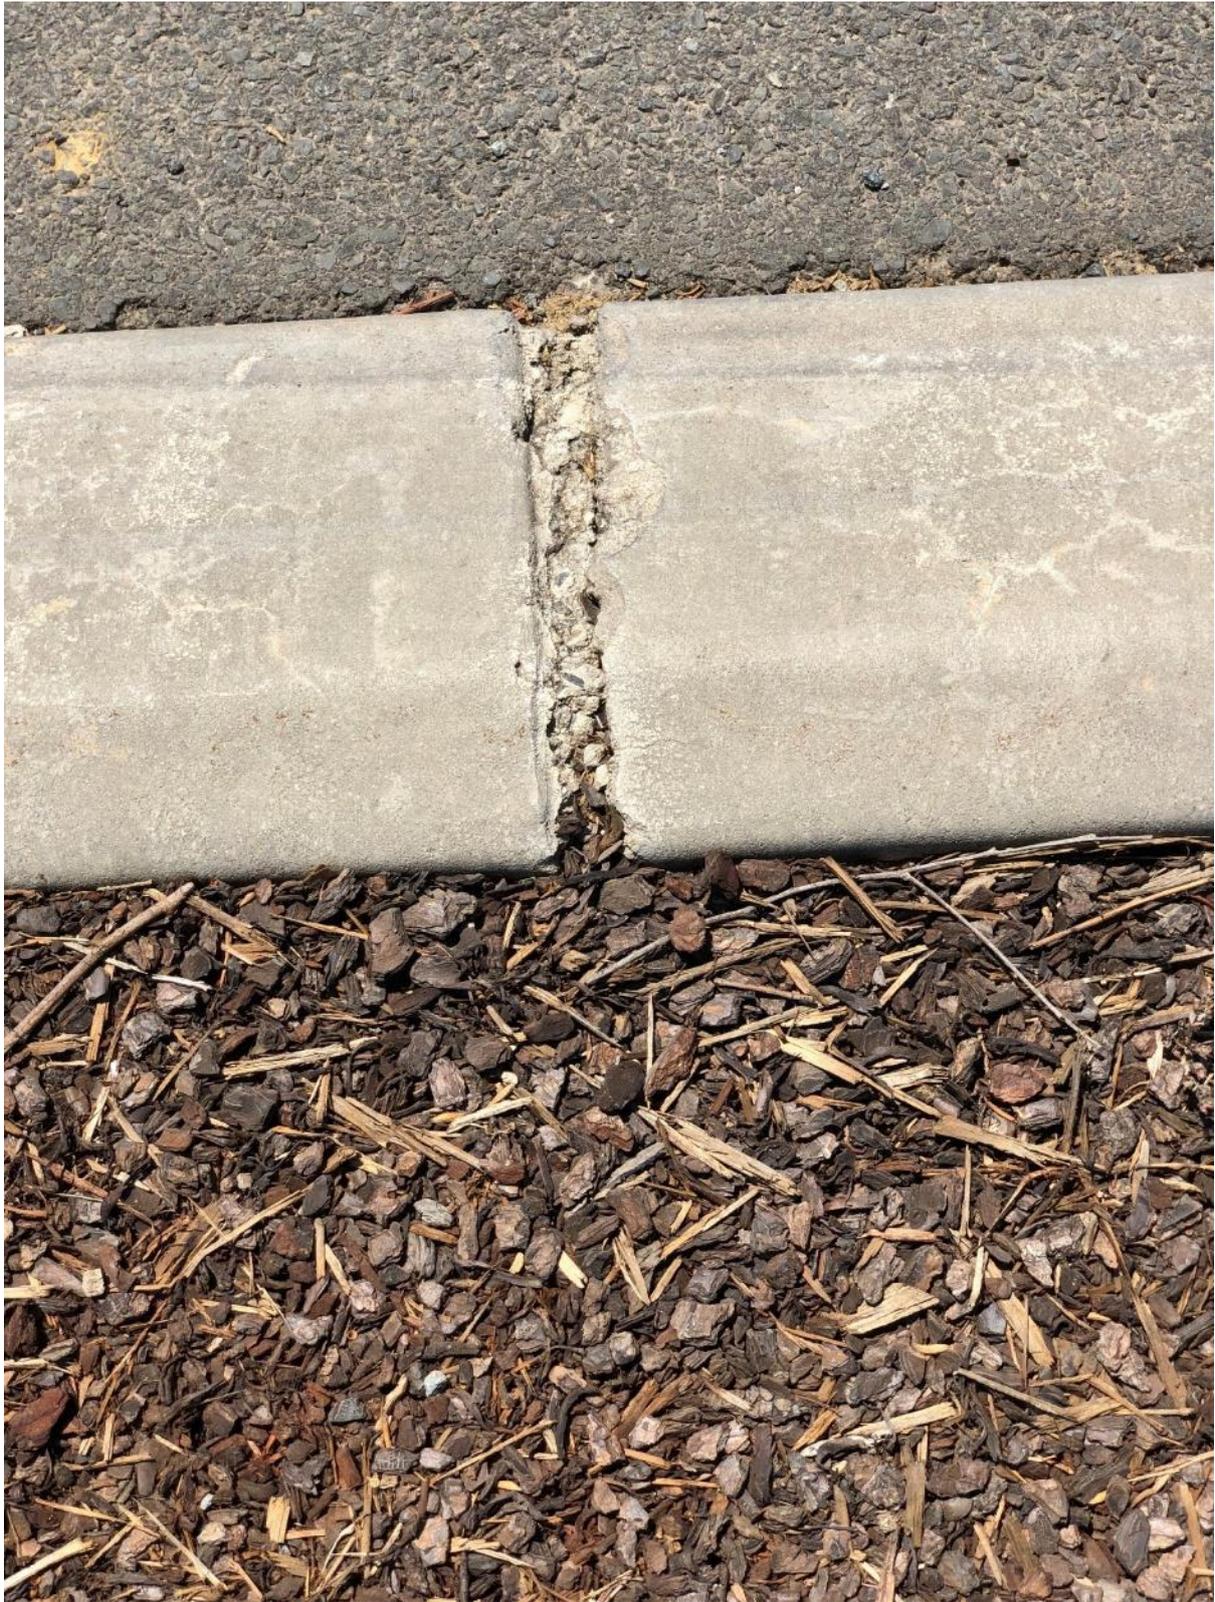
Figure 18: separation of median strip kerb.

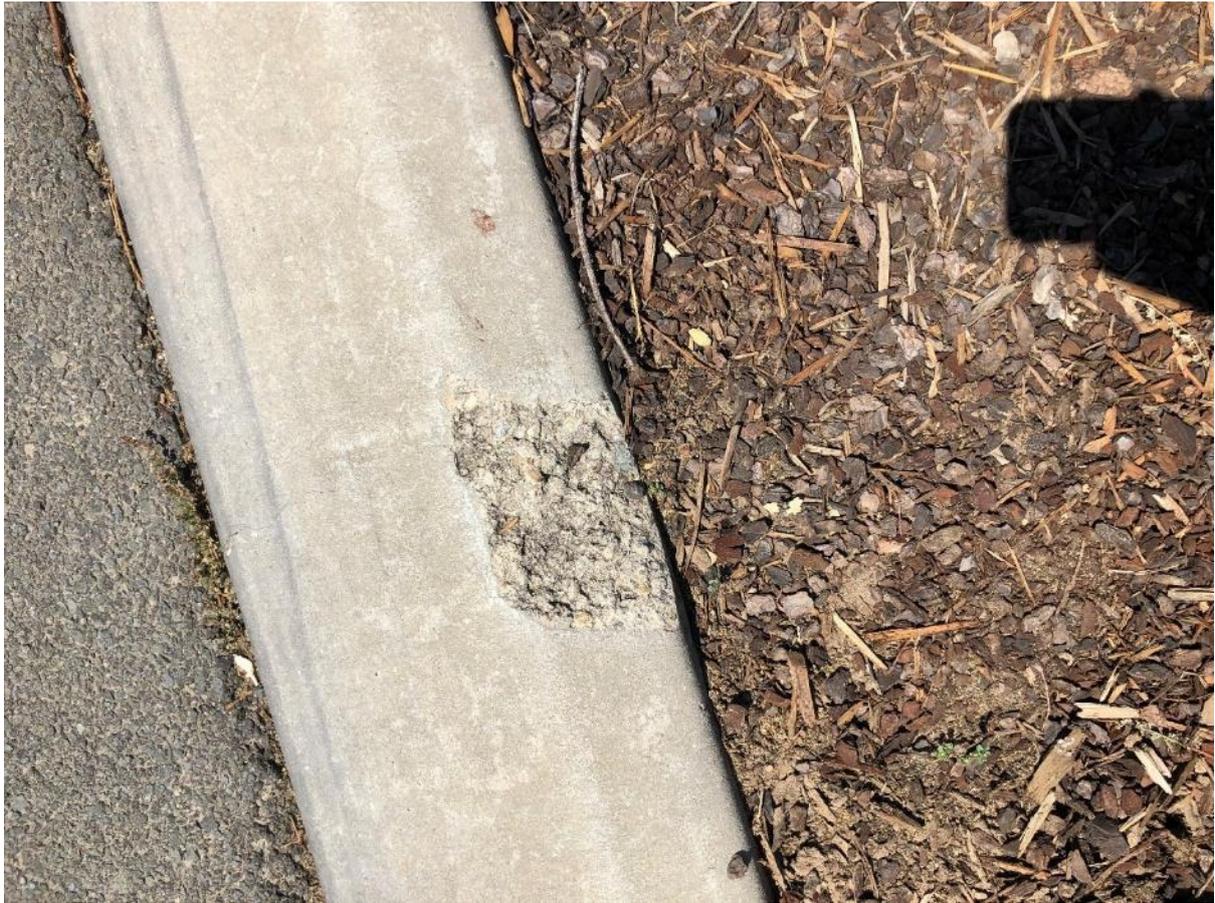
Figure 19: chip on top of median strip kerb.

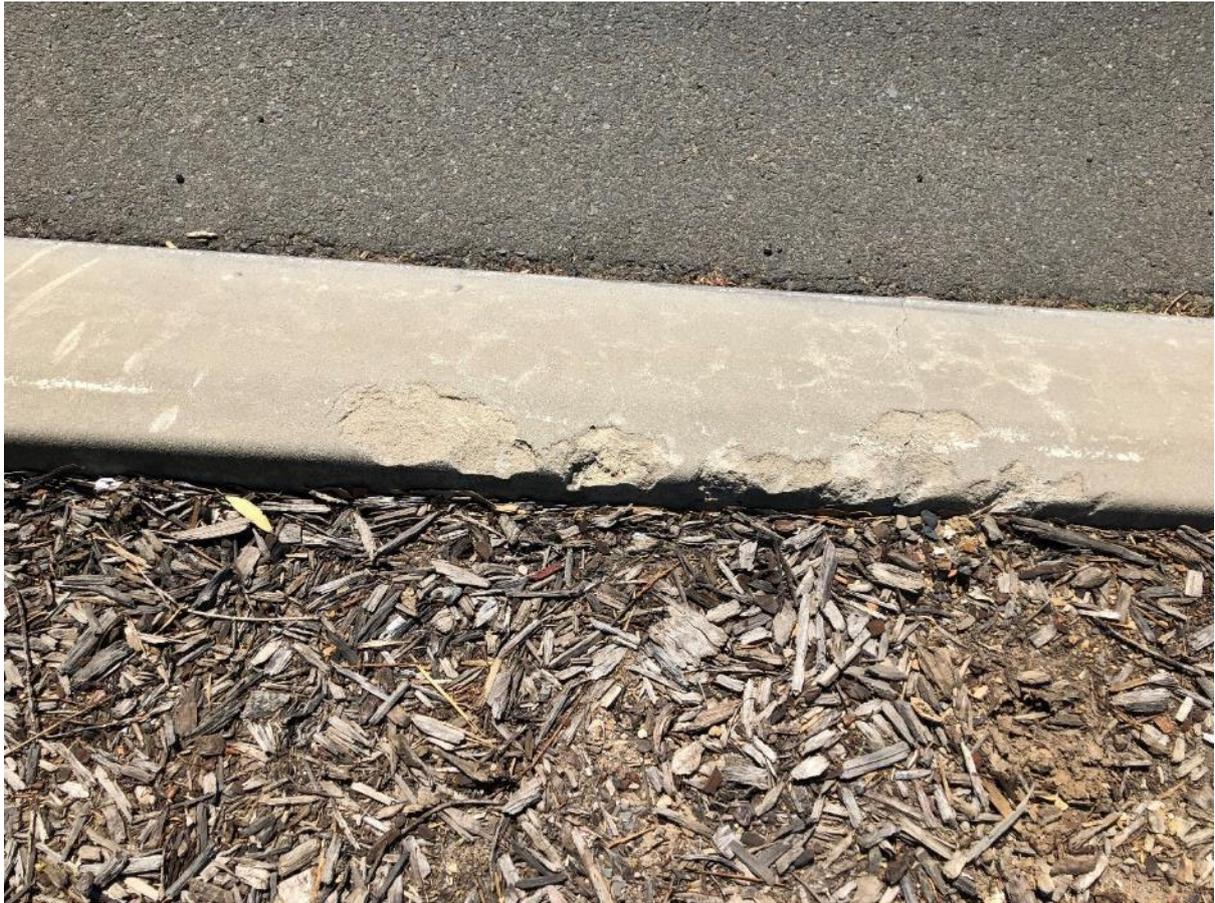
Figure 20: chips on top of median strip kerb.

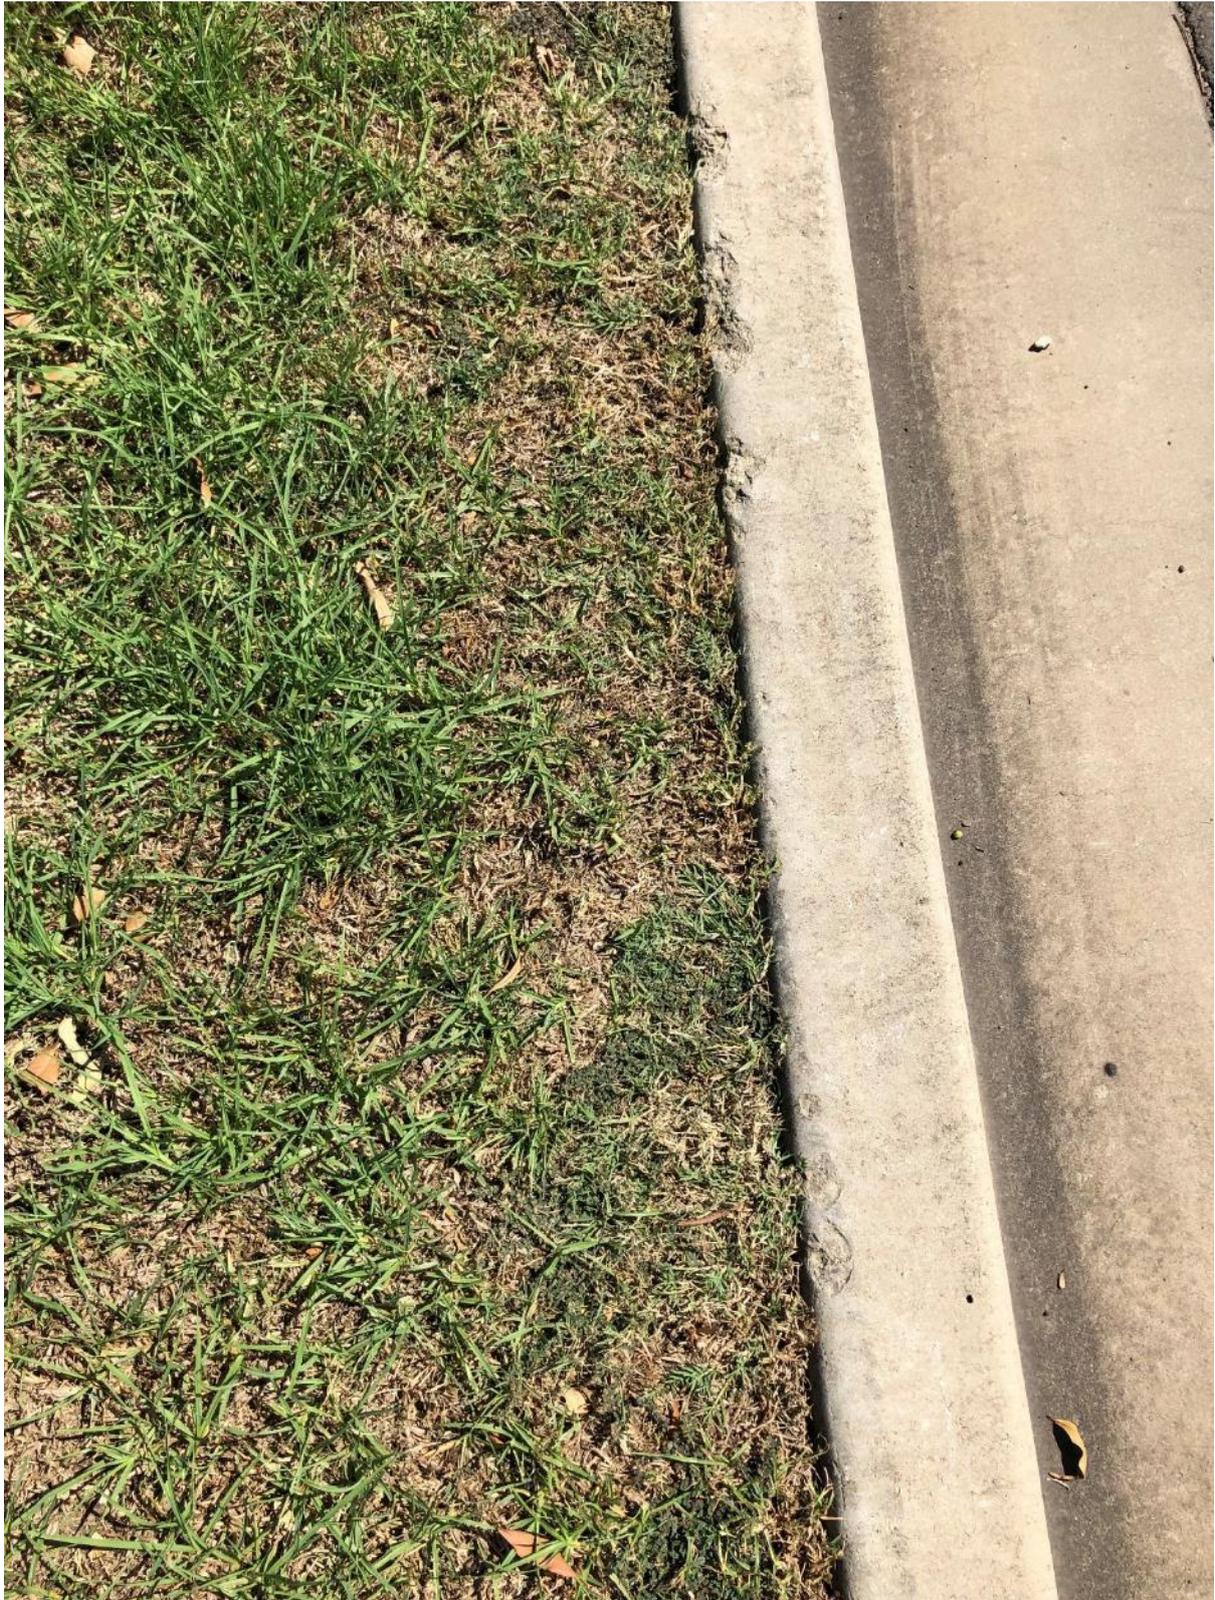
Figure 40: chips to top of kerb and gutter.

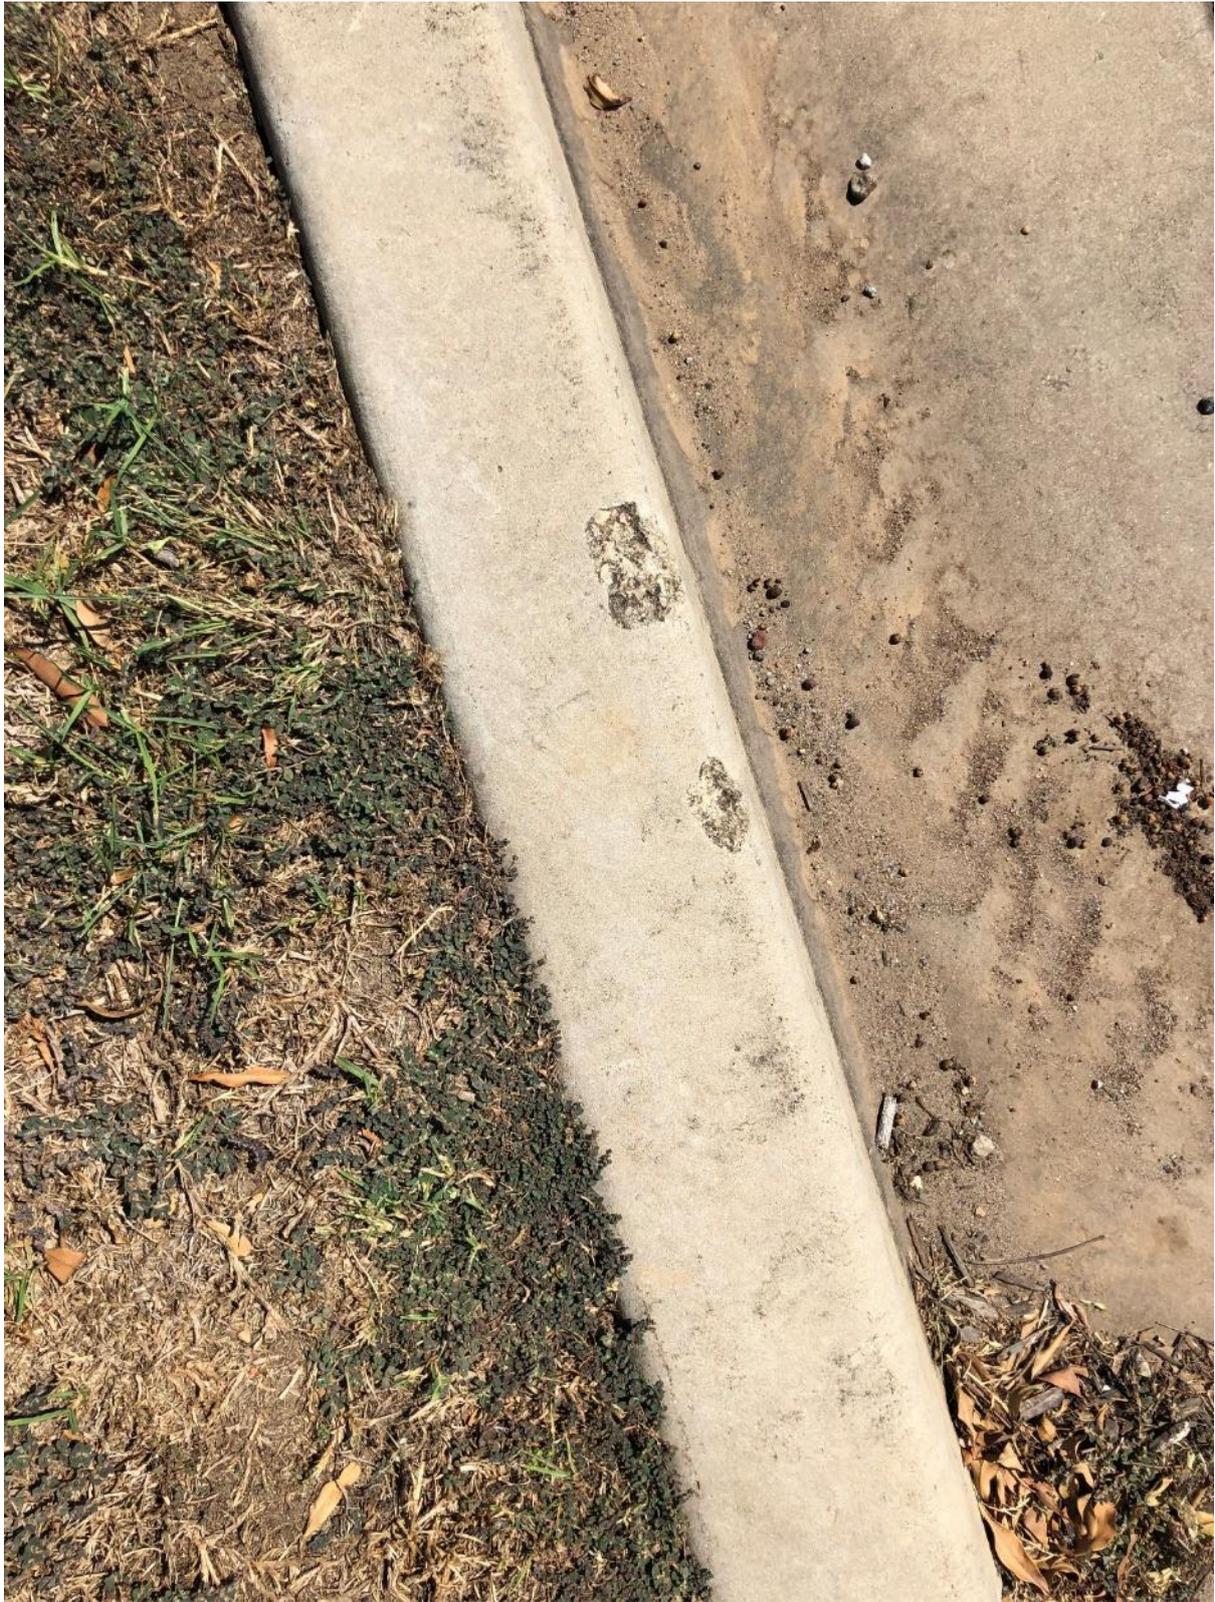
Figure 41: chips on top of kerb.

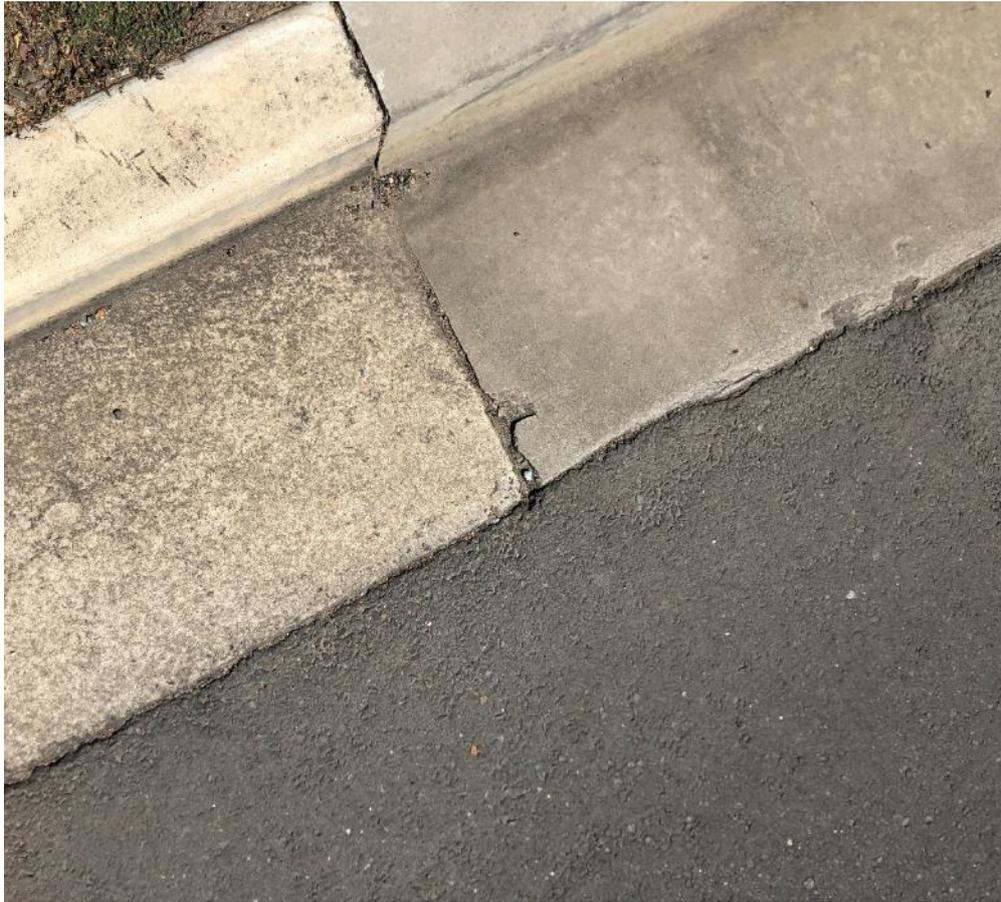
Figure 42: spalling on edge of construction joint interface on gutter.

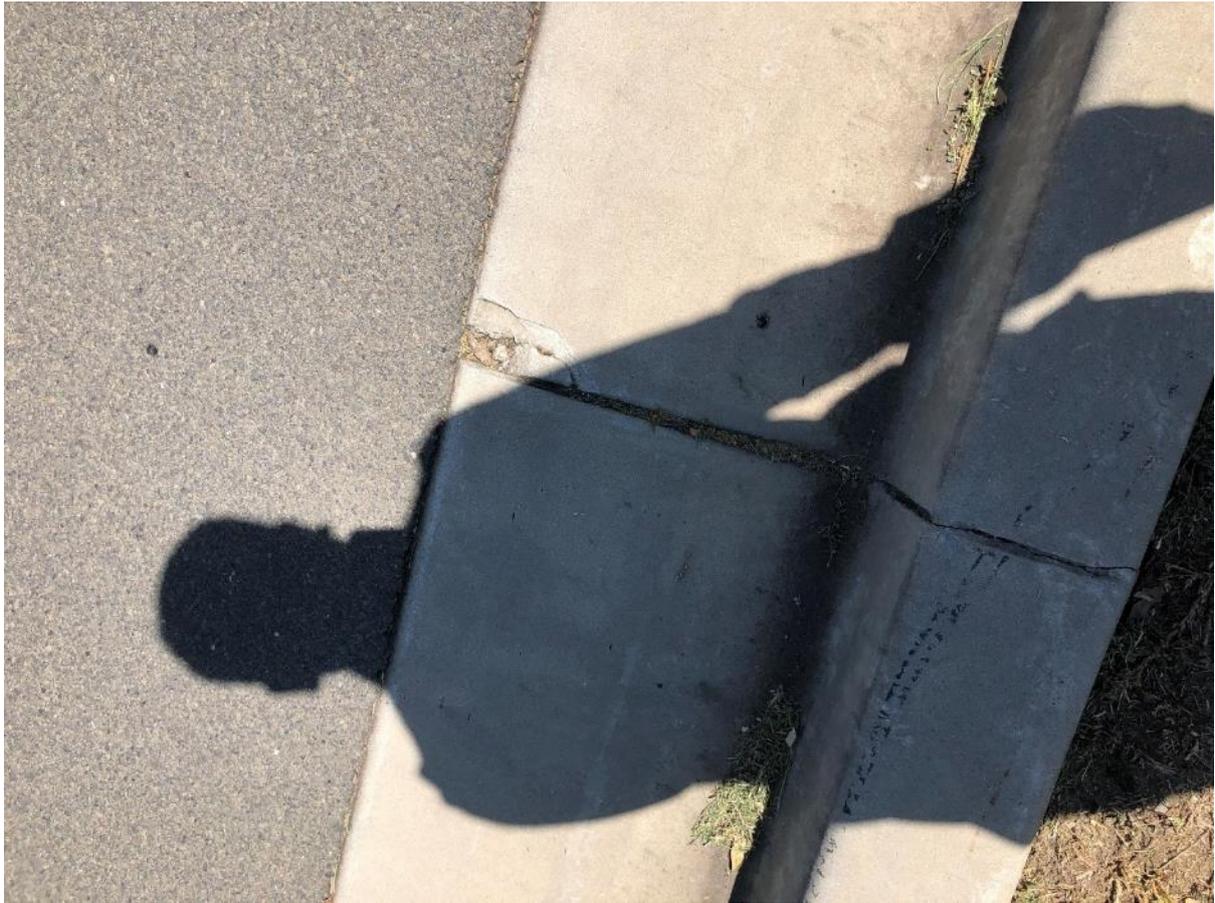
Figure 72: chip to gutter at construction joint interface.

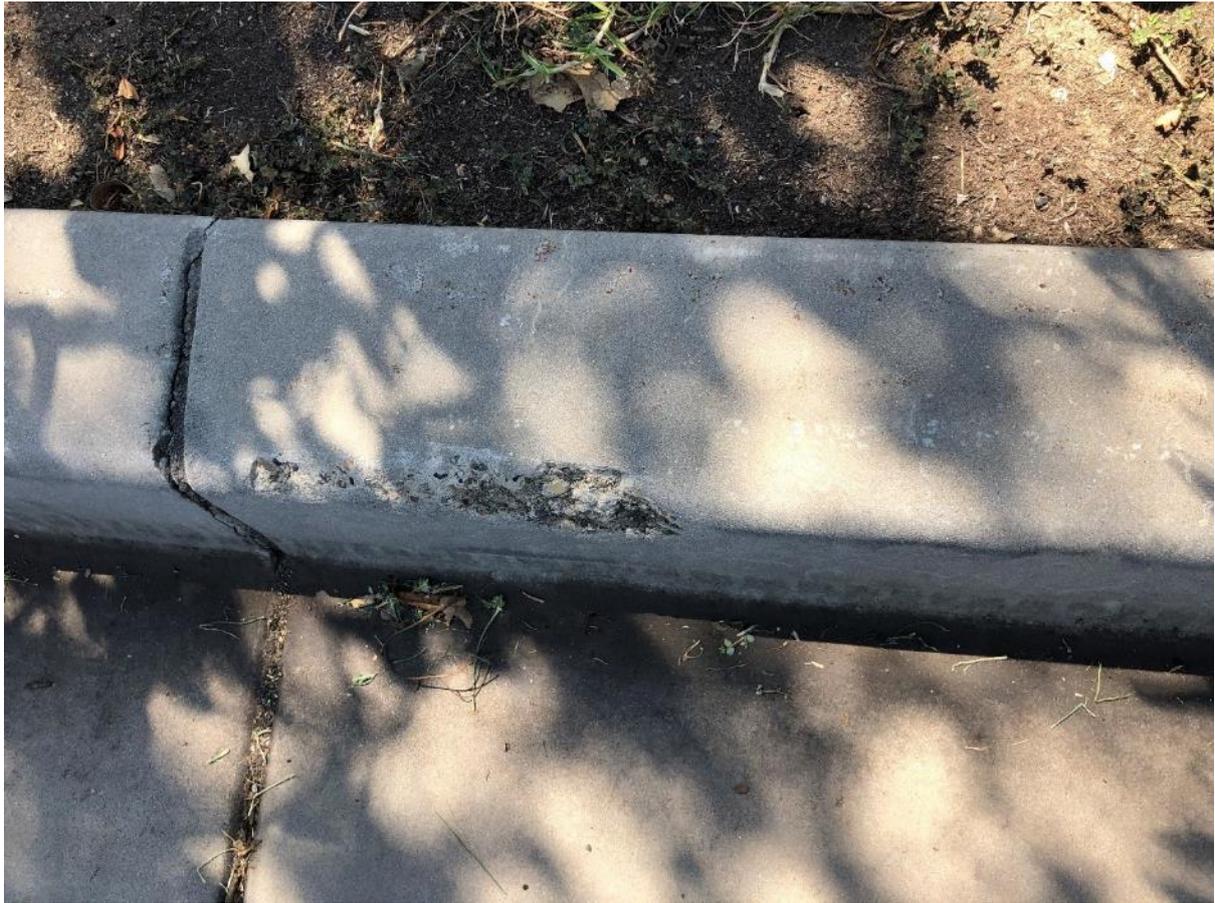
Figure 74: chip to top of gutter.

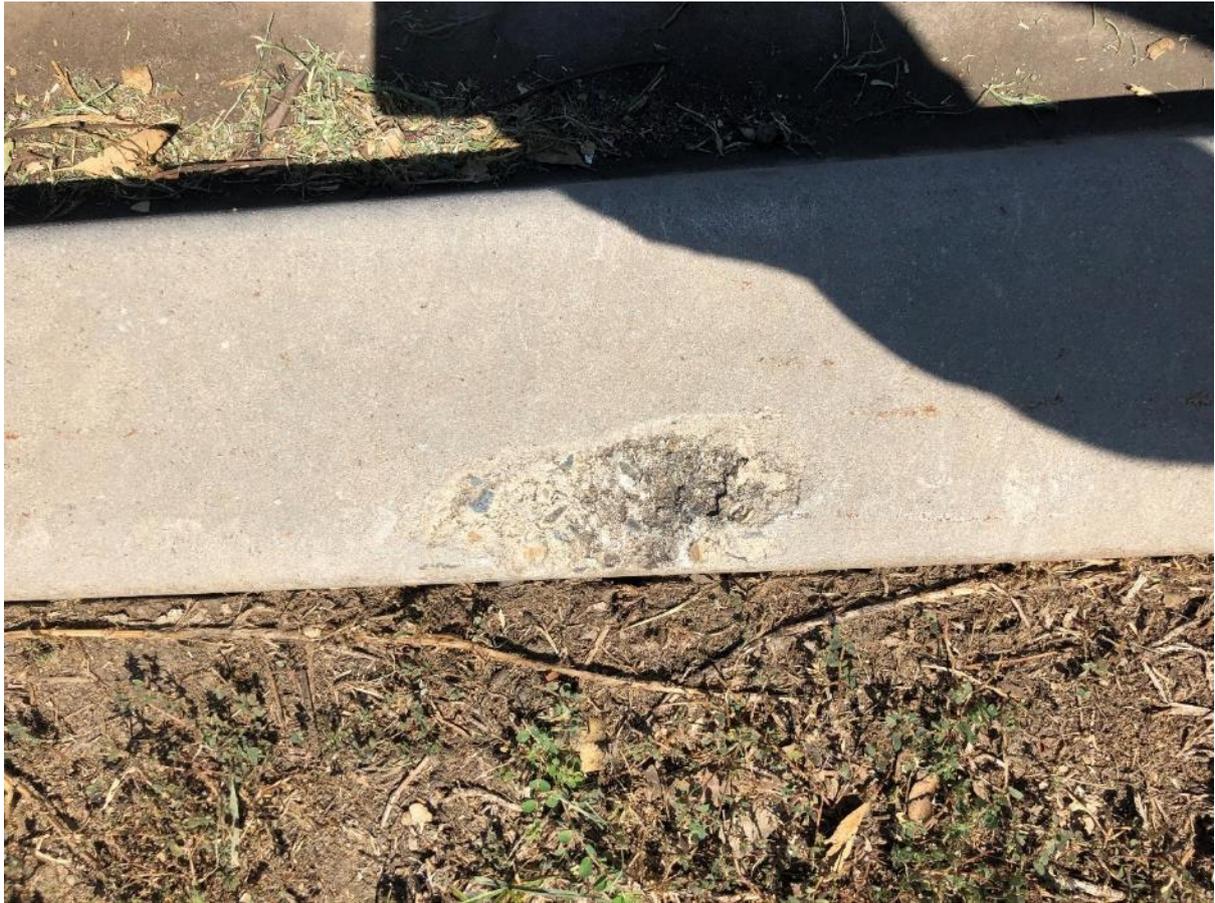
Figure 75: chip to top of gutter.

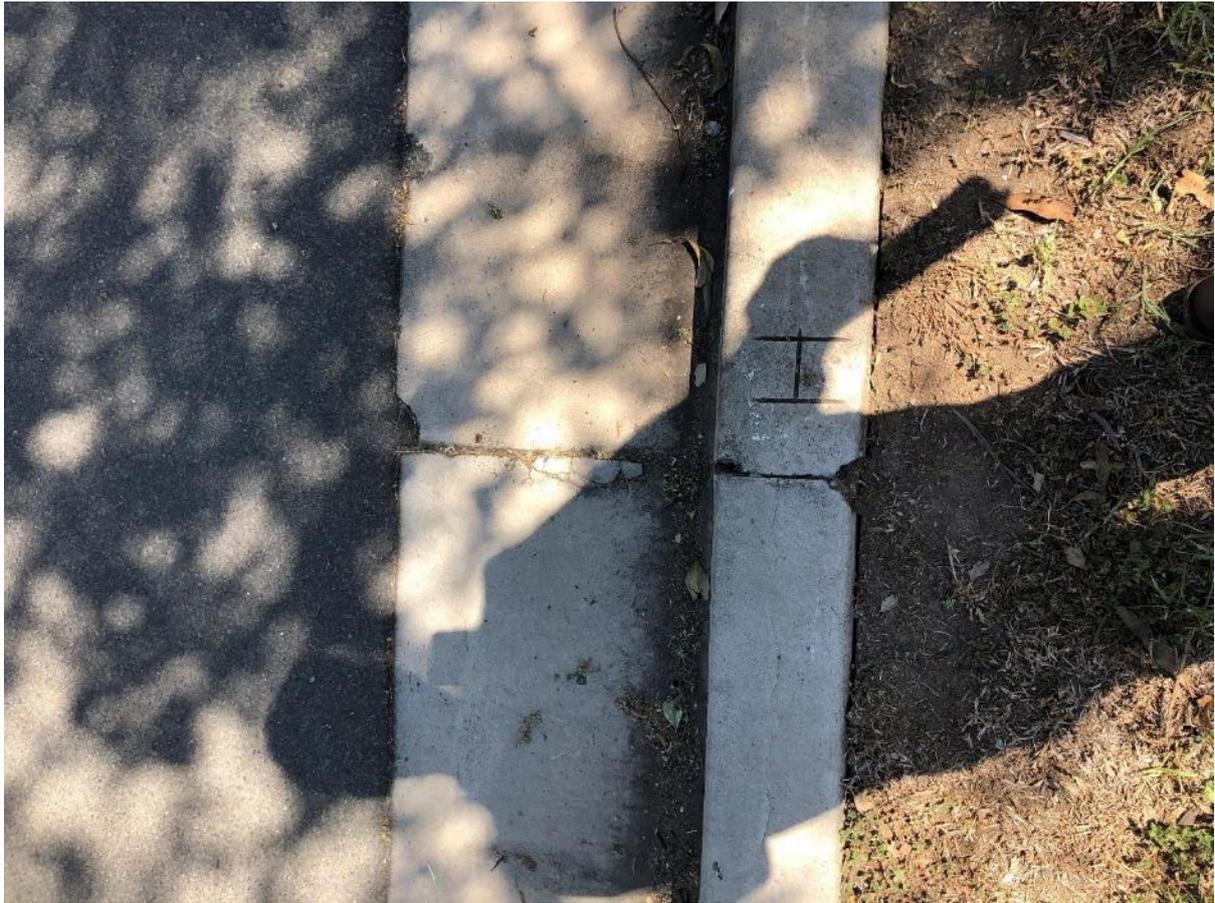
Figure 76: chipping to kerb and gutter construction joint interface.

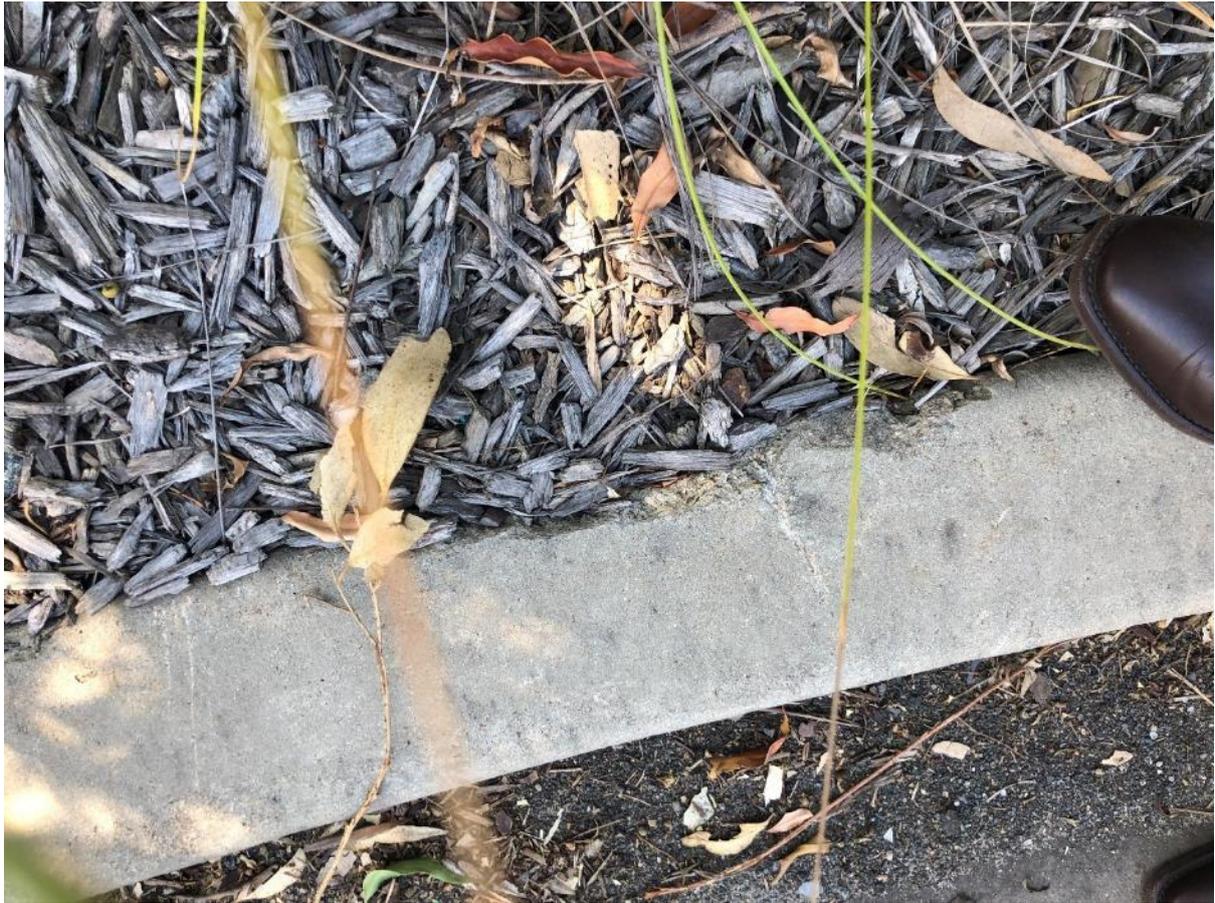
Figure 77: chip to top of kerb.

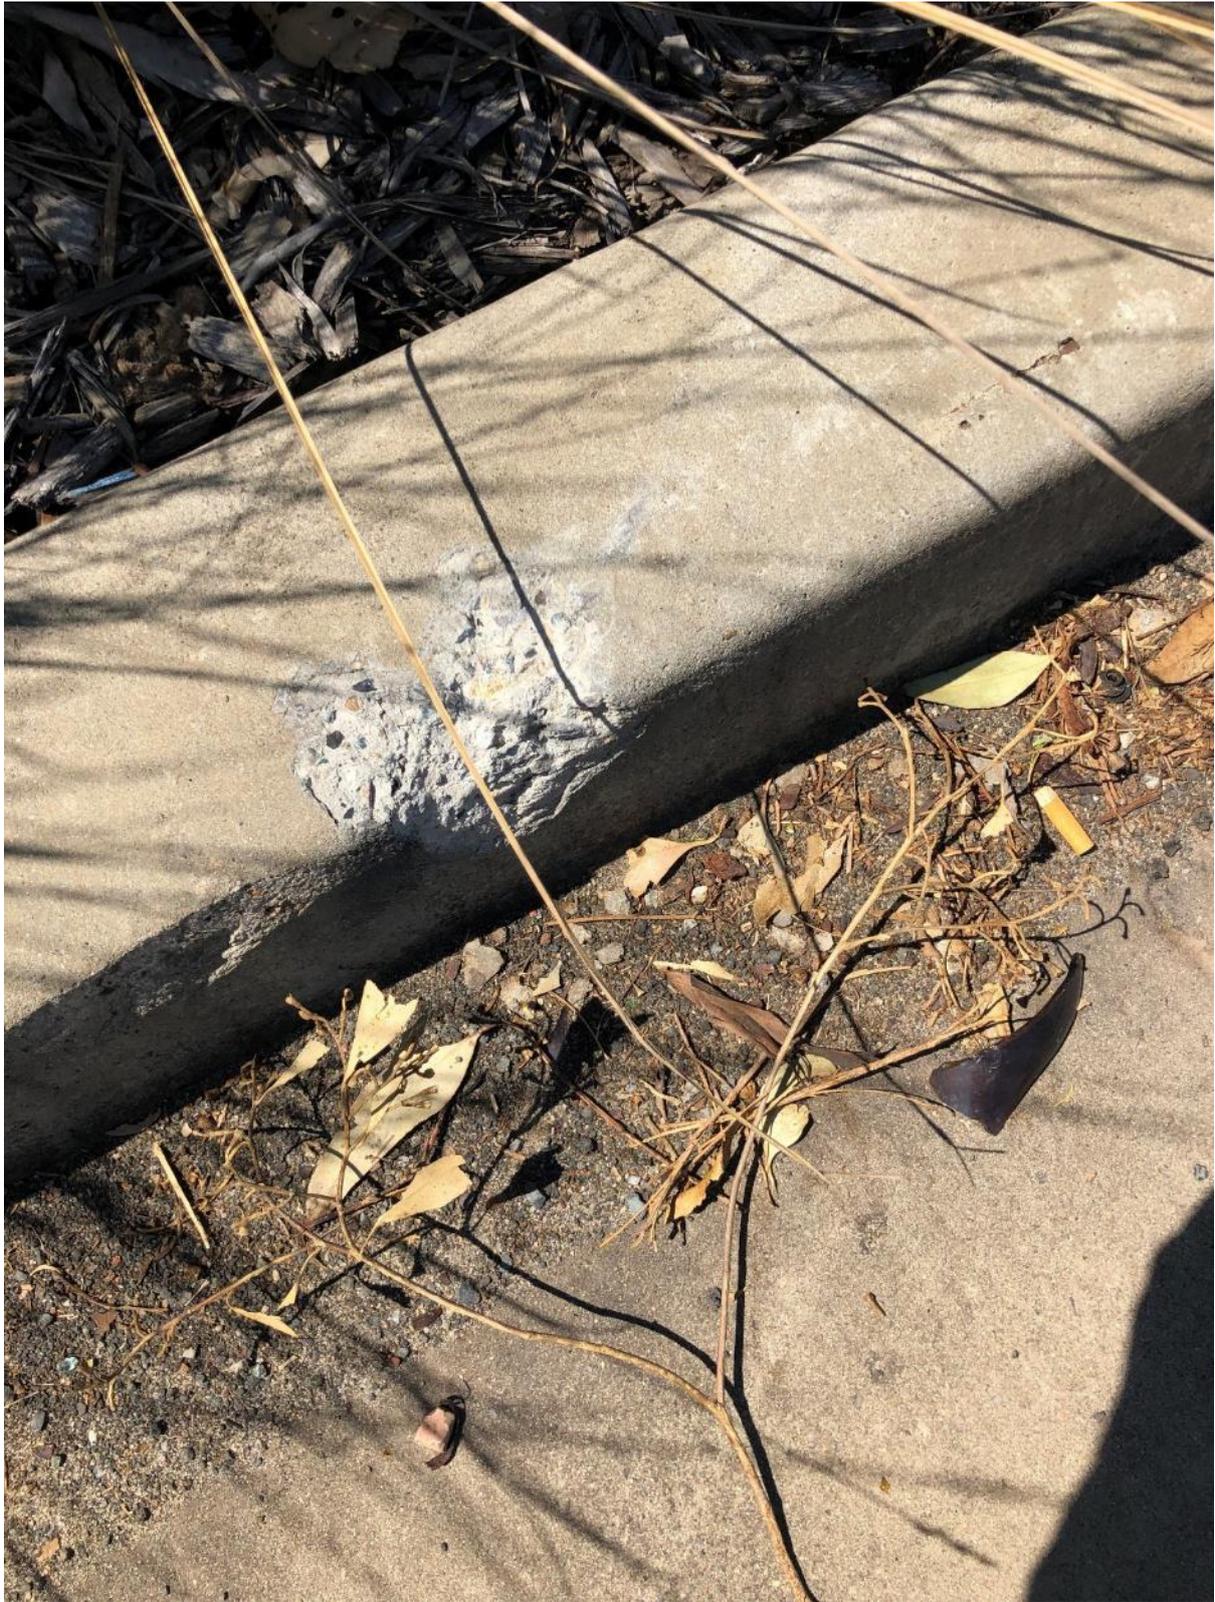
Figure 78: chip to top of kerb.

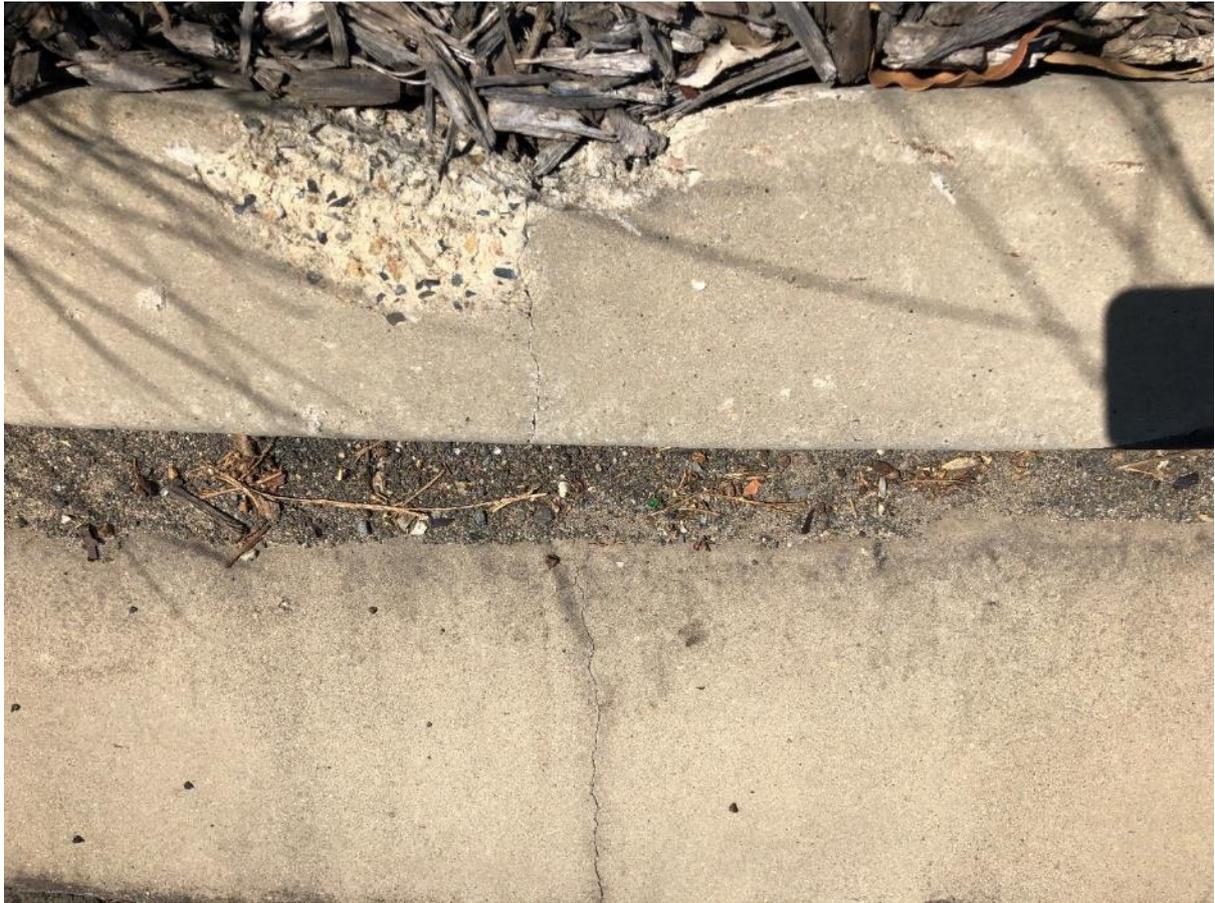
Figure 79: chip to top of kerb.

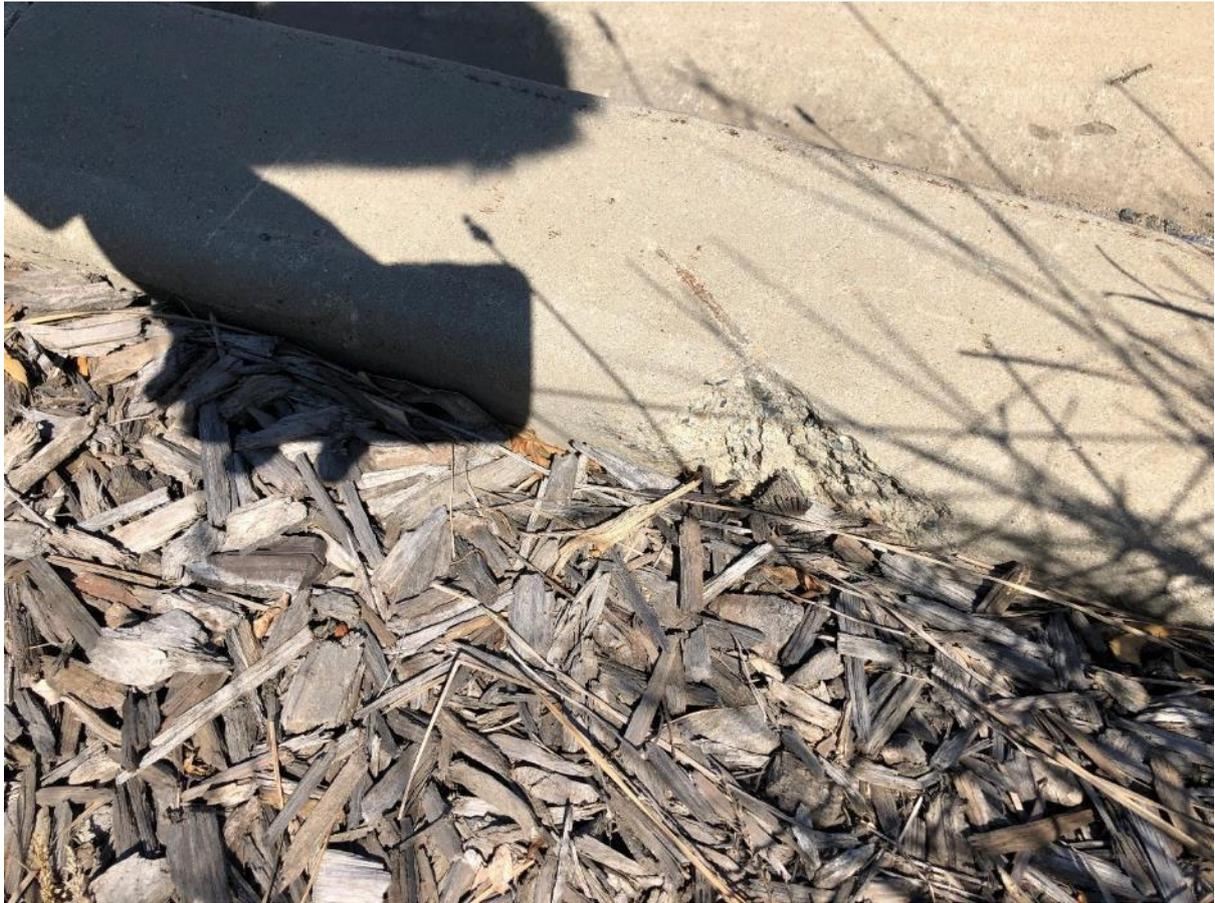
Figure 80: chip to top of kerb.

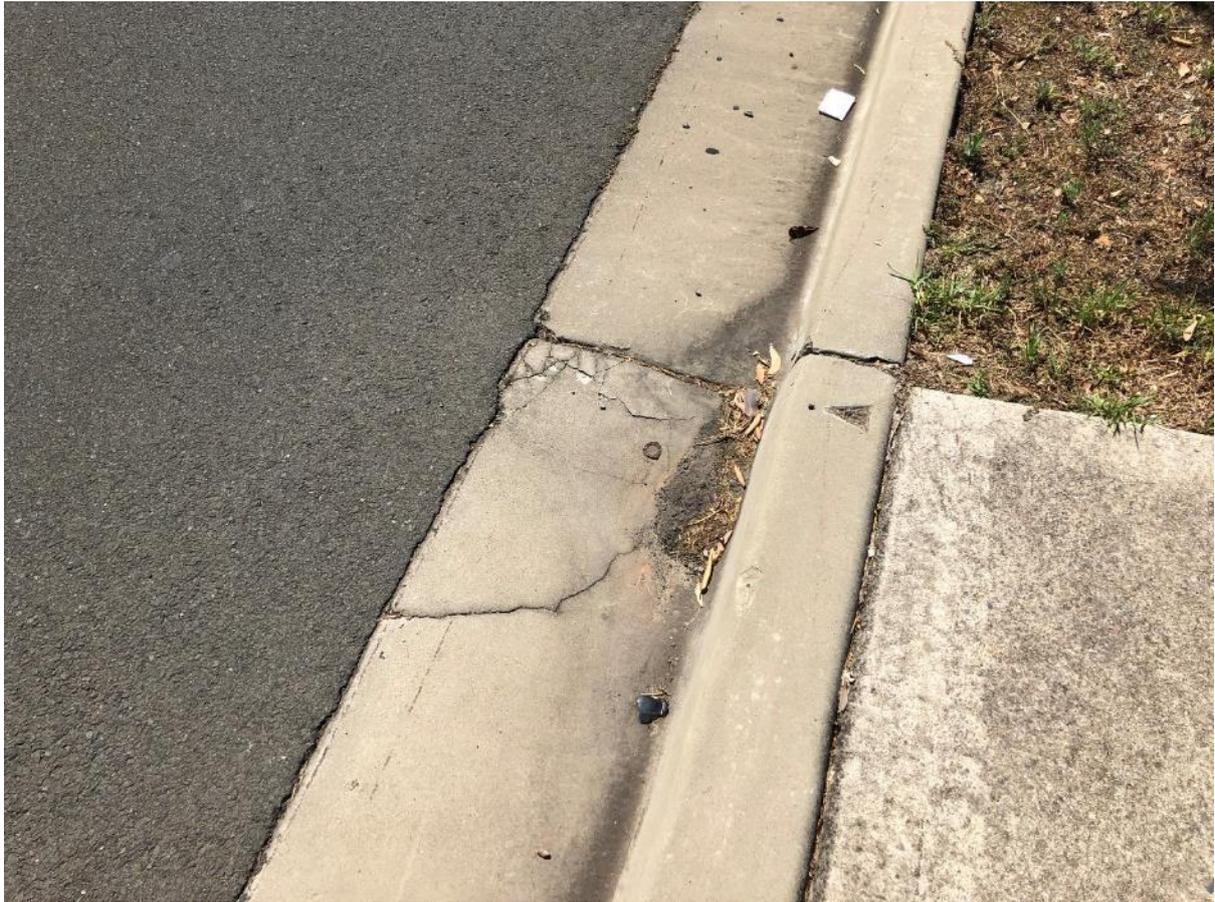
Figure 83: cracking to gutter, adjacent to top of left wing.

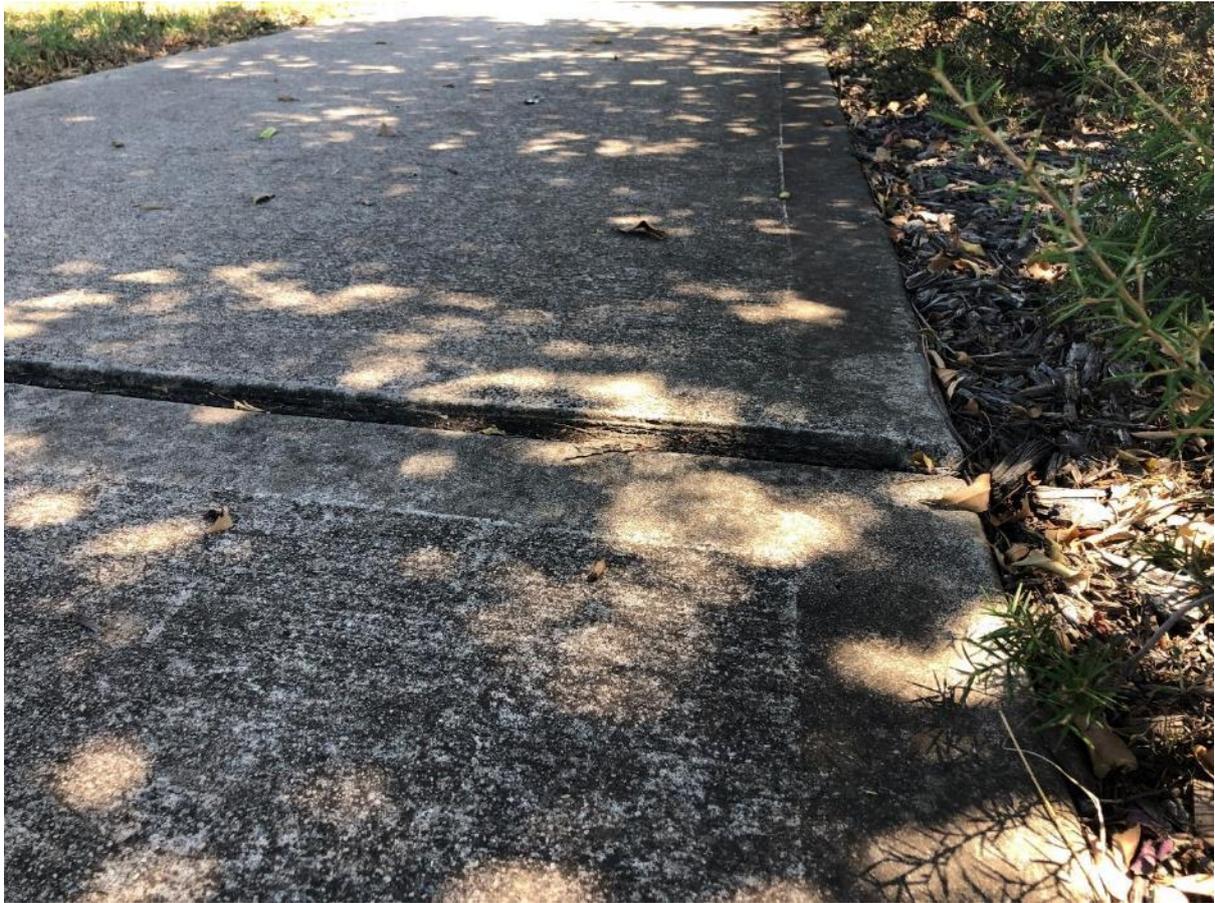
Figure 84: footpath bay lifted at expansion joint interface.
