J K Williams Contracting Pty Ltd

Dilapidation Report

Proposed Works - Jordan Springs Stage 2 Retirement Living

James Sae Siew
5th March 2019
Revision 1

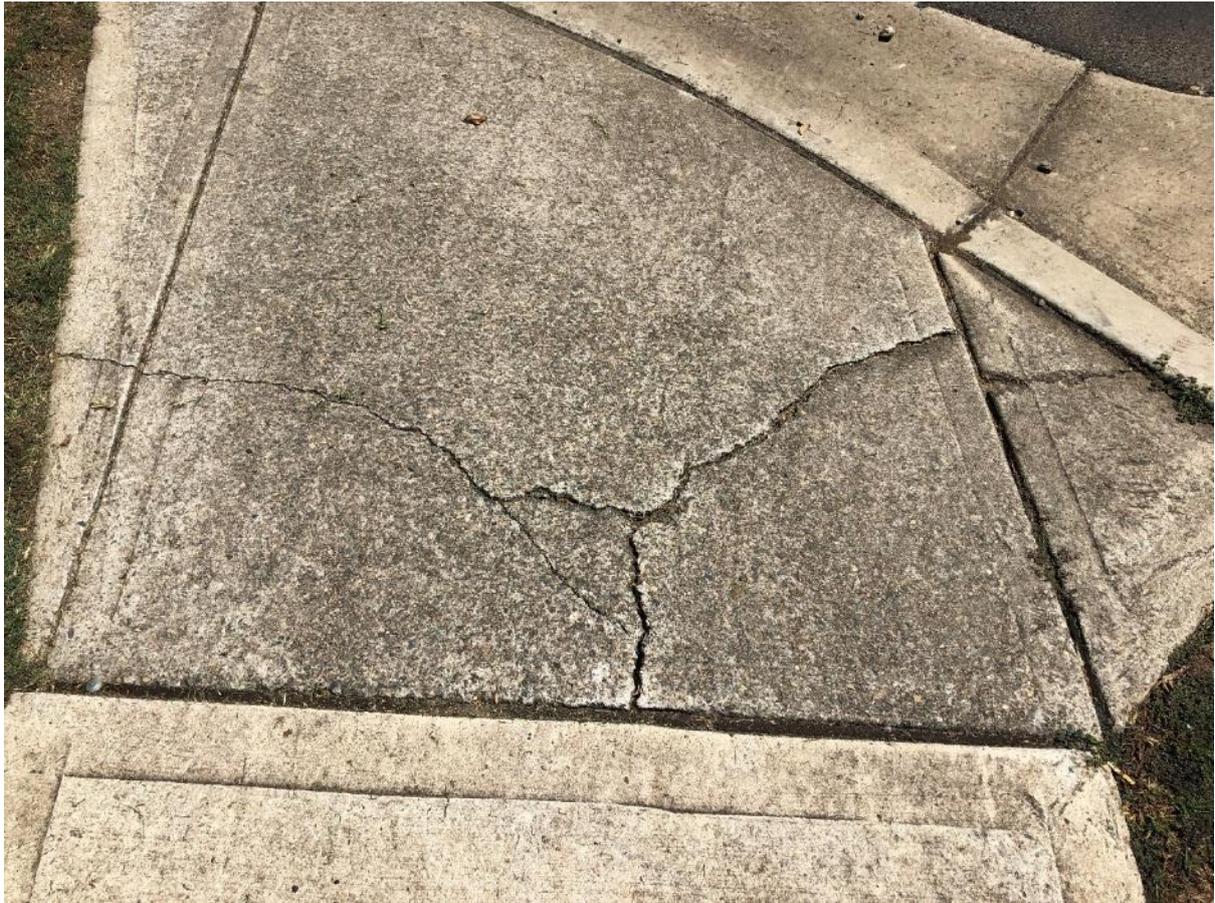
Figure 85: cracking to pram ramp located left of proposed site entry.

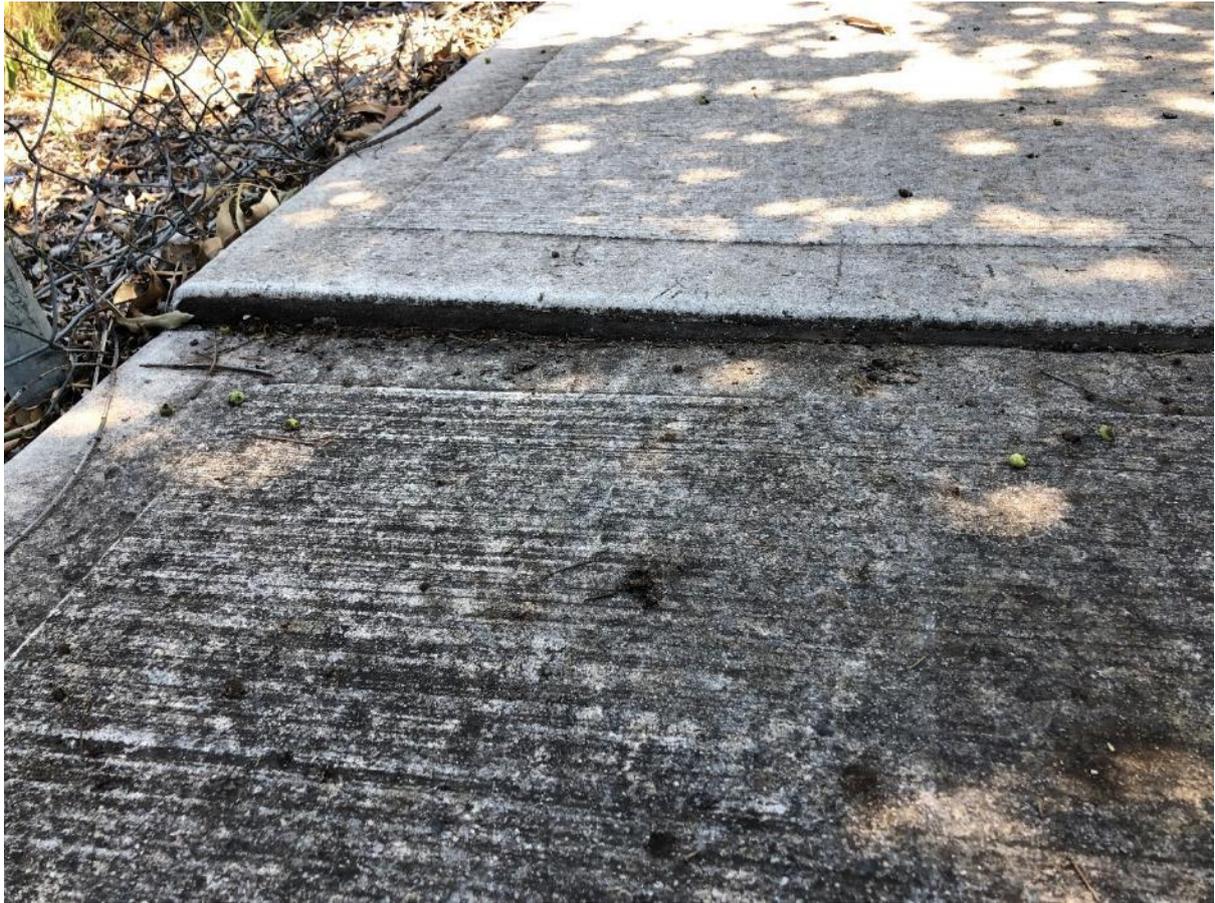
Figure 87: footpath bay lifted at expansion joint interface.

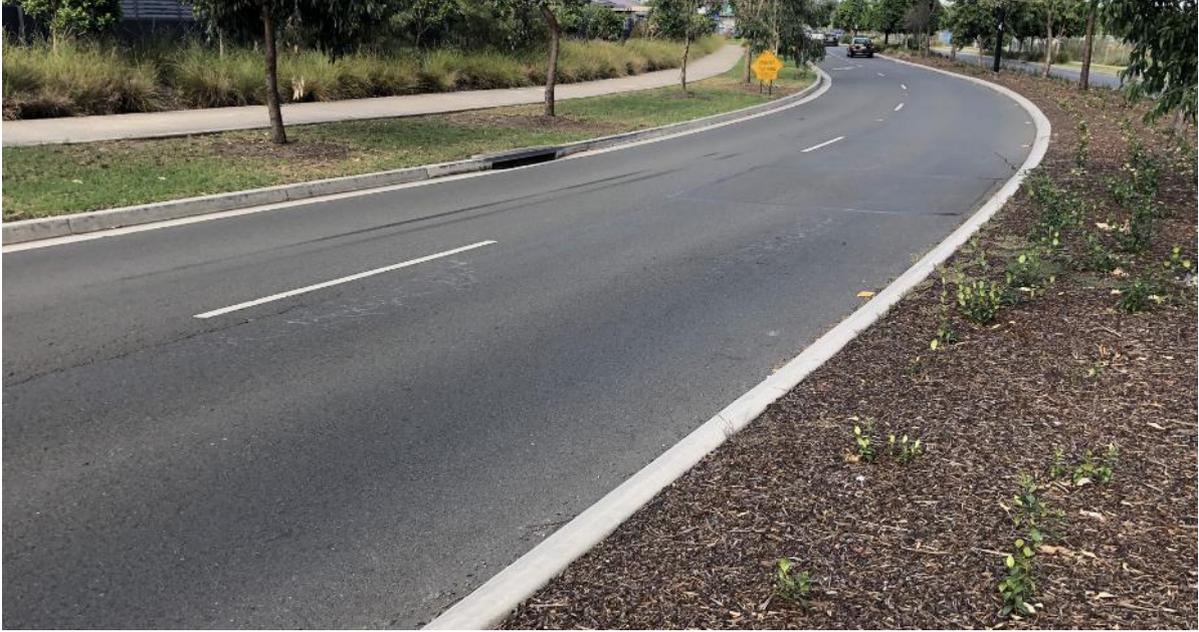
Figure 88: Approx CH250 EB pavement failure (P53)

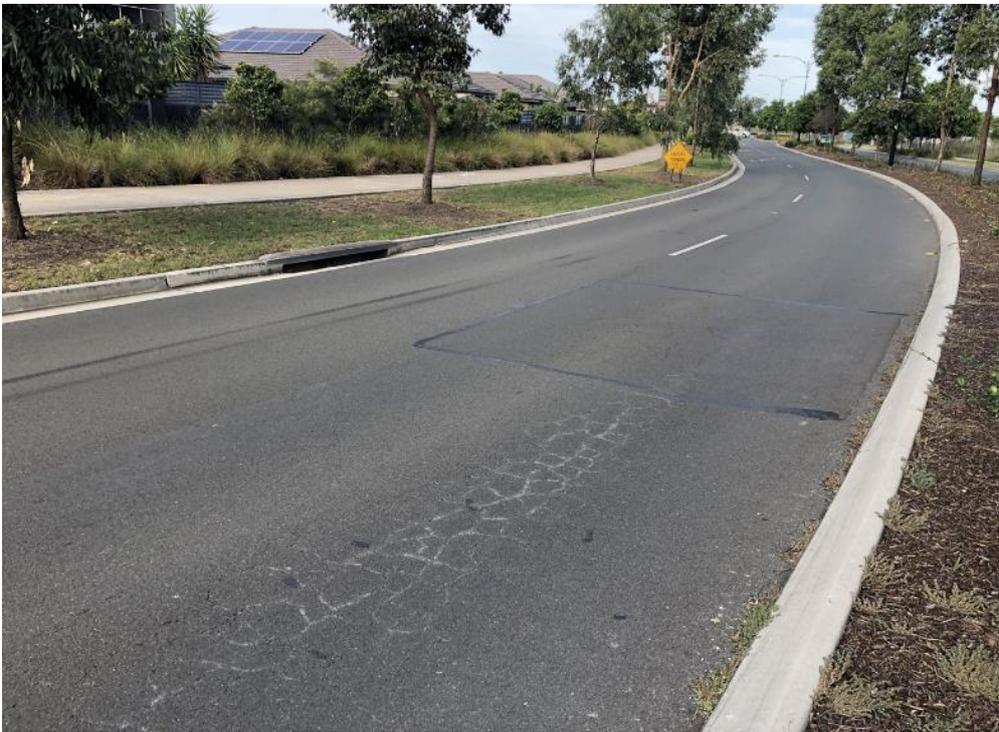
Figure 89: Approx CH255 EB Pavement failure

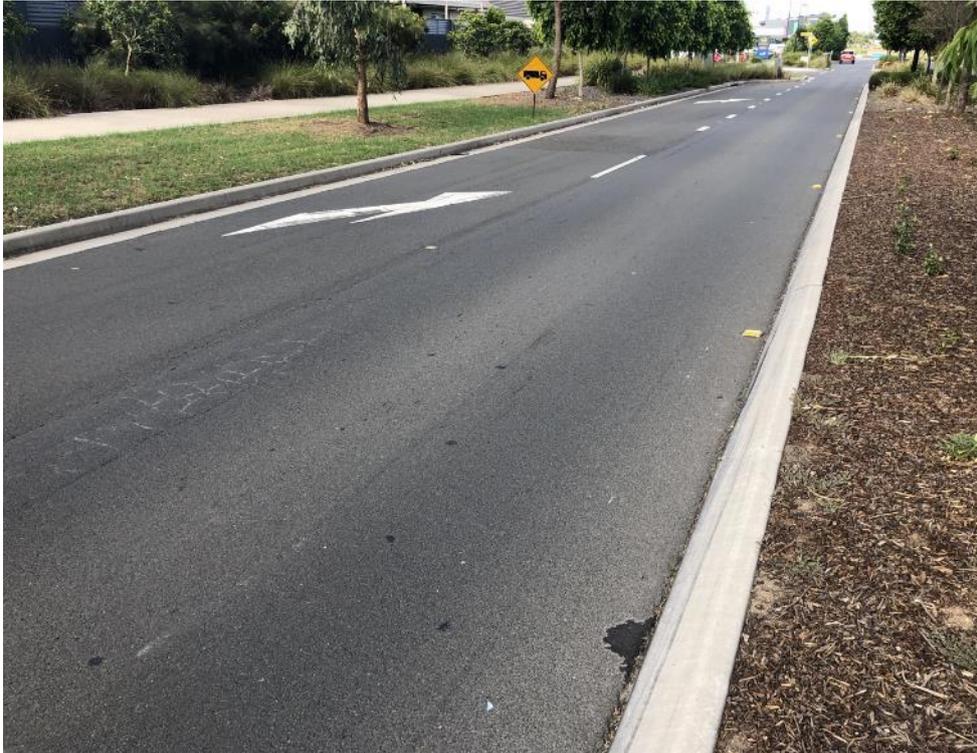
Figure 90: Approx CH300 EB Pavement failure (P66)

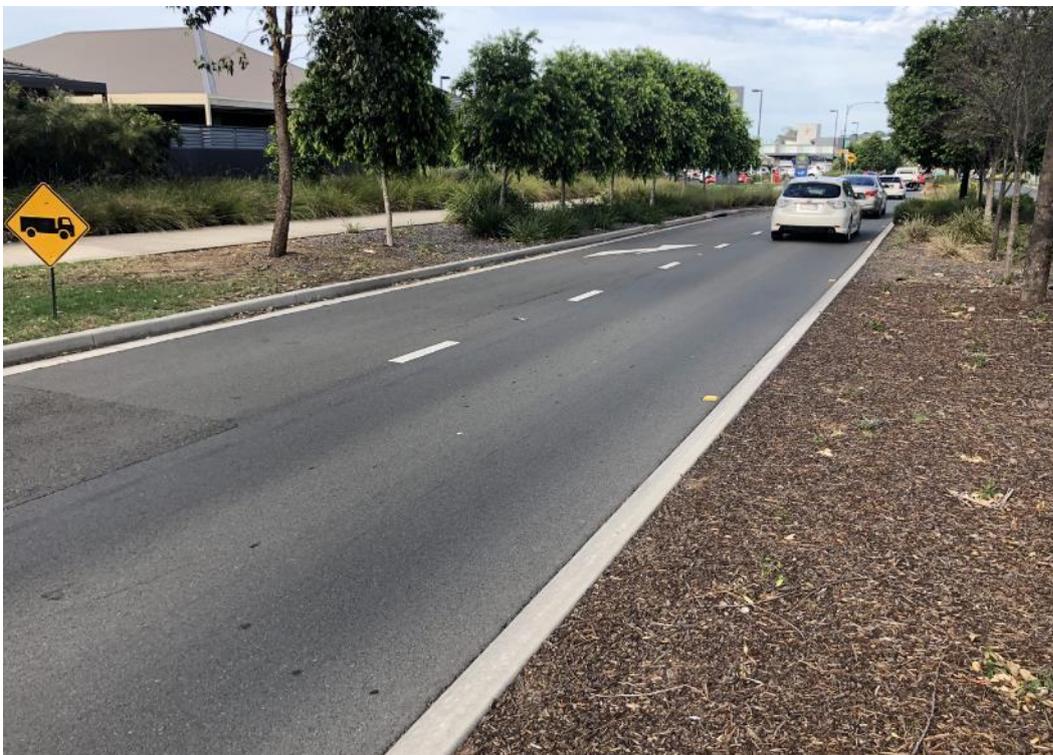
Figure 91: Approx CH320 EB Pavement failure

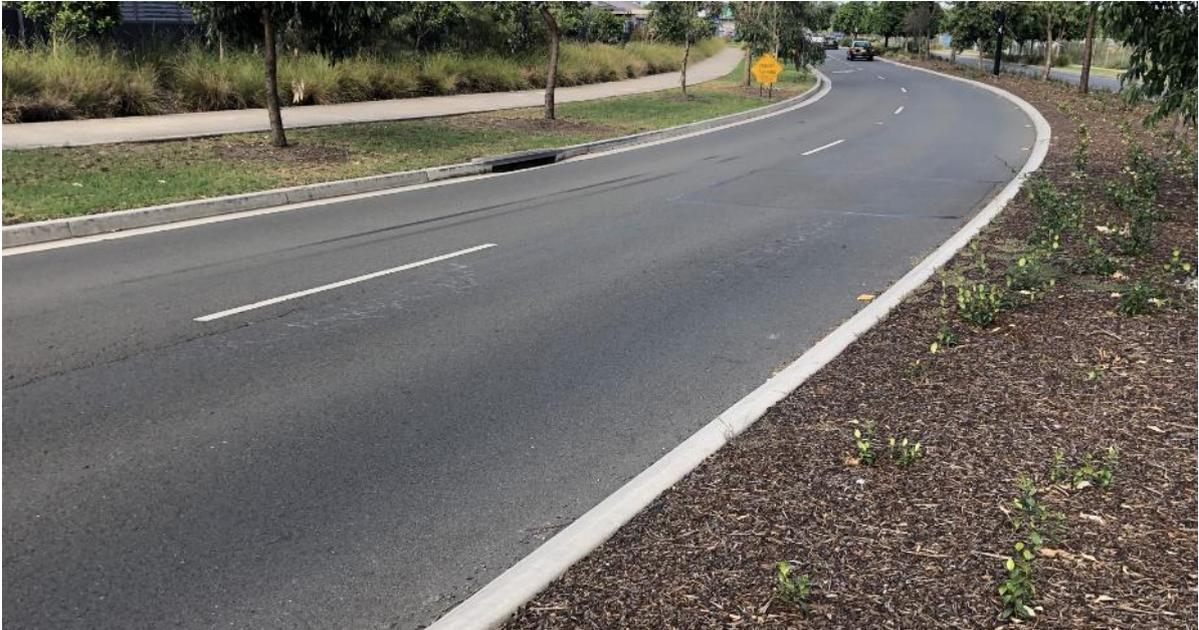
Figure 88: Approx CH250 EB pavement failure (P53)

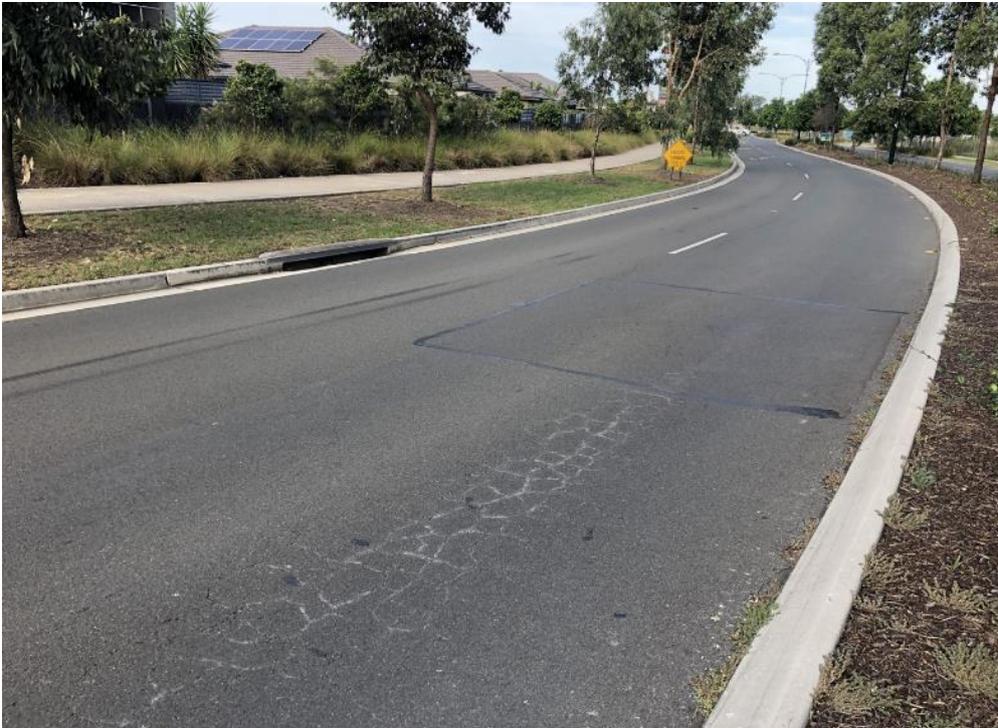
Figure 89: Approx CH255 EB Pavement failure

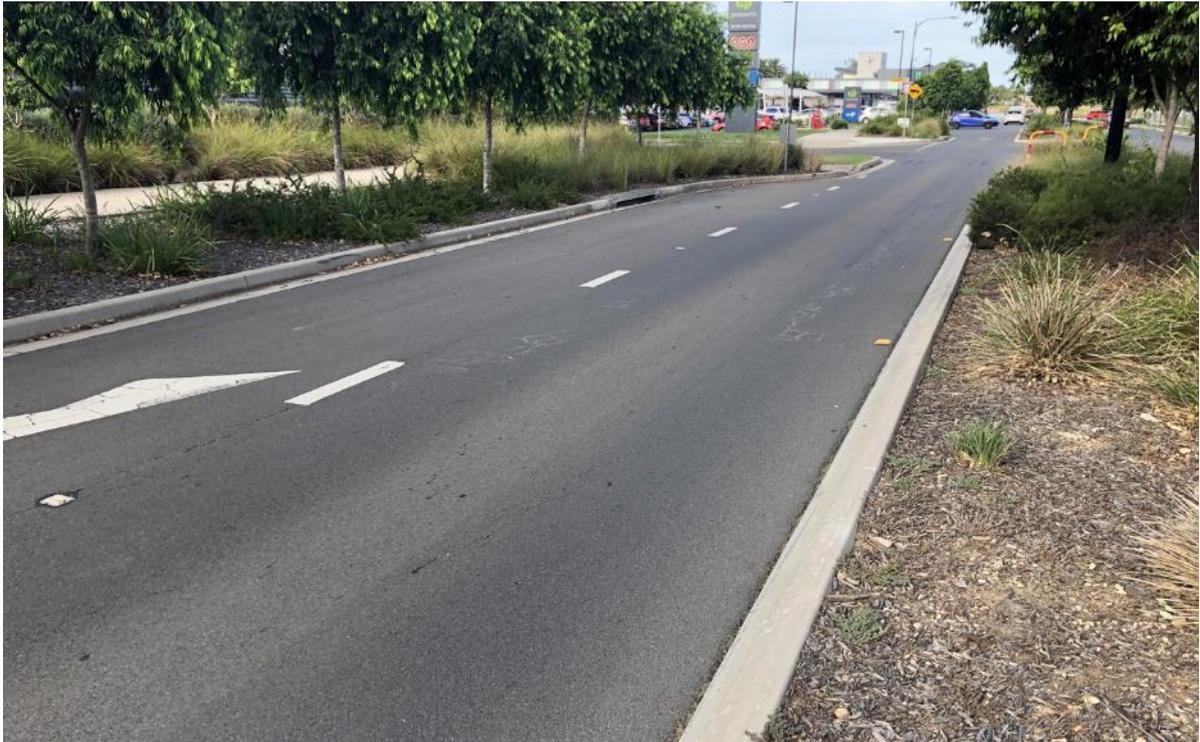
Figure 90: CH325-330 Pavement failure at wheel track (P70)

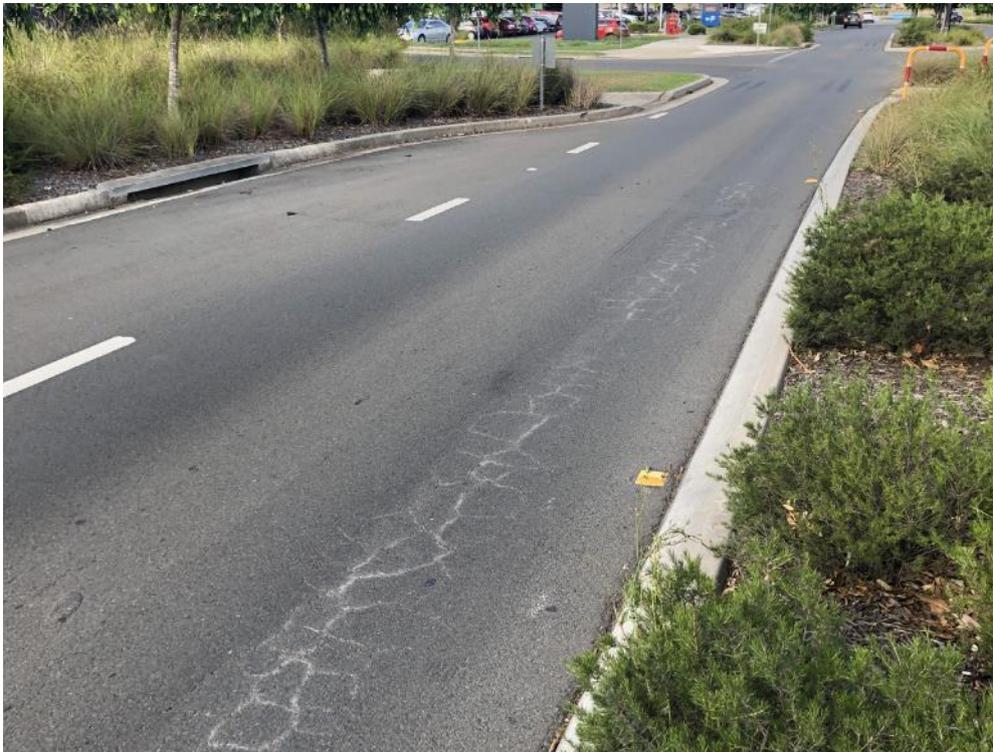
Figure 91: CH330 EB pavement failure at wheel track (P72)

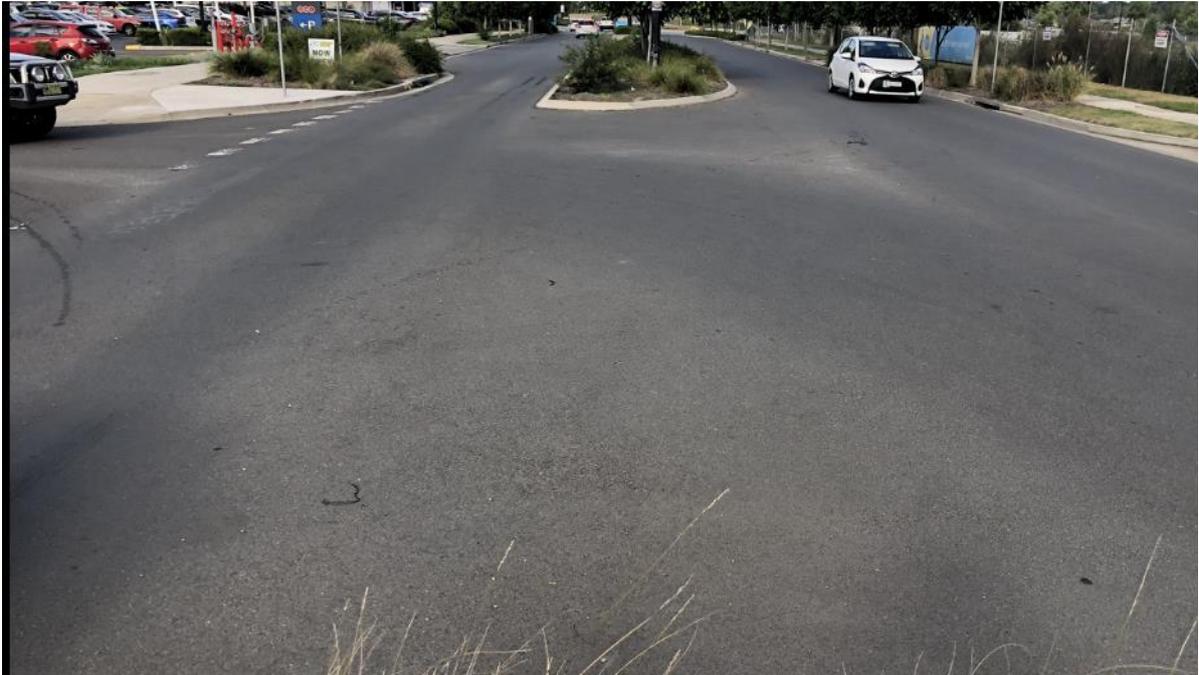
Figure 92: CH475 EB pavement failure at McGarrity Pde (P78)

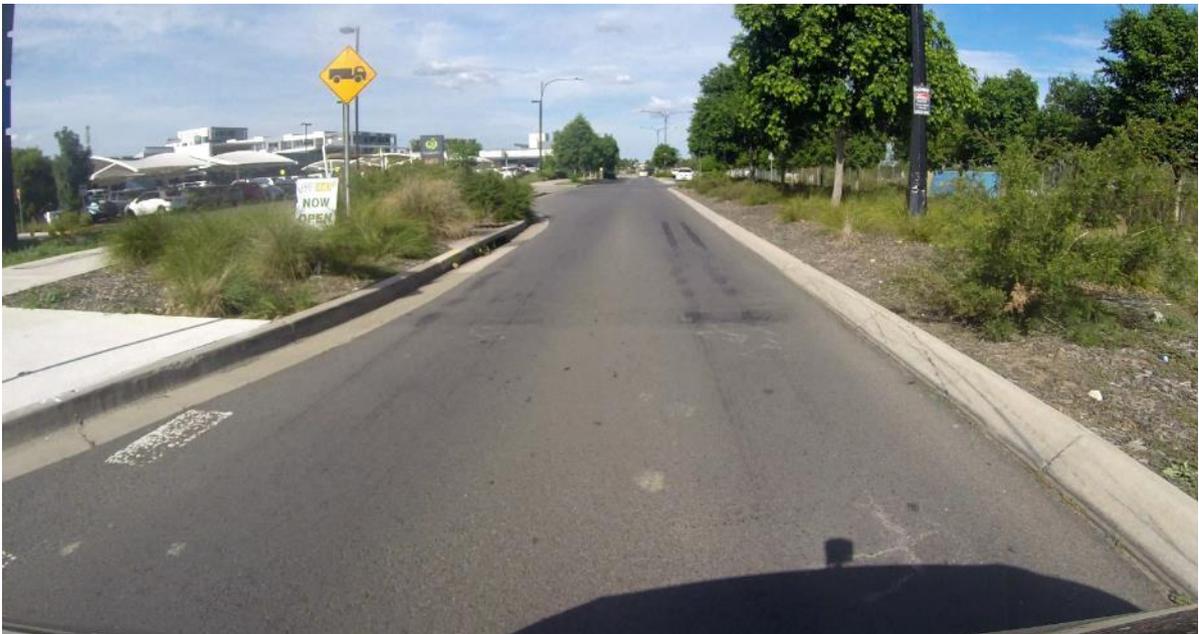
Figure 93: CH380 EB pavement failure

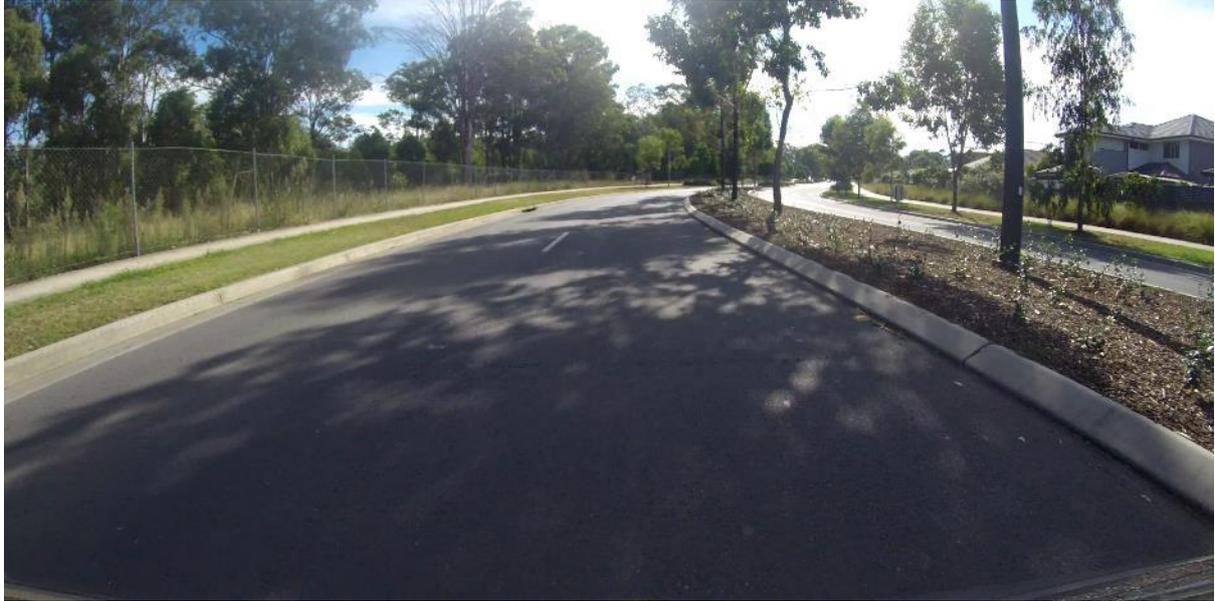
Figure 94: Approx CH200 WB horizontal crack

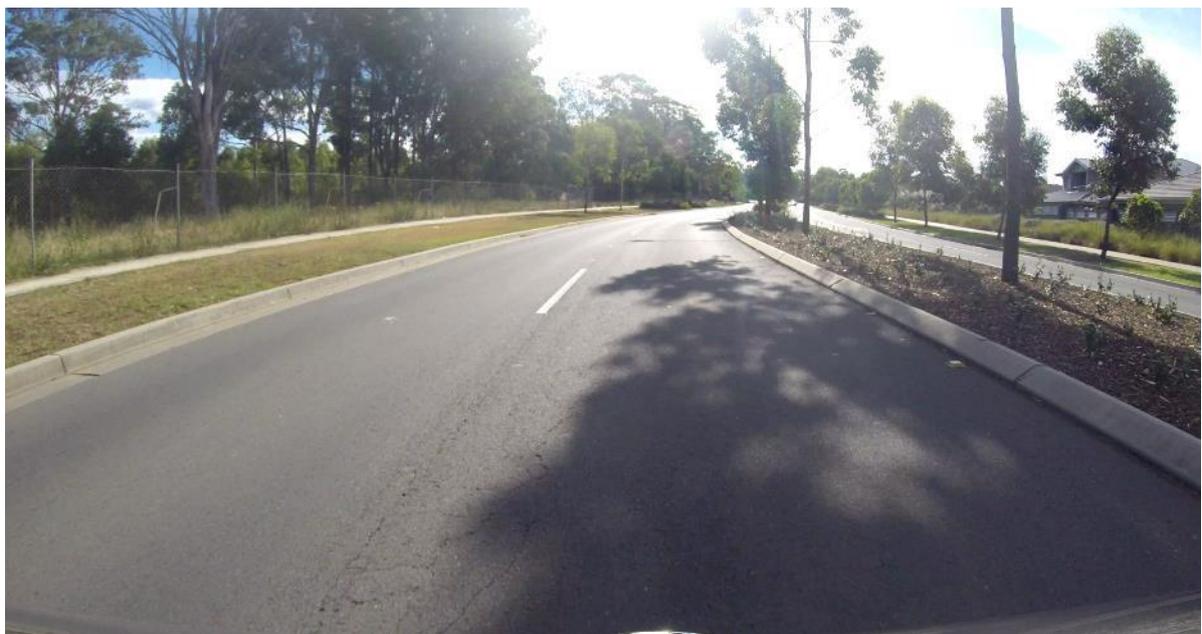
Figure 95: Approx CH210 WB Pavement failure

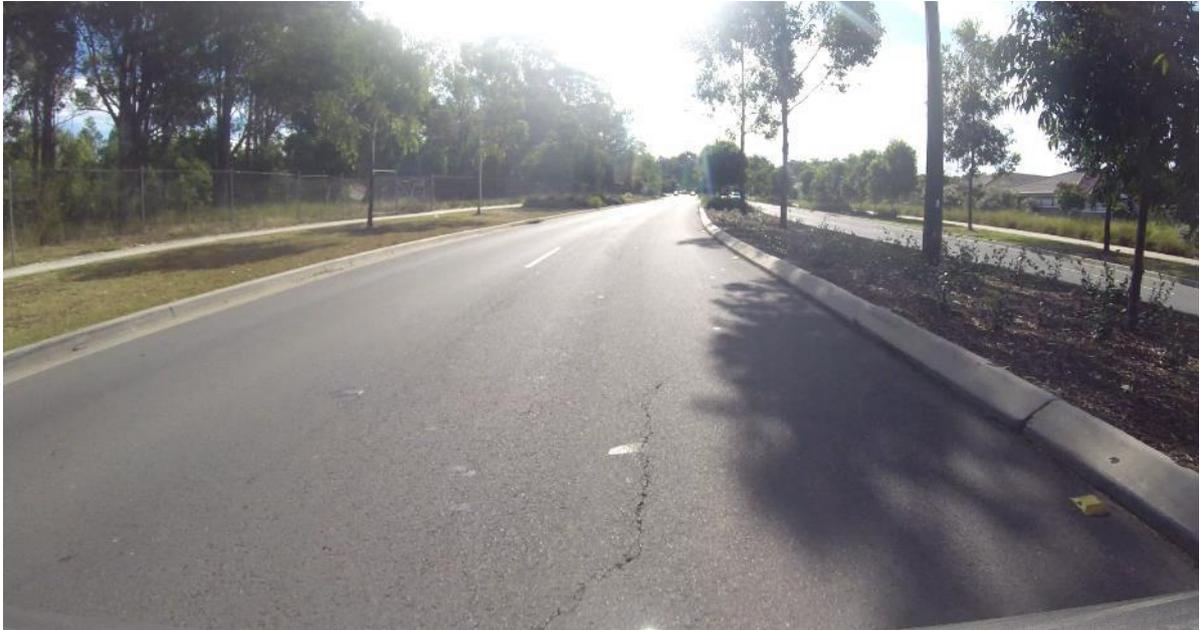
Figure 96: CH250 WB pavement crack/failure

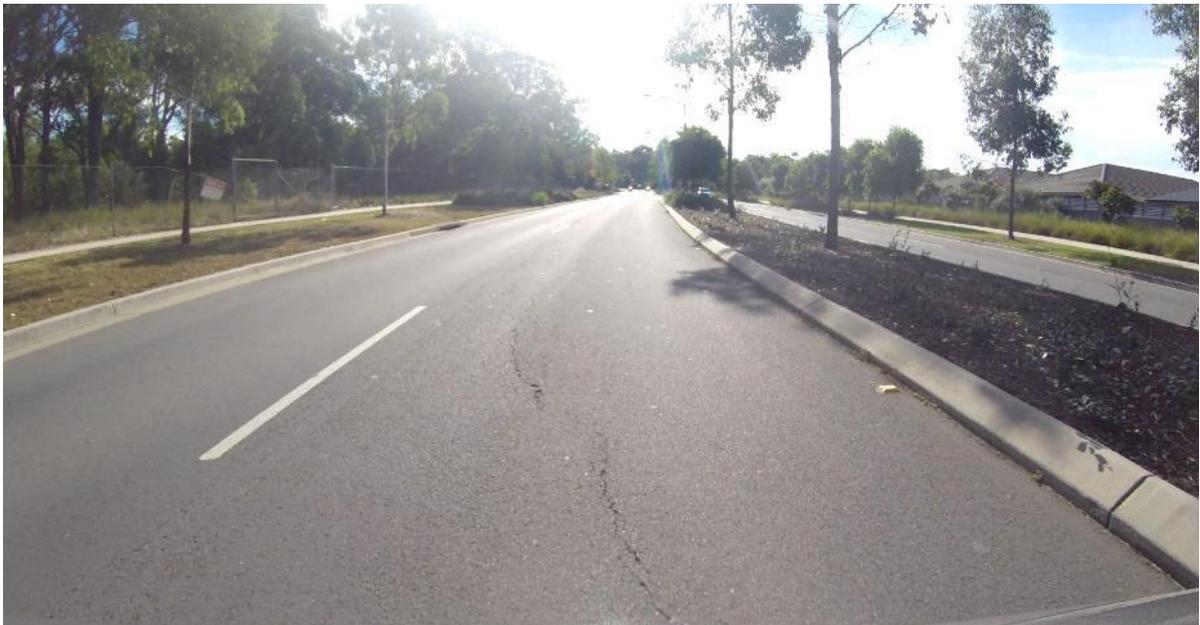
Figure 97: CH250-275 WB pavement crack/failure cont.

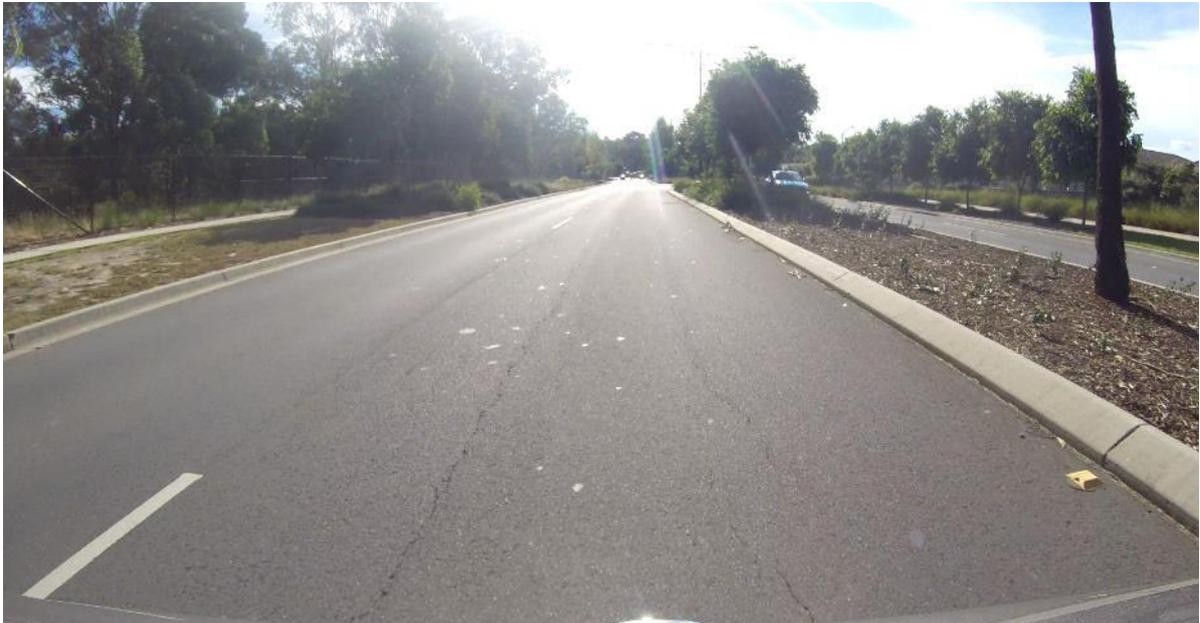
Figure 98: CH250-275 WB pavement crack/failure cont.

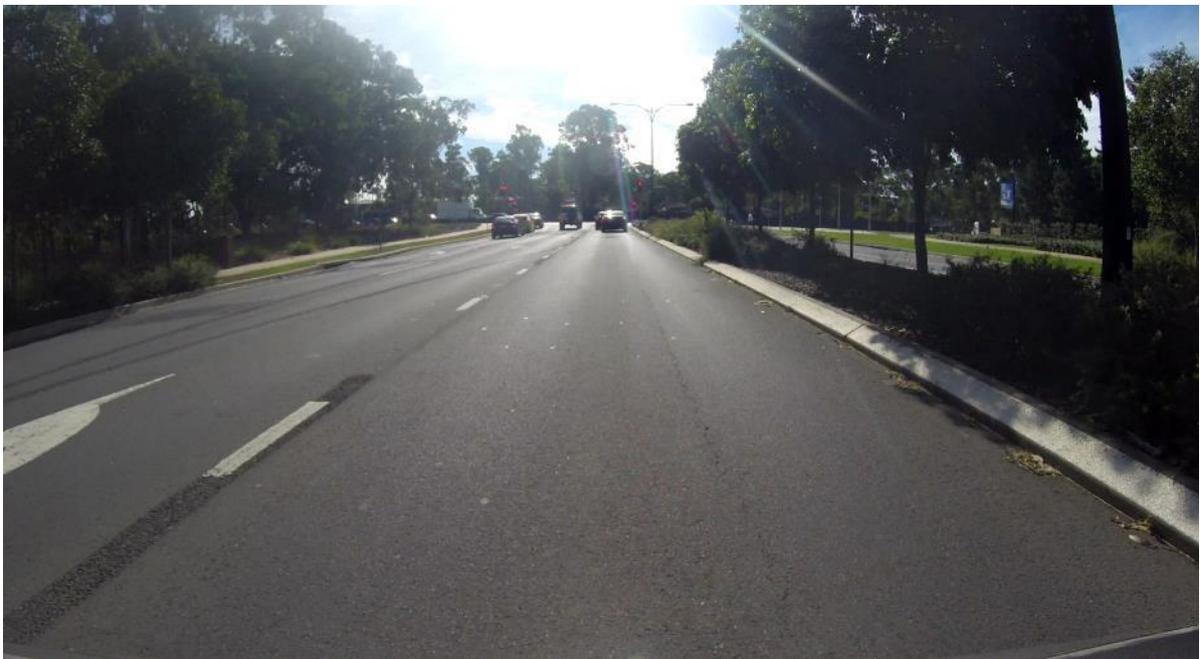
Figure 99: CH440 WB pavement crack/failure
